Investigation Report

PEQAM 18 / 1526

Field failure: DFDS Finlandia Seaways; 12V 48/60; fracture of connecting rod head (PSHR-2018-008)

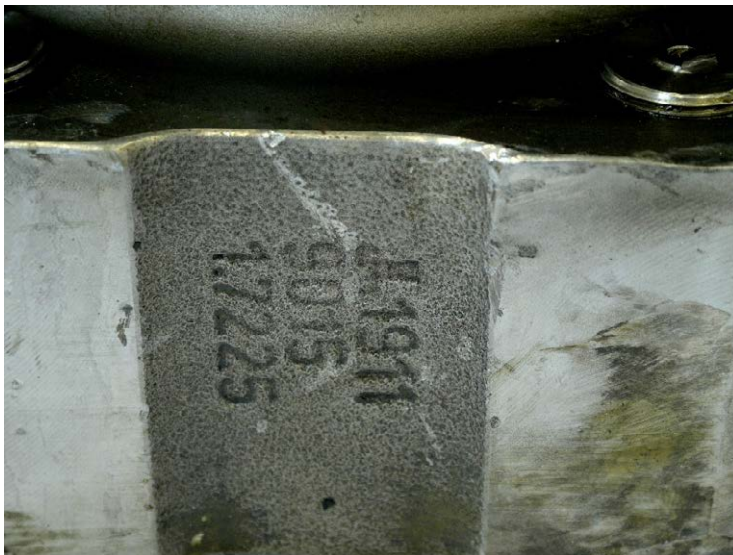
Picture 2:
Connecting rod head A5; marking 1

The first imprinted marking of the connecting rod head.

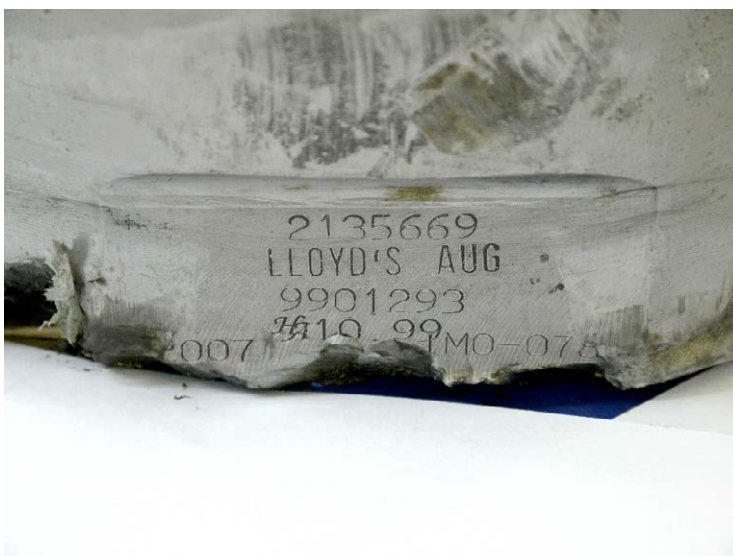
Picture 3:
Connecting rod head A5; lower piece

The second imprinted marking of the connecting rod head.

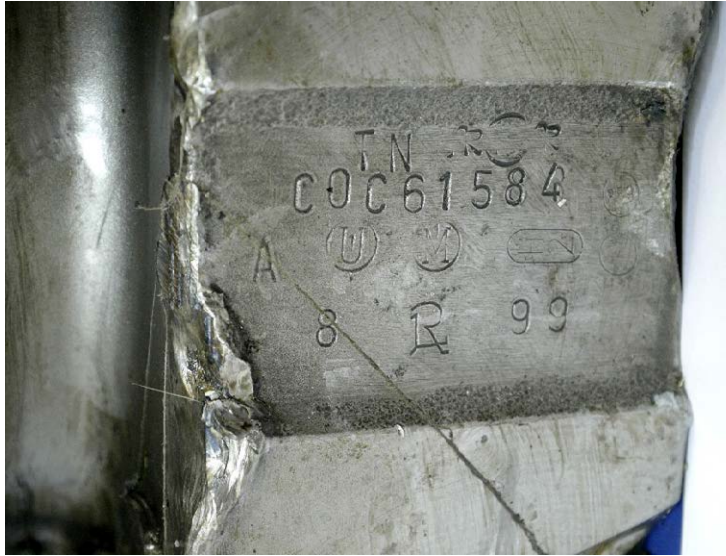
Picture 4:
Connecting rod head A5; lower piece

The third imprinted marking of the connecting rod head.

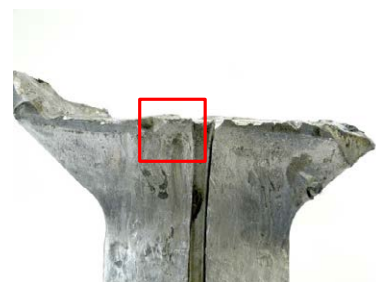
Picture 15:
**Connecting rod head A5; bearing surface
 exhaust side (upper piece)**

On the opposite side of the oil channel similar damage is visible.

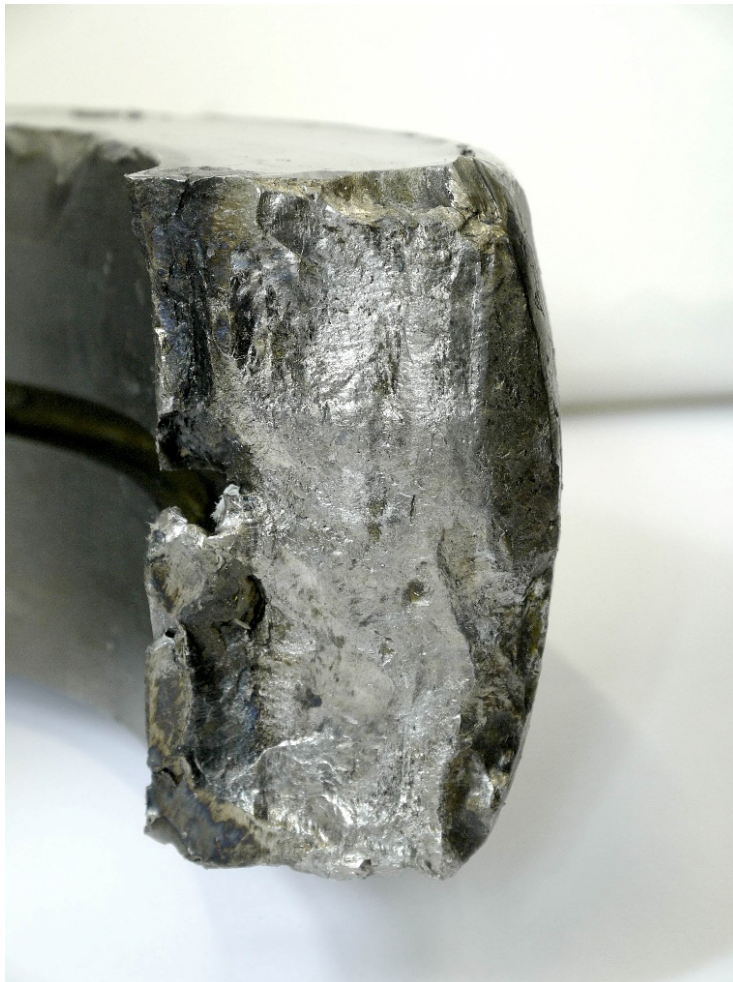
Picture 17:
Connecting rod head A5; bearing surface control side (upper piece)

The bearing surface showed heavy impact damage and deformation. Especially the edge of the fracture surface was found destroyed completely.

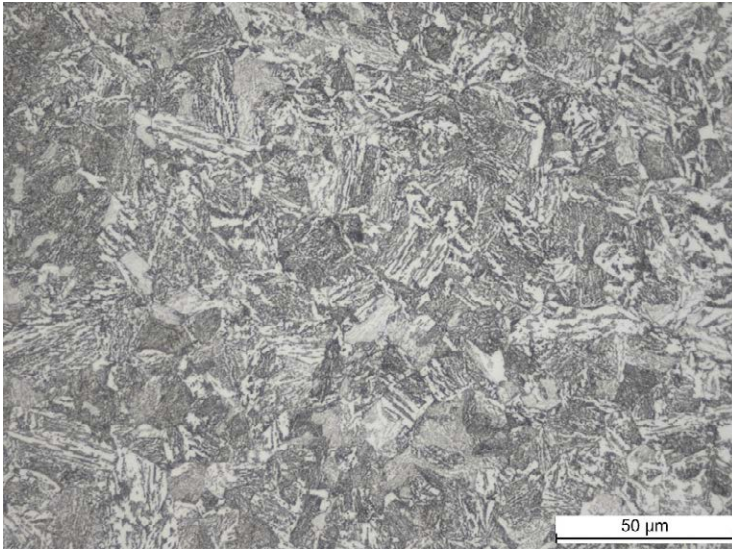
Picture 18:
Connecting rod head A5; microsection (bright area)

The microsection showed a quenched and tempered microstructure.

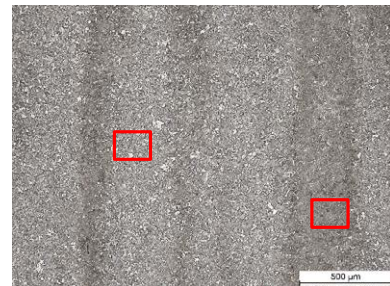
Picture 19:
Connecting rod head A5; microsection (dark area)

The microsection showed a quenched and tempered microstructure.

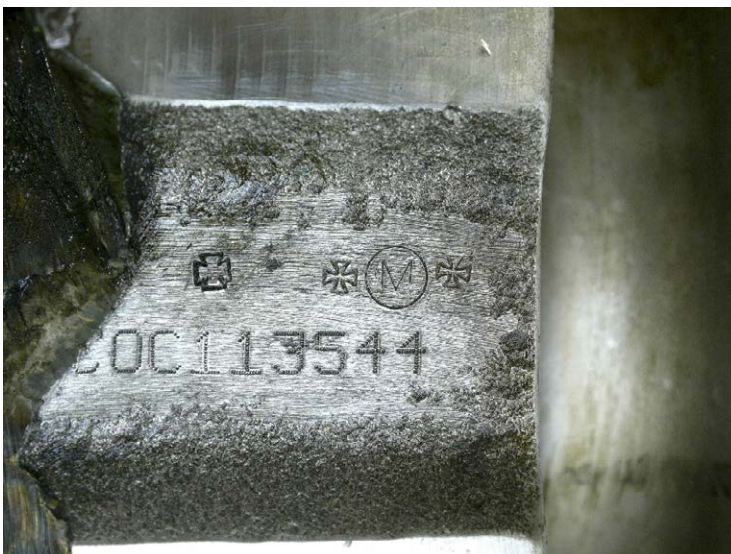
Picture 22:
Connecting rod head B5; marking 1

The first imprinted marking of the connecting rod head B5.

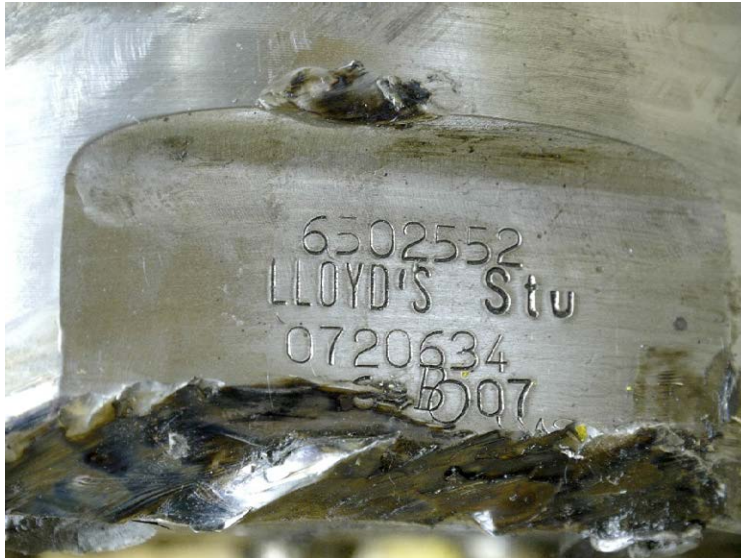
Picture 23:
Connecting rod head B5; marking 2

The second imprinted marking of the connecting rod head B5.

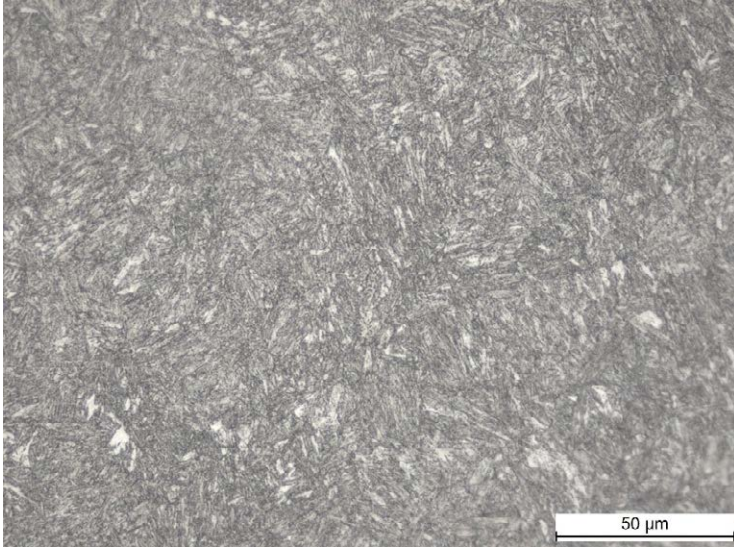
Picture 27:
Connecting rod head A5; microsection

The microsection showed a uniform, fine grained, quenched and tempered microstructure.
