Supporting the uptake of resilient repair during the recovery process (FD2706)

Appendix 6: Eden Bridge House Case Study

REVIEW OF DEFRA EDEN BRIDGE HOUSE PROPERTY FLOOD RESILIENCE IMPLEMENTATION

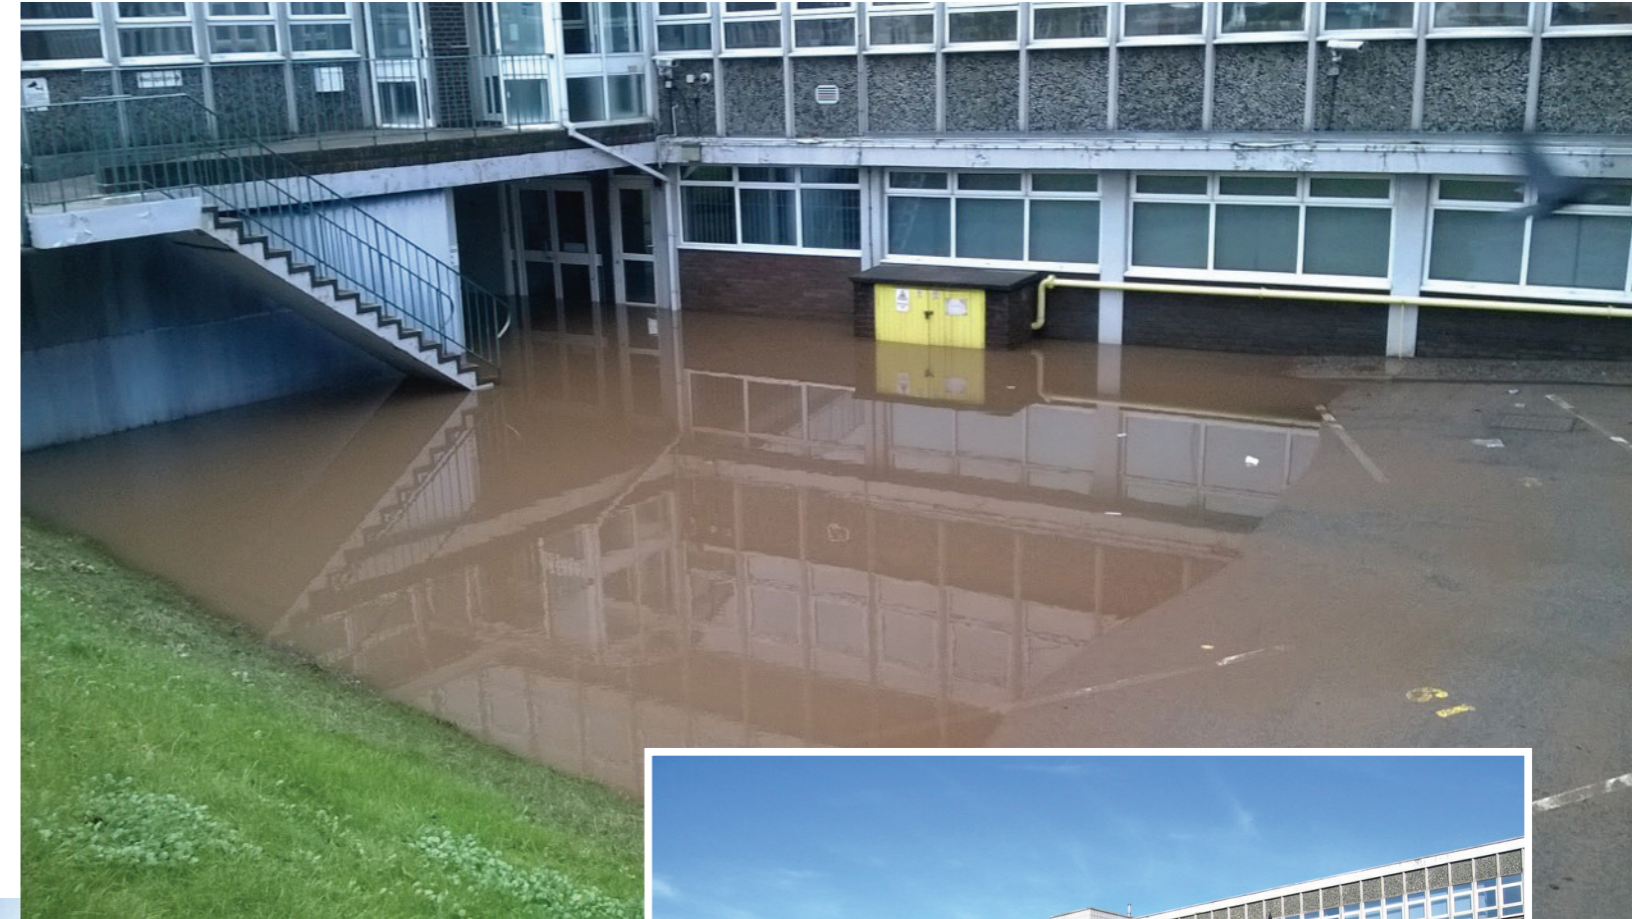
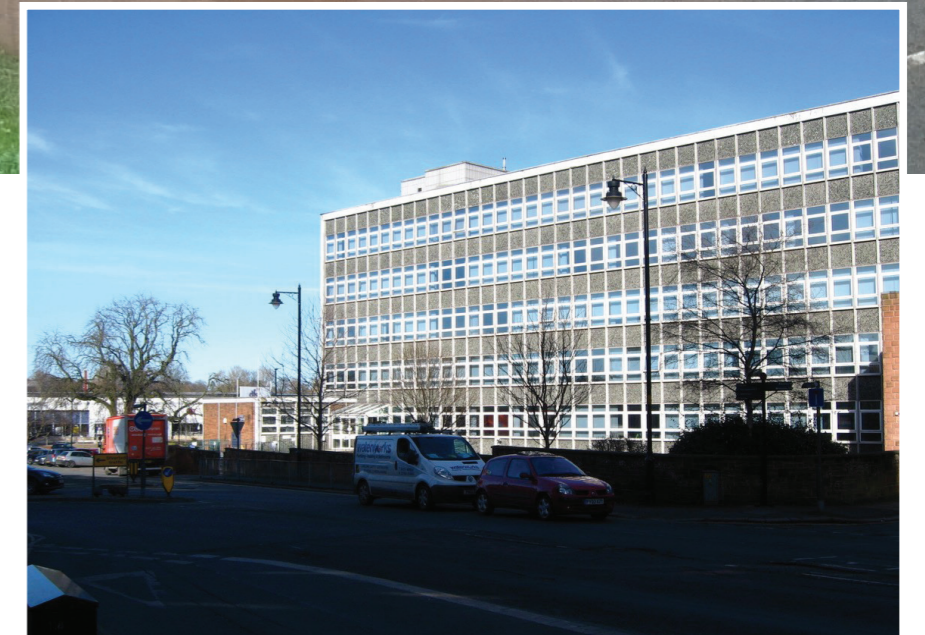
Case Study – Eden Bridge House, Carlisle

The building is a 1960s office block that suffered significant flood damage to the lower ground floor in December 2015, the second time in 5 years that the building flooded. Extensive repair work was required to the lower ground floor before it could be returned to use.

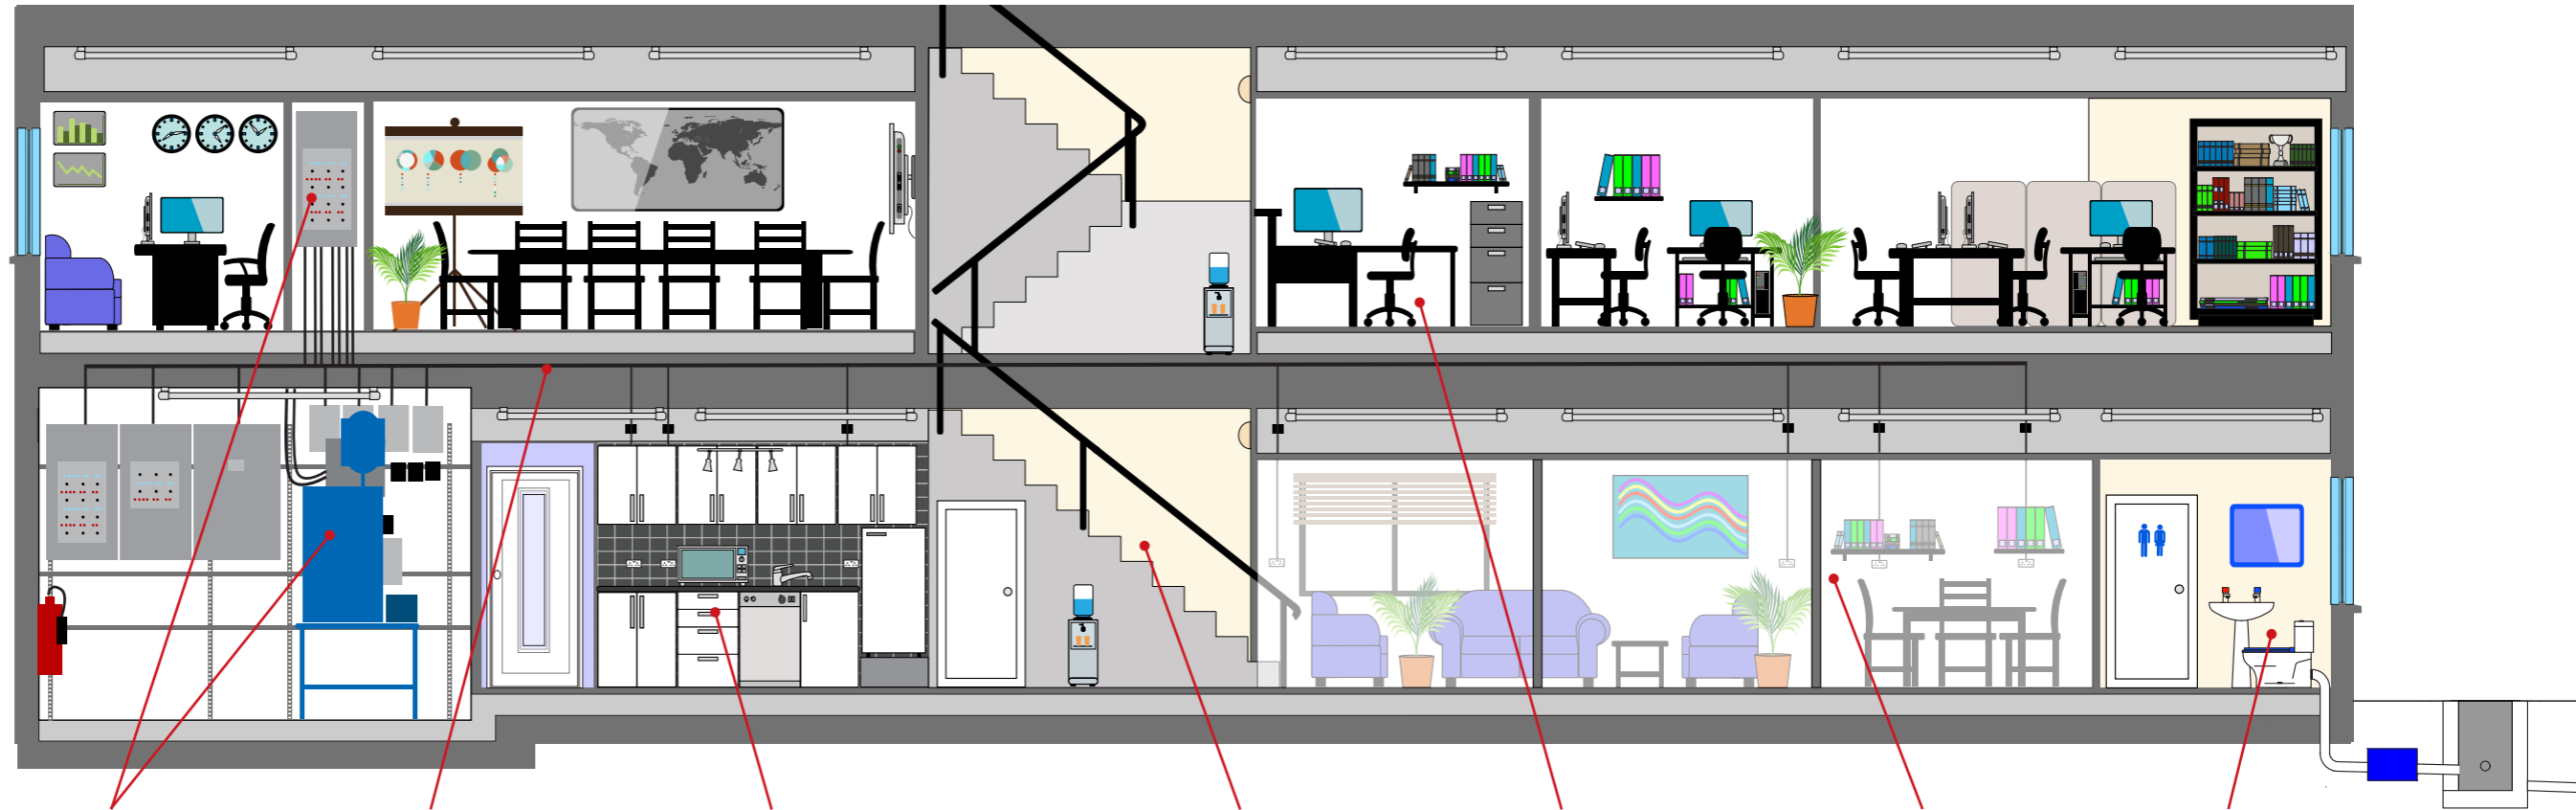
Electrical supply

Electrical panel relocated upstairs. A generator connection was also added to this panel which would enable a temporary electrical supply to be given to the building in the event that local electrical network distribution had been knocked out by the flood.
