Report on the investigation of
the engine failure and fire on board
the ro-ro cargo vessel

Finlandia Seaways

11 miles east of Lowestoft

16 April 2018

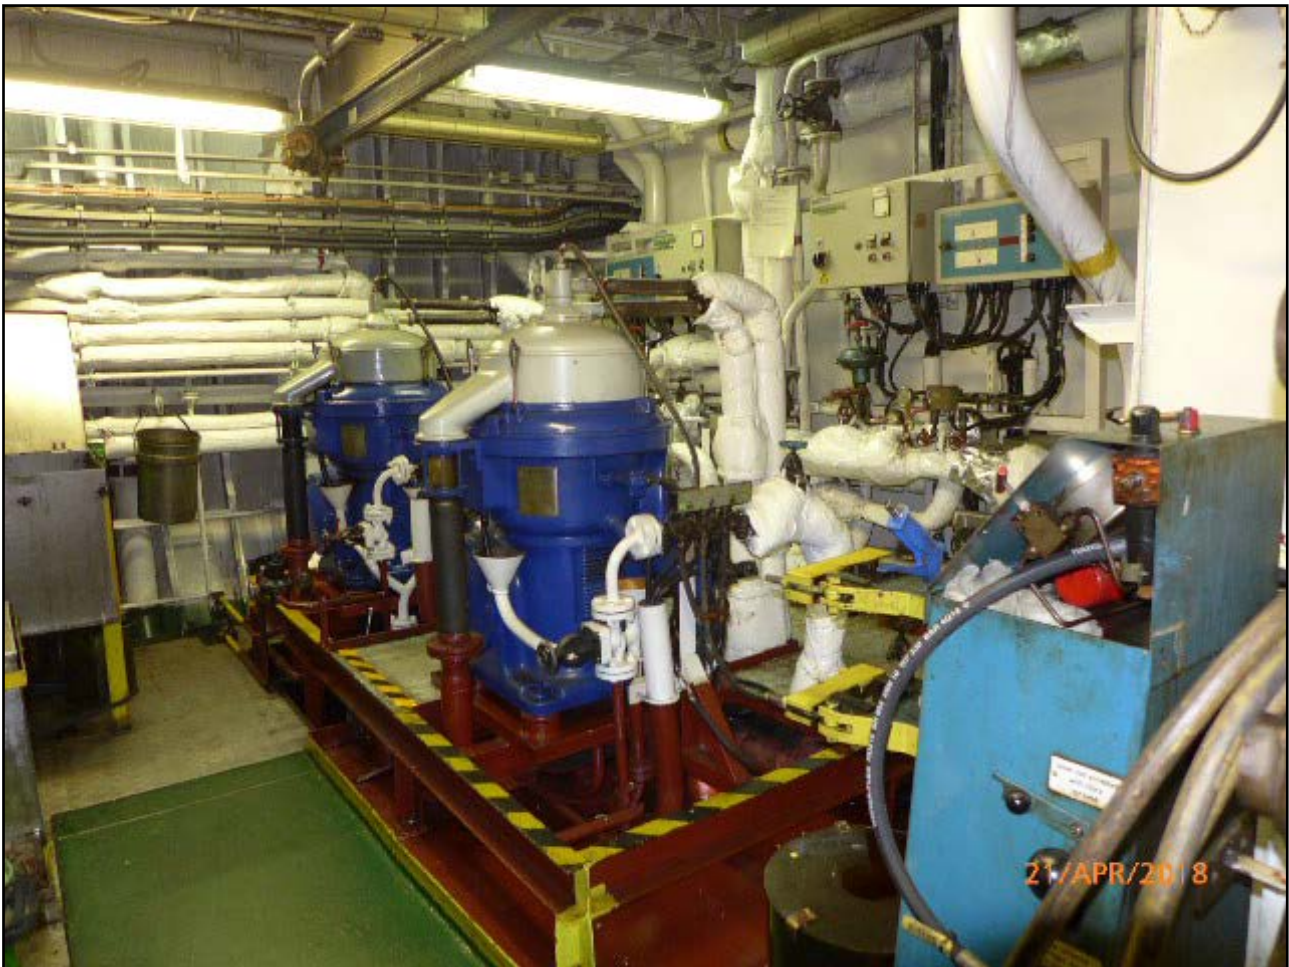
Figure 2: Engine room purifier room

At about 2000, the 3/E left the ECR and commenced his hourly rounds of the engine room and machinery spaces. Shortly after entering the purifier room (**Figure 2**), he heard loud metallic knocking sounds coming from the engine room. At the same time, powerful vibrations were being felt on the bridge by the officer of the watch (OOW), who immediately checked the propeller pitch angle and main engine speed gauges. The OOW saw that both gauges were fluctuating and immediately reduced the propeller pitch from 60% to 25%. He then saw that the fuel consumption meter was also fluctuating and giving abnormal readings, while various engine warning lights were illuminated.

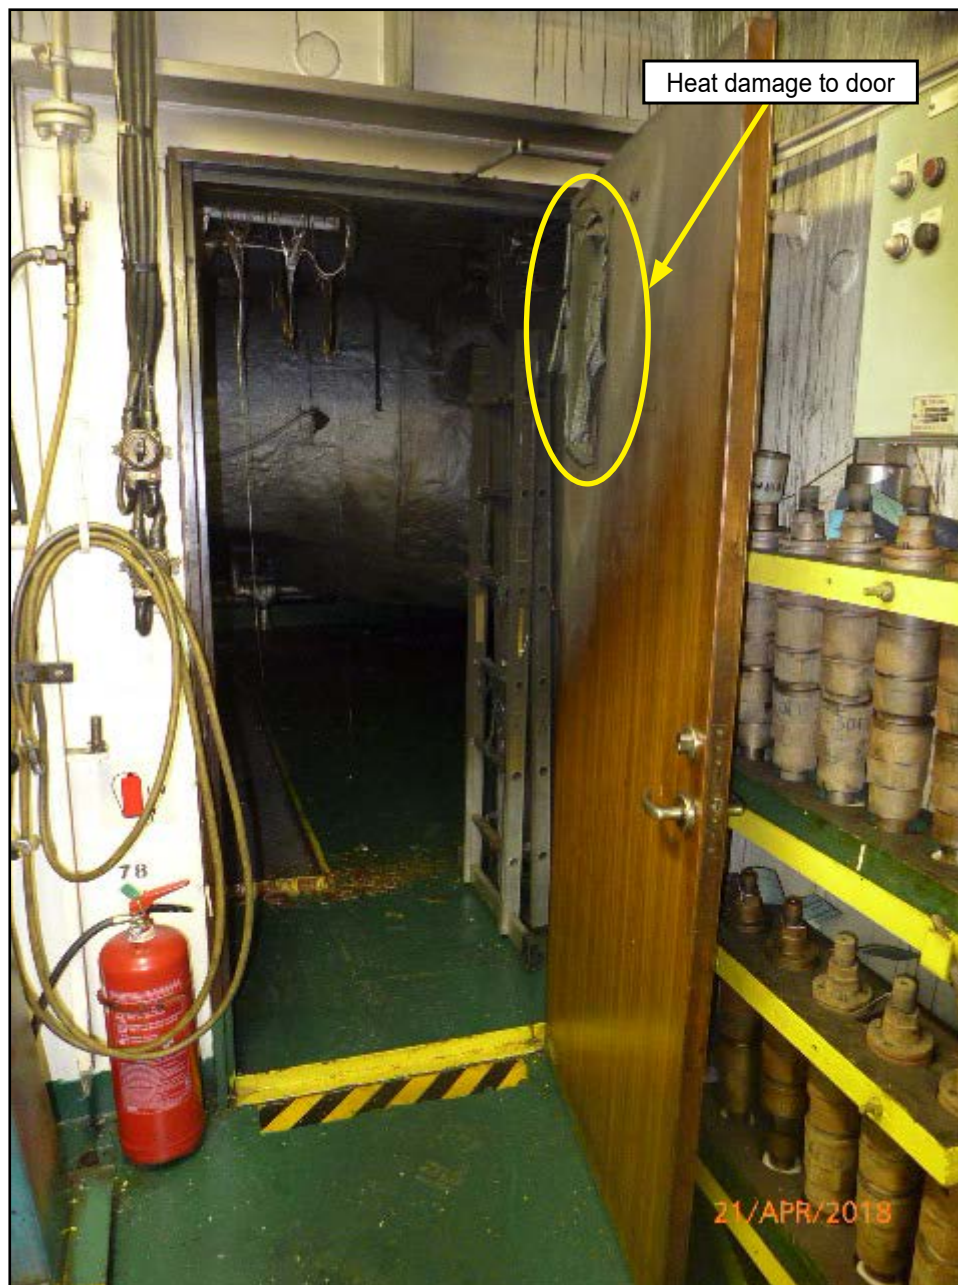
Figure 3: Purifier room door

The 3/E opened the purifier room door, looked out into the engine room and saw smoke rising from the port forward end of the main engine. The noise and vibration levels rapidly increased and, sensing danger, the 3/E ran back into the purifier room and crouched behind one of the purifiers. Almost immediately, at 2003, there was a loud bang and flames flashed past the open purifier room door (**Figure 3**) and the space filled with thick black smoke. The ship blacked out¹, but within seconds the emergency generator cut-in and the emergency lighting came on. Despite this, the smoke in the engine room had reduced the 3/E's visibility to almost nothing.

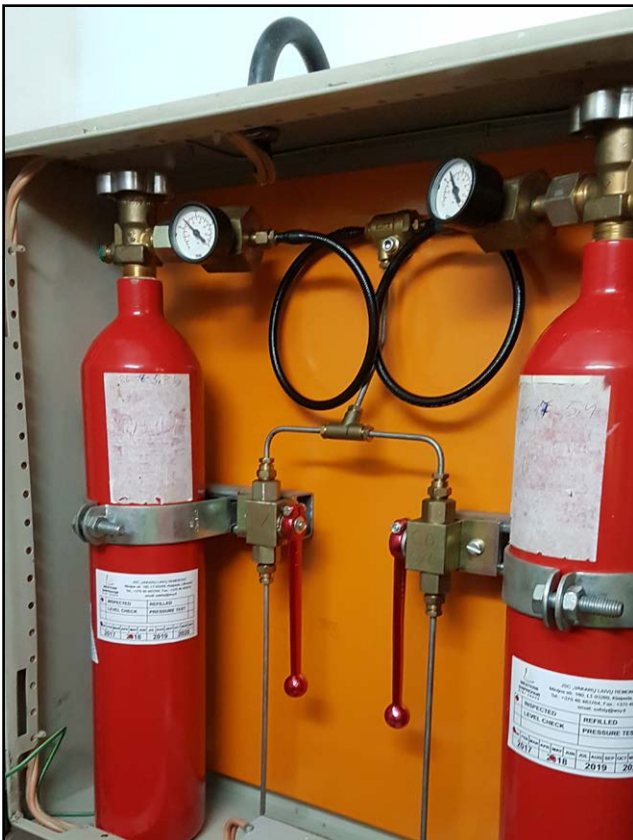
Figure 10: CO₂ remote release station

The 2/E and the second officer went to the CO₂ remote release station (**Figure 10**) on the forecastle deck and, at about 2020, released the CO₂ into the engine room. The 2/E then went down to the main deck and entered the CO₂ bottle room (**Figure 11**). He found that the control lever for the engine room had operated correctly and that the CO₂ pipework had frosted. He also noted that the main CO₂ supply line pressure gauge was indicating about 20bar pressure, and a short time later he saw it reduce to zero.

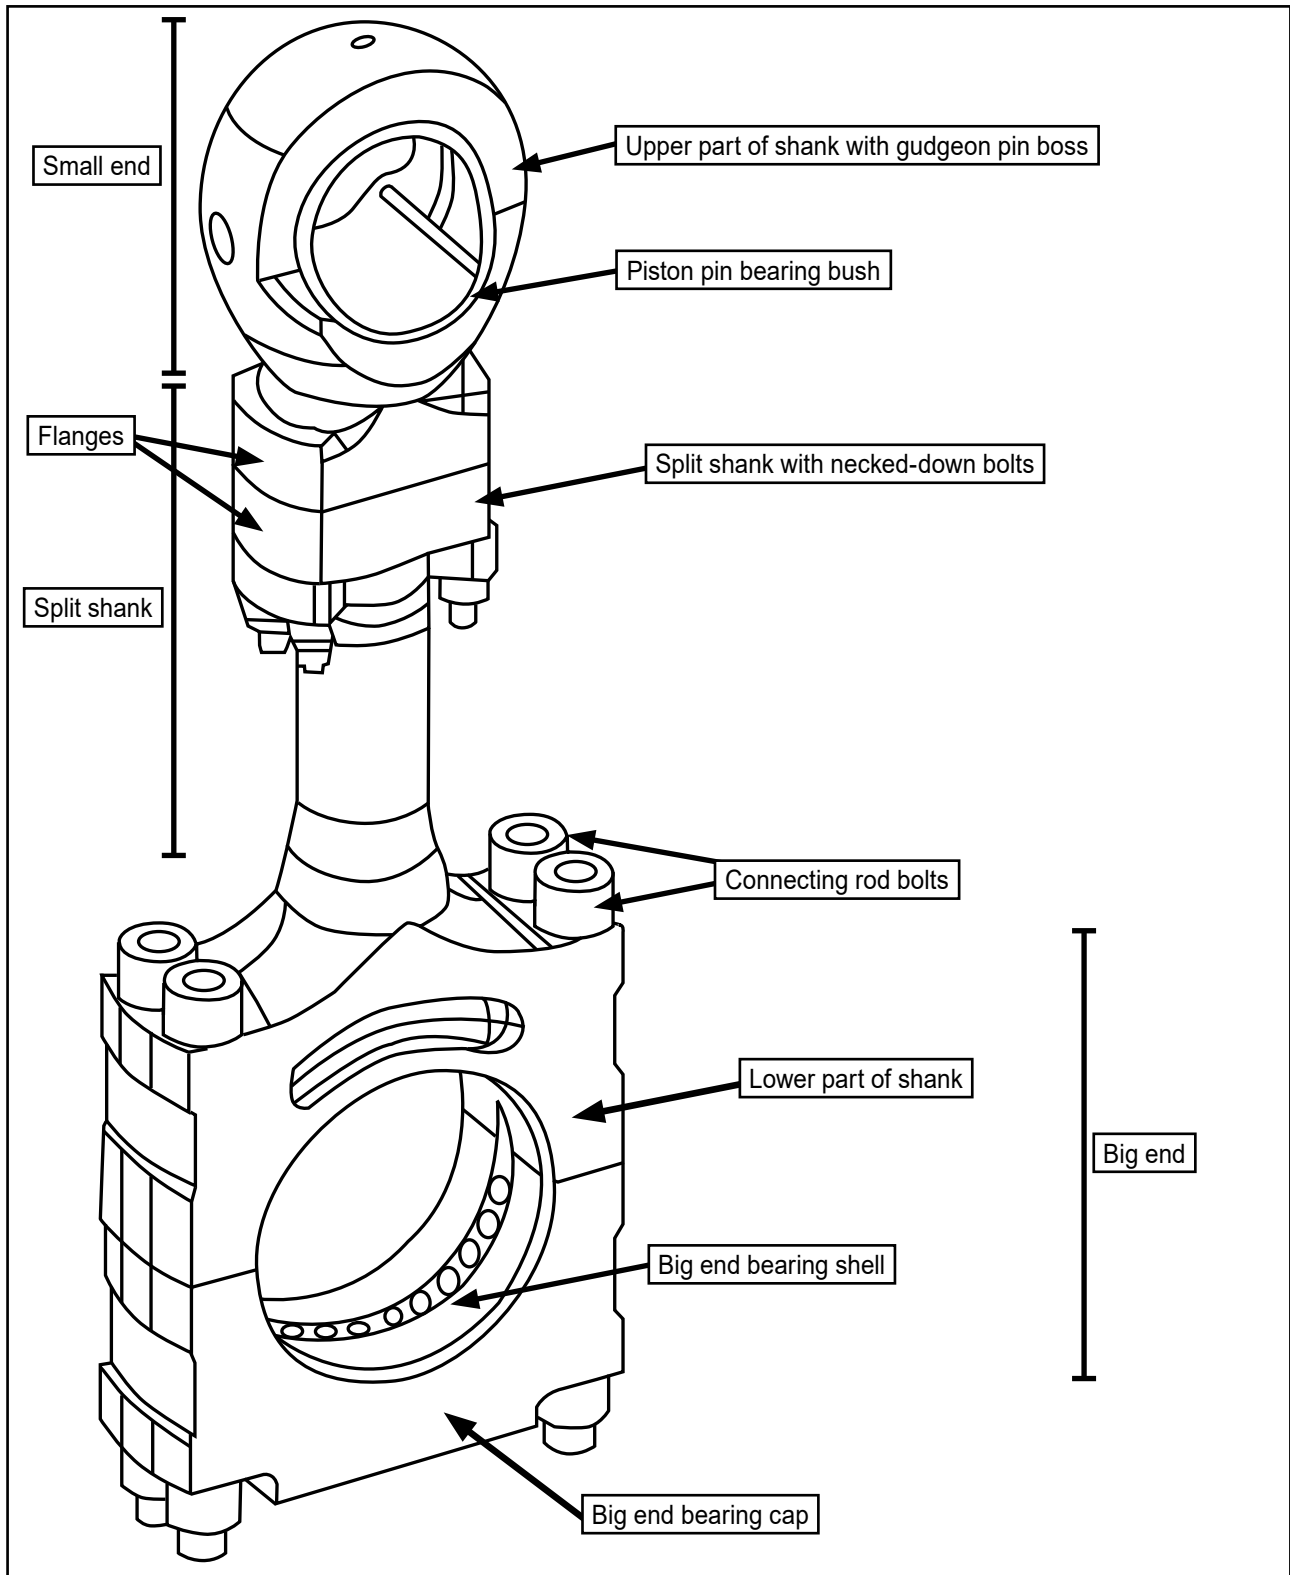
Figure 14: Connecting rod assembly

The piston connecting rods were cast in one piece. During manufacture, the connecting rod shank was cut below the small end eye, flanged and bolted together. This was to facilitate piston removal without the need to remove the connecting rod big end bearing. The shank’s flanged connection was the weakest part of the connecting rod assembly (**Figure 14**).

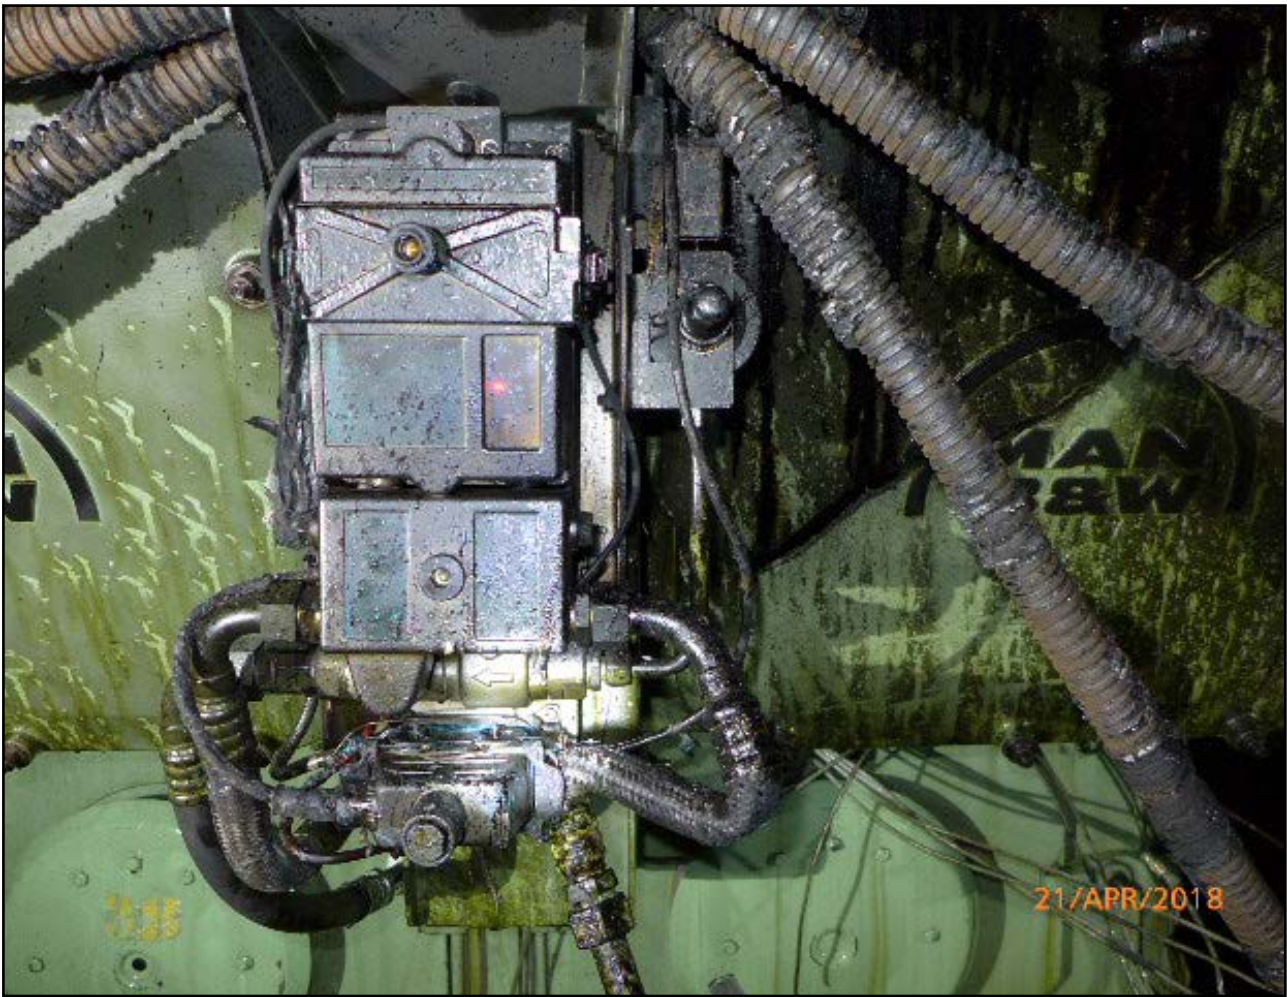
Figure 16: Crankcase oil mist detector

The OMD was manufactured by Schaller Automation and was fitted on the starboard side of the engine crankcase (**Figure 16**). The OMD measured and compared the oil vapour concentrations present in each crankcase compartment and provided an audible and visual alarm when anomalies were identified. The OMD could also trigger an engine shutdown if high levels of mist developed in one or more compartments.
