Rail Accident Investigation Branch

Rail Accident Report

Freight train derailment at Eastleigh, Hampshire 28 January 2020

Report 02/2021
March 2021

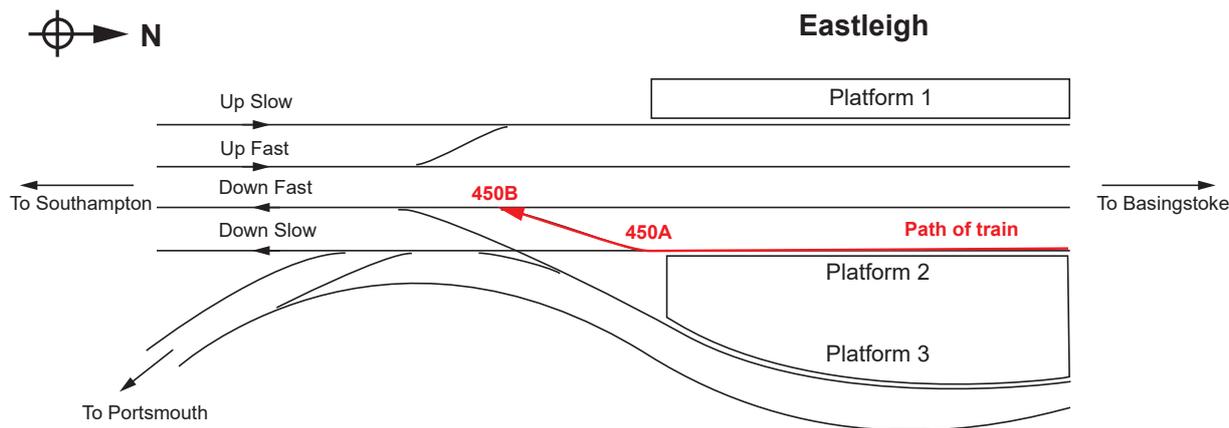
Figure 3: Track layout at Eastleigh station

- 7 The derailment occurred at the south end of Eastleigh station platform 2, as the train traversed 450A points. These form part of a crossover² with 450B points. At the time of the accident, both 450A and 450B points were set for trains to travel from the down slow line to the down fast line (figure 3). The maximum permitted speed for trains to pass over the crossover is 15 mph (24 km/h).
- 8 Although the railway is level and generally straight at this location, trains need to negotiate tight radius curves when travelling over the crossover.
