ACCIDENT

Aircraft Type and Registration:	SB-5E glider, G-DEJH	
No & Type of Engines:	None	
Year of Manufacture:	1970 (Serial no: 5041A)	
Date & Time (UTC):	7 August 2019 at 1303 hrs	
Location:	Summit of Cross Fell, Pennines, Cumbria	
Type of Flight:	Private	
Persons on Board:	Crew - 1	Passengers - None
Injuries:	Crew - 1 (Serious)	Passengers - N/A
Nature of Damage:	Destroyed	
Commander's Licence:	BGA Glider Certificate with Bronze endorsement	
Commander's Age:	15 years	
Commander's Flying Experience:	69 hours (of which 2 hours were on type) Last 90 days - 21 hours Last 28 days - 9 hours	
Information Source:	AAIB Field Investigation

Synopsis

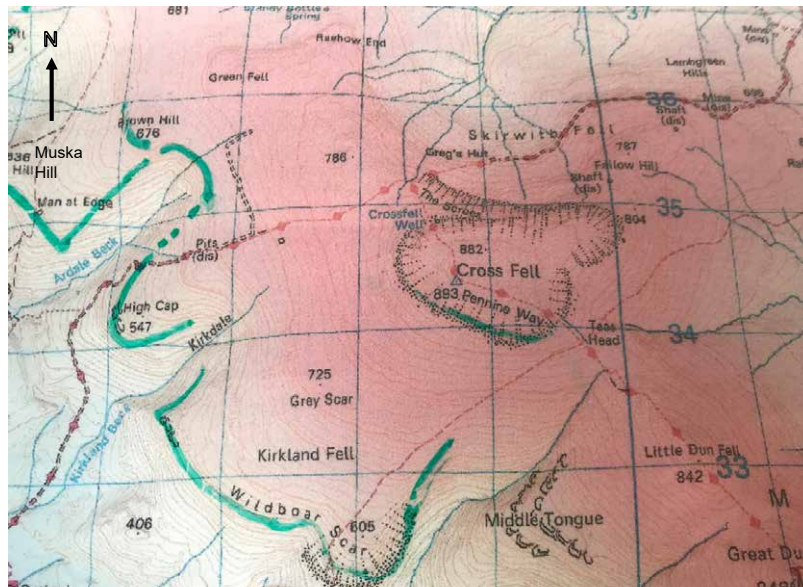
Figure 1

Ordnance Survey Map used for the briefing on the day of the accident

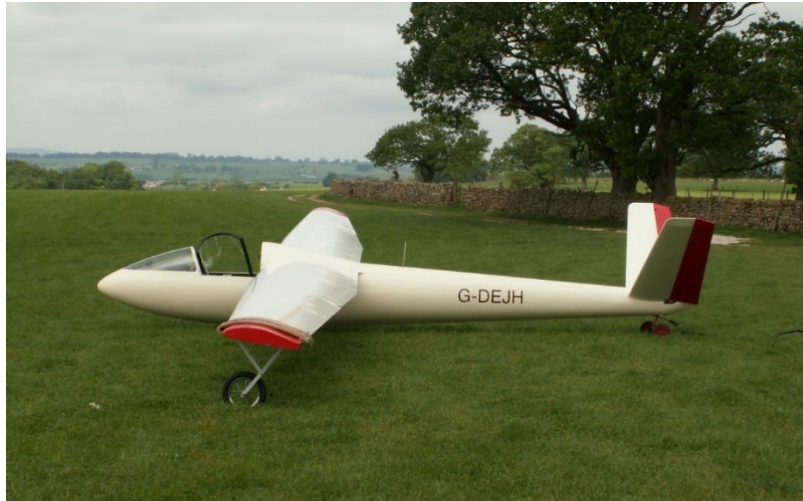
Figure 4

SB-5E glider, registration G-DEJH (Image used with permission)

It was observed that the ruddervators were not mass balanced and it was found that the centre of gravity (CG) was aft of the hinge line; this was later confirmed by the manufacturer to be by design.

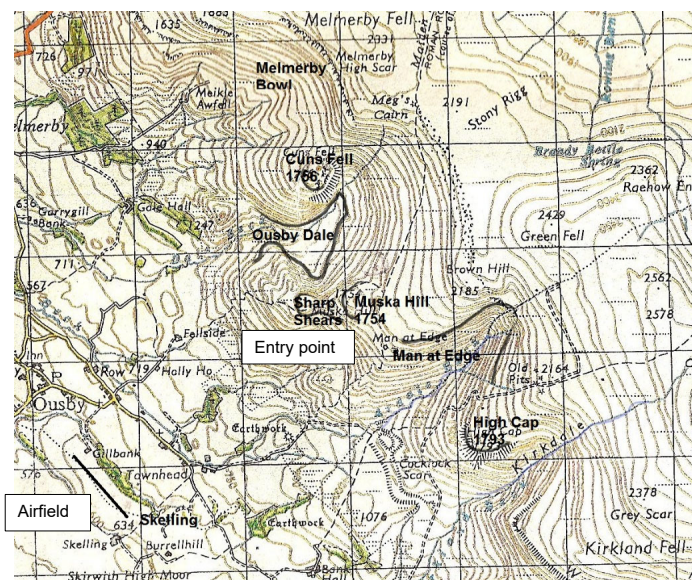
Figure 7

The gliding club operated from an unlicensed field (Figure 7), approximately 4 nm west-north-west from the summit of Cross Fell. The ridges used by the club lie beneath the summit of Cross Fell and are recognised as ideal, but challenging, due to the complex ridge structure¹⁵ and its gullies. After entering the area at Muska Hill, pilots are advised to be above 1,500 ft aal before either crossing in front of Man at Edge to the south, or into Ousby Dale to the north.

The ridge structure below Cross Fell
