The collision between the commercial fishing vessel *Vertrouwen* and recreational motor cruiser *James 2* resulting in the sinking of *James 2* and loss of three lives Shoreham-by-Sea 6 August 2017

SUMMARY

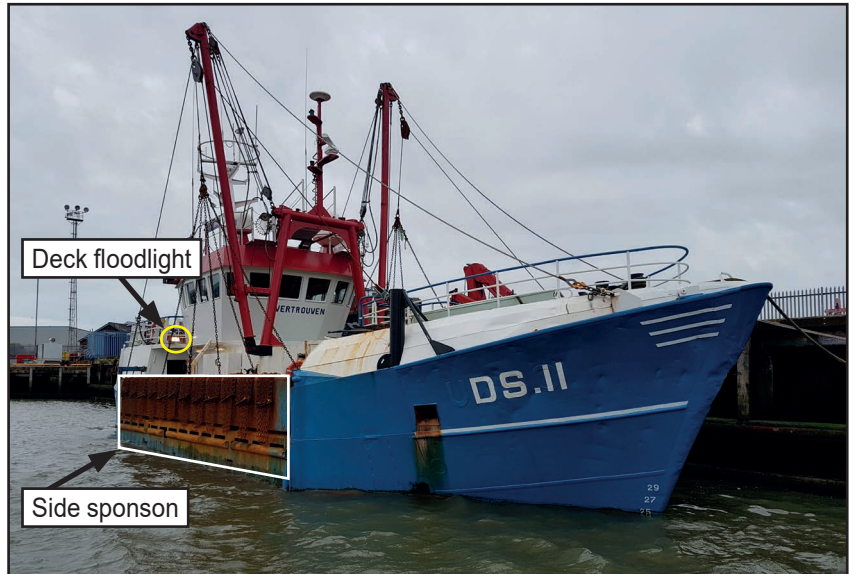
On 1 August 2017, the UK registered fishing vessel *Vertrouwen* (**Figure 1**) arrived at Shoreham harbour and entered the port's dry dock for repairs to a leaking propeller shaft seal. The vessel was scheduled to sail on Friday 4 August, but problems with the supply of spare parts and extra-emergent work delayed its departure by 24 hours.

Figure 1: fv *Vertrouwen*

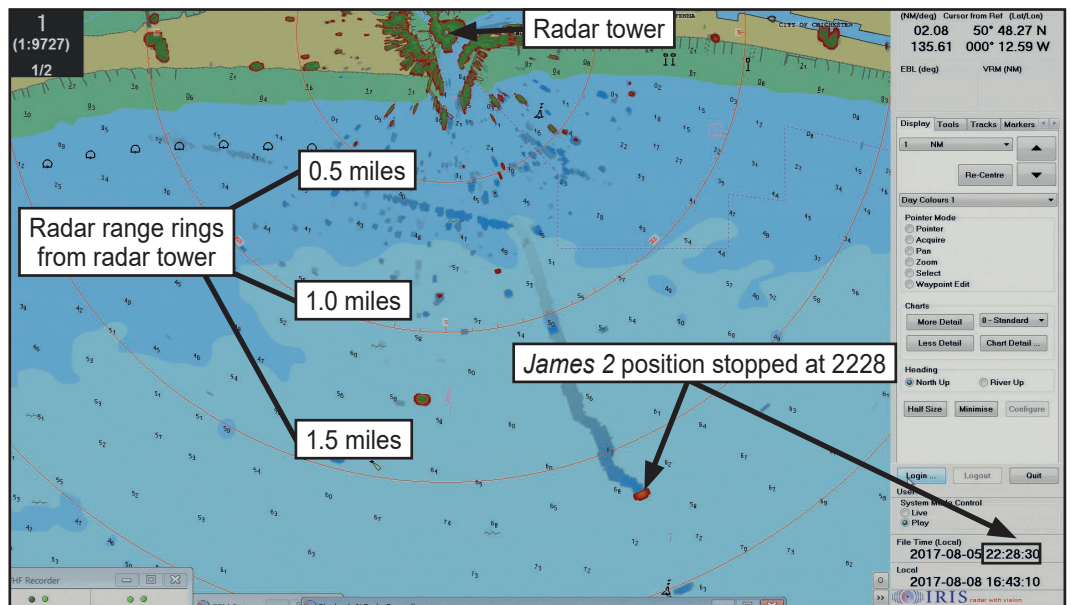
Figure 3a: *James 2* stopped and drifting having left Shoreham

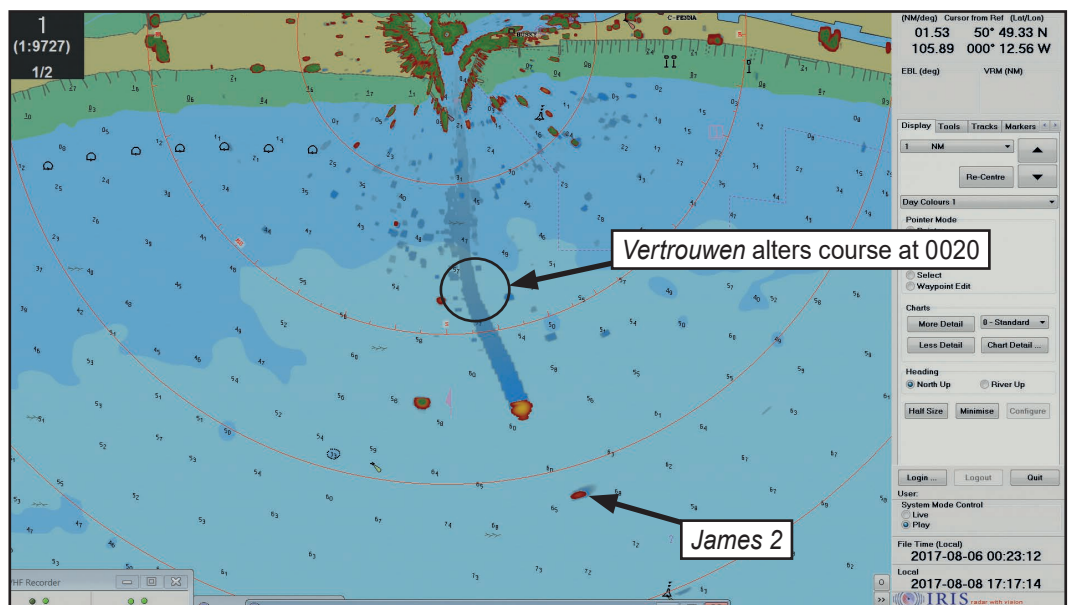
At 2354, *Vertrouwen's* skipper manoeuvred his vessel out of the dry dock and into the harbour lock. About 15 minutes later, *Vertrouwen* left the lock and proceeded out of the port, passing the outer breakwaters at 0015 (6 August). As the skipper brought the vessel out of the port, his crew made their way from the deck to the wheelhouse. The skipper told the crew that he had no other work for them to do and that he would take the first watch. The crew left the wheelhouse and went to their bunks. Once clear of Shoreham, the skipper increased *Vertrouwen's* speed to about 7kts and set a southerly course on the autopilot. At 0020, he altered course slightly to port, putting the vessel on a south-south-easterly heading (Figure 3b).

Figure 3b: *Vertrouwen* passage from Shoreham

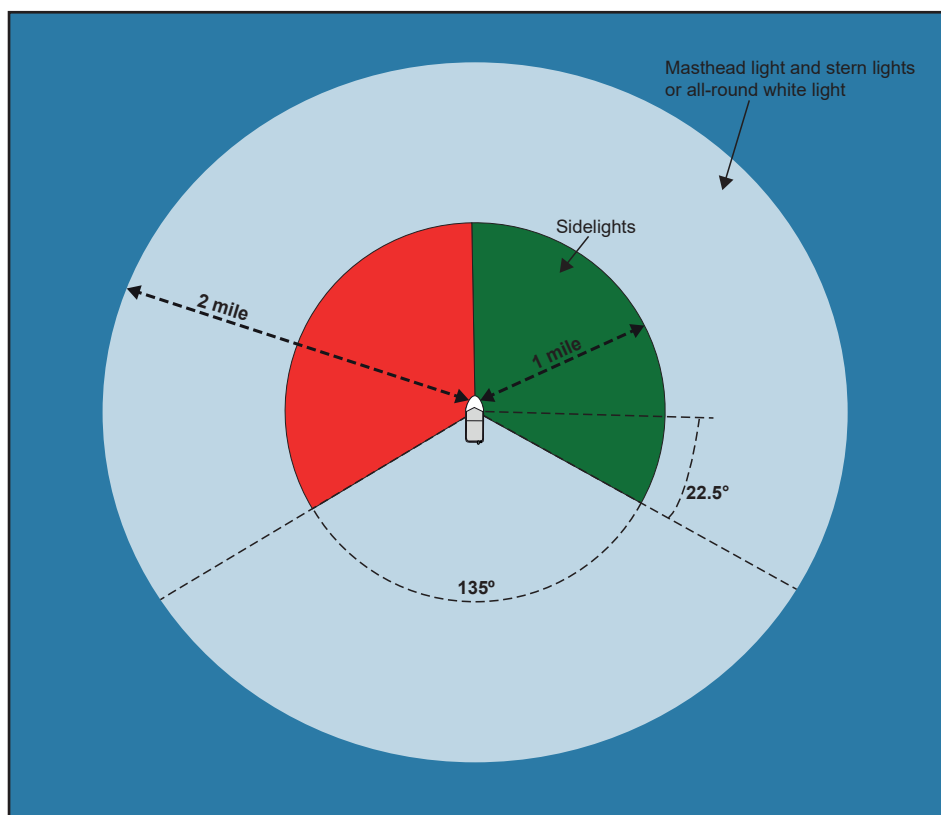
The COLREGS set out the requirements for the visual identification of vessels during the hours of darkness. Power-driven vessels underway³ are required to display a white masthead light, red and green (port and starboard) sidelights and a white sternlight. The minimum visible range of *Vertrouwen*'s masthead light was required to be 5 miles, and its side and sternlight 2 miles. For vessels less than 12m in length, such as *James 2*, a single all-round white light can be displayed in lieu of the masthead light and sternlight. The minimum range of the white navigation lights should be 2 miles and the sidelights 1 mile. The sidelights should be fixed to show the light from right ahead to 22.5° abaft the beam on its respective side (Figure 5).

Figure 5: Navigation lights required for a vessel the size of *James 2*

James 2 had port and starboard sidelights and these were on when the boat departed Shoreham (**Figure 2**). It did not have a masthead light, sternlight or all-round white light. Mircea used *James 2*'s forward-facing spotlights to assist his manoeuvre off the pontoon in the marina and out of Riverside Yard, but they were switched off before the vessel entered the lock and left the port. Mircea and Irinel wore LED head torches on the evening of the accident, and they also had hand torches available on board.
