RE: Request for Information – RFI3321

TITLE HITCHIN HOSPITAL BEDFORD ROAD HITCHIN		(DRAFT)

Homes & Communities Agency
Site Name:	Hitchin Hospital	
Site ID:

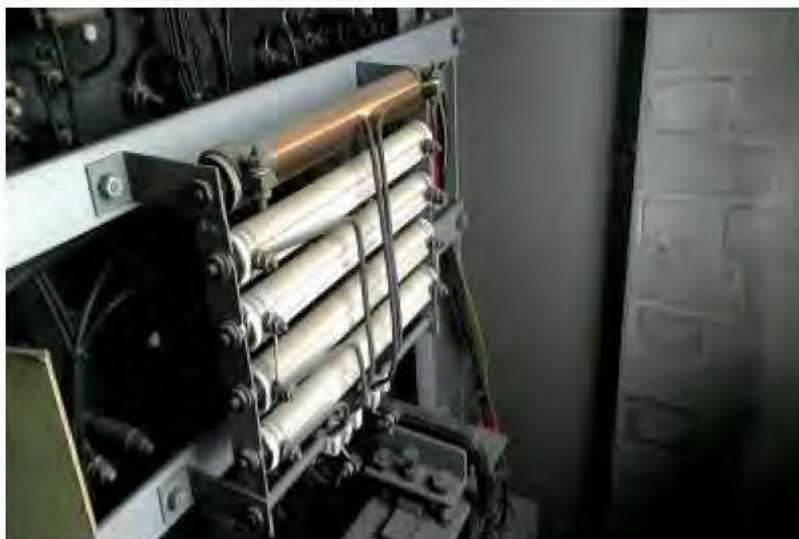
Inspection Number	2	Reference Number:	BB000224
Inspection / Sample	Sample taken	Inspection Cross Reference / Visual I.D.	Asbestos Identified

Building	Laburnum House
Floor Level	Roof Void
Area / Room	1 Lift Motor Room
Feature	Resistor packs
Product Type	Asbestos Textiles/Paper
Extent Amount	4 no.

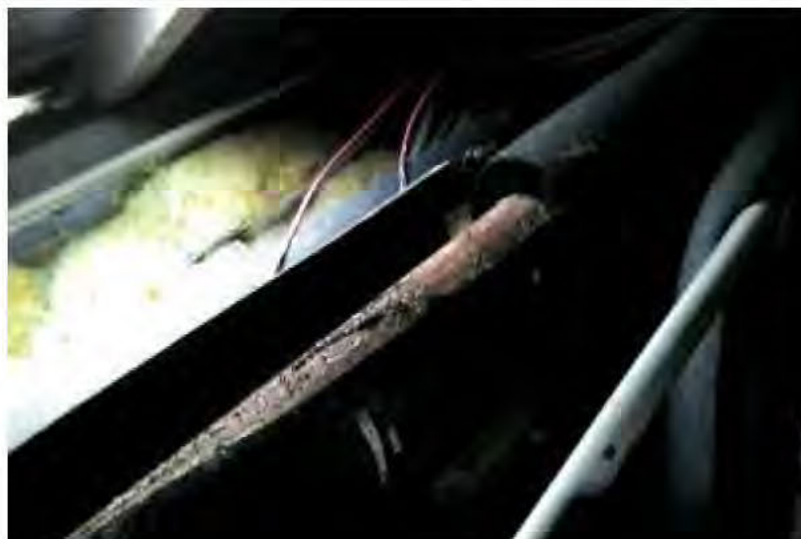
Inspection Number	5	Reference Number:	BB000227
Inspection / Sample	Sample taken	Inspection Cross Reference / Visual I.D.	N.A.D.I.S

Building	Laburnum House
Floor Level	Roof Void
Area / Room	2 Roof space next to lift motor room
Feature	Residue to pipework
Product Type	Dust/Debris
Extent Amount	9 m

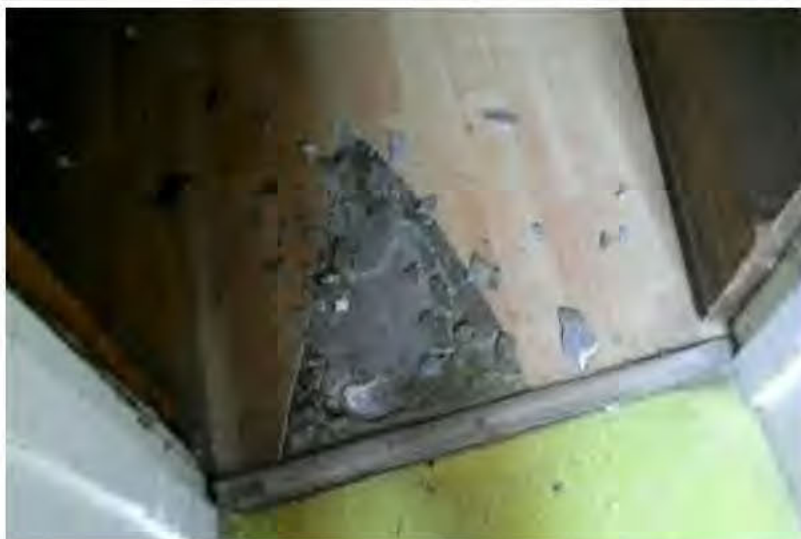
Inspection Number	6	Reference Number:	BB000228
Inspection / Sample	Sample taken	Inspection Cross Reference / Visual I.D.	N.A.D.I.S

Building	Laburnum House
Floor Level	1st Floor
Area / Room	12 Linen Cupboard
Feature	Floor screed beneath vinyl
Product Type	Reinforced Composite
Extent Amount	5 m ²

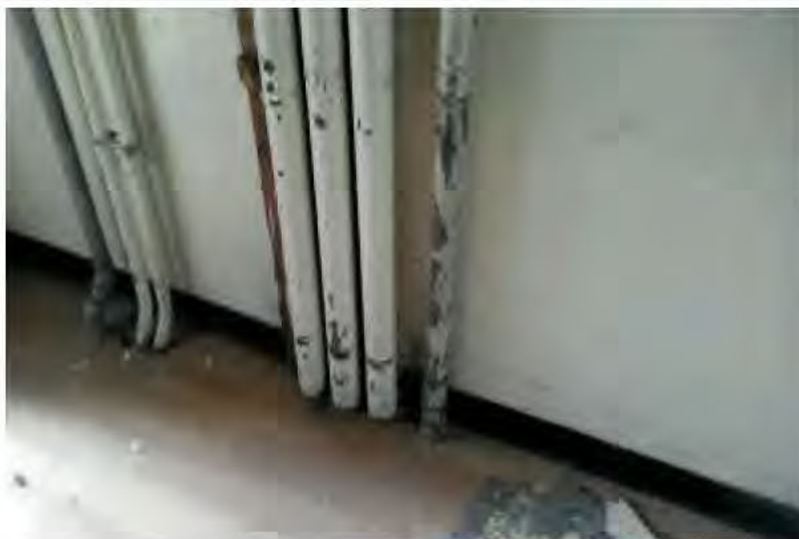
Inspection Number	7	Reference Number:	BB000229
Inspection / Sample	Sample taken	Inspection Cross Reference / Visual I.D.	N.A.D.I.S

Building	Laburnum House
Floor Level	1st Floor
Area / Room	12 Linen Cupboard
Feature	Residue to pipework
Product Type	Dust/Debris
Extent Amount	14 m

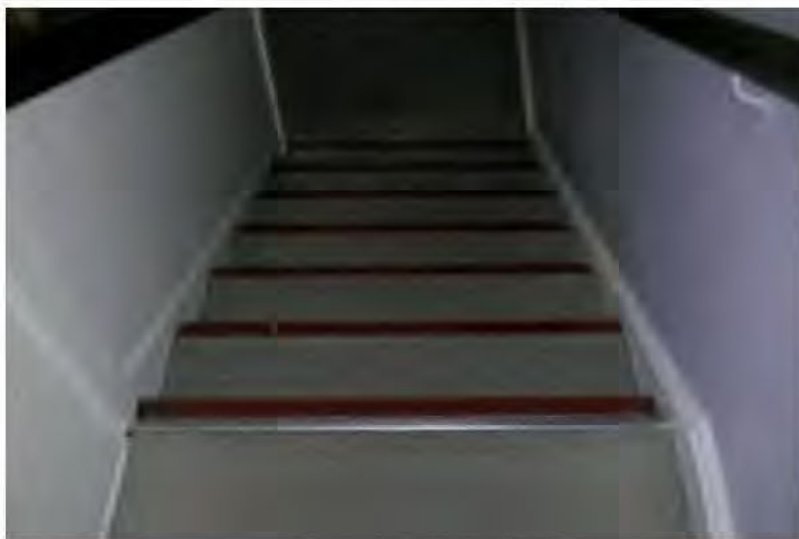
Inspection Number	8	Reference Number:	BB000230
Inspection / Sample	Sample taken	Inspection Cross Reference / Visual I.D.	Asbestos Identified

Building	Laburnum House
Floor Level	1st Floor
Area / Room	16 Stairwell
Feature	Stair nosing
Product Type	Reinforced Composite
Extent Amount	25 m

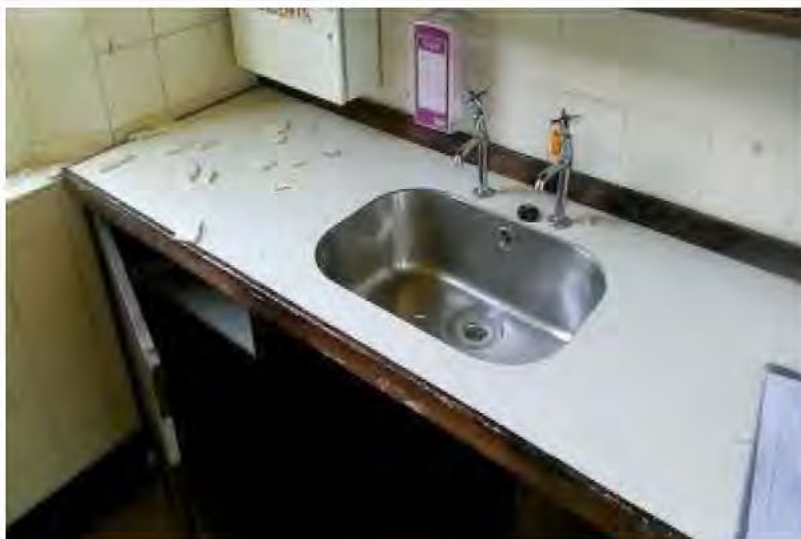
Inspection Number	9	Reference Number:	BB000231
Inspection / Sample	Sample taken	Inspection Cross Reference / Visual I.D.	N.A.D.I.S

Building	Laburnum House
Floor Level	1st Floor
Area / Room	17 Washroom
Feature	Bitumen pad to underside of sink
Product Type	Well Bound Material
Extent Amount	1 no.

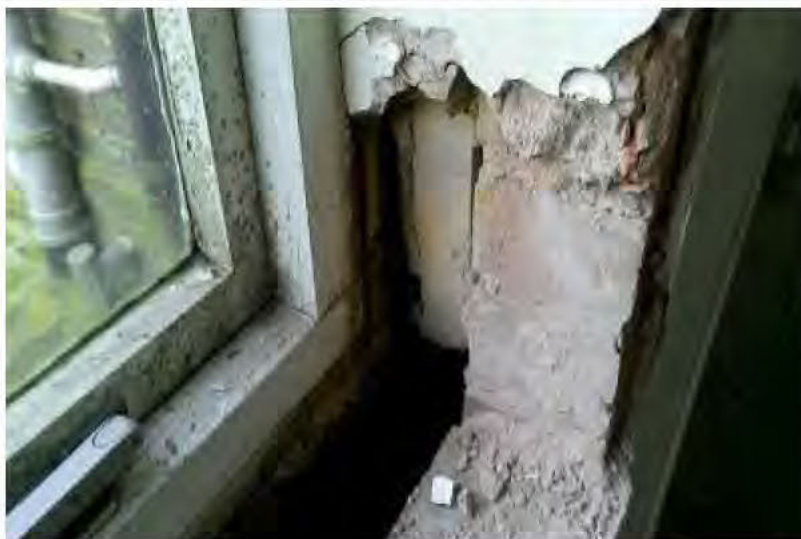
Inspection Number	10	Reference Number:	BB000232
Inspection / Sample	Sample taken	Inspection Cross Reference / Visual I.D.	Asbestos Identified

Building	Laburnum House
Floor Level	1st Floor
Area / Room	20 Day Room
Feature	Damp proof course within wall cavity
Product Type	Well Bound Material
Extent Amount	> 50 m

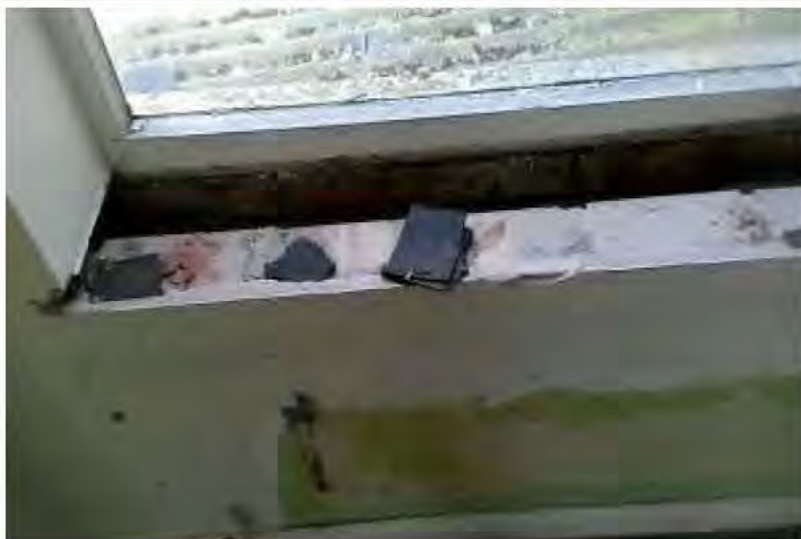
Inspection Number	11	Reference Number:	BB000233
Inspection / Sample	Sample taken	Inspection Cross Reference / Visual I.D.	Asbestos Identified

Building	Laburnum House
Floor Level	1st Floor
Area / Room	20 Day Room
Feature	Damp proof course beneath window sill
Product Type	Well Bound Material
Extent Amount	< 1 m ²

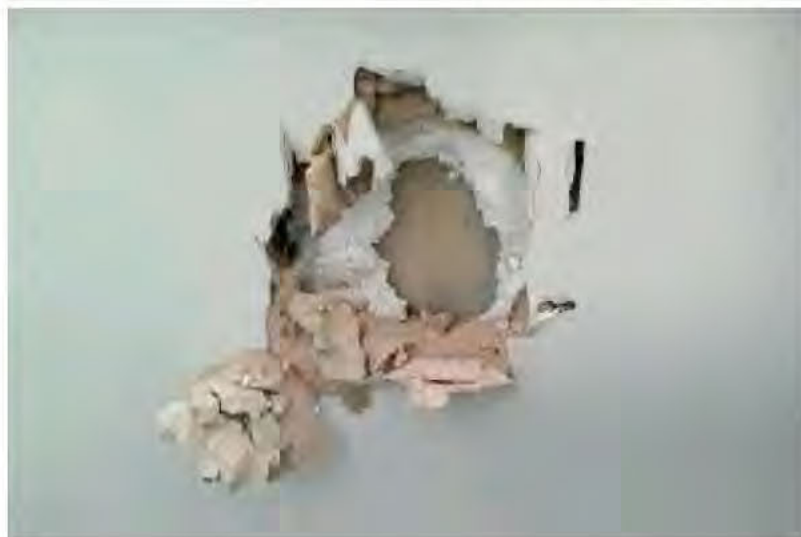
Inspection Number	13	Reference Number:	BB000235
Inspection / Sample	Sample taken	Inspection Cross Reference / Visual I.D.	N.A.D.I.S

Building	Laburnum House
Floor Level	1st Floor
Area / Room	24 Office
Feature	Wall panels to outer shell
Product Type	Insulating Board
Extent Amount	55 m ²

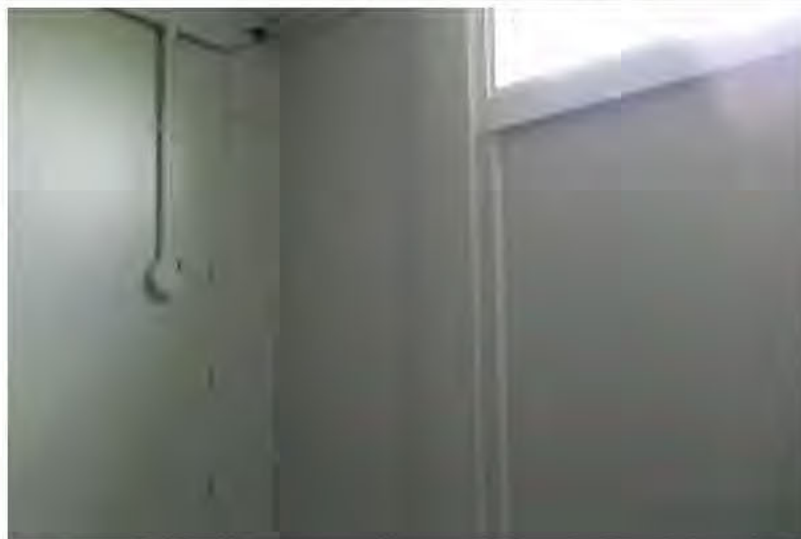
Inspection Number	15	Reference Number:	As Sample BB000235
Inspection / Sample	Visually similar to	Inspection Cross Reference / Visual I.D.	As Sample

Building	Laburnum House
Floor Level	1st Floor
Area / Room	26 Store
Feature	Wall panels to outer shell
Product Type	Insulating Board
Extent Amount	3 m ²

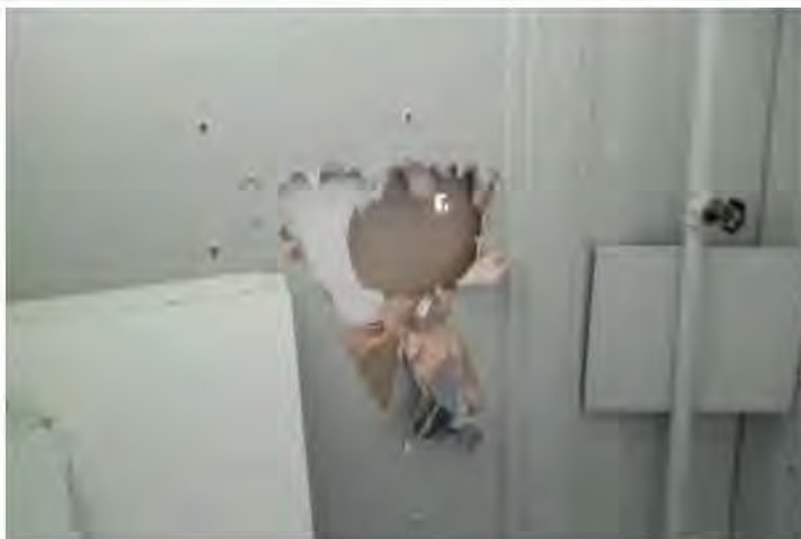
Inspection Number	16	Reference Number:	As Sample BB000235
Inspection / Sample	Visually similar to	Inspection Cross Reference / Visual I.D.	As Sample

Building	Laburnum House
Floor Level	1st Floor
Area / Room	27 Store
Feature	Wall panels to outer shell
Product Type	Insulating Board
Extent Amount	3 m ²

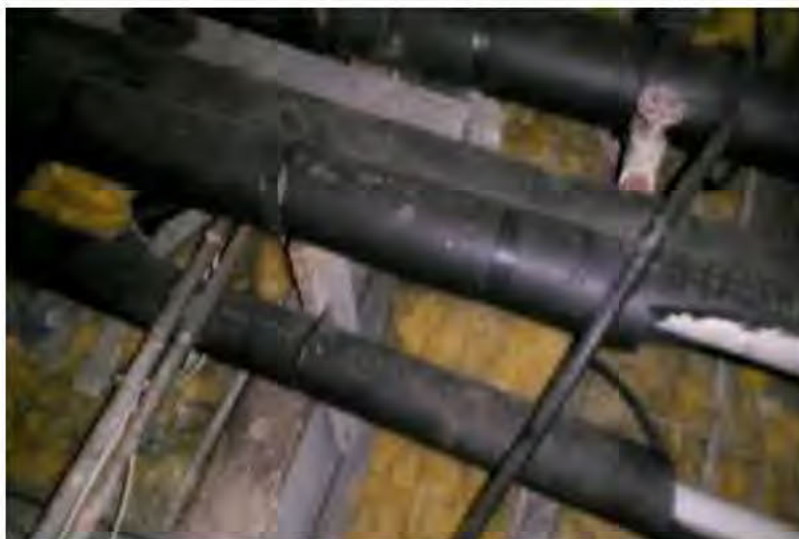
Inspection Number	17	Reference Number:	BB000236
Inspection / Sample	Sample taken	Inspection Cross Reference / Visual I.D.	N.A.D.I.S

Building	Laburnum House
Floor Level	Roof Void
Area / Room	3 Main Roof Space
Feature	Debris to pipework
Product Type	Insulation
Extent Amount	> 50 m

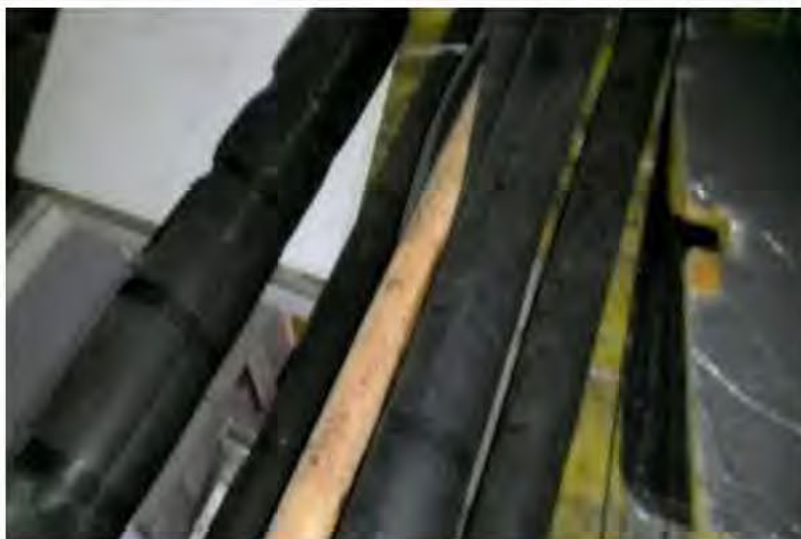
Inspection Number	18	Reference Number:	BB000237
Inspection / Sample	Sample taken	Inspection Cross Reference / Visual I.D.	Asbestos Identified

Building	Laburnum House
Floor Level	Roof Void
Area / Room	3 Main Roof Space
Feature	Debris to pipework
Product Type	Dust/Debris
Extent Amount	> 50 m

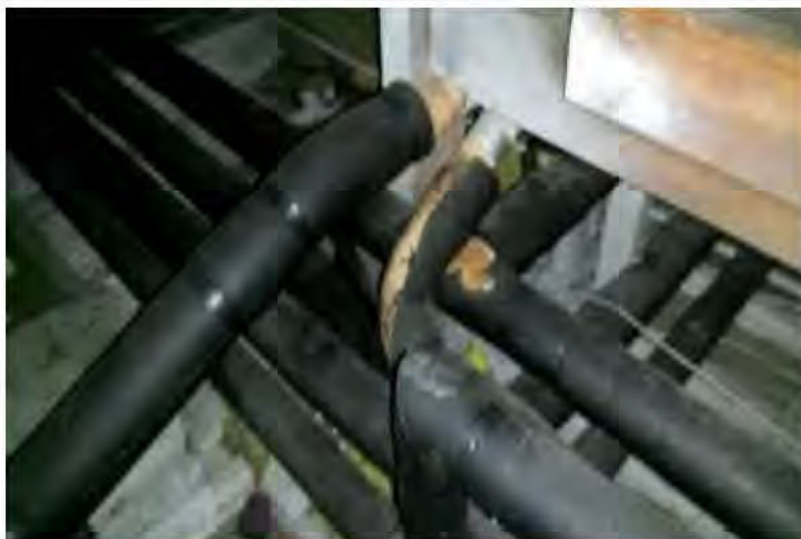
Inspection Number	19	Reference Number:	BB000238
Inspection / Sample	Sample taken	Inspection Cross Reference / Visual I.D.	N.A.D.I.S

Building	Laburnum House
Floor Level	Roof Void
Area / Room	3 Main Roof Space
Feature	Debris to pipework
Product Type	Dust/Debris
Extent Amount	> 50 m

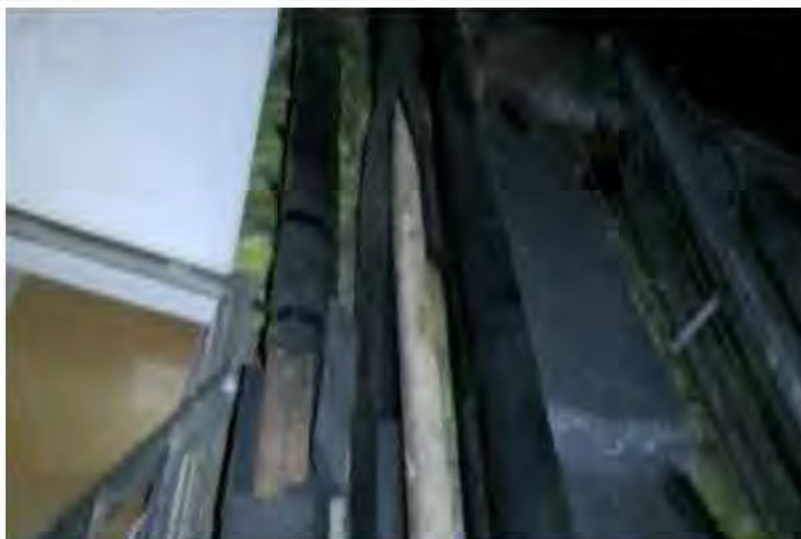
Inspection Number	20	Reference Number:	BB000239
Inspection / Sample	Sample taken	Inspection Cross Reference / Visual I.D.	N.A.D.I.S

Building	Laburnum House
Floor Level	Roof Void
Area / Room	3 Main Roof Space
Feature	Debris to pipework
Product Type	Dust/Debris
Extent Amount	> 50 m

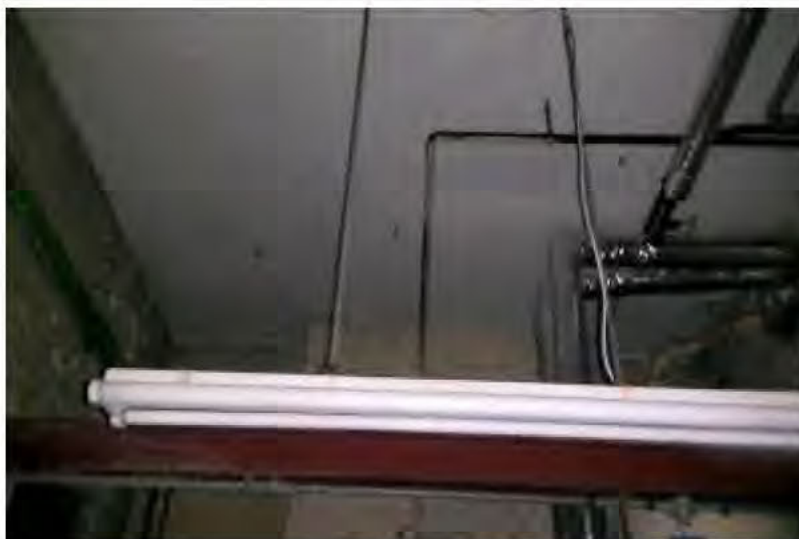
Inspection Number	21	Reference Number:	BB000240
Inspection / Sample	Sample taken	Inspection Cross Reference / Visual I.D.	Asbestos Identified

Building	Laburnum House
Floor Level	Ground Floor
Area / Room	1 Boiler House
Feature	Ceiling panels
Product Type	Asbestos Insulating Board
Extent Amount	15 m ²

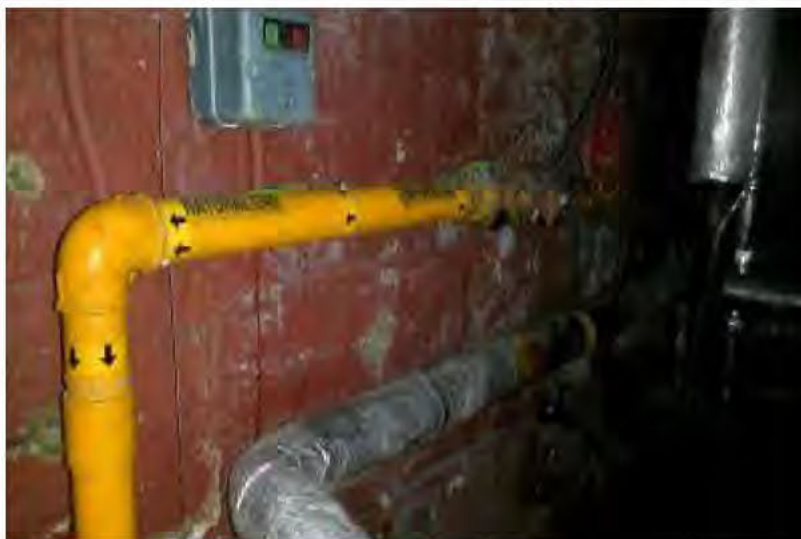
Inspection Number	22	Reference Number:	BB000241
Inspection / Sample	Sample taken	Inspection Cross Reference / Visual I.D.	N.A.D.I.S

Building	Laburnum House
Floor Level	Ground Floor
Area / Room	1 Boiler House
Feature	Wall debris
Product Type	Insulation
Extent Amount	15 m ²

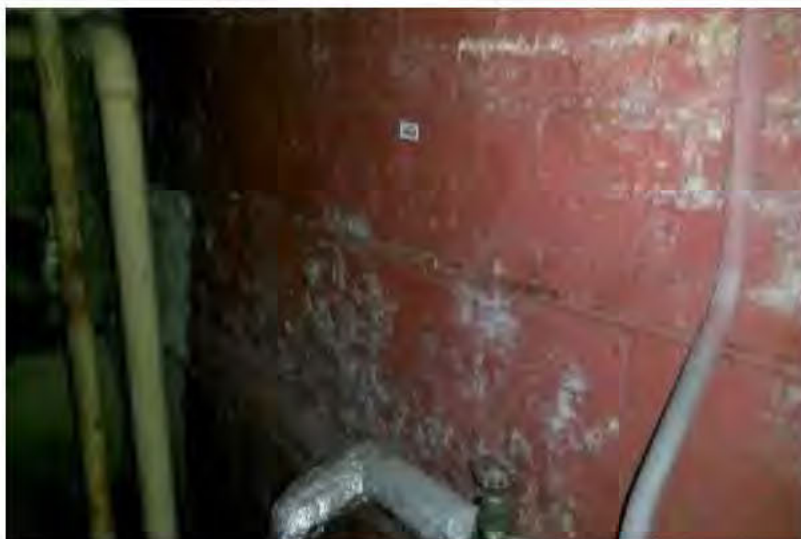
Inspection Number	23	Reference Number:	BB000242
Inspection / Sample	Sample taken	Inspection Cross Reference / Visual I.D.	N.A.D.I.S

Building	Laburnum House
Floor Level	Ground Floor
Area / Room	1 Boiler House
Feature	Wall debris
Product Type	Dust/Debris
Extent Amount	15 m ²

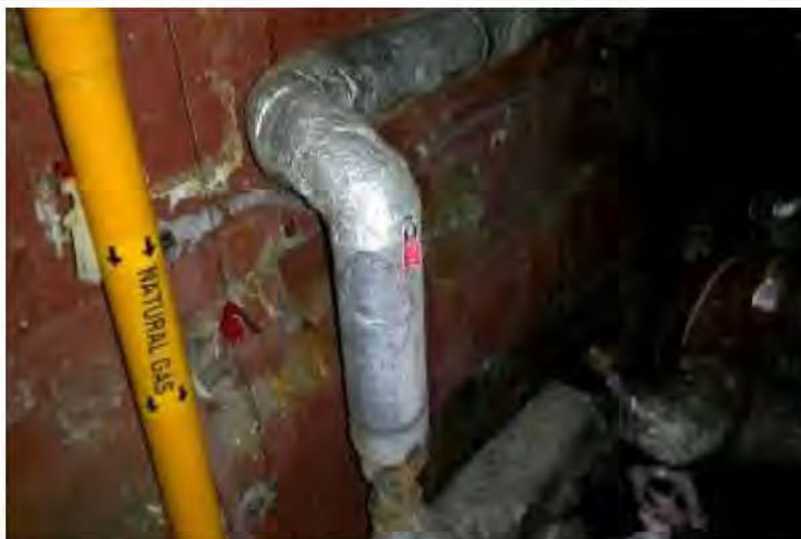
Inspection Number	25	Reference Number:	BB000244
Inspection / Sample	Sample taken	Inspection Cross Reference / Visual I.D.	N.A.D.I.S

Building	Laburnum House
Floor Level	Ground Floor
Area / Room	1 Boiler House
Feature	Residue to pipework
Product Type	Insulation
Extent Amount	> 25 m

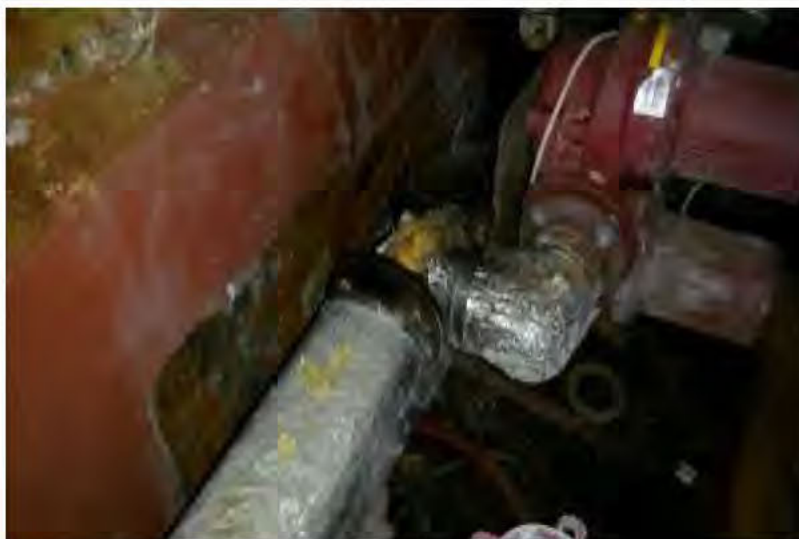
Inspection Number	26	Reference Number:	BB000245
Inspection / Sample	Sample taken	Inspection Cross Reference / Visual I.D.	Asbestos Identified

Building	Laburnum House
Floor Level	Ground Floor
Area / Room	1 Boiler House
Feature	Gasket to pipework
Product Type	Asbestos Textiles/Paper
Extent Amount	> 10 no.

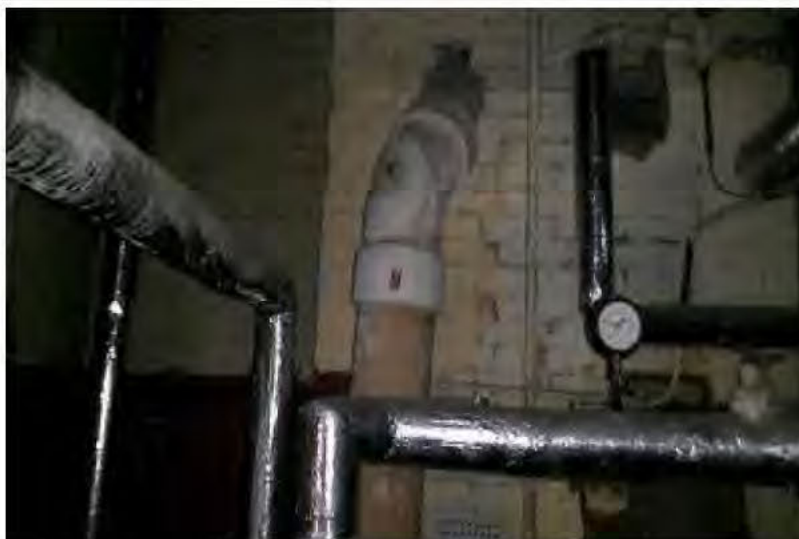
Inspection Number	27	Reference Number:	BB000246
Inspection / Sample	Sample taken	Inspection Cross Reference / Visual I.D.	Asbestos Identified

Building	Laburnum House
Floor Level	Ground Floor
Area / Room	1 Boiler House
Feature	Cement flue
Product Type	Asbestos Cement
Extent Amount	3 m

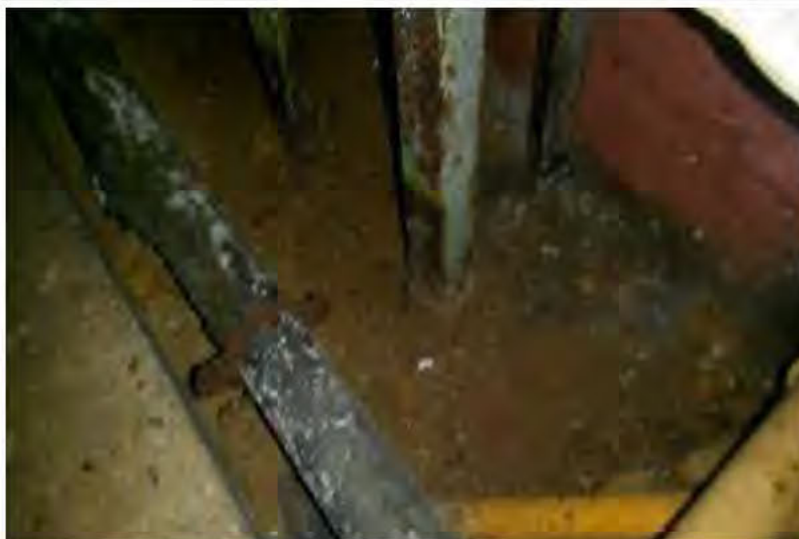
Inspection Number	29	Reference Number:	BB000248
Inspection / Sample	Sample taken	Inspection Cross Reference / Visual I.D.	N.A.D.I.S

Building	Laburnum House
Floor Level	Ground Floor
Area / Room	1 Boiler House
Feature	Debris to floor
Product Type	Dust/Debris
Extent Amount	15 m ²

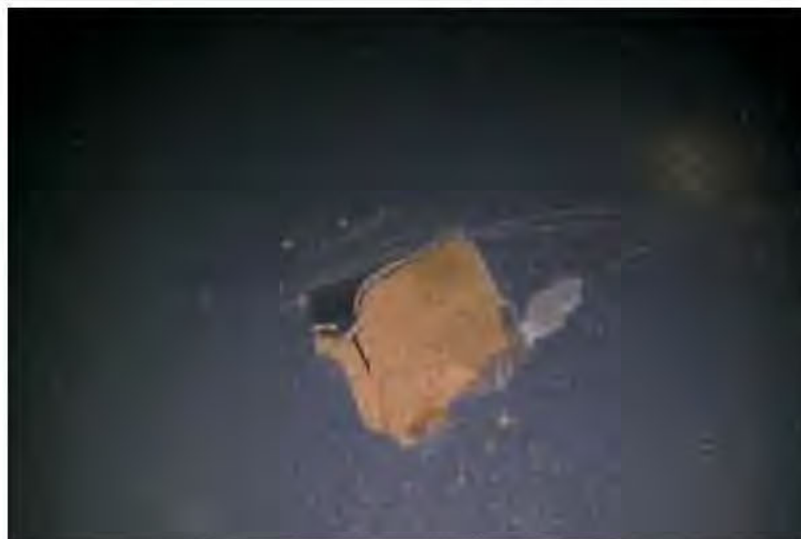
Inspection Number	30	Reference Number:	BB000249
Inspection / Sample	Sample taken	Inspection Cross Reference / Visual I.D.	N.A.D.I.S

Building	Laburnum House
Floor Level	Ground Floor
Area / Room	2 Patient Room
Feature	Floor screed beneath lino
Product Type	Well Bound Material
Extent Amount	25 m ²

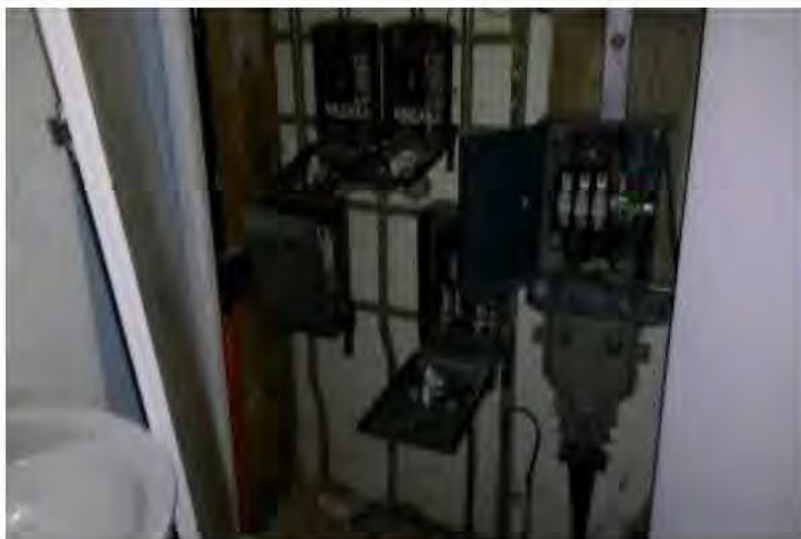
Inspection Number	33	Reference Number:	As Sample BB000250
Inspection / Sample	Visually similar to	Inspection Cross Reference / Visual I.D.	As Sample

Building	Laburnum House
Floor Level	Ground Floor
Area / Room	4 Treatment Room
Feature	Rope seal to fuse carriers
Product Type	Asbestos Textiles/Paper
Extent Amount	14 no.

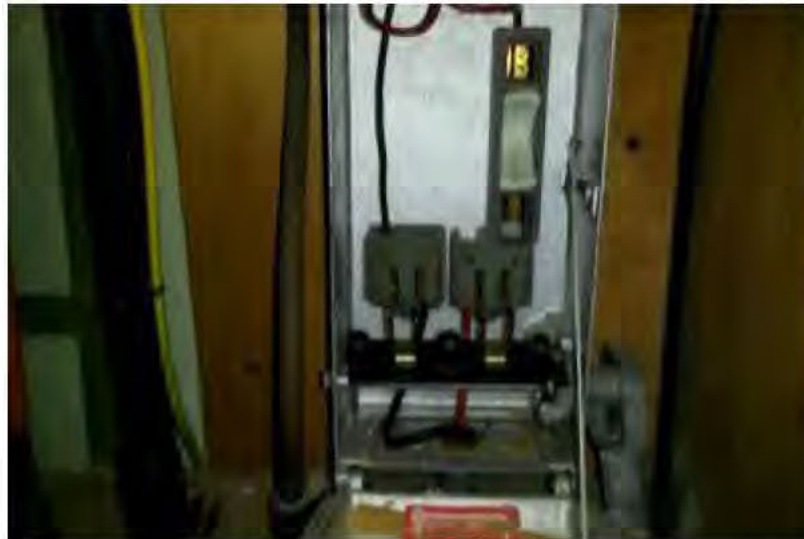
Inspection Number	35	Reference Number:	BB000251
Inspection / Sample	Sample taken	Inspection Cross Reference / Visual I.D.	N.A.D.I.S

Building	Laburnum House
Floor Level	Ground Floor
Area / Room	4 Treatment Room
Feature	Circuit breaker within fuse box
Product Type	Reinforced Composite
Extent Amount	6 no.

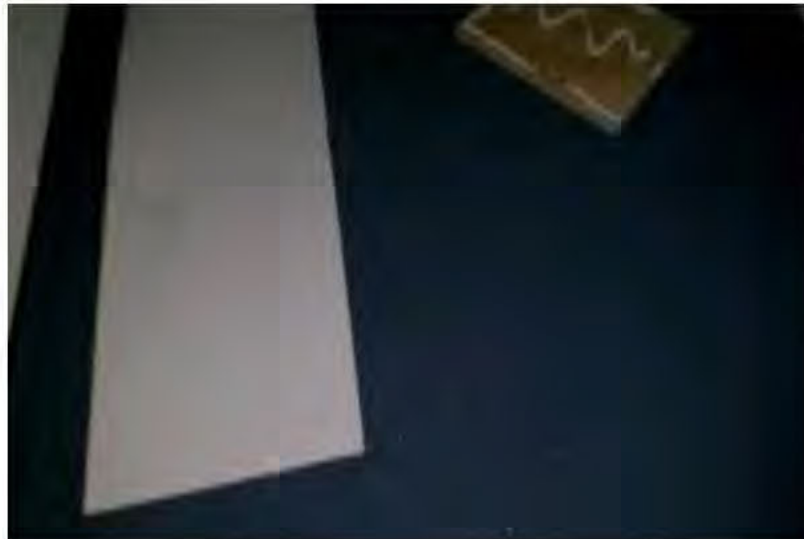
Inspection Number	36	Reference Number:	As Sample BB000249
Inspection / Sample	Visually similar to	Inspection Cross Reference / Visual I.D.	As Sample

Building	Laburnum House
Floor Level	Ground Floor
Area / Room	5 Toilet
Feature	Floor screed beneath lino
Product Type	Well Bound Material
Extent Amount	5 m ²

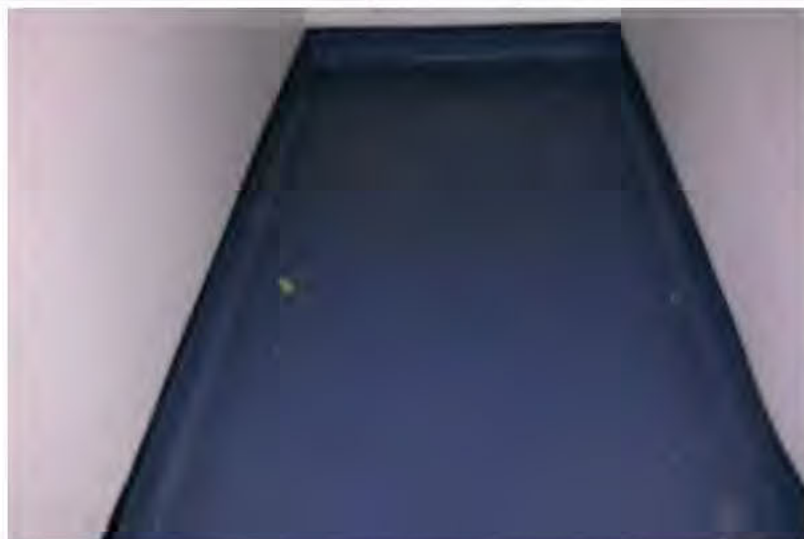
Inspection Number	37	Reference Number:	As Sample BB000249
Inspection / Sample	Visually similar to	Inspection Cross Reference / Visual I.D.	As Sample

Building	Laburnum House
Floor Level	Ground Floor
Area / Room	6 Wet Room
Feature	Floor screed beneath lino
Product Type	Well Bound Material
Extent Amount	3 m ²

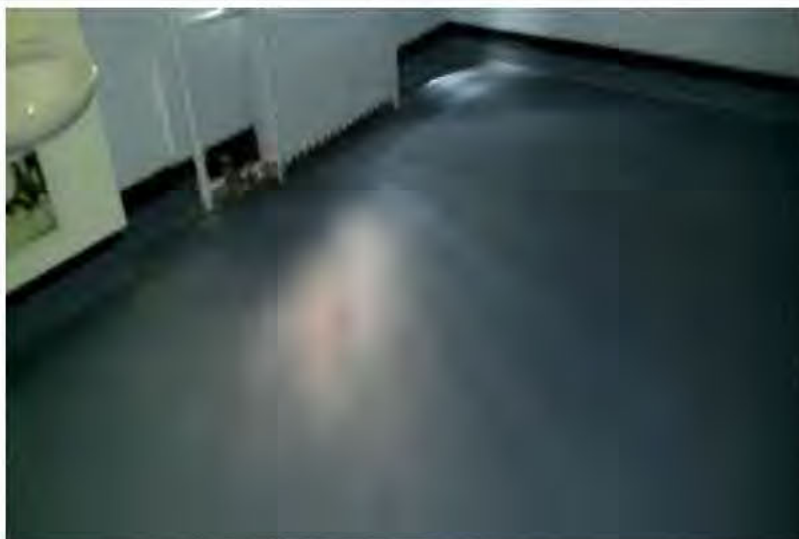
Inspection Number	38	Reference Number:	As Sample BB000249
Inspection / Sample	Visually similar to	Inspection Cross Reference / Visual I.D.	As Sample

Building	Laburnum House
Floor Level	Ground Floor
Area / Room	7 Patient Room
Feature	Floor screed beneath lino
Product Type	Well Bound Material
Extent Amount	26 m ²

Product Score	Low Fibre Release - Asbestos reinforced composites (plastics, resins, mastics, roofing felts, vinyl floor tiles, semi-rigid paits or decorative finishes, asbestos cement, etc.)	0
Extent of Damage	Good Condition	0
Surface Treatment	Completely Sealed	0
Asbestos Type	No Asbestos Detected	0

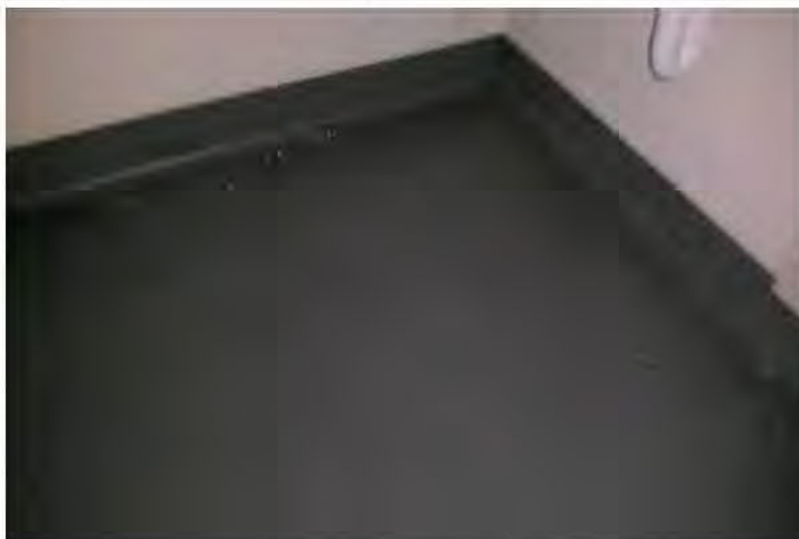
Inspection Number	40	Reference Number:	As Sample BB000249
Inspection / Sample	Visually similar to	Inspection Cross Reference / Visual I.D.	As Sample

Building	Laburnum House
Floor Level	Ground Floor
Area / Room	9 Sluice Room
Feature	Floor screed beneath lino
Product Type	Well Bound Material
Extent Amount	5 m ²

Product Score	Low Fibre Release - Asbestos reinforced composites (plastics, resins, mastics, roofing felts, vinyl floor tiles, semi-rigid paits or decorative finishes, asbestos cement, etc.)	0
Extent of Damage	Good Condition	0
Surface Treatment	Completely Sealed	0
Asbestos Type	No Asbestos Detected	0

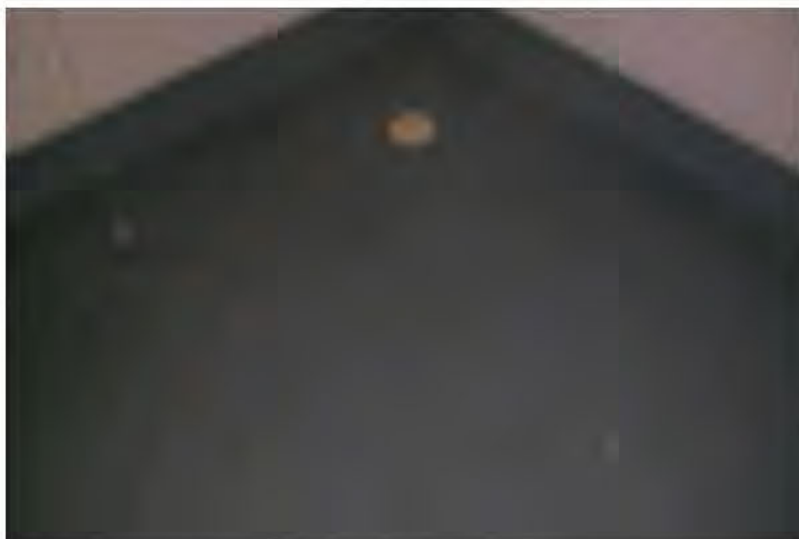
Inspection Number	41	Reference Number:	As Sample BB000249
Inspection / Sample	Visually similar to	Inspection Cross Reference / Visual I.D.	As Sample

Building	Laburnum House
Floor Level	Ground Floor
Area / Room	10 Patient Toilet
Feature	Floor screed beneath lino
Product Type	Well Bound Material
Extent Amount	6 m ²

Product Score	Low Fibre Release - Asbestos reinforced composites (plastics, resins, mastics, roofing felts, vinyl floor tiles, semi-rigid paits or decorative finishes, asbestos cement, etc.)	0
Extent of Damage	Good Condition	0
Surface Treatment	Completely Sealed	0
Asbestos Type	No Asbestos Detected	0

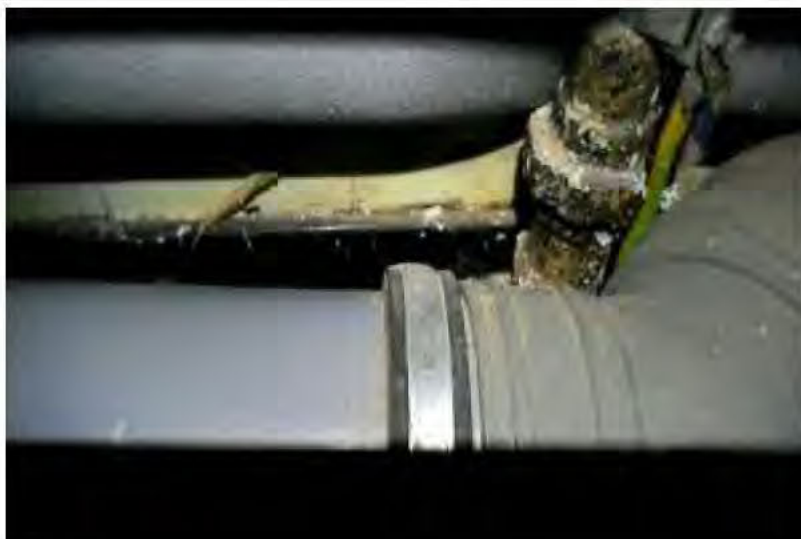
Inspection Number	42	Reference Number:	BB000252
Inspection / Sample	Sample taken	Inspection Cross Reference / Visual I.D.	N.A.D.I.S

Building	Laburnum House
Floor Level	Ground Floor
Area / Room	10 Patient Toilet
Feature	Residue to pipework
Product Type	Insulation
Extent Amount	5 m

Product Score	High Fibre Release - Thermal insulation (e.g. pipe and boiler lagging) sprayed asbestos, loose asbestos, asbestos mattresses and packing	0
Extent of Damage	High Damage	0
Surface Treatment	Unsealed	0
Asbestos Type	No Asbestos Detected	0

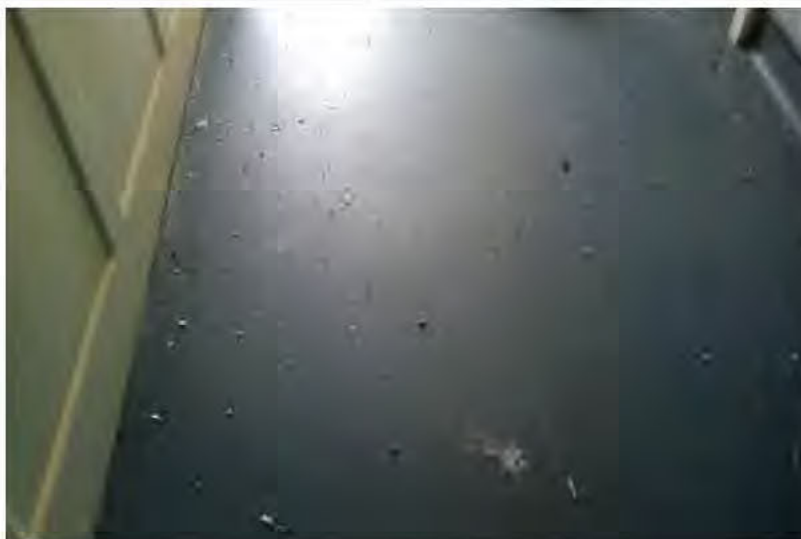
Inspection Number	43	Reference Number:	As Sample BB000249
Inspection / Sample	Visually similar to	Inspection Cross Reference / Visual I.D.	As Sample

Building	Laburnum House
Floor Level	Ground Floor
Area / Room	11 Corridor / Stairwell
Feature	Floor screed beneath lino
Product Type	Well Bound Material
Extent Amount	23 m ²

Product Score	Low Fibre Release - Asbestos reinforced composites (plastics, resins, mastics, roofing felts, vinyl floor tiles, semi-rigid paits or decorative finishes, asbestos cement, etc.)	0
Extent of Damage	Good Condition	0
Surface Treatment	Completely Sealed	0
Asbestos Type	No Asbestos Detected	0

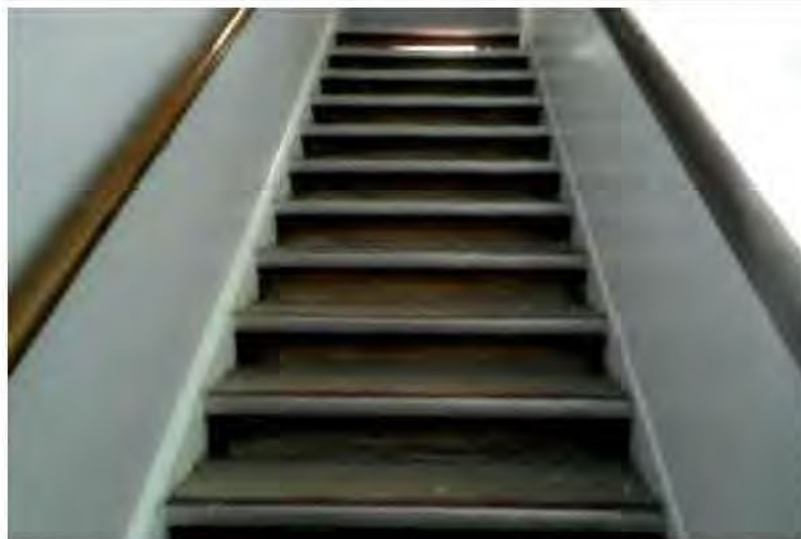
Inspection Number	44	Reference Number:	As Sample BB000230
Inspection / Sample	Visually similar to	Inspection Cross Reference / Visual I.D.	As Sample

Building	Laburnum House
Floor Level	Ground Floor
Area / Room	11 Corridor / Stairwell
Feature	Stair nosing
Product Type	Reinforced Composite
Extent Amount	23 m

Product Score	Low Fibre Release - Asbestos reinforced composites (plastics, resins, mastics, roofing felts, vinyl floor tiles, semi-rigid paits or decorative finishes, asbestos cement, etc.)	1
Extent of Damage	Low Damage	1
Surface Treatment	Completely Sealed	0
Asbestos Type	Chrysotile	1

Recommendation	Remove if likely to be disturbed
----------------	----------------------------------

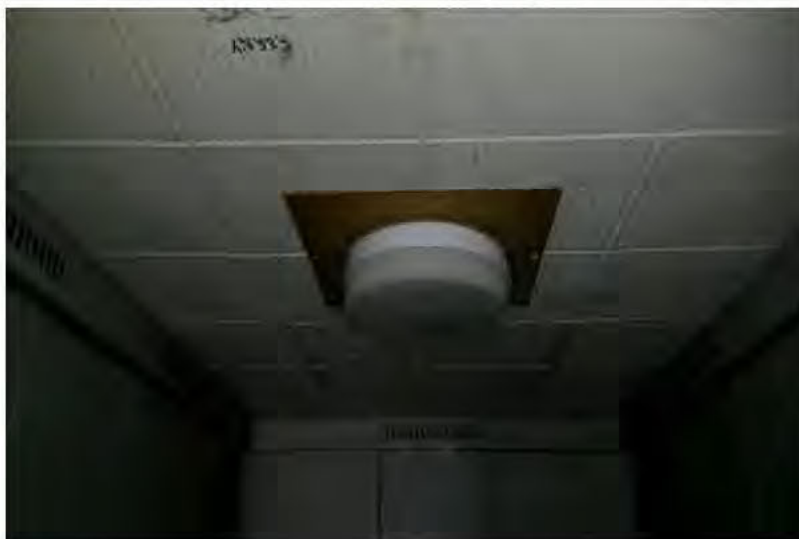
Inspection Number	45	Reference Number:	BB000253
Inspection / Sample	Sample taken	Inspection Cross Reference / Visual I.D.	N.A.D.I.S

Building	Laburnum House
Floor Level	Ground Floor
Area / Room	12 Lift
Feature	Paper to ceiling tiles
Product Type	Textiles/Paper
Extent Amount	4 m ²

Product Score	Medium Fibre Release - Asbestos insulating board, mill board, other low density insulation board, asbestos textiles, gaskets, rope and woven textiles, asbestos paper and felt	0
Extent of Damage	Medium Damage	0
Surface Treatment	Unsealed	0
Asbestos Type	No Asbestos Detected	0

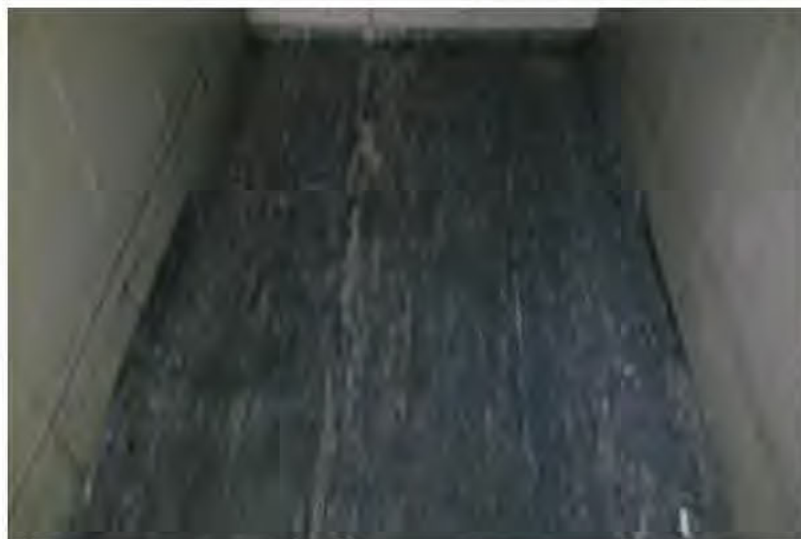
Inspection Number	46	Reference Number:	BB000254
Inspection / Sample	Sample taken	Inspection Cross Reference / Visual I.D.	N.A.D.I.S

Building	Laburnum House
Floor Level	Ground Floor
Area / Room	12 Lift
Feature	Vinyl floor covering
Product Type	Reinforced Composite
Extent Amount	4 m ²

Product Score	Low Fibre Release - Asbestos reinforced composites (plastics, resins, mastics, roofing felts, vinyl floor tiles, semi-rigid paits or decorative finishes, asbestos cement, etc.)	0
Extent of Damage	Medium Damage	0
Surface Treatment	Completely Sealed	0
Asbestos Type	No Asbestos Detected	0

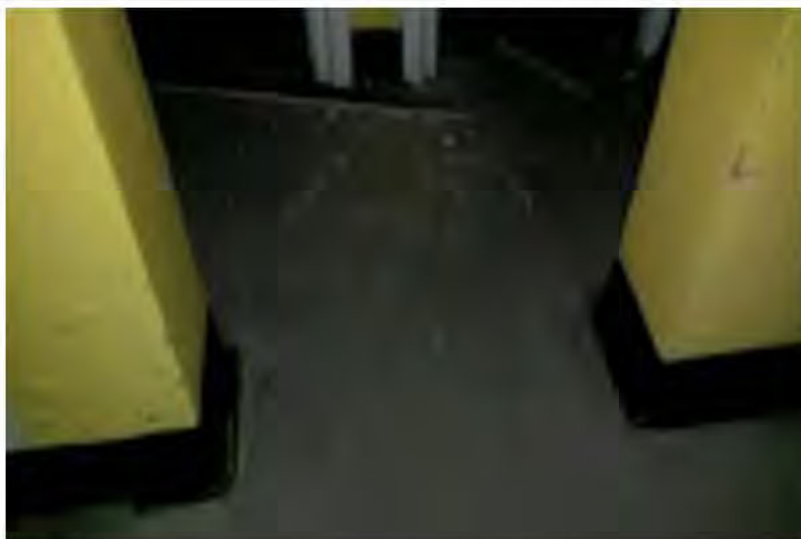
Inspection Number	47	Reference Number:	As Sample BB000249
Inspection / Sample	Visually similar to	Inspection Cross Reference / Visual I.D.	As Sample

Building	Laburnum House
Floor Level	Ground Floor
Area / Room	13 Toilets
Feature	Floor screed beneath lino
Product Type	Well Bound Material
Extent Amount	12 m ²

Product Score	Low Fibre Release - Asbestos reinforced composites (plastics, resins, mastics, roofing felts, vinyl floor tiles, semi-rigid paits or decorative finishes, asbestos cement, etc.)	0
Extent of Damage	Low Damage	0
Surface Treatment	Completely Sealed	0
Asbestos Type	No Asbestos Detected	0

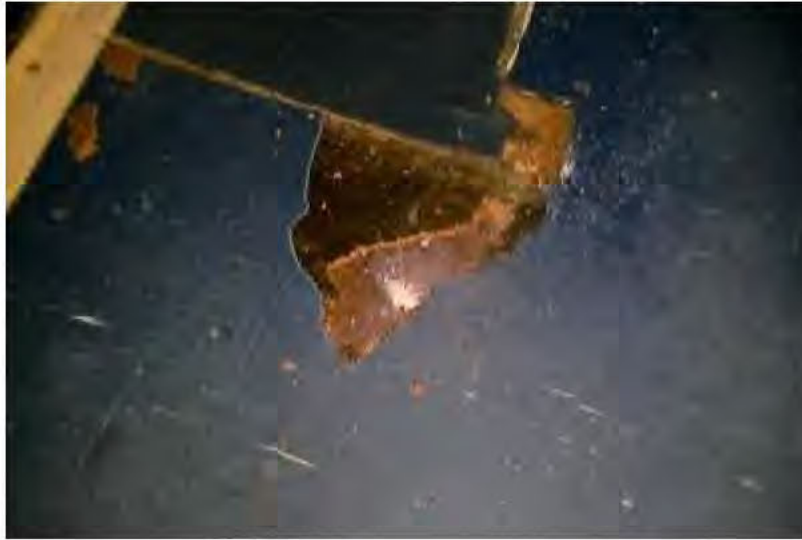
Inspection Number	49	Reference Number:	BB000256
Inspection / Sample	Sample taken	Inspection Cross Reference / Visual I.D.	N.A.D.I.S

Building	Laburnum House
Floor Level	Ground Floor
Area / Room	15 Office
Feature	Floor screed beneath lino
Product Type	Well Bound Material
Extent Amount	7 m ²

Product Score	Low Fibre Release - Asbestos reinforced composites (plastics, resins, mastics, roofing felts, vinyl floor tiles, semi-rigid paits or decorative finishes, asbestos cement, etc.)	0
Extent of Damage	High Damage	0
Surface Treatment	Completely Sealed	0
Asbestos Type	No Asbestos Detected	0

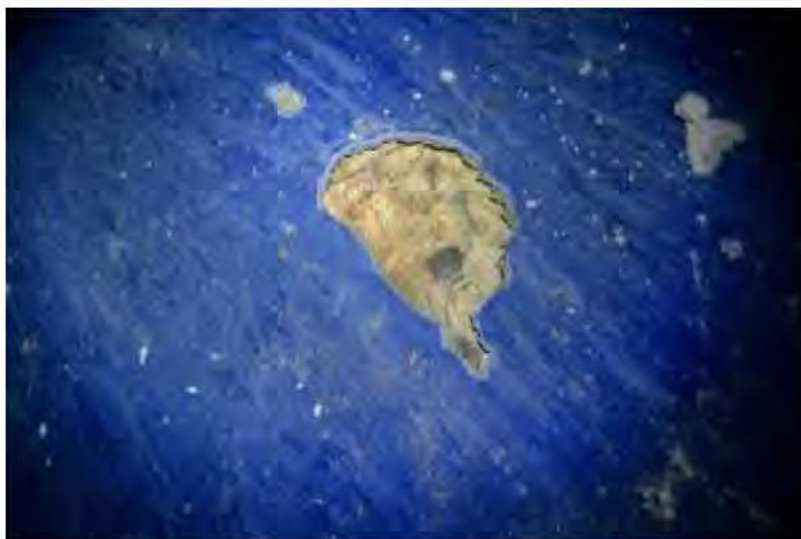
Inspection Number	50	Reference Number:	As Sample BB000256
Inspection / Sample	Visually similar to	Inspection Cross Reference / Visual I.D.	As Sample

Building	Laburnum House
Floor Level	Ground Floor
Area / Room	16 Linen Cupboard
Feature	Floor screed beneath lino
Product Type	Well Bound Material
Extent Amount	5 m ²

Product Score	Low Fibre Release - Asbestos reinforced composites (plastics, resins, mastics, roofing felts, vinyl floor tiles, semi-rigid paits or decorative finishes, asbestos cement, etc.)	0
Extent of Damage	Low Damage	0
Surface Treatment	Completely Sealed	0
Asbestos Type	No Asbestos Detected	0

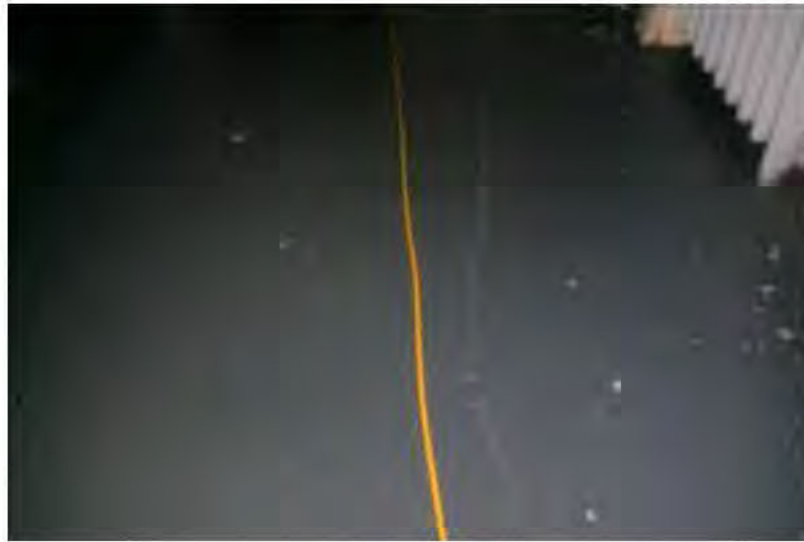
Inspection Number	51	Reference Number:	As Sample BB000256
Inspection / Sample	Visually similar to	Inspection Cross Reference / Visual I.D.	As Sample

Building	Laburnum House
Floor Level	Ground Floor
Area / Room	17 Corridor
Feature	Floor screed beneath lino
Product Type	Well Bound Material
Extent Amount	5 m ²

Product Score	Low Fibre Release - Asbestos reinforced composites (plastics, resins, mastics, roofing felts, vinyl floor tiles, semi-rigid paits or decorative finishes, asbestos cement, etc.)	0
Extent of Damage	Good Condition	0
Surface Treatment	Completely Sealed	0
Asbestos Type	No Asbestos Detected	0

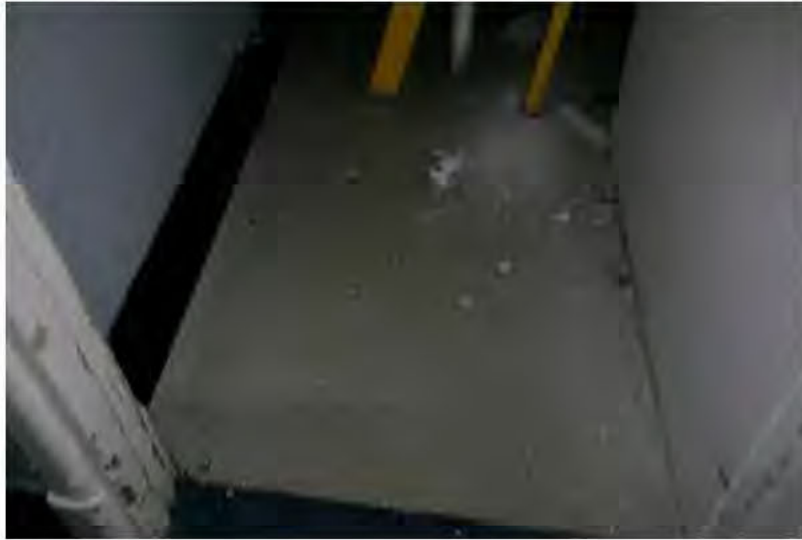
Inspection Number	52	Reference Number:	As Sample BB000256
Inspection / Sample	Visually similar to	Inspection Cross Reference / Visual I.D.	As Sample

Building	Laburnum House
Floor Level	Ground Floor
Area / Room	18 Store
Feature	Floor screed beneath lino
Product Type	Well Bound Material
Extent Amount	5 m ²

Product Score	Low Fibre Release - Asbestos reinforced composites (plastics, resins, mastics, roofing felts, vinyl floor tiles, semi-rigid paits or decorative finishes, asbestos cement, etc.)	0
Extent of Damage	Good Condition	0
Surface Treatment	Completely Sealed	0
Asbestos Type	No Asbestos Detected	0

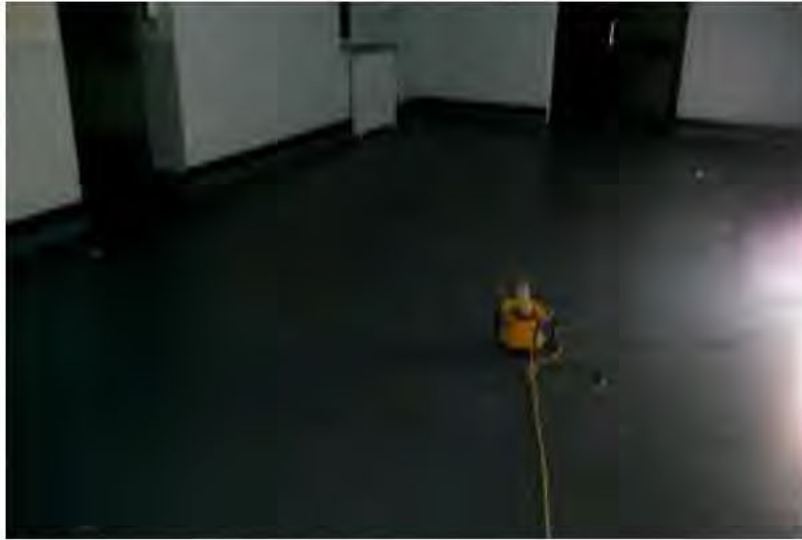
Inspection Number	54	Reference Number:	As Sample BB000256
Inspection / Sample	Visually similar to	Inspection Cross Reference / Visual I.D.	As Sample

Building	Laburnum House
Floor Level	Ground Floor
Area / Room	20 Lobby
Feature	Floor screed beneath lino
Product Type	Well Bound Material
Extent Amount	47 m ²

Product Score	Low Fibre Release - Asbestos reinforced composites (plastics, resins, mastics, roofing felts, vinyl floor tiles, semi-rigid paits or decorative finishes, asbestos cement, etc.)	0
Extent of Damage	Good Condition	0
Surface Treatment	Completely Sealed	0
Asbestos Type	No Asbestos Detected	0

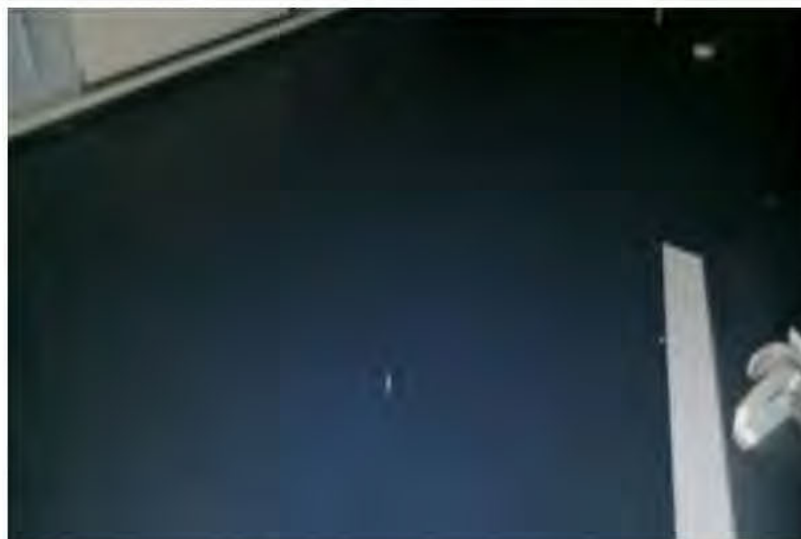
Inspection Number	56	Reference Number:	As Sample BB000256
Inspection / Sample	Visually similar to	Inspection Cross Reference / Visual I.D.	As Sample

Building	Laburnum House
Floor Level	Ground Floor
Area / Room	22 Patient Room
Feature	Floor screed beneath lino
Product Type	Well Bound Material
Extent Amount	34 m ²

Product Score	Low Fibre Release - Asbestos reinforced composites (plastics, resins, mastics, roofing felts, vinyl floor tiles, semi-rigid paits or decorative finishes, asbestos cement, etc.)	0
Extent of Damage	Good Condition	0
Surface Treatment	Completely Sealed	0
Asbestos Type	No Asbestos Detected	0
