RE: Request for Information – RFI3321

TITLE HITCHIN HOSPITAL BEDFORD ROAD HITCHIN		(DRAFT)

Homes & Communities Agency
Site Name:	Hitchin Hospital	
Site ID:

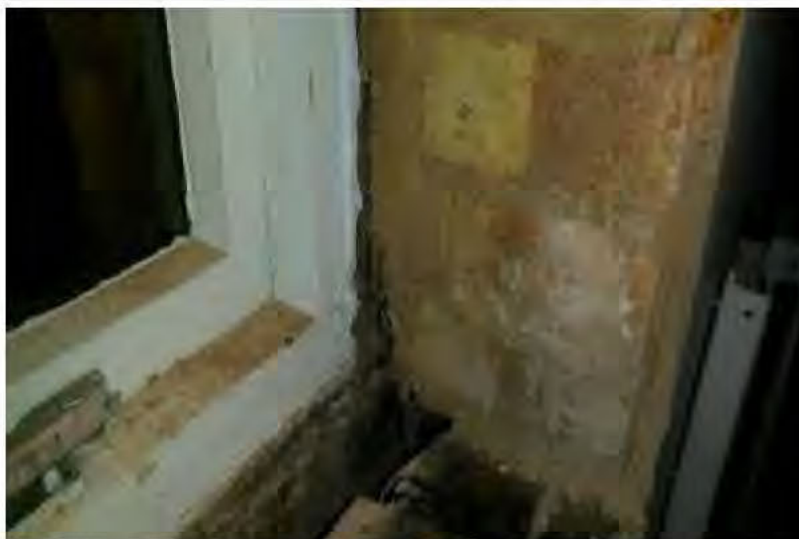
Inspection Number	57	Reference Number:	As Sample BB000232
Inspection / Sample	Visually similar to	Inspection Cross Reference / Visual I.D.	As Sample

Building	Laburnum House
Floor Level	Ground Floor
Area / Room	22 Patient Room
Feature	Damp proof course within wall cavity
Product Type	Well Bound Material
Extent Amount	> 50 m

Product Score	Low Fibre Release - Asbestos reinforced composites (plastics, resins, mastics, roofing felts, vinyl floor tiles, semi-rigid paits or decorative finishes, asbestos cement, etc.)	1
Extent of Damage	Good Condition	0
Surface Treatment	Completely Sealed	0
Asbestos Type	Chrysotile	1

Recommendation	Remove if likely to be disturbed
----------------	----------------------------------

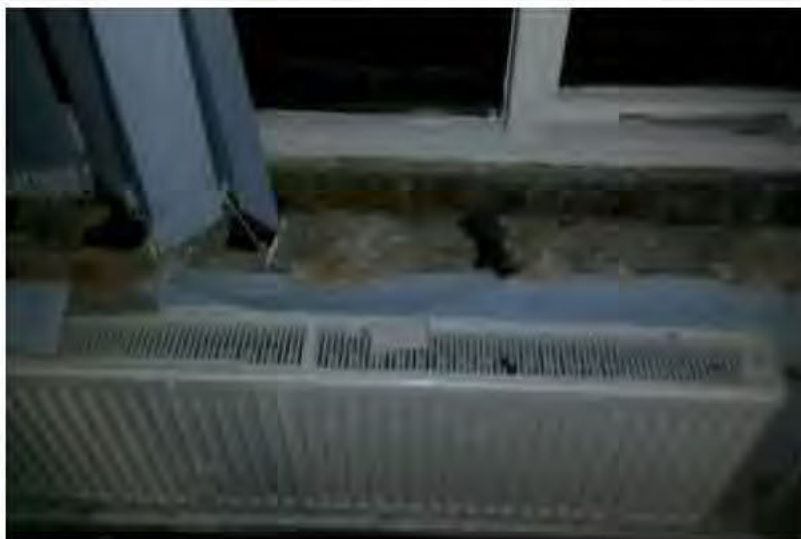
Inspection Number	58	Reference Number:	As Sample BB000233
Inspection / Sample	Visually similar to	Inspection Cross Reference / Visual I.D.	As Sample

Building	Laburnum House
Floor Level	Ground Floor
Area / Room	22 Patient Room
Feature	Damp proof course beneath window sill
Product Type	Well Bound Material
Extent Amount	2 m

Product Score	Low Fibre Release - Asbestos reinforced composites (plastics, resins, mastics, roofing felts, vinyl floor tiles, semi-rigid paits or decorative finishes, asbestos cement, etc.)	1
Extent of Damage	Low Damage	1
Surface Treatment	Completely Sealed	0
Asbestos Type	Chrysotile	1

Recommendation	Remove if likely to be disturbed
----------------	----------------------------------

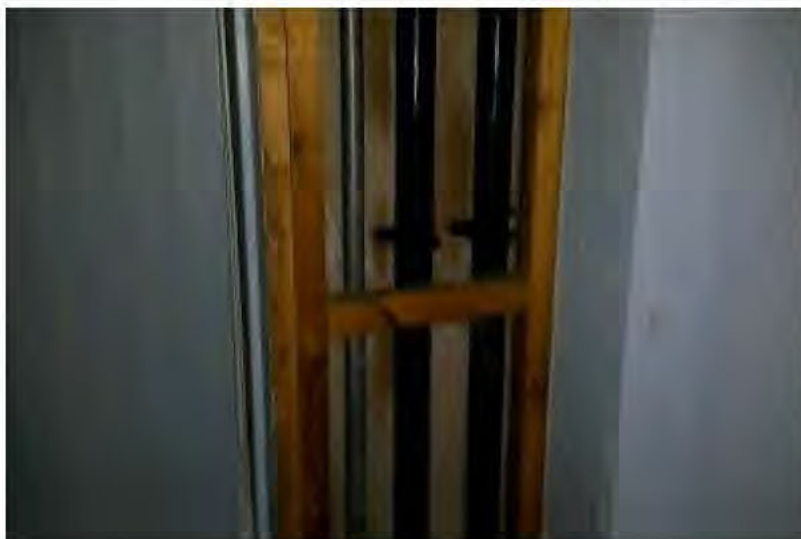
Inspection Number	59	Reference Number:	BB000257
Inspection / Sample	Sample taken	Inspection Cross Reference / Visual I.D.	N.A.D.I.S

Building	Laburnum House
Floor Level	Ground Floor
Area / Room	22 Patient Room
Feature	Debris to pipework within timber boxing and ceiling void
Product Type	Dust/Debris
Extent Amount	30 m

Product Score	High Fibre Release - Thermal insulation (e.g. pipe and boiler lagging) sprayed asbestos, loose asbestos, asbestos mattresses and packing	0
Extent of Damage	High Damage	0
Surface Treatment	Unsealed	0
Asbestos Type	No Asbestos Detected	0

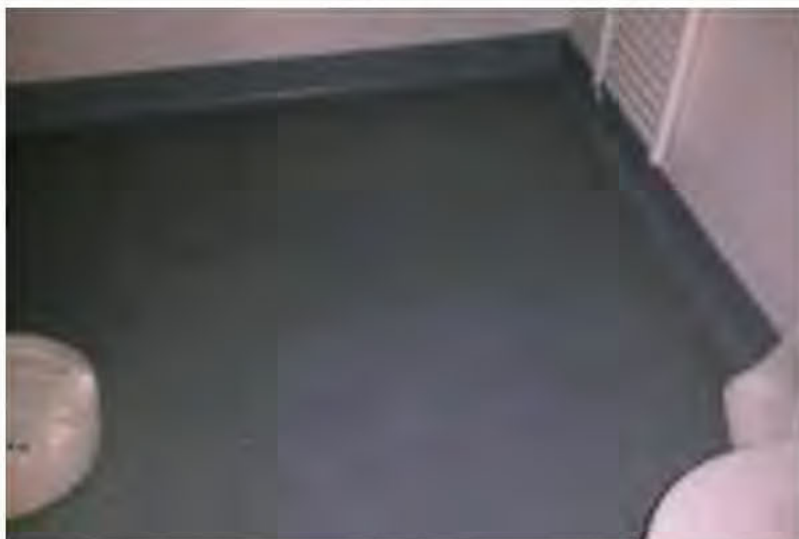
Inspection Number	60	Reference Number:	As Sample BB000256
Inspection / Sample	Visually similar to	Inspection Cross Reference / Visual I.D.	As Sample

Building	Laburnum House
Floor Level	Ground Floor
Area / Room	23 Toilet
Feature	Floor screed beneath lino
Product Type	Well Bound Material
Extent Amount	9 m ²

Product Score	Low Fibre Release - Asbestos reinforced composites (plastics, resins, mastics, roofing felts, vinyl floor tiles, semi-rigid paits or decorative finishes, asbestos cement, etc.)	0
Extent of Damage	High Damage	0
Surface Treatment	Completely Sealed	0
Asbestos Type	No Asbestos Detected	0

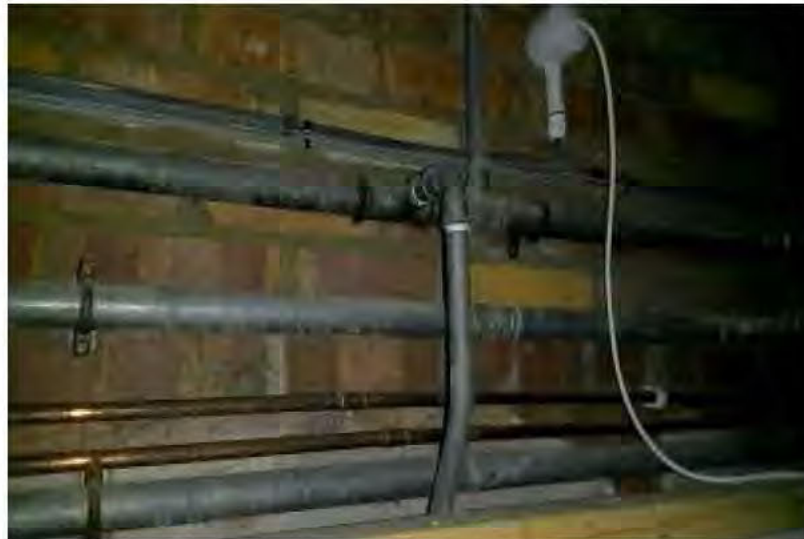
Inspection Number	61	Reference Number:	BB000258
Inspection / Sample	Sample taken	Inspection Cross Reference / Visual I.D.	N.A.D.I.S

Building	Laburnum House
Floor Level	Ground Floor
Area / Room	23 Toilet
Feature	Rope seal to pipework join within ceiling void
Product Type	Textiles/Paper
Extent Amount	< 1 m

Product Score	Medium Fibre Release - Asbestos insulating board, mill board, other low density insulation board, asbestos textiles, gaskets, rope and woven textiles, asbestos paper and felt	0
Extent of Damage	Low Damage	0
Surface Treatment	Unsealed	0
Asbestos Type	No Asbestos Detected	0

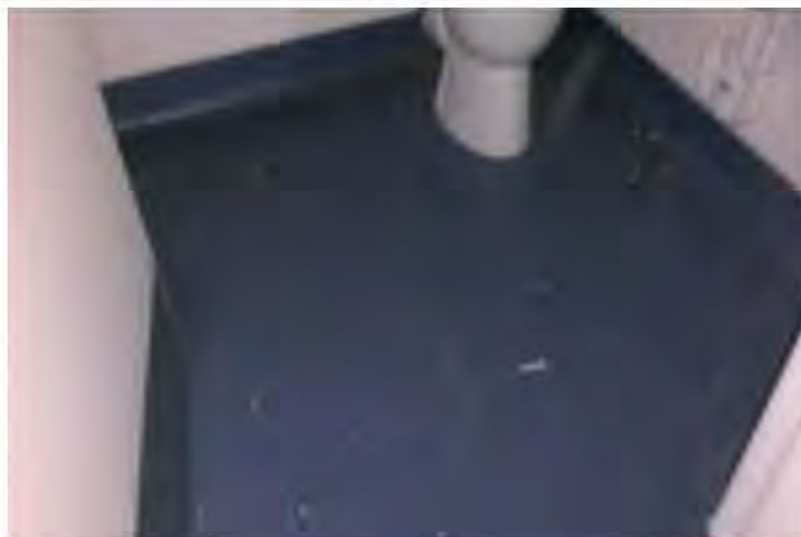
Inspection Number	63	Reference Number:	As Sample BB000256
Inspection / Sample	Visually similar to	Inspection Cross Reference / Visual I.D.	As Sample

Building	Laburnum House
Floor Level	Ground Floor
Area / Room	25 Toilet
Feature	Floor screed beneath lino
Product Type	Well Bound Material
Extent Amount	7 m ²

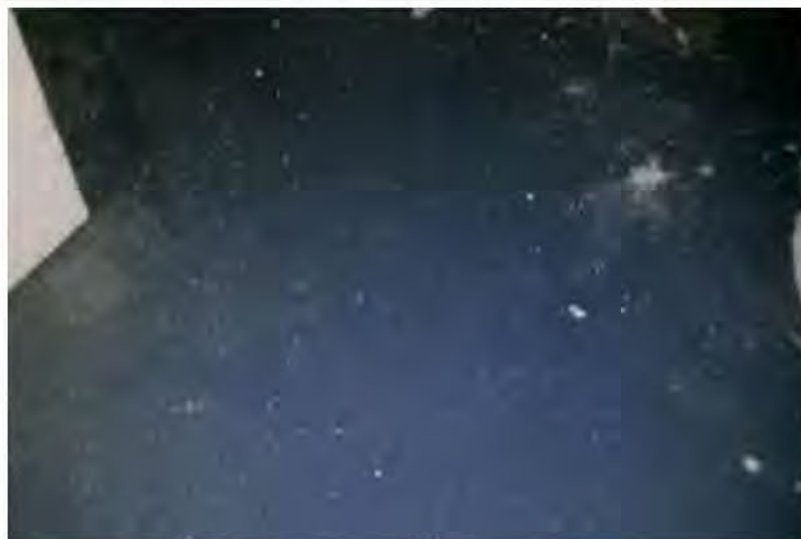
Inspection Number	64	Reference Number:	As Sample BB000256
Inspection / Sample	Visually similar to	Inspection Cross Reference / Visual I.D.	As Sample

Building	Laburnum House
Floor Level	Ground Floor
Area / Room	26 Patient Room
Feature	Floor screed beneath lino
Product Type	Well Bound Material
Extent Amount	40 m ²

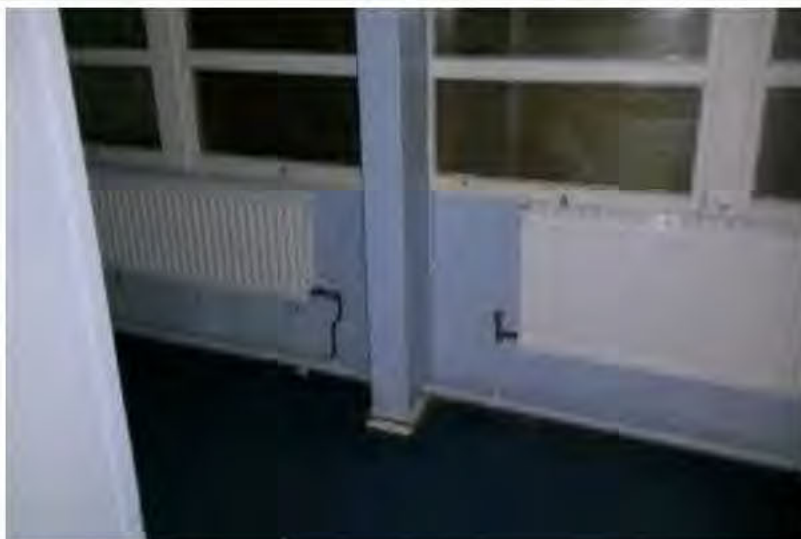
Inspection Number	65	Reference Number:	As Sample BB000240
Inspection / Sample	Visually similar to	Inspection Cross Reference / Visual I.D.	As Sample

Building	Laburnum House
Floor Level	Ground Floor
Area / Room	26 Patient Room
Feature	Boxing panels
Product Type	Asbestos Insulating Board
Extent Amount	18 m

Recommendation	Restrict access and remove
----------------	----------------------------

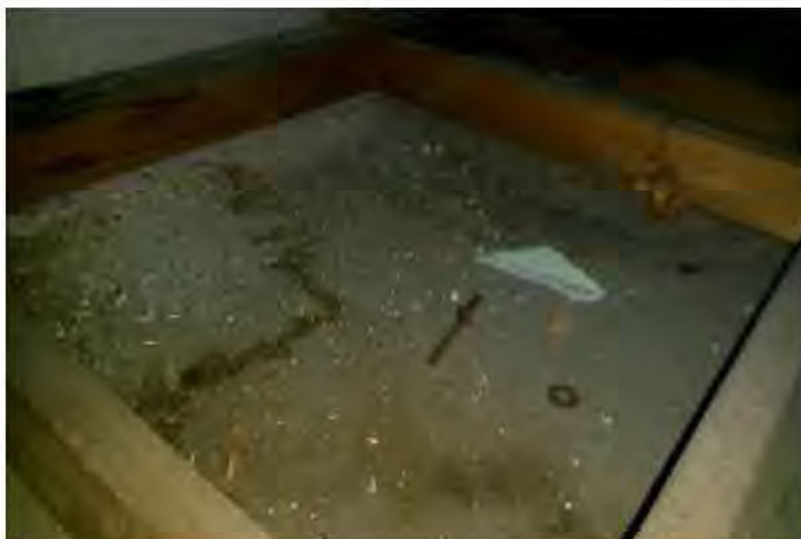
Inspection Number	67	Reference Number:	As Sample BB000240
Inspection / Sample	Visually similar to	Inspection Cross Reference / Visual I.D.	As Sample

Building	Laburnum House
Floor Level	Ground Floor
Area / Room	26 Patient Room
Feature	Debris in ceiling void
Product Type	Asbestos Insulating Board
Extent Amount	1 m ²

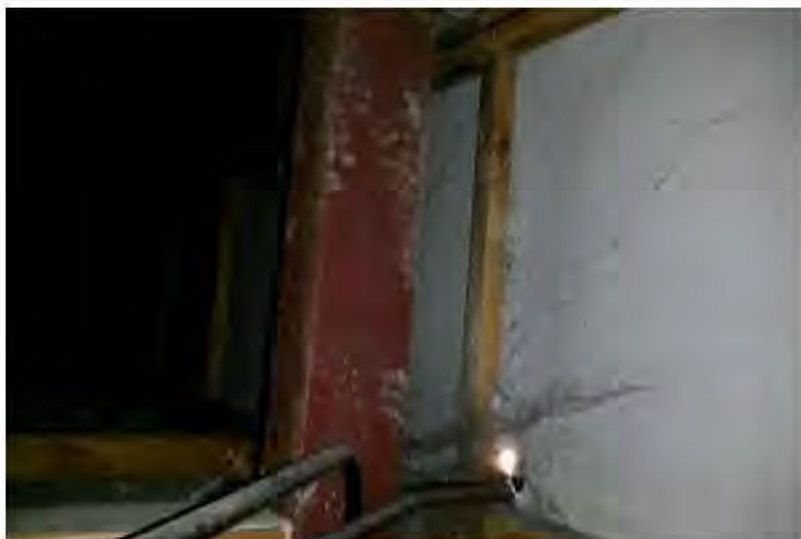
Inspection Number	68	Reference Number:	As Sample BB000240
Inspection / Sample	Visually similar to	Inspection Cross Reference / Visual I.D.	As Sample

Building	Laburnum House
Floor Level	Ground Floor
Area / Room	26 Patient Room
Feature	Wall panels to outer shell and within ceiling void
Product Type	Asbestos Insulating Board
Extent Amount	> 100 m ²

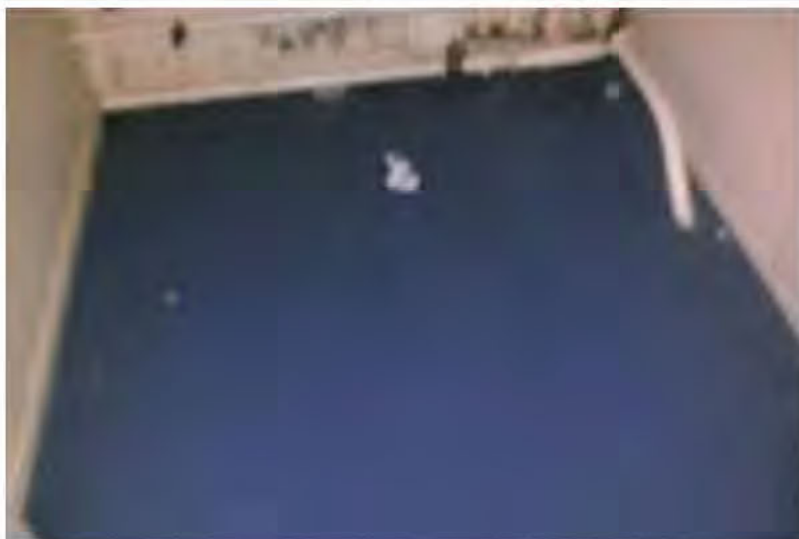
Inspection Number	69	Reference Number:	As Sample BB000256
Inspection / Sample	Visually similar to	Inspection Cross Reference / Visual I.D.	As Sample

Building	Laburnum House
Floor Level	Ground Floor
Area / Room	27 Store
Feature	Floor screed beneath lino
Product Type	Well Bound Material
Extent Amount	6 m ²

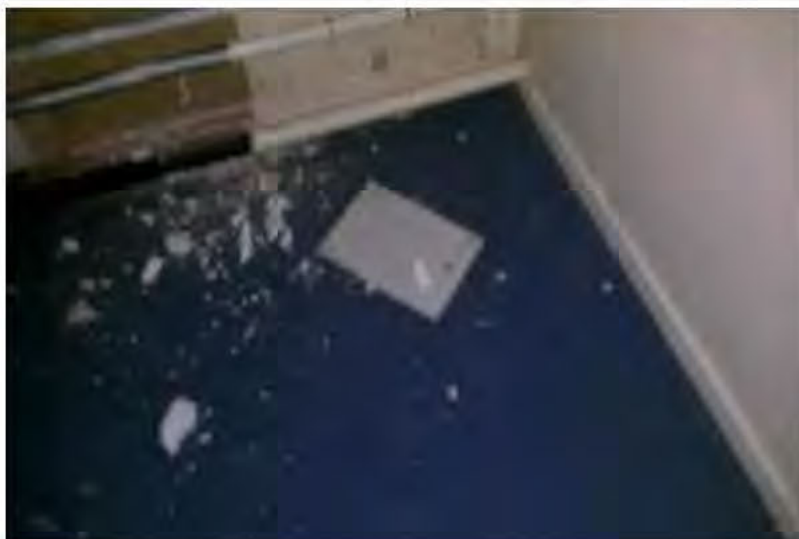
Inspection Number	71	Reference Number:	As Sample BB000256
Inspection / Sample	Visually similar to	Inspection Cross Reference / Visual I.D.	As Sample

Building	Laburnum House
Floor Level	Ground Floor
Area / Room	28 Store
Feature	Floor screed beneath lino
Product Type	Well Bound Material
Extent Amount	6 m ²

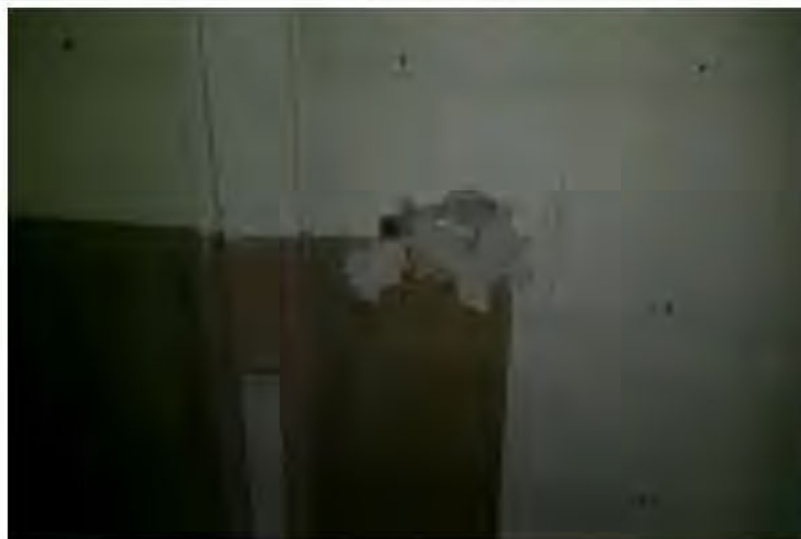
Inspection Number	72	Reference Number:	As Sample BB000240
Inspection / Sample	Visually similar to	Inspection Cross Reference / Visual I.D.	As Sample

Building	Laburnum House
Floor Level	Ground Floor
Area / Room	28 Store
Feature	Panels to outer shell and within ceiling void
Product Type	Asbestos Insulating Board
Extent Amount	8 m ²

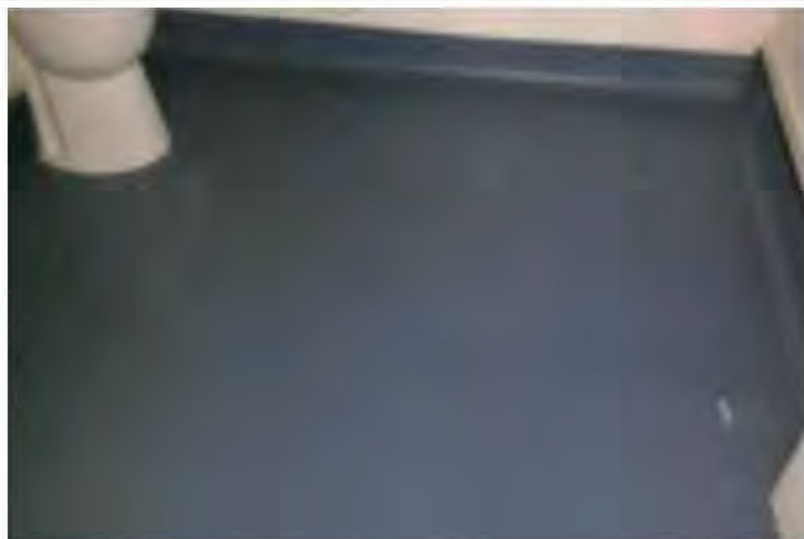
Inspection Number	73	Reference Number:	As Sample BB000256
Inspection / Sample	Visually similar to	Inspection Cross Reference / Visual I.D.	As Sample

Building	Laburnum House
Floor Level	Ground Floor
Area / Room	29 Toilet
Feature	Floor screed beneath lino
Product Type	Well Bound Material
Extent Amount	6 m ²

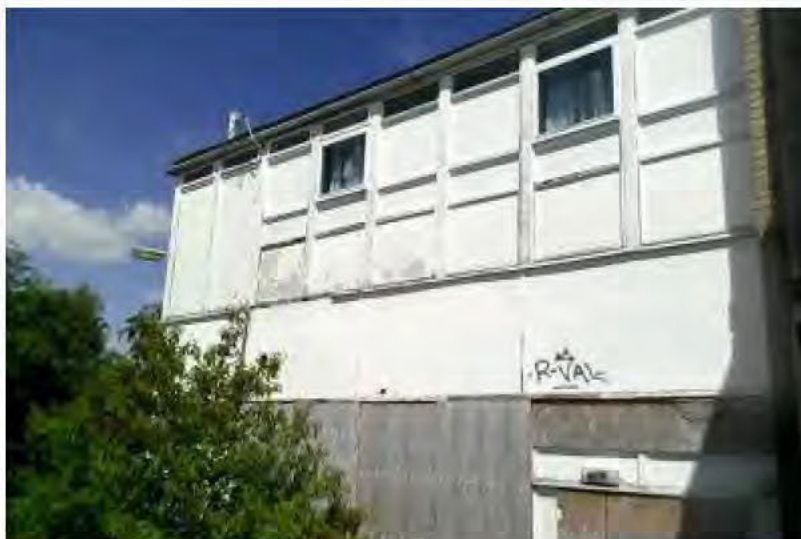
Inspection Number	75	Reference Number:	As Sample BB000240
Inspection / Sample	Visually similar to	Inspection Cross Reference / Visual I.D.	As Sample

Building	Laburnum House
Floor Level	External
Area / Room	1 Externals
Feature	Wall panels
Product Type	Asbestos Insulating Board
Extent Amount	> 100 m ²

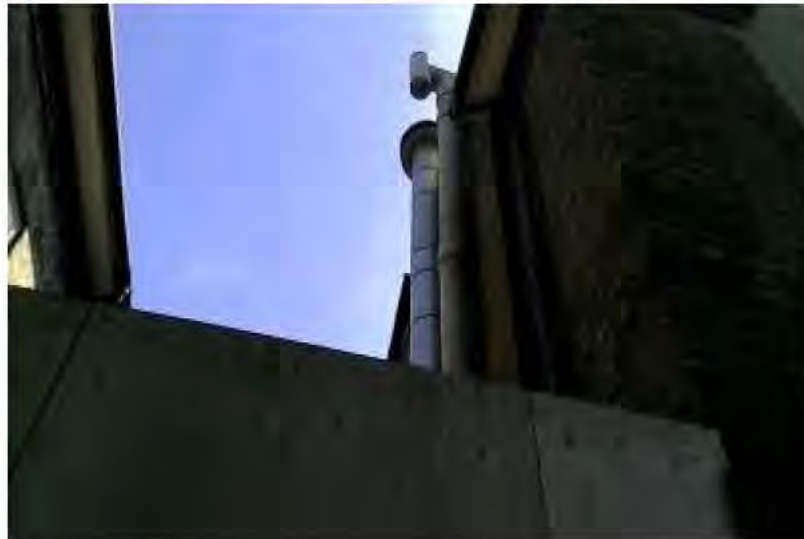
Inspection Number	76	Reference Number:	As Sample BB000246
Inspection / Sample	Visually similar to	Inspection Cross Reference / Visual I.D.	As Sample

Building	Laburnum House
Floor Level	External
Area / Room	1 Externals
Feature	Cement flue
Product Type	Asbestos Cement
Extent Amount	10 m

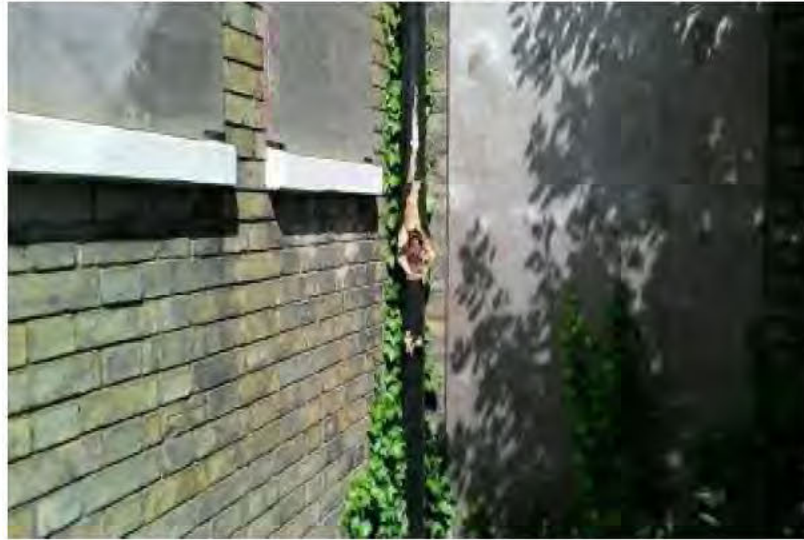
Inspection Number	78	Reference Number:	BB000261
Inspection / Sample	Sample taken	Inspection Cross Reference / Visual I.D.	N.A.D.I.S

Building	Laburnum House
Floor Level	External
Area / Room	1 Externals
Feature	Debris to pipework
Product Type	Insulation
Extent Amount	8 m

Product Score	High Fibre Release - Thermal insulation (e.g. pipe and boiler lagging) sprayed asbestos, loose asbestos, asbestos mattresses and packing	0
Extent of Damage	High Damage	0
Surface Treatment	Unsealed	0
Asbestos Type	No Asbestos Detected	0

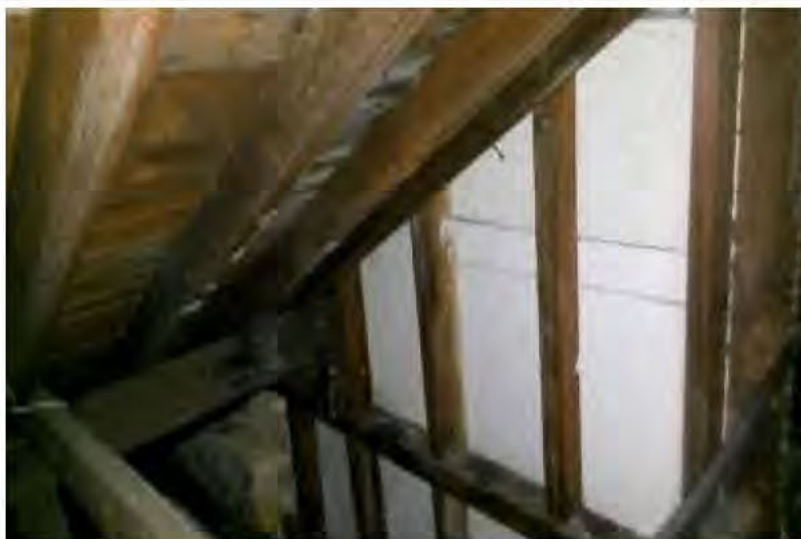
Inspection Number	79	Reference Number:	BB000262
Inspection / Sample	Sample taken	Inspection Cross Reference / Visual I.D.	N.A.D.I.S

Building	Cherry Tree
Floor Level	Roof Void
Area / Room	1 Roof Space
Feature	Boxing panels and associated debris
Product Type	Insulating Board
Extent Amount	7 m ²

Product Score	Medium Fibre Release - Asbestos insulating board, mill board, other low density insulation board, asbestos textiles, gaskets, rope and woven textiles, asbestos paper and felt	0
Extent of Damage	High Damage	0
Surface Treatment	Unsealed	0
Asbestos Type	No Asbestos Detected	0

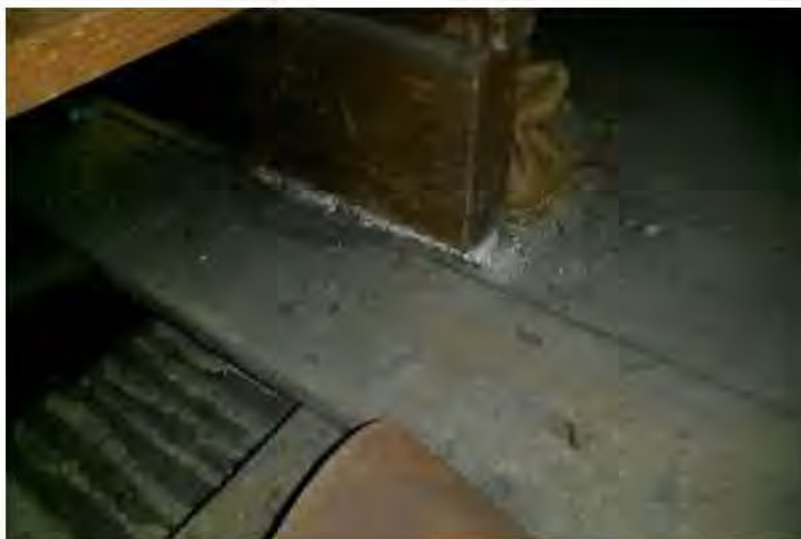
Inspection Number	80	Reference Number:	BB000263
Inspection / Sample	Sample taken	Inspection Cross Reference / Visual I.D.	N.A.D.I.S

Building	Cherry Tree
Floor Level	Roof Void
Area / Room	1 Roof Space
Feature	Packers beneath water tank
Product Type	Insulating Board
Extent Amount	< 1 m

Product Score	Medium Fibre Release - Asbestos insulating board, mill board, other low density insulation board, asbestos textiles, gaskets, rope and woven textiles, asbestos paper and felt	0
Extent of Damage	High Damage	0
Surface Treatment	Unsealed	0
Asbestos Type	No Asbestos Detected	0

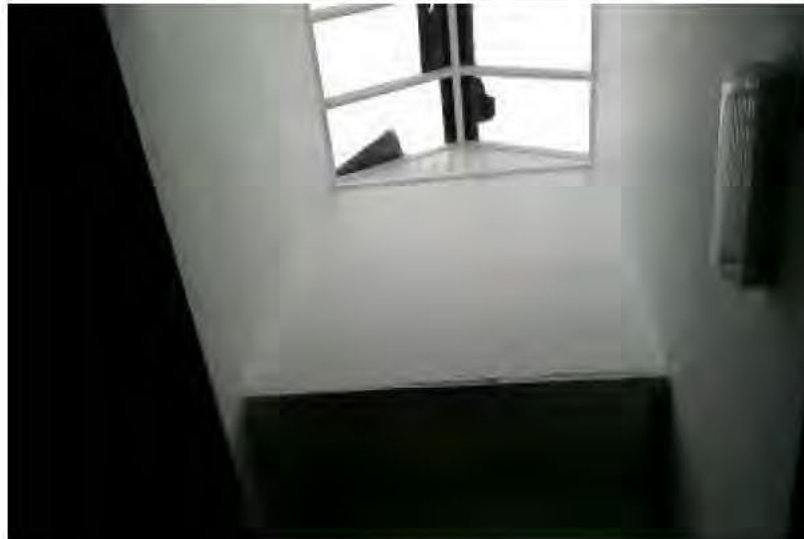
Inspection Number	81	Reference Number:	As Sample BB000262
Inspection / Sample	Visually similar to	Inspection Cross Reference / Visual I.D.	As Sample

Building	Cherry Tree
Floor Level	1st Floor
Area / Room	1 Landing
Feature	Skylight panels and boxing
Product Type	Insulating Board
Extent Amount	12 m ²

Product Score	Medium Fibre Release - Asbestos insulating board, mill board, other low density insulation board, asbestos textiles, gaskets, rope and woven textiles, asbestos paper and felt	0
Extent of Damage	Medium Damage	0
Surface Treatment	Unsealed	0
Asbestos Type	No Asbestos Detected	0

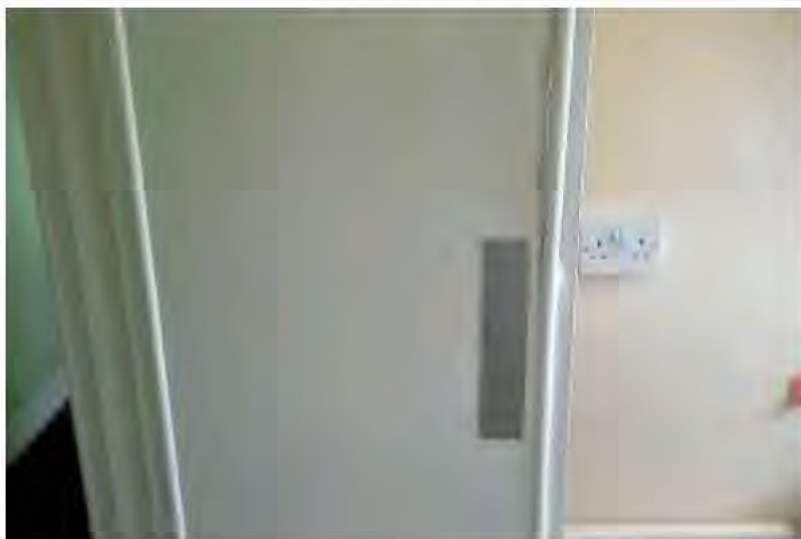
Inspection Number	82	Reference Number:	BB000264
Inspection / Sample	Sample taken	Inspection Cross Reference / Visual I.D.	Asbestos Identified

Building	Cherry Tree
Floor Level	1st Floor
Area / Room	2 Corridor
Feature	Door panel
Product Type	Asbestos Insulating Board
Extent Amount	2 m ²

Product Score	Medium Fibre Release - Asbestos insulating board, mill board, other low density insulation board, asbestos textiles, gaskets, rope and woven textiles, asbestos paper and felt	2
Extent of Damage	Low Damage	1
Surface Treatment	Unsealed	2
Asbestos Type	Chrysotile + Amosite	2

Recommendation	Remove if likely to be disturbed
----------------	----------------------------------

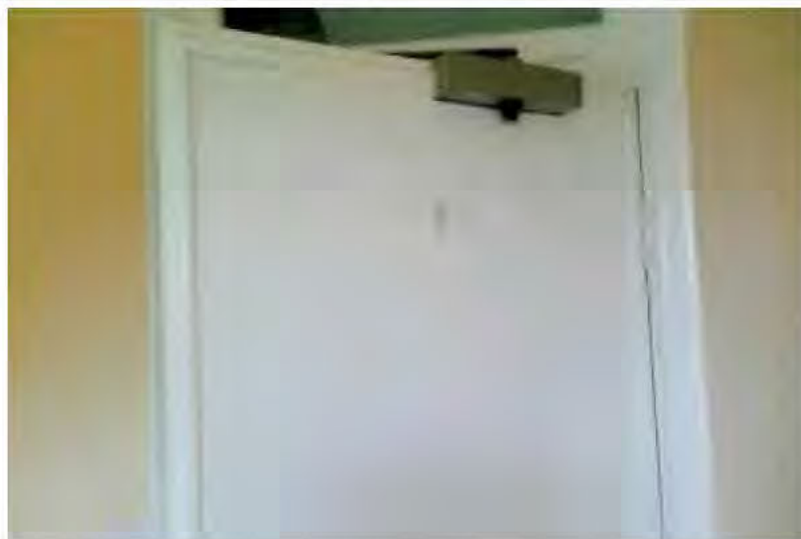
Inspection Number	83	Reference Number:	As Sample BB000264
Inspection / Sample	Visually similar to	Inspection Cross Reference / Visual I.D.	As Sample

Building	Cherry Tree
Floor Level	1st Floor
Area / Room	12 Kitchen
Feature	Door panel
Product Type	Asbestos Insulating Board
Extent Amount	2 m ²

Product Score	Medium Fibre Release - Asbestos insulating board, mill board, other low density insulation board, asbestos textiles, gaskets, rope and woven textiles, asbestos paper and felt	2
Extent of Damage	Low Damage	1
Surface Treatment	Surface Sealed	1
Asbestos Type	Chrysotile + Amosite	2

Recommendation	Remove if likely to be disturbed
----------------	----------------------------------

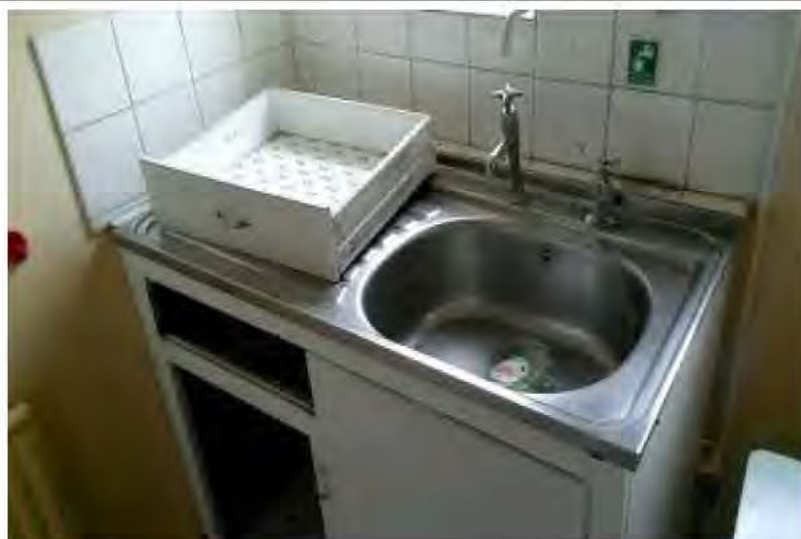
Inspection Number	84	Reference Number:	BB000265
Inspection / Sample	Sample taken	Inspection Cross Reference / Visual I.D.	Asbestos Identified

Building	Cherry Tree
Floor Level	1st Floor
Area / Room	12 Kitchen
Feature	Bitumen pads to underside of sink and drainer
Product Type	Well Bound Material
Extent Amount	2 no.

Product Score	Low Fibre Release - Asbestos reinforced composites (plastics, resins, mastics, roofing felts, vinyl floor tiles, semi-rigid paits or decorative finishes, asbestos cement, etc.)	1
Extent of Damage	Low Damage	1
Surface Treatment	Completely Sealed	0
Asbestos Type	Chrysotile	1

Recommendation	Remove if likely to be disturbed
----------------	----------------------------------

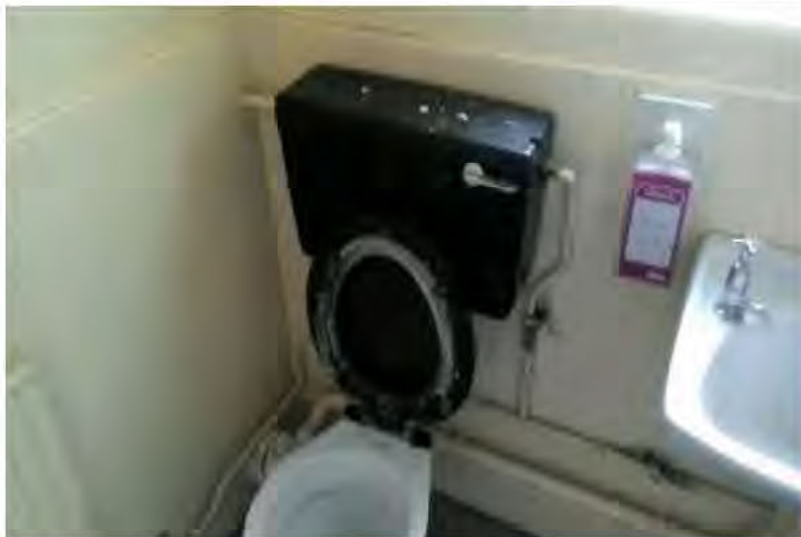
Inspection Number	85	Reference Number:	BB000266
Inspection / Sample	Sample taken	Inspection Cross Reference / Visual I.D.	Asbestos Identified

Building	Cherry Tree
Floor Level	1st Floor
Area / Room	15 Toilet
Feature	Toilet cistern
Product Type	Reinforced Composite
Extent Amount	1 no.

Product Score	Low Fibre Release - Asbestos reinforced composites (plastics, resins, mastics, roofing felts, vinyl floor tiles, semi-rigid paits or decorative finishes, asbestos cement, etc.)	1
Extent of Damage	Good Condition	0
Surface Treatment	Completely Sealed	0
Asbestos Type	Amosite	2

Recommendation	Remove if likely to be disturbed
----------------	----------------------------------

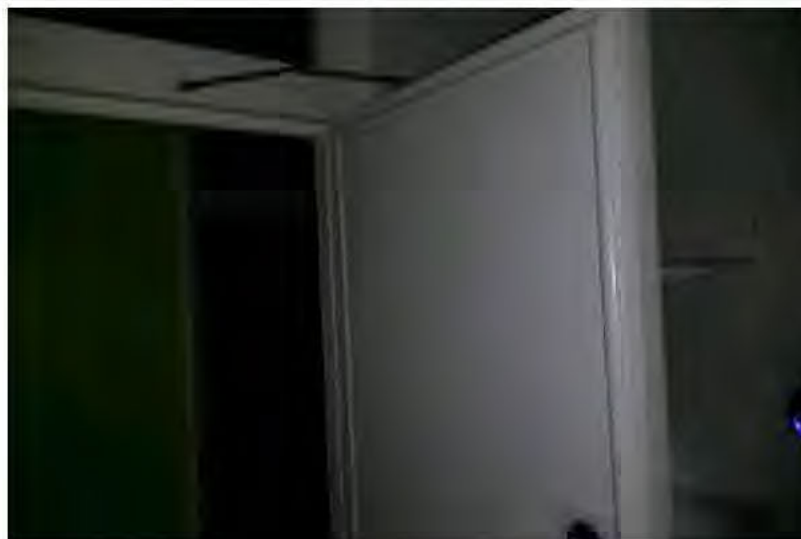
Inspection Number	86	Reference Number:	As Sample BB000264
Inspection / Sample	Visually similar to	Inspection Cross Reference / Visual I.D.	As Sample

Building	Cherry Tree
Floor Level	Ground Floor
Area / Room	4 Corridor
Feature	Door panels
Product Type	Asbestos Insulating Board
Extent Amount	4 m ²

Product Score	Medium Fibre Release - Asbestos insulating board, mill board, other low density insulation board, asbestos textiles, gaskets, rope and woven textiles, asbestos paper and felt	2
Extent of Damage	Low Damage	1
Surface Treatment	Unsealed	2
Asbestos Type	Chrysotile + Amosite	2

Recommendation	Remove if likely to be disturbed
----------------	----------------------------------

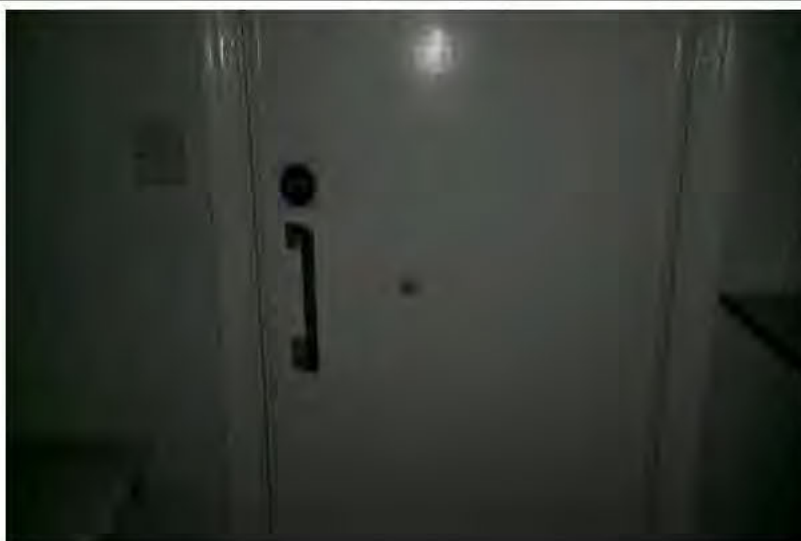
Inspection Number	87	Reference Number:	As Sample BB000264
Inspection / Sample	Visually similar to	Inspection Cross Reference / Visual I.D.	As Sample

Building	Cherry Tree
Floor Level	Ground Floor
Area / Room	7 Kitchen
Feature	Door panel
Product Type	Asbestos Insulating Board
Extent Amount	2 m ²

Product Score	Medium Fibre Release - Asbestos insulating board, mill board, other low density insulation board, asbestos textiles, gaskets, rope and woven textiles, asbestos paper and felt	2
Extent of Damage	High Damage	3
Surface Treatment	Unsealed	2
Asbestos Type	Chrysotile + Amosite	2

Recommendation	Remove if likely to be disturbed
----------------	----------------------------------

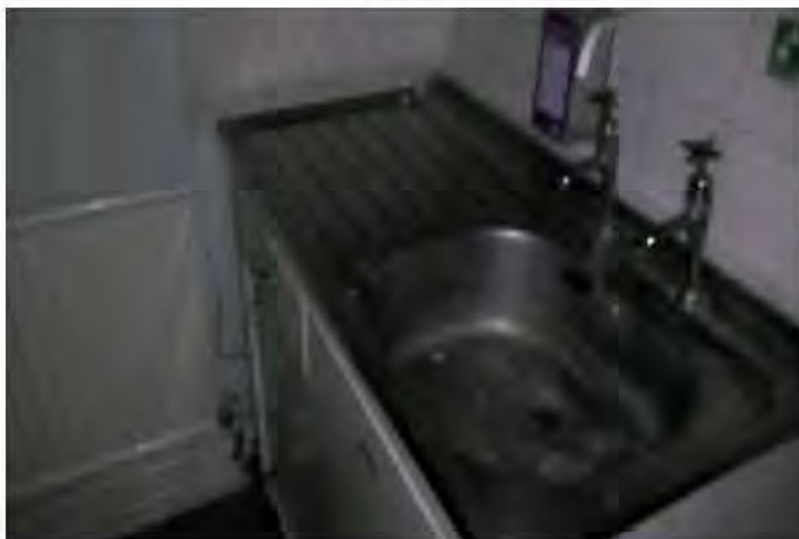
Inspection Number	88	Reference Number:	As Sample BB000265
Inspection / Sample	Visually similar to	Inspection Cross Reference / Visual I.D.	As Sample

Building	Cherry Tree
Floor Level	Ground Floor
Area / Room	7 Kitchen
Feature	Bitumen pads to underside of sink and drainer
Product Type	Well Bound Material
Extent Amount	2 no.

Product Score	Low Fibre Release - Asbestos reinforced composites (plastics, resins, mastics, roofing felts, vinyl floor tiles, semi-rigid paits or decorative finishes, asbestos cement, etc.)	1
Extent of Damage	Low Damage	1
Surface Treatment	Completely Sealed	0
Asbestos Type	Chrysotile	1

Recommendation	Remove if likely to be disturbed
----------------	----------------------------------

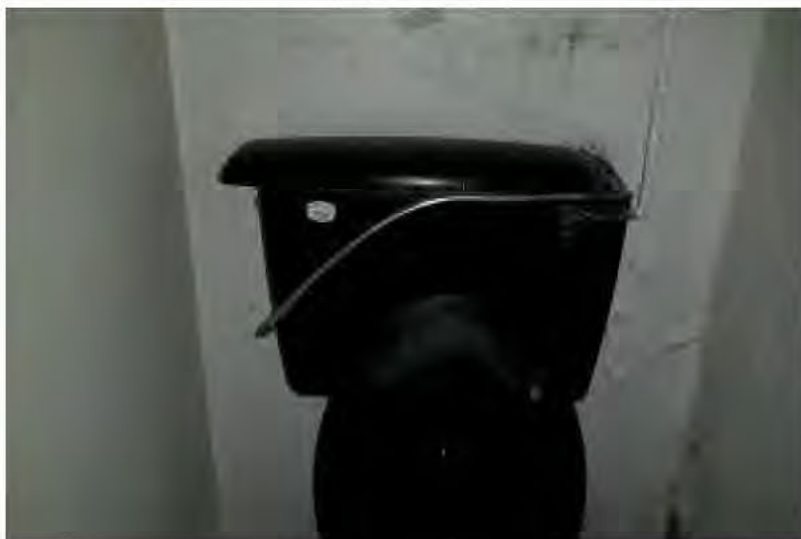
Inspection Number	89	Reference Number:	As Sample BB000266
Inspection / Sample	Visually similar to	Inspection Cross Reference / Visual I.D.	As Sample

Building	Cherry Tree
Floor Level	Ground Floor
Area / Room	12 Toilet
Feature	Toilet cistern
Product Type	Reinforced Composite
Extent Amount	1 no.

Product Score	Low Fibre Release - Asbestos reinforced composites (plastics, resins, mastics, roofing felts, vinyl floor tiles, semi-rigid paits or decorative finishes, asbestos cement, etc.)	1
Extent of Damage	Good Condition	0
Surface Treatment	Completely Sealed	0
Asbestos Type	Amosite	2

Recommendation	Remove if likely to be disturbed
----------------	----------------------------------

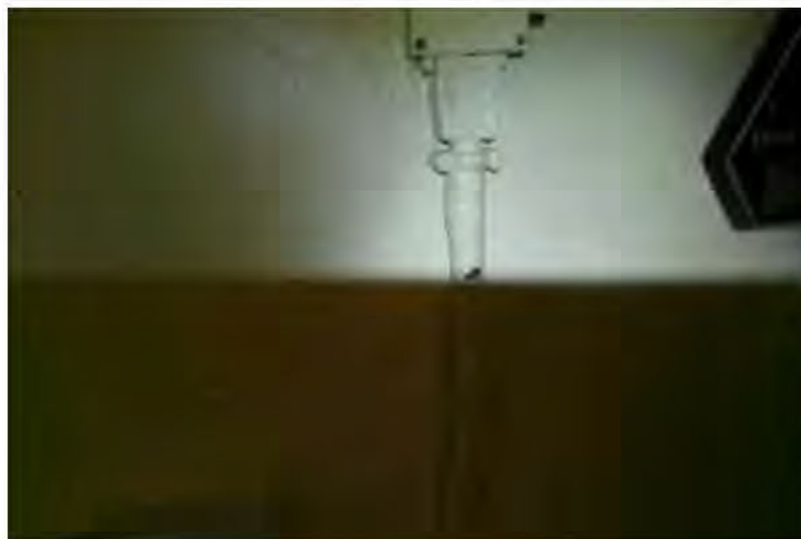
Inspection Number	91	Reference Number:	BB000268
Inspection / Sample	Sample taken	Inspection Cross Reference / Visual I.D.	N.A.D.I.S

Building	Cherry Tree
Floor Level	Ground Floor
Area / Room	4 Corridor
Feature	Cable wrap
Product Type	Well Bound Material
Extent Amount	2 m

Product Score	Low Fibre Release - Asbestos reinforced composites (plastics, resins, mastics, roofing felts, vinyl floor tiles, semi-rigid paits or decorative finishes, asbestos cement, etc.)	0
Extent of Damage	Low Damage	0
Surface Treatment	Completely Sealed	0
Asbestos Type	No Asbestos Detected	0

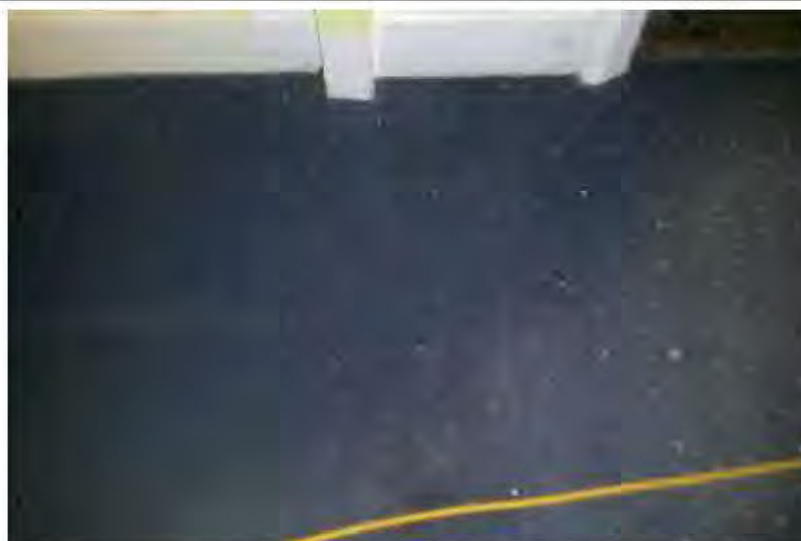
Inspection Number	92	Reference Number:	As Sample BB000267
Inspection / Sample	Visually similar to	Inspection Cross Reference / Visual I.D.	As Sample

Building	Cherry Tree
Floor Level	Ground Floor
Area / Room	4 Corridor
Feature	Loose lagging within floor void
Product Type	Asbestos Insulation/Coating
Extent Amount	4 m ²

Product Score	High Fibre Release - Thermal insulation (e.g. pipe and boiler lagging) sprayed asbestos, loose asbestos, asbestos mattresses and packing	3
Extent of Damage	High Damage	3
Surface Treatment	Unsealed	3
Asbestos Type	Chrysotile + Amosite	2

Recommendation	Restrict access and remove
----------------	----------------------------

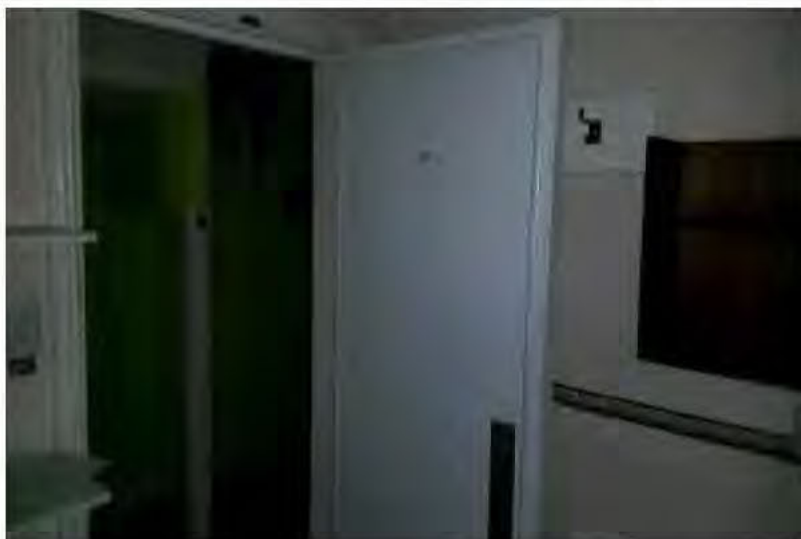
Inspection Number	93	Reference Number:	As Sample BB000264
Inspection / Sample	Visually similar to	Inspection Cross Reference / Visual I.D.	As Sample

Building	Cherry Tree
Floor Level	Ground Floor
Area / Room	16 Office
Feature	Door panel
Product Type	Asbestos Insulating Board
Extent Amount	2 m ²

Product Score	Medium Fibre Release - Asbestos insulating board, mill board, other low density insulation board, asbestos textiles, gaskets, rope and woven textiles, asbestos paper and felt	2
Extent of Damage	Low Damage	1
Surface Treatment	Surface Sealed	1
Asbestos Type	Chrysotile + Amosite	2

Recommendation	Remove if likely to be disturbed
----------------	----------------------------------

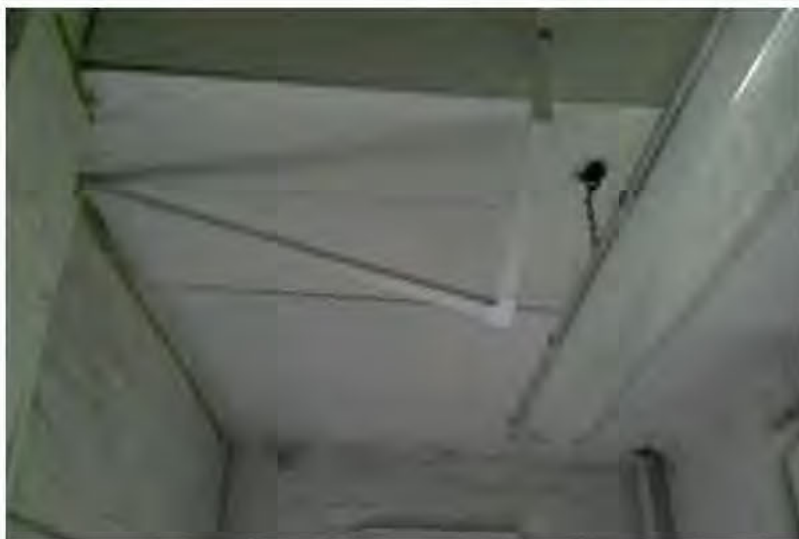
Inspection Number	94	Reference Number:	BB000269
Inspection / Sample	Sample taken	Inspection Cross Reference / Visual I.D.	N.A.D.I.S

Building	Cherry Tree
Floor Level	Ground Floor
Area / Room	20 Boiler Room
Feature	Ceiling panels
Product Type	Insulating Board
Extent Amount	4 m ²

Product Score	Medium Fibre Release - Asbestos insulating board, mill board, other low density insulation board, asbestos textiles, gaskets, rope and woven textiles, asbestos paper and felt	0
Extent of Damage	Low Damage	0
Surface Treatment	Unsealed	0
Asbestos Type	No Asbestos Detected	0

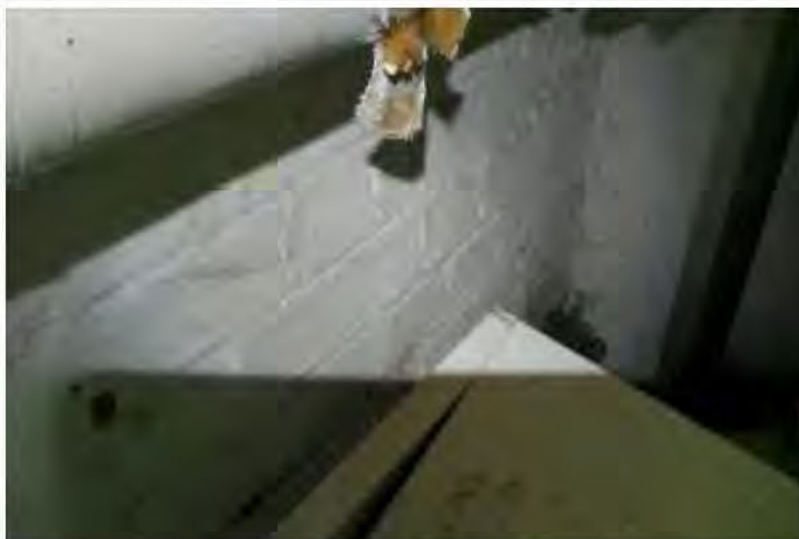
Inspection Number	95	Reference Number:	BB000270
Inspection / Sample	Sample taken	Inspection Cross Reference / Visual I.D.	N.A.D.I.S

Building	Cherry Tree
Floor Level	Ground Floor
Area / Room	20 Boiler Room
Feature	Wall debris
Product Type	Insulation
Extent Amount	15 m ²

Product Score	High Fibre Release - Thermal insulation (e.g. pipe and boiler lagging) sprayed asbestos, loose asbestos, asbestos mattresses and packing	0
Extent of Damage	High Damage	0
Surface Treatment	Unsealed	0
Asbestos Type	No Asbestos Detected	0

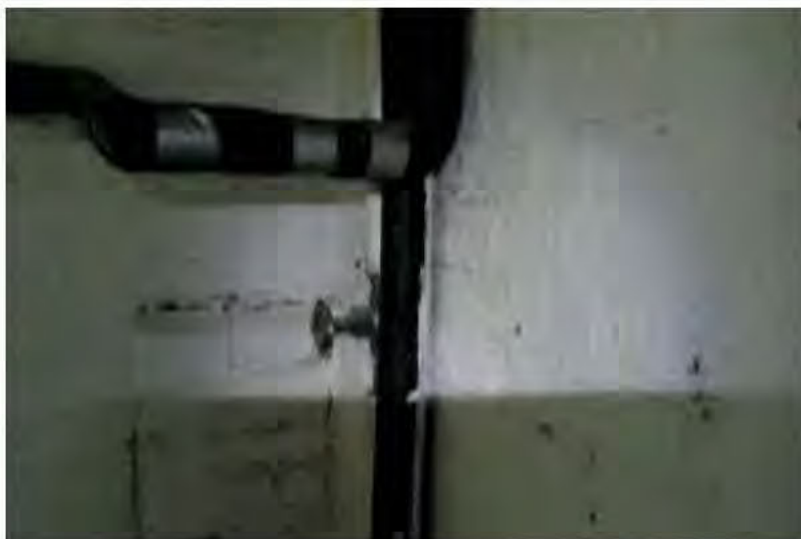
Inspection Number	96	Reference Number:	BB000271
Inspection / Sample	Sample taken	Inspection Cross Reference / Visual I.D.	Asbestos Identified

Building	Cherry Tree
Floor Level	Ground Floor
Area / Room	20 Boiler Room
Feature	Wall debris
Product Type	Asbestos Insulation/Coating
Extent Amount	15 m ²

Product Score	High Fibre Release - Thermal insulation (e.g. pipe and boiler lagging) sprayed asbestos, loose asbestos, asbestos mattresses and packing	3
Extent of Damage	High Damage	3
Surface Treatment	Unsealed	3
Asbestos Type	Chrysotile + Amosite	2

Recommendation	Restrict access and remove
----------------	----------------------------

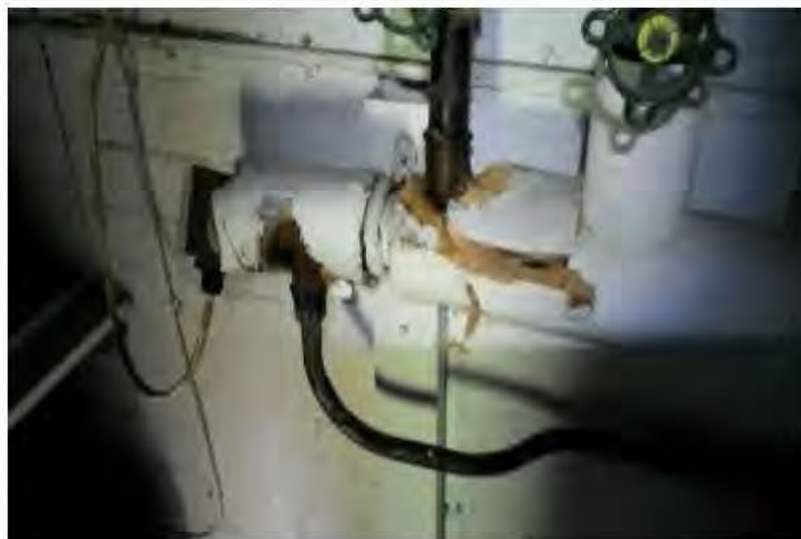
Inspection Number	97	Reference Number:	BB000272
Inspection / Sample	Sample taken	Inspection Cross Reference / Visual I.D.	N.A.D.I.S

Building	Cherry Tree
Floor Level	Ground Floor
Area / Room	20 Boiler Room
Feature	Residues to pipework
Product Type	Insulation
Extent Amount	35 m

Product Score	High Fibre Release - Thermal insulation (e.g. pipe and boiler lagging) sprayed asbestos, loose asbestos, asbestos mattresses and packing	0
Extent of Damage	High Damage	0
Surface Treatment	Unsealed	0
Asbestos Type	No Asbestos Detected	0

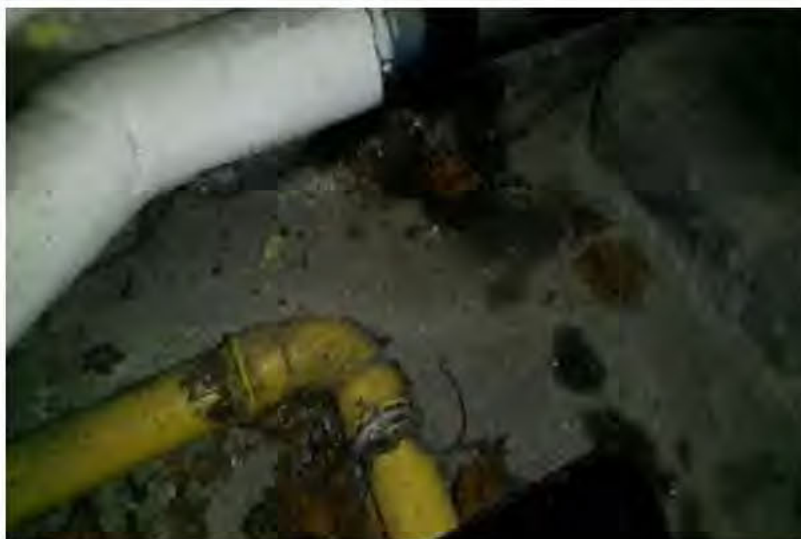
Inspection Number	98	Reference Number:	BB000273
Inspection / Sample	Sample taken	Inspection Cross Reference / Visual I.D.	Asbestos Identified

Building	Cherry Tree
Floor Level	Ground Floor
Area / Room	20 Boiler Room
Feature	Debris to floor
Product Type	Dust/Debris
Extent Amount	9 m ²

Product Score	High Fibre Release - Thermal insulation (e.g. pipe and boiler lagging) sprayed asbestos, loose asbestos, asbestos mattresses and packing	3
Extent of Damage	High Damage	3
Surface Treatment	Unsealed	3
Asbestos Type	Chrysotile	1

Recommendation	Restrict access and remove
----------------	----------------------------

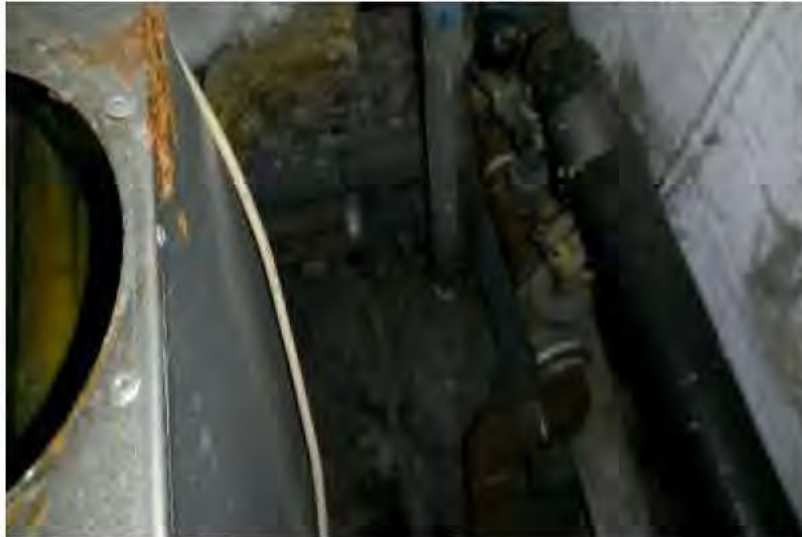
Inspection Number	99	Reference Number:	BB000274
Inspection / Sample	Sample taken	Inspection Cross Reference / Visual I.D.	Asbestos Identified

Building	Cherry Tree
Floor Level	Ground Floor
Area / Room	20 Boiler Room
Feature	Debris to floor
Product Type	Dust/Debris
Extent Amount	9 m ²

Product Score	High Fibre Release - Thermal insulation (e.g. pipe and boiler lagging) sprayed asbestos, loose asbestos, asbestos mattresses and packing	3
Extent of Damage	High Damage	3
Surface Treatment	Unsealed	3
Asbestos Type	Chrysotile	1

Recommendation	Restrict access and remove
----------------	----------------------------

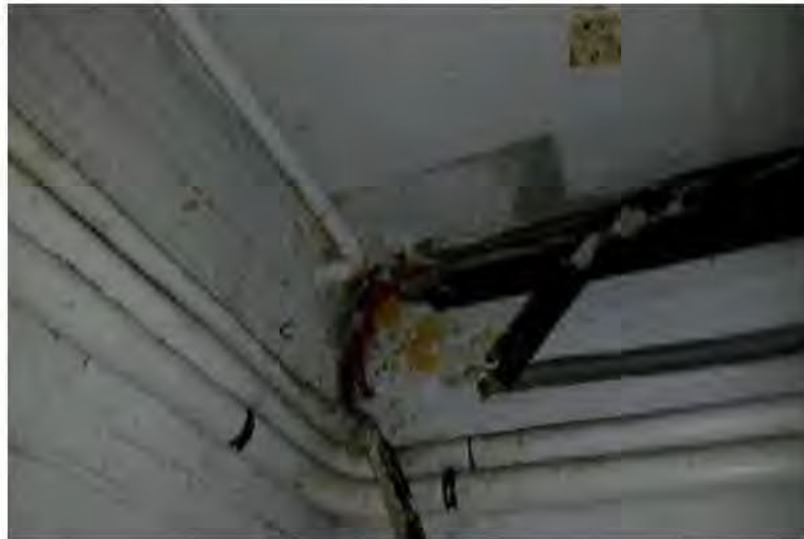
Inspection Number	100	Reference Number:	As Sample BB000272
Inspection / Sample	Visually similar to	Inspection Cross Reference / Visual I.D.	As Sample

Building	Cherry Tree
Floor Level	Ground Floor
Area / Room	20 Boiler Room
Feature	Lagging with ceiling
Product Type	Insulation
Extent Amount	< 1 m ²

Product Score	High Fibre Release - Thermal insulation (e.g. pipe and boiler lagging) sprayed asbestos, loose asbestos, asbestos mattresses and packing	0
Extent of Damage	High Damage	0
Surface Treatment	Unsealed	0
Asbestos Type	No Asbestos Detected	0

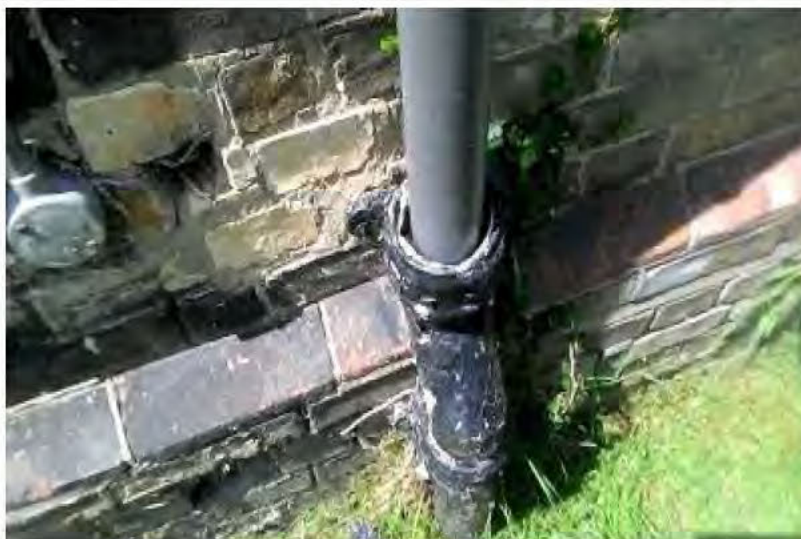
Inspection Number	101	Reference Number:	BB000275
Inspection / Sample	Sample taken	Inspection Cross Reference / Visual I.D.	N.A.D.I.S

Building	Cherry Tree
Floor Level	External
Area / Room	1 External
Feature	Putty seal to down pipe
Product Type	Well Bound Material
Extent Amount	< 1 m ²

Product Score	Low Fibre Release - Asbestos reinforced composites (plastics, resins, mastics, roofing felts, vinyl floor tiles, semi-rigid paits or decorative finishes, asbestos cement, etc.)	0
Extent of Damage	Medium Damage	0
Surface Treatment	Completely Sealed	0
Asbestos Type	No Asbestos Detected	0
