RE: Request for Information – RFI3321

TITLE HITCHIN HOSPITAL BEDFORD ROAD HITCHIN		(DRAFT)

Homes & Communities Agency
Site Name:	Hitchin Hospital	
Site ID:

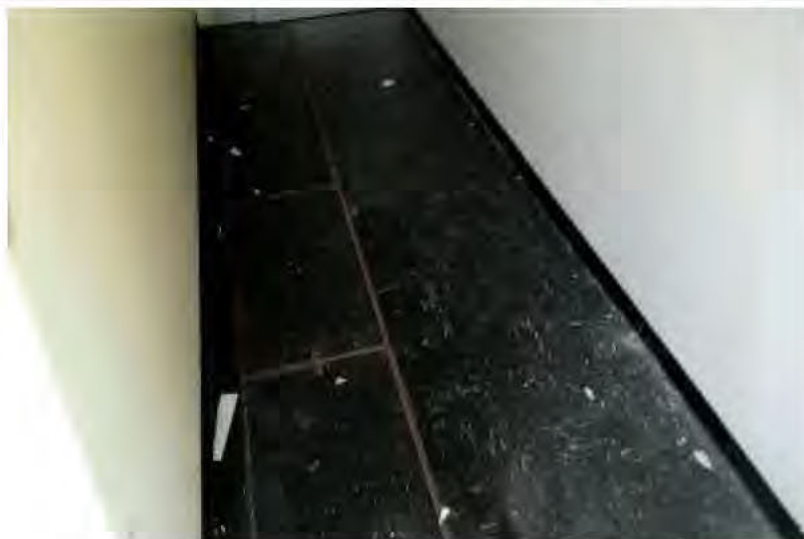
Inspection Number	102	Reference Number:	BB000276
Inspection / Sample	Sample taken	Inspection Cross Reference / Visual I.D.	N.A.D.I.S

Building	Apple Tree
Floor Level	Ground Floor
Area / Room	1 Entrance / Corridor
Feature	Vinyl floor tiles and bitumen adhesive below
Product Type	Reinforced Composite
Extent Amount	5 m ²

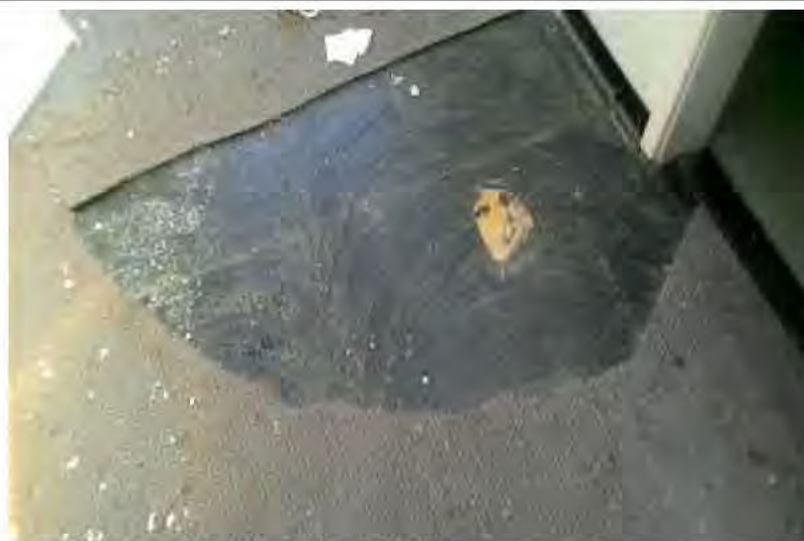
Inspection Number	103	Reference Number:	BB000277
Inspection / Sample	Sample taken	Inspection Cross Reference / Visual I.D.	N.A.D.I.S

Building	Apple Tree
Floor Level	Ground Floor
Area / Room	1 Entrance / Corridor
Feature	Bitumen adhesive beneath carpet and lino
Product Type	Well Bound Material
Extent Amount	20 m ²

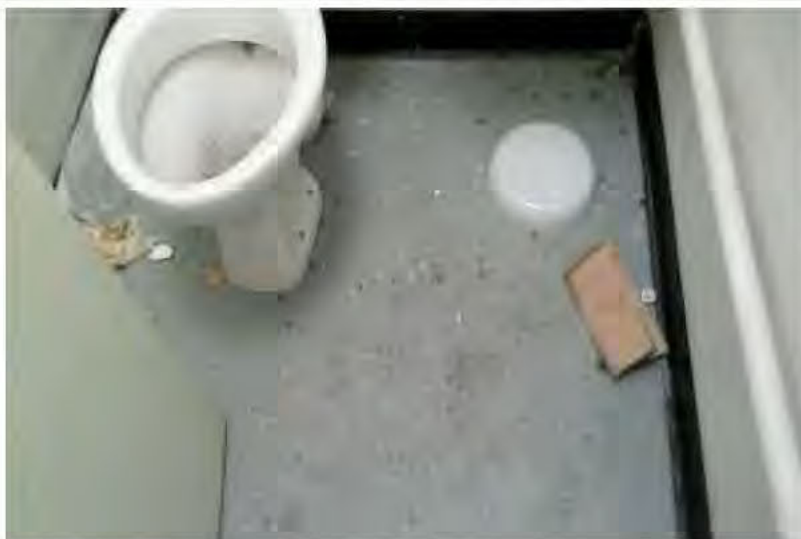
Inspection Number	104	Reference Number:	As Sample BB000277
Inspection / Sample	Visually similar to	Inspection Cross Reference / Visual I.D.	As Sample

Building	Apple Tree
Floor Level	Ground Floor
Area / Room	2 Toilet
Feature	Bitumen adhesive beneath lino
Product Type	Well Bound Material
Extent Amount	3 m ²

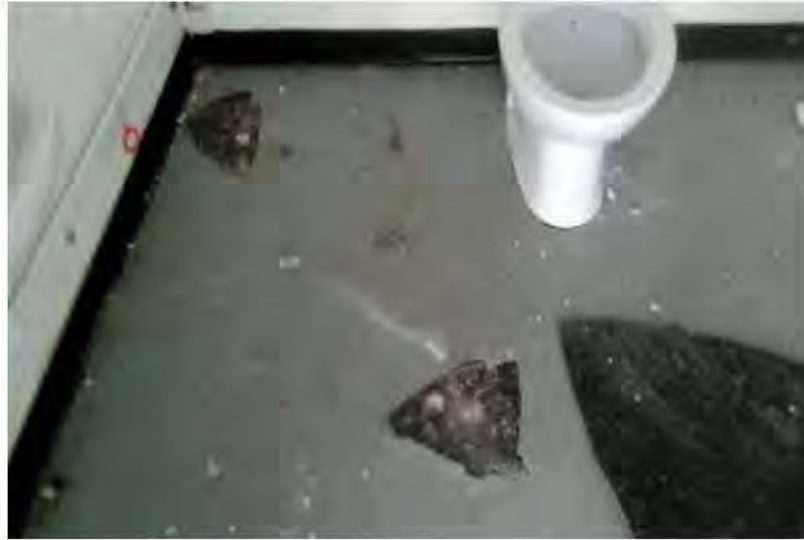
Inspection Number	105	Reference Number:	As Sample BB000277
Inspection / Sample	Visually similar to	Inspection Cross Reference / Visual I.D.	As Sample

Building	Apple Tree
Floor Level	Ground Floor
Area / Room	3 Disabled Toilet
Feature	Bitumen adhesive beneath lino
Product Type	Well Bound Material
Extent Amount	6 m ²

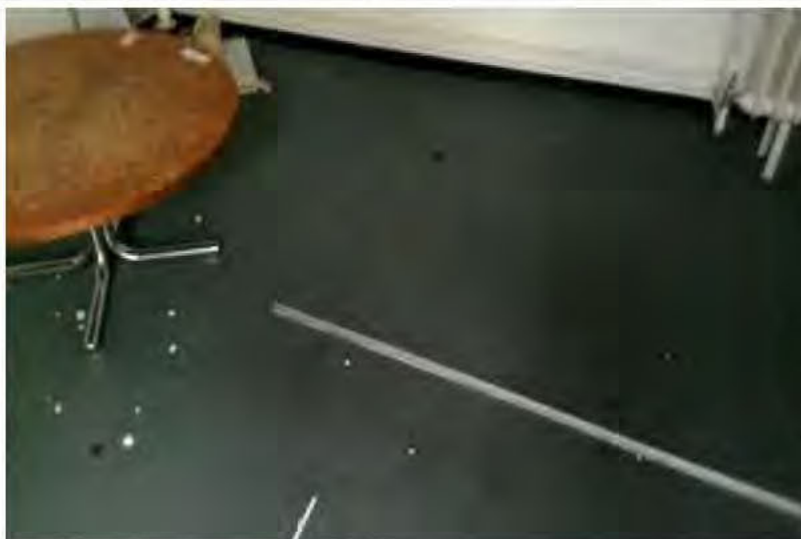
Inspection Number	106	Reference Number:	As Sample BB000277
Inspection / Sample	Visually similar to	Inspection Cross Reference / Visual I.D.	As Sample

Building	Apple Tree
Floor Level	Ground Floor
Area / Room	4 Office
Feature	Bitumen adhesive beneath lino
Product Type	Well Bound Material
Extent Amount	12 m ²

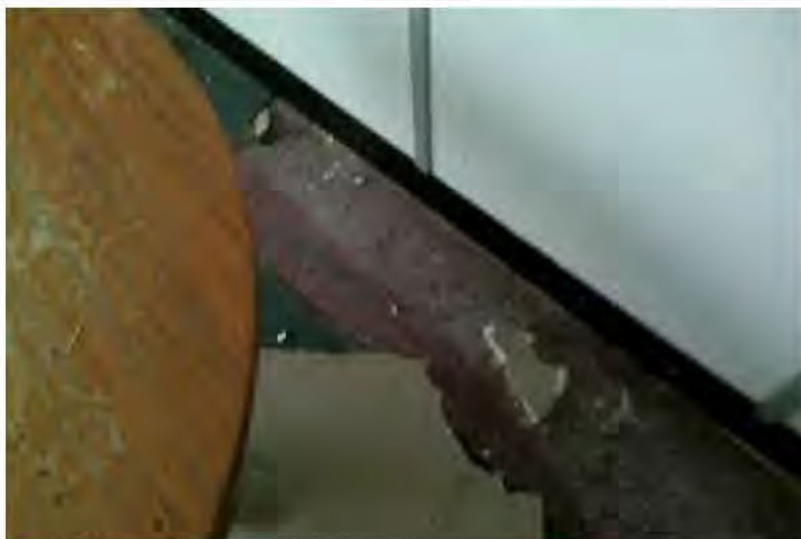
Inspection Number	107	Reference Number:	BB000278
Inspection / Sample	Sample taken	Inspection Cross Reference / Visual I.D.	N.A.D.I.S

Building	Apple Tree
Floor Level	Ground Floor
Area / Room	4 Office
Feature	Red vinyl beneath carpet
Product Type	Reinforced Composite
Extent Amount	12 m ²

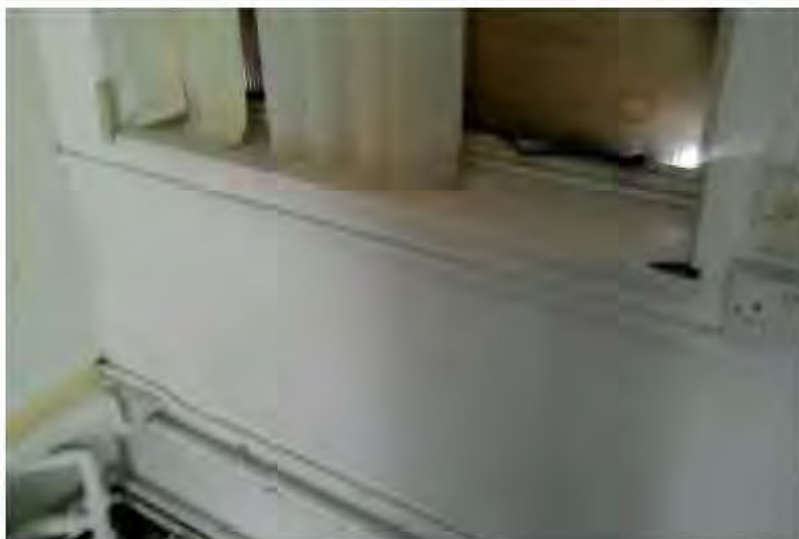
Inspection Number	108	Reference Number:	BB000279
Inspection / Sample	Sample taken	Inspection Cross Reference / Visual I.D.	N.A.D.I.S

Building	Apple Tree
Floor Level	Ground Floor
Area / Room	4 Office
Feature	Window Sill
Product Type	Cement
Extent Amount	3 m

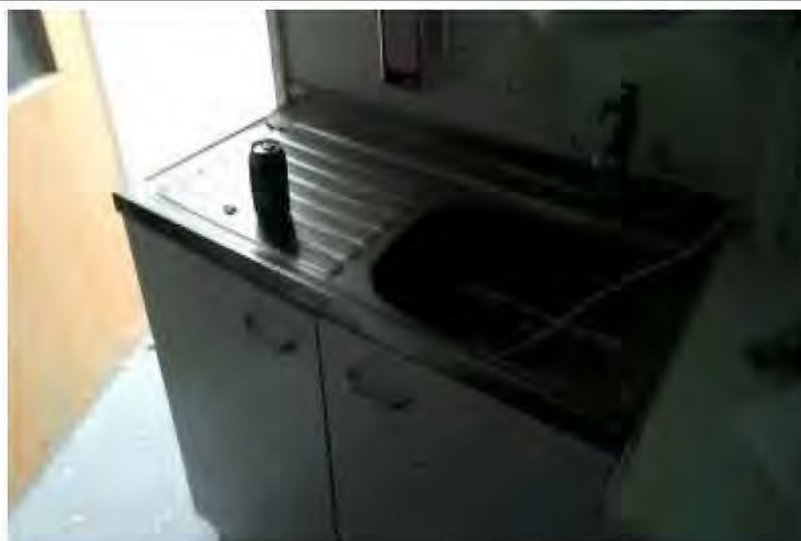
Inspection Number	110	Reference Number:	BB000281
Inspection / Sample	Sample taken	Inspection Cross Reference / Visual I.D.	N.A.D.I.S

Building	Apple Tree
Floor Level	Ground Floor
Area / Room	5 Kitchen
Feature	Bitumen pad to underside of sink
Product Type	Well Bound Material
Extent Amount	1 no.

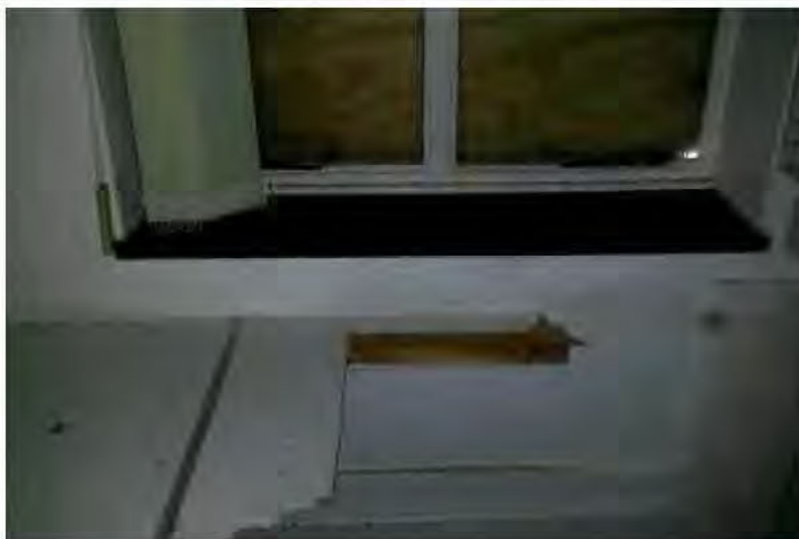
Inspection Number	111	Reference Number:	As Sample BB000279
Inspection / Sample	Visually similar to	Inspection Cross Reference / Visual I.D.	As Sample

Building	Apple Tree
Floor Level	Ground Floor
Area / Room	5 Kitchen
Feature	Window sills
Product Type	Cement
Extent Amount	2 m

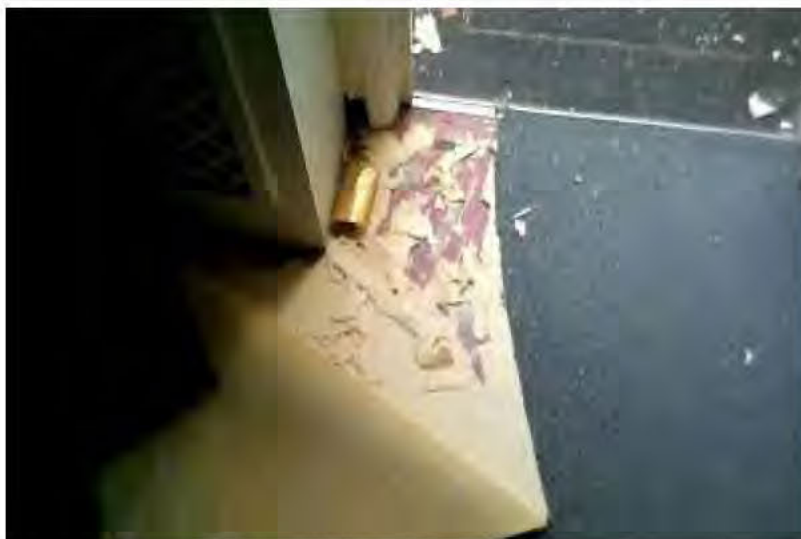
Inspection Number	112	Reference Number:	As Sample BB000277
Inspection / Sample	Visually similar to	Inspection Cross Reference / Visual I.D.	As Sample

Building	Apple Tree
Floor Level	Ground Floor
Area / Room	6 Office
Feature	Bitumen adhesive beneath lino
Product Type	Well Bound Material
Extent Amount	14 m ²

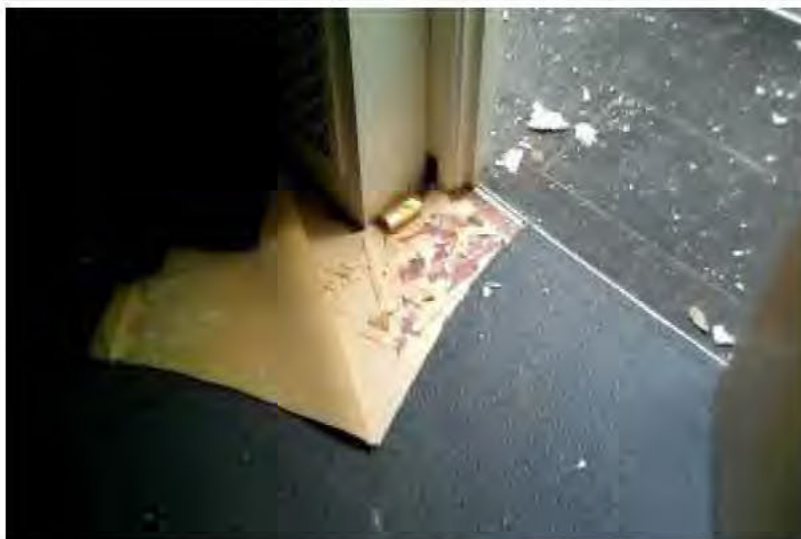
Inspection Number	113	Reference Number:	As Sample BB000278
Inspection / Sample	Visually similar to	Inspection Cross Reference / Visual I.D.	As Sample

Building	Apple Tree
Floor Level	Ground Floor
Area / Room	6 Office
Feature	Red vinyl beneath carpet
Product Type	Reinforced Composite
Extent Amount	14 m ²

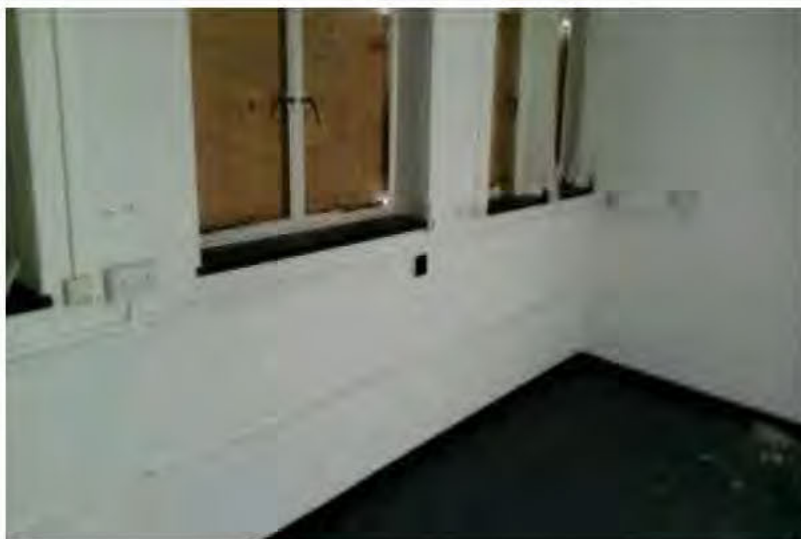
Inspection Number	114	Reference Number:	As Sample BB000279
Inspection / Sample	Visually similar to	Inspection Cross Reference / Visual I.D.	As Sample

Building	Apple Tree
Floor Level	Ground Floor
Area / Room	6 Office
Feature	Window Sill
Product Type	Cement
Extent Amount	3 m

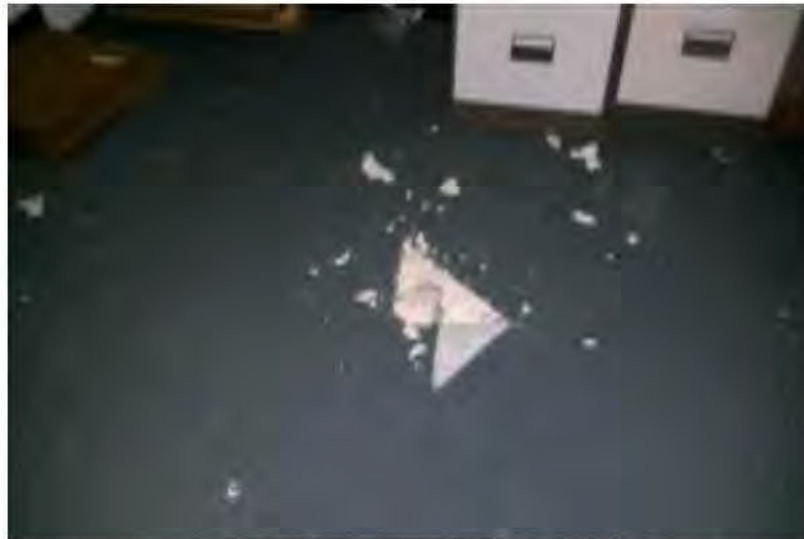
Inspection Number	115	Reference Number:	As Sample BB000277
Inspection / Sample	Visually similar to	Inspection Cross Reference / Visual I.D.	As Sample

Building	Apple Tree
Floor Level	Ground Floor
Area / Room	7 Office
Feature	Bitumen adhesive beneath carpet
Product Type	Well Bound Material
Extent Amount	9 m ²

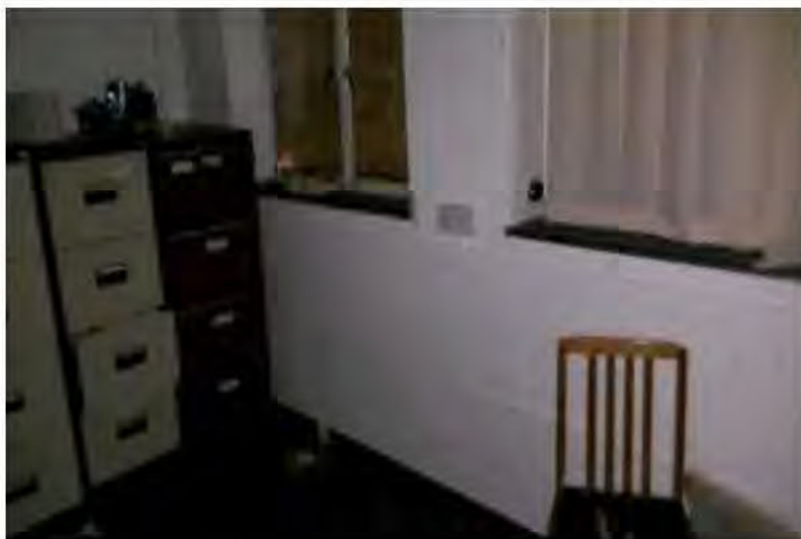
Inspection Number	116	Reference Number:	As Sample BB000279
Inspection / Sample	Visually similar to	Inspection Cross Reference / Visual I.D.	As Sample

Building	Apple Tree
Floor Level	Ground Floor
Area / Room	7 Office
Feature	Window sills
Product Type	Cement
Extent Amount	2 m

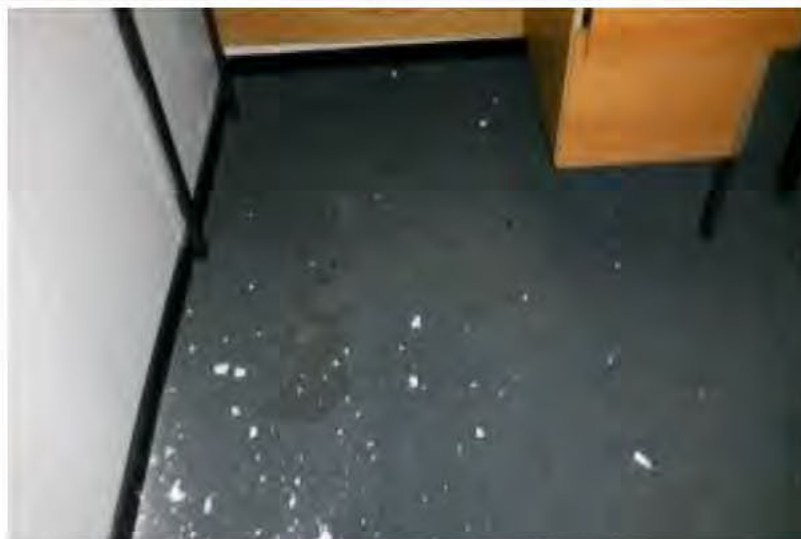
Inspection Number	117	Reference Number:	As Sample BB000277
Inspection / Sample	Visually similar to	Inspection Cross Reference / Visual I.D.	As Sample

Building	Apple Tree
Floor Level	Ground Floor
Area / Room	8 Office
Feature	Bitumen adhesive beneath carpet
Product Type	Well Bound Material
Extent Amount	7 m ²

Product Score	Low Fibre Release - Asbestos reinforced composites (plastics, resins, mastics, roofing felts, vinyl floor tiles, semi-rigid paits or decorative finishes, asbestos cement, etc.)	0
Extent of Damage	Low Damage	0
Surface Treatment	Completely Sealed	0
Asbestos Type	No Asbestos Detected	0

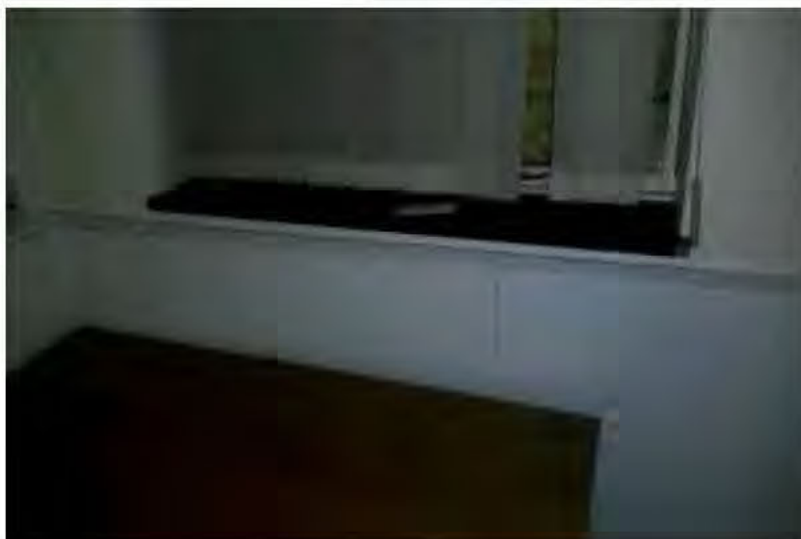
Inspection Number	118	Reference Number:	As Sample BB000279
Inspection / Sample	Visually similar to	Inspection Cross Reference / Visual I.D.	As Sample

Building	Apple Tree
Floor Level	Ground Floor
Area / Room	8 Office
Feature	Window sills
Product Type	Cement
Extent Amount	1 m

Product Score	Low Fibre Release - Asbestos reinforced composites (plastics, resins, mastics, roofing felts, vinyl floor tiles, semi-rigid paits or decorative finishes, asbestos cement, etc.)	0
Extent of Damage	Good Condition	0
Surface Treatment	Surface Sealed	0
Asbestos Type	No Asbestos Detected	0

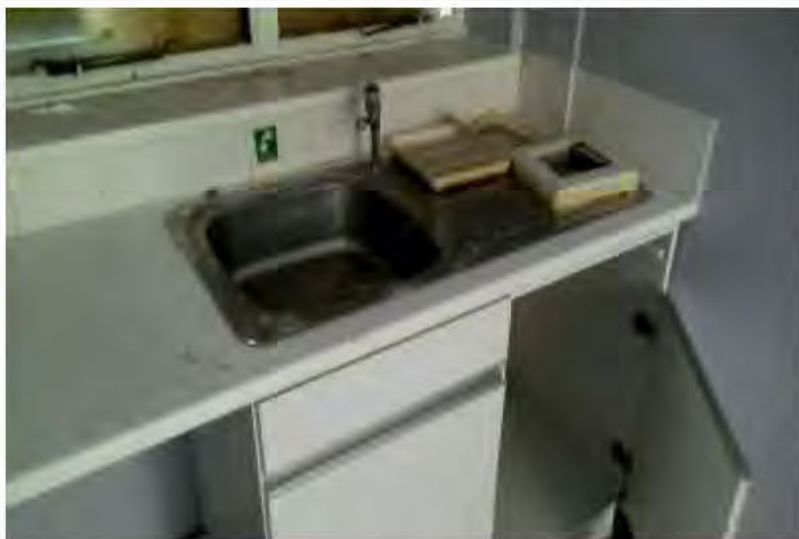
Inspection Number	119	Reference Number:	As Sample BB000281
Inspection / Sample	Visually similar to	Inspection Cross Reference / Visual I.D.	As Sample

Building	Apple Tree
Floor Level	Ground Floor
Area / Room	9 Kitchen
Feature	Bitumen pads to underside of sink and drainer
Product Type	Well Bound Material
Extent Amount	2 no.

Product Score	Low Fibre Release - Asbestos reinforced composites (plastics, resins, mastics, roofing felts, vinyl floor tiles, semi-rigid paits or decorative finishes, asbestos cement, etc.)	0
Extent of Damage	Low Damage	0
Surface Treatment	Completely Sealed	0
Asbestos Type	No Asbestos Detected	0

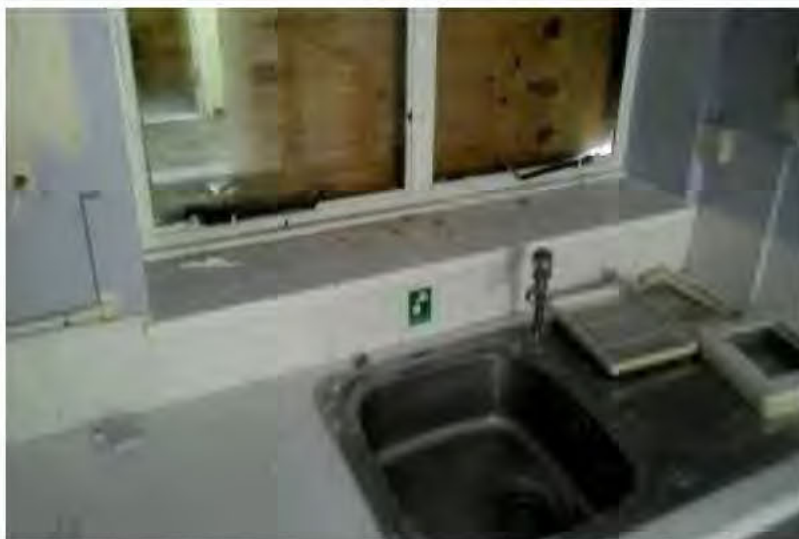
Inspection Number	120	Reference Number:	As Sample BB000279
Inspection / Sample	Visually similar to	Inspection Cross Reference / Visual I.D.	As Sample

Building	Apple Tree
Floor Level	Ground Floor
Area / Room	9 Kitchen
Feature	Window sill
Product Type	Cement
Extent Amount	1 no.

Product Score	Low Fibre Release - Asbestos reinforced composites (plastics, resins, mastics, roofing felts, vinyl floor tiles, semi-rigid paits or decorative finishes, asbestos cement, etc.)	0
Extent of Damage	Good Condition	0
Surface Treatment	Surface Sealed	0
Asbestos Type	No Asbestos Detected	0

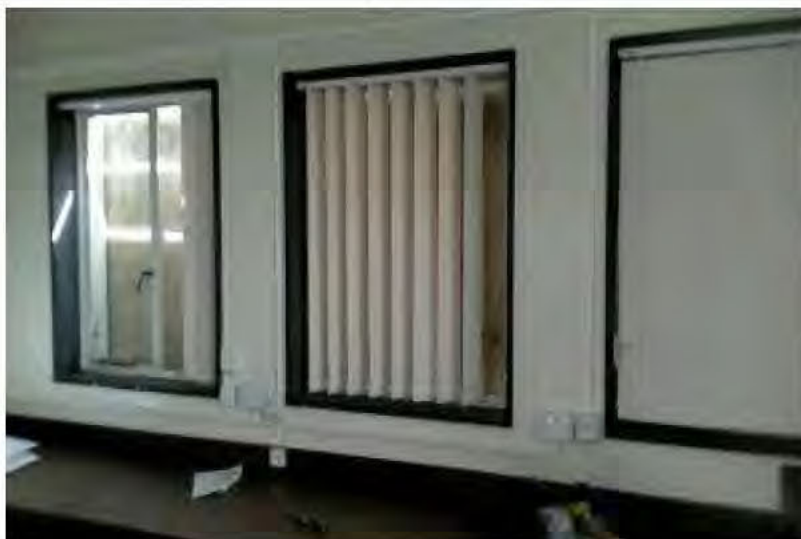
Inspection Number	121	Reference Number:	As Sample BB000279
Inspection / Sample	Visually similar to	Inspection Cross Reference / Visual I.D.	As Sample

Building	Apple Tree
Floor Level	Ground Floor
Area / Room	10 Reception
Feature	Window sill and surrounds
Product Type	Cement
Extent Amount	12 m

Product Score	Low Fibre Release - Asbestos reinforced composites (plastics, resins, mastics, roofing felts, vinyl floor tiles, semi-rigid paits or decorative finishes, asbestos cement, etc.)	0
Extent of Damage	Good Condition	0
Surface Treatment	Surface Sealed	0
Asbestos Type	No Asbestos Detected	0

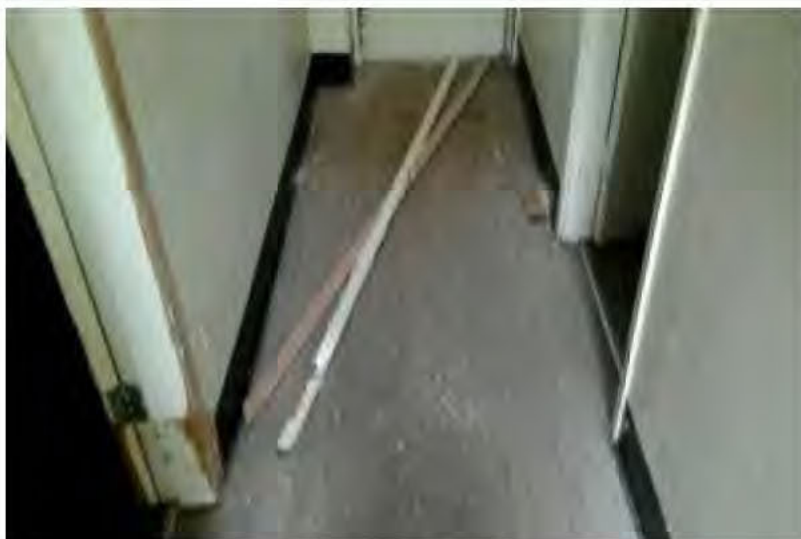
Inspection Number	122	Reference Number:	As Sample BB000277
Inspection / Sample	Visually similar to	Inspection Cross Reference / Visual I.D.	As Sample

Building	Apple Tree
Floor Level	Ground Floor
Area / Room	11 Rear Corridor
Feature	Bitumen adhesive beneath lino
Product Type	Well Bound Material
Extent Amount	4 m ²

Product Score	Low Fibre Release - Asbestos reinforced composites (plastics, resins, mastics, roofing felts, vinyl floor tiles, semi-rigid paits or decorative finishes, asbestos cement, etc.)	0
Extent of Damage	Good Condition	0
Surface Treatment	Completely Sealed	0
Asbestos Type	No Asbestos Detected	0

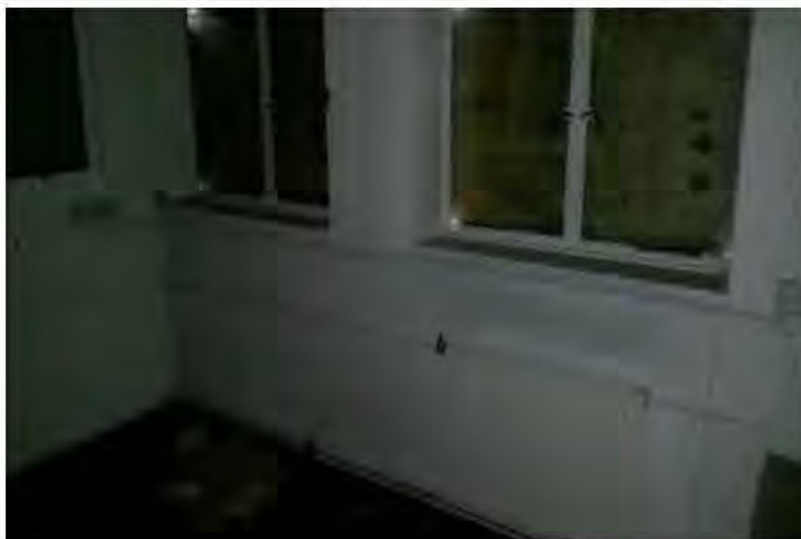
Inspection Number	123	Reference Number:	As Sample BB000279
Inspection / Sample	Visually similar to	Inspection Cross Reference / Visual I.D.	As Sample

Building	Apple Tree
Floor Level	Ground Floor
Area / Room	12 Office
Feature	Window sills
Product Type	Cement
Extent Amount	2 m

Product Score	Low Fibre Release - Asbestos reinforced composites (plastics, resins, mastics, roofing felts, vinyl floor tiles, semi-rigid paits or decorative finishes, asbestos cement, etc.)	0
Extent of Damage	Good Condition	0
Surface Treatment	Surface Sealed	0
Asbestos Type	No Asbestos Detected	0

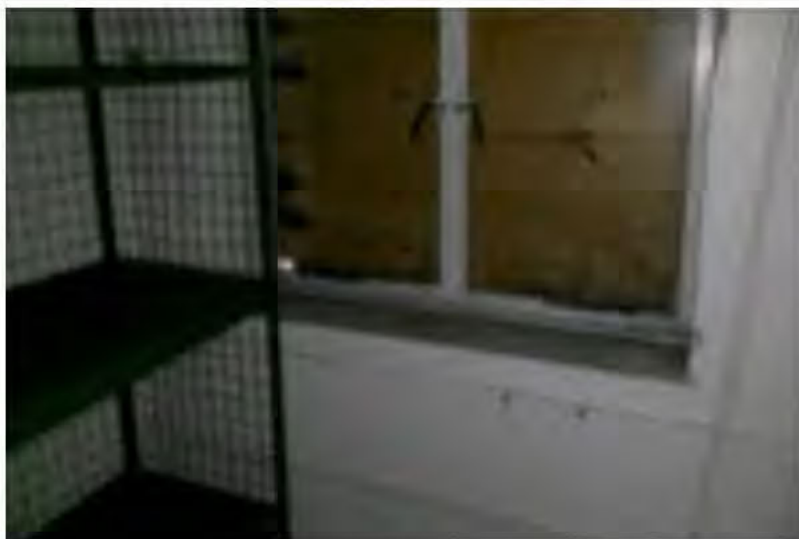
Inspection Number	124	Reference Number:	As Sample BB000279
Inspection / Sample	Visually similar to	Inspection Cross Reference / Visual I.D.	As Sample

Building	Apple Tree
Floor Level	Ground Floor
Area / Room	13 Store
Feature	Window sill
Product Type	Cement
Extent Amount	1 m

Product Score	Low Fibre Release - Asbestos reinforced composites (plastics, resins, mastics, roofing felts, vinyl floor tiles, semi-rigid paits or decorative finishes, asbestos cement, etc.)	0
Extent of Damage	Good Condition	0
Surface Treatment	Surface Sealed	0
Asbestos Type	No Asbestos Detected	0

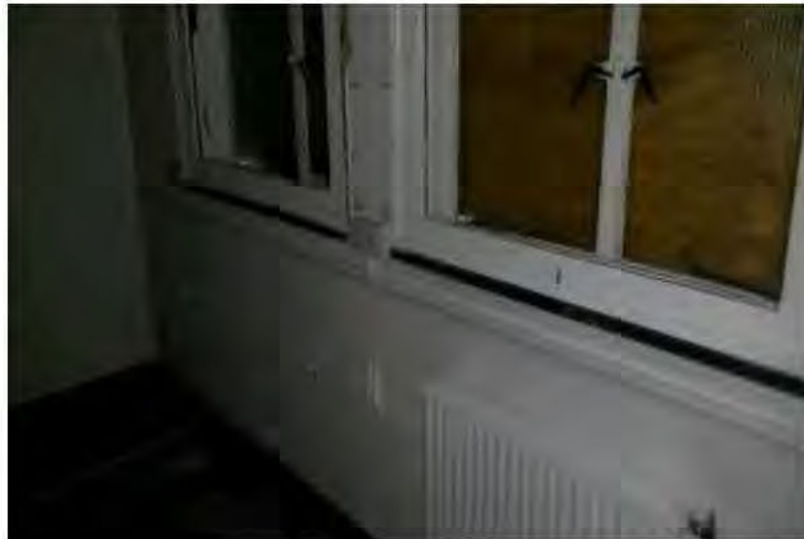
Inspection Number	125	Reference Number:	As Sample BB000279
Inspection / Sample	Visually similar to	Inspection Cross Reference / Visual I.D.	As Sample

Building	Apple Tree
Floor Level	Ground Floor
Area / Room	14 Office
Feature	Window sills
Product Type	Cement
Extent Amount	2 m

Product Score	Low Fibre Release - Asbestos reinforced composites (plastics, resins, mastics, roofing felts, vinyl floor tiles, semi-rigid paits or decorative finishes, asbestos cement, etc.)	0
Extent of Damage	Good Condition	0
Surface Treatment	Surface Sealed	0
Asbestos Type	No Asbestos Detected	0

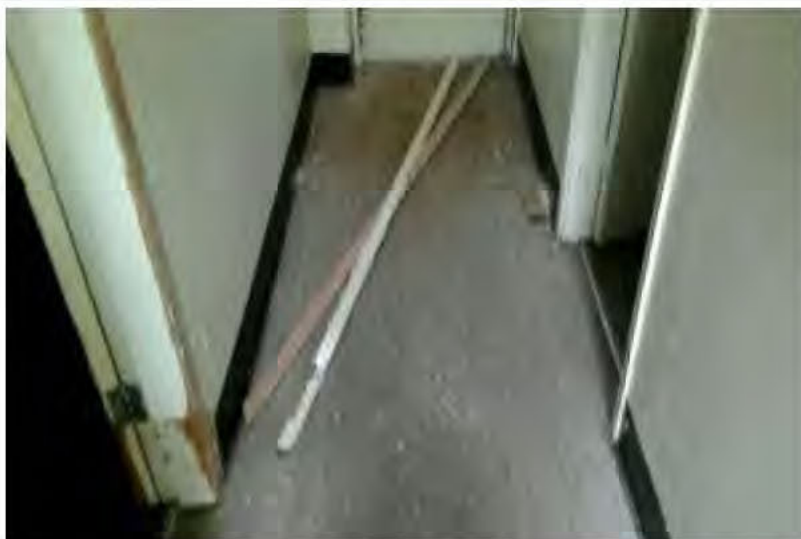
Inspection Number	126	Reference Number:	As Sample BB000277
Inspection / Sample	Visually similar to	Inspection Cross Reference / Visual I.D.	As Sample

Building	Apple Tree
Floor Level	Ground Floor
Area / Room	14 Office
Feature	Bitumen adhesive beneath lino
Product Type	Well Bound Material
Extent Amount	9 m ²

Product Score	Low Fibre Release - Asbestos reinforced composites (plastics, resins, mastics, roofing felts, vinyl floor tiles, semi-rigid paits or decorative finishes, asbestos cement, etc.)	0
Extent of Damage	Low Damage	0
Surface Treatment	Completely Sealed	0
Asbestos Type	No Asbestos Detected	0

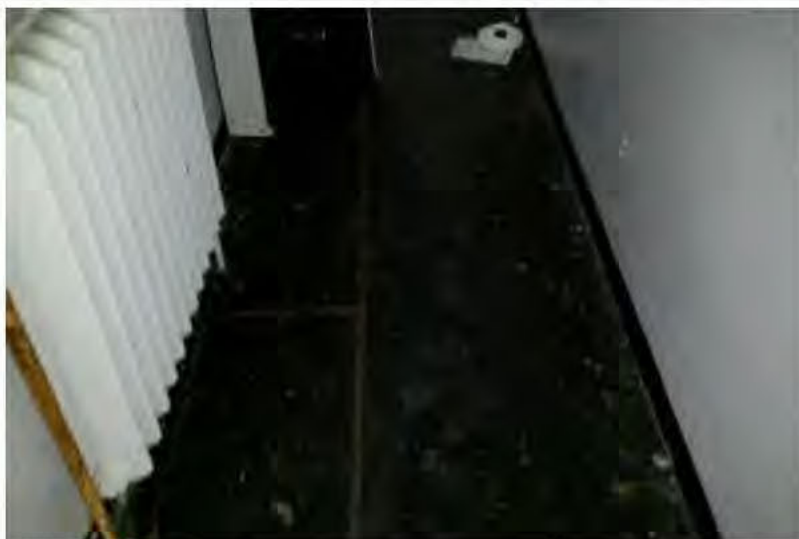
Inspection Number	127	Reference Number:	BB000282
Inspection / Sample	Sample taken	Inspection Cross Reference / Visual I.D.	N.A.D.I.S

Building	Apple Tree
Floor Level	Ground Floor
Area / Room	15 Corridor
Feature	Vinyl to floor
Product Type	Reinforced Composite
Extent Amount	12 m ²

Product Score	Low Fibre Release - Asbestos reinforced composites (plastics, resins, mastics, roofing felts, vinyl floor tiles, semi-rigid paits or decorative finishes, asbestos cement, etc.)	0
Extent of Damage	High Damage	0
Surface Treatment	Completely Sealed	0
Asbestos Type	No Asbestos Detected	0

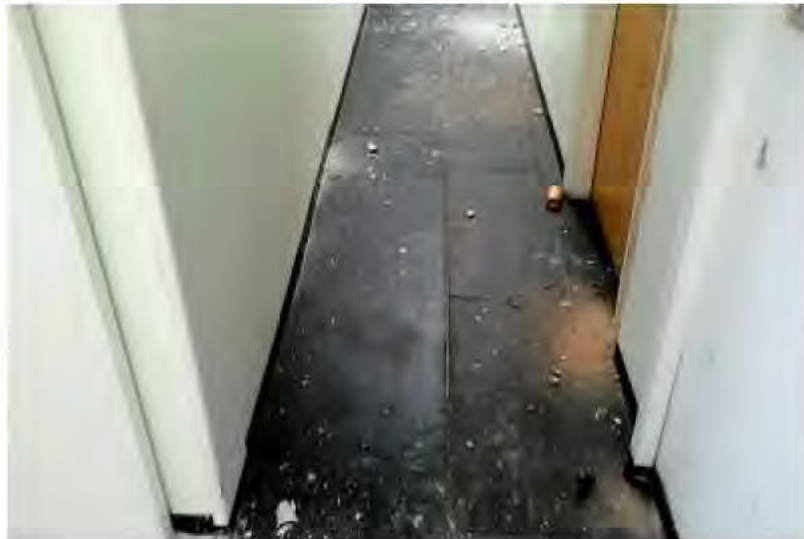
Inspection Number	128	Reference Number:	As Sample BB000282
Inspection / Sample	Visually similar to	Inspection Cross Reference / Visual I.D.	As Sample

Building	Apple Tree
Floor Level	Ground Floor
Area / Room	1 Entrance / Corridor
Feature	Vinyl to floor
Product Type	Reinforced Composite
Extent Amount	18 m ²

Product Score	Low Fibre Release - Asbestos reinforced composites (plastics, resins, mastics, roofing felts, vinyl floor tiles, semi-rigid paits or decorative finishes, asbestos cement, etc.)	0
Extent of Damage	Low Damage	0
Surface Treatment	Completely Sealed	0
Asbestos Type	No Asbestos Detected	0

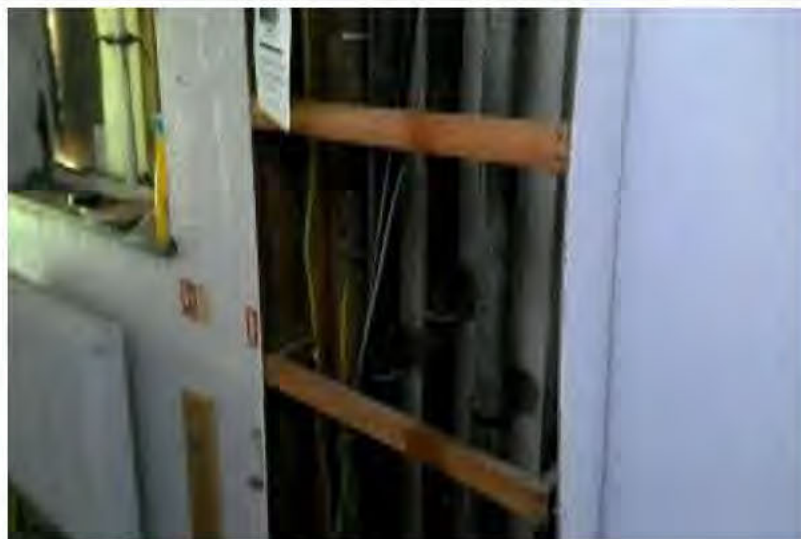
Inspection Number	129	Reference Number:	BB000283
Inspection / Sample	Sample taken	Inspection Cross Reference / Visual I.D.	N.A.D.I.S

Building	Apple Tree
Floor Level	Ground Floor
Area / Room	15 Corridor
Feature	Residues to pipework
Product Type	Dust/Debris
Extent Amount	23 m

Product Score	High Fibre Release - Thermal insulation (e.g. pipe and boiler lagging) sprayed asbestos, loose asbestos, asbestos mattresses and packing	0
Extent of Damage	High Damage	0
Surface Treatment	Unsealed	0
Asbestos Type	No Asbestos Detected	0

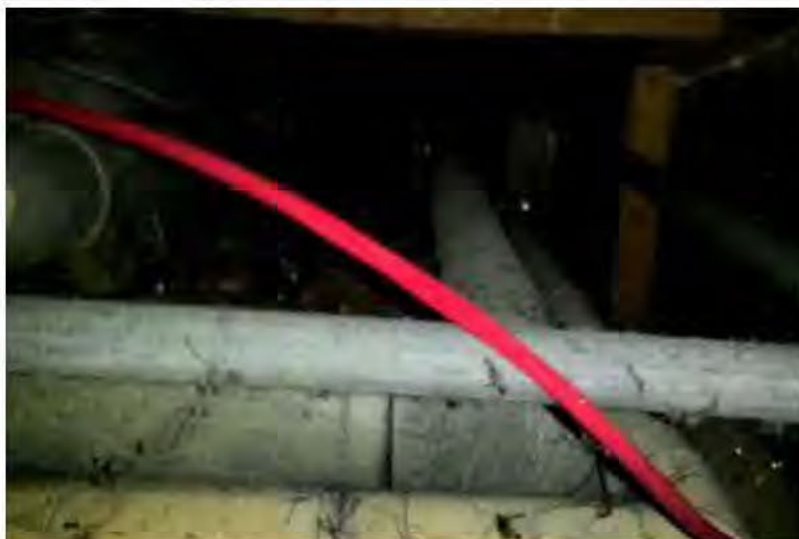
Inspection Number	130	Reference Number:	BB000284
Inspection / Sample	Sample taken	Inspection Cross Reference / Visual I.D.	Asbestos Identified

Building	Apple Tree
Floor Level	Ground Floor
Area / Room	16 Treatment room
Feature	Paper backing to fibreglass lagged pipework
Product Type	Asbestos Textiles/Paper
Extent Amount	16 m

Product Score	Medium Fibre Release - Asbestos insulating board, mill board, other low density insulation board, asbestos textiles, gaskets, rope and woven textiles, asbestos paper and felt	2
Extent of Damage	Low Damage	1
Surface Treatment	Unsealed	2
Asbestos Type	Chrysotile	1

Recommendation	Remove if likely to be disturbed
----------------	----------------------------------

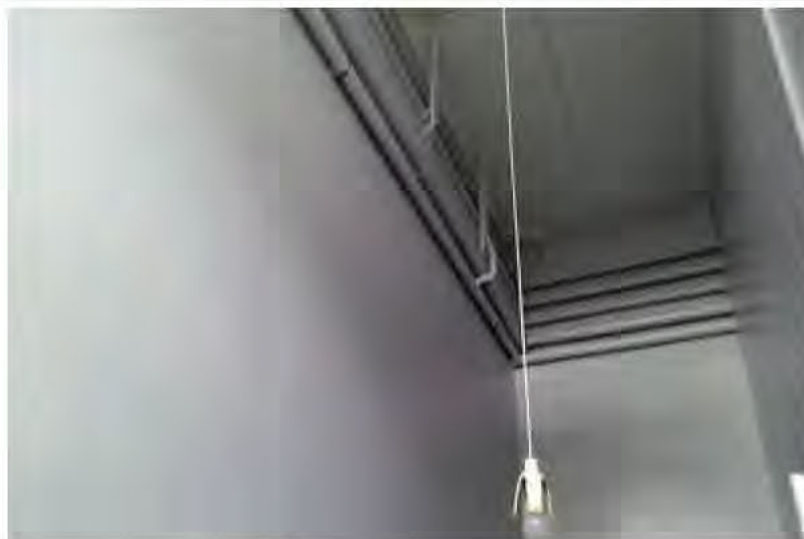
Inspection Number	131	Reference Number:	As Sample BB000284
Inspection / Sample	Visually similar to	Inspection Cross Reference / Visual I.D.	As Sample

Building	Apple Tree
Floor Level	Ground Floor
Area / Room	15 Corridor
Feature	Paper backing to fibreglass lagged pipework
Product Type	Asbestos Textiles/Paper
Extent Amount	12 m

Product Score	Medium Fibre Release - Asbestos insulating board, mill board, other low density insulation board, asbestos textiles, gaskets, rope and woven textiles, asbestos paper and felt	2
Extent of Damage	Good Condition	0
Surface Treatment	Surface Sealed	1
Asbestos Type	Chrysotile	1

Recommendation	Remove if likely to be disturbed
----------------	----------------------------------

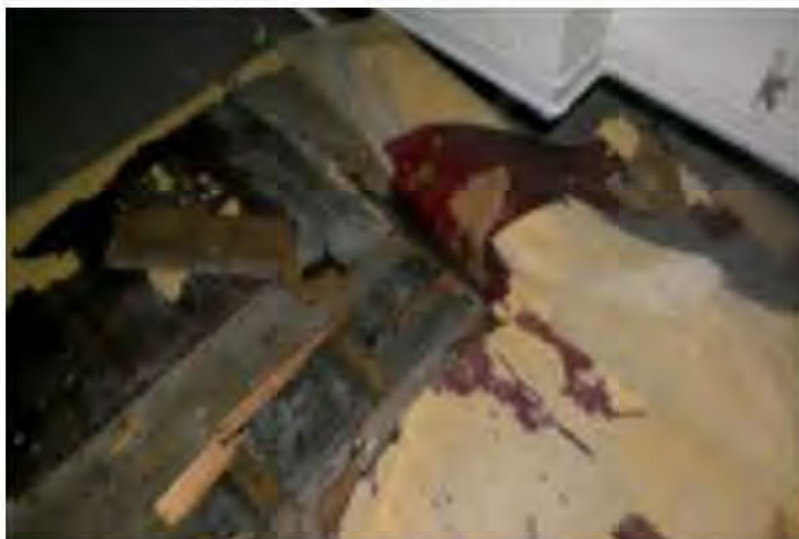
Inspection Number	132	Reference Number:	As Sample BB000278
Inspection / Sample	Visually similar to	Inspection Cross Reference / Visual I.D.	As Sample

Building	Apple Tree
Floor Level	Ground Floor
Area / Room	17 Office
Feature	Red vinyl beneath carpet
Product Type	Reinforced Composite
Extent Amount	18 m ²

Product Score	Low Fibre Release - Asbestos reinforced composites (plastics, resins, mastics, roofing felts, vinyl floor tiles, semi-rigid paits or decorative finishes, asbestos cement, etc.)	0
Extent of Damage	Low Damage	0
Surface Treatment	Completely Sealed	0
Asbestos Type	No Asbestos Detected	0

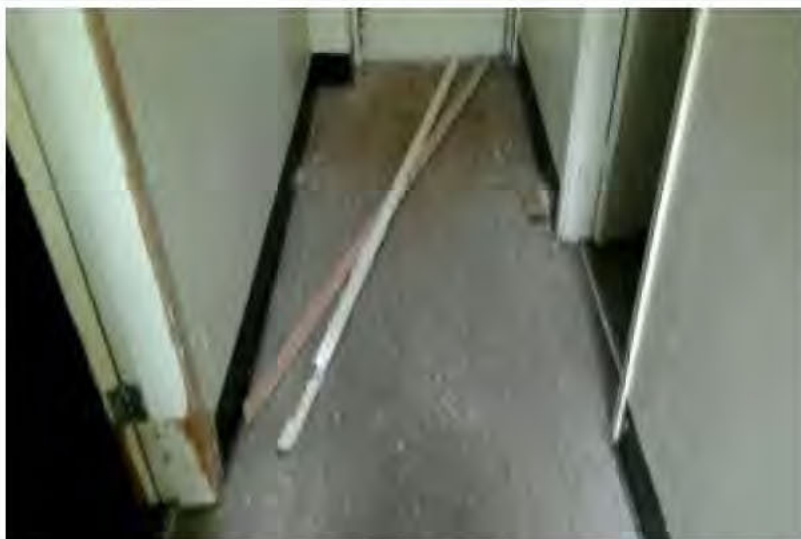
Inspection Number	133	Reference Number:	As Sample BB000277
Inspection / Sample	Visually similar to	Inspection Cross Reference / Visual I.D.	As Sample

Building	Apple Tree
Floor Level	Ground Floor
Area / Room	18 Male toilets
Feature	Bitumen adhesive beneath lino
Product Type	Well Bound Material
Extent Amount	12 m ²

Product Score	Low Fibre Release - Asbestos reinforced composites (plastics, resins, mastics, roofing felts, vinyl floor tiles, semi-rigid paits or decorative finishes, asbestos cement, etc.)	0
Extent of Damage	Good Condition	0
Surface Treatment	Completely Sealed	0
Asbestos Type	No Asbestos Detected	0

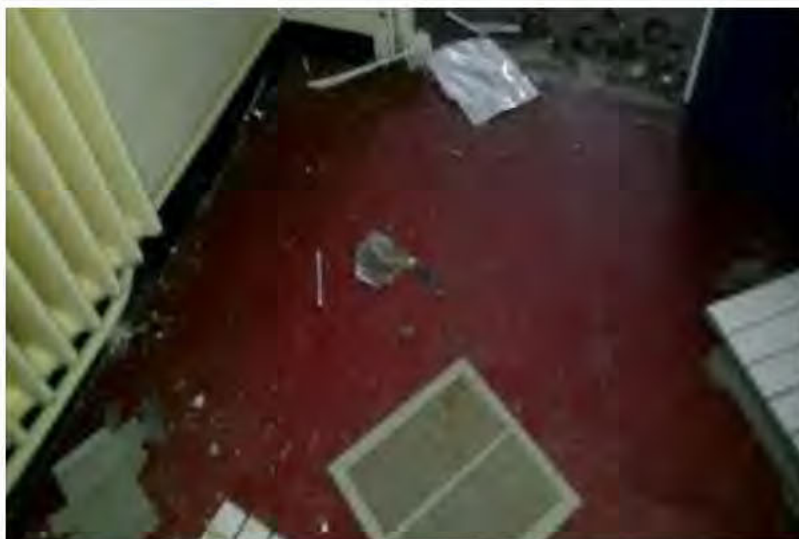
Inspection Number	134	Reference Number:	As Sample BB000278
Inspection / Sample	Visually similar to	Inspection Cross Reference / Visual I.D.	As Sample

Building	Apple Tree
Floor Level	Ground Floor
Area / Room	19 Kitchen
Feature	Red vinyl beneath carpet
Product Type	Reinforced Composite
Extent Amount	8 m ²

Product Score	Low Fibre Release - Asbestos reinforced composites (plastics, resins, mastics, roofing felts, vinyl floor tiles, semi-rigid paits or decorative finishes, asbestos cement, etc.)	0
Extent of Damage	Low Damage	0
Surface Treatment	Completely Sealed	0
Asbestos Type	No Asbestos Detected	0

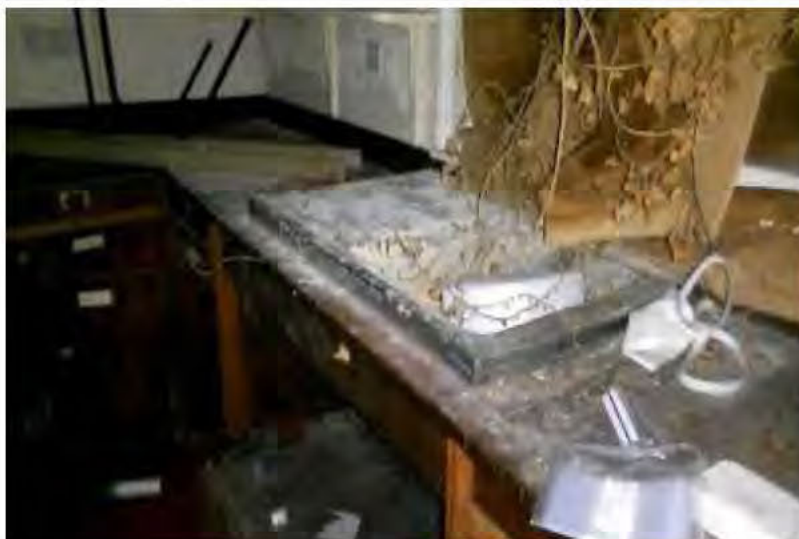
Inspection Number	135	Reference Number:	BB000285
Inspection / Sample	Sample taken	Inspection Cross Reference / Visual I.D.	N.A.D.I.S

Building	Apple Tree
Floor Level	Ground Floor
Area / Room	19 Kitchen
Feature	Bitumen pads to underside of sink and drainer
Product Type	Well Bound Material
Extent Amount	2 no.

Product Score	Low Fibre Release - Asbestos reinforced composites (plastics, resins, mastics, roofing felts, vinyl floor tiles, semi-rigid paits or decorative finishes, asbestos cement, etc.)	0
Extent of Damage	Low Damage	0
Surface Treatment	Completely Sealed	0
Asbestos Type	No Asbestos Detected	0

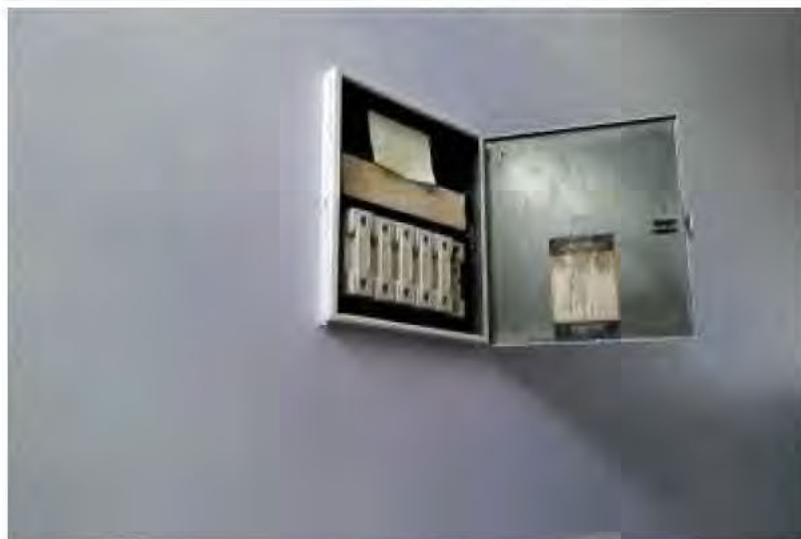
Inspection Number	137	Reference Number:	As Sample BB000286
Inspection / Sample	Visually similar to	Inspection Cross Reference / Visual I.D.	As Sample

Building	Apple Tree
Floor Level	Ground Floor
Area / Room	15 Corridor
Feature	Textiles within fuses
Product Type	Asbestos Textiles/Paper
Extent Amount	> 10 no.

Product Score	Medium Fibre Release - Asbestos insulating board, mill board, other low density insulation board, asbestos textiles, gaskets, rope and woven textiles, asbestos paper and felt	2
Extent of Damage	Low Damage	1
Surface Treatment	Surface Sealed	1
Asbestos Type	Chrysotile	1

Recommendation	Remove if likely to be disturbed
----------------	----------------------------------

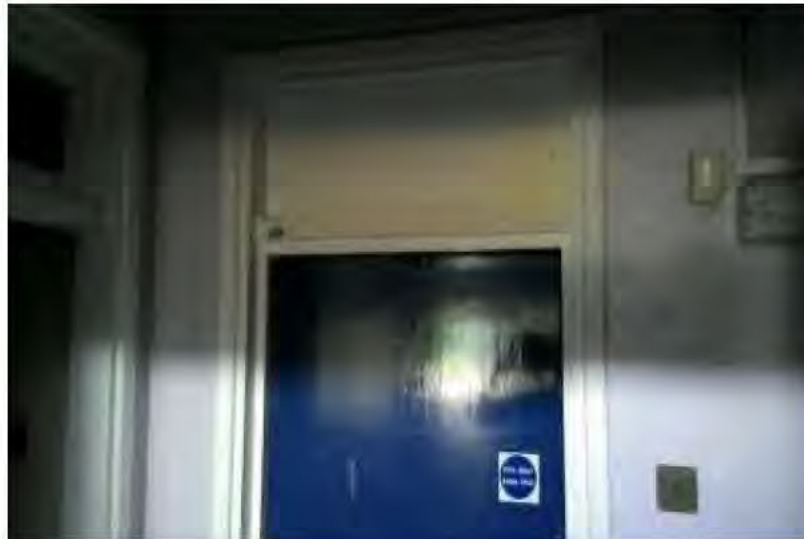
Inspection Number	138	Reference Number:	BB000288
Inspection / Sample	Sample taken	Inspection Cross Reference / Visual I.D.	N.A.D.I.S

Building	Apple Tree
Floor Level	Ground Floor
Area / Room	15 Corridor
Feature	Header panel
Product Type	Insulating Board
Extent Amount	1 m ²

Product Score	Medium Fibre Release - Asbestos insulating board, mill board, other low density insulation board, asbestos textiles, gaskets, rope and woven textiles, asbestos paper and felt	0
Extent of Damage	Low Damage	0
Surface Treatment	Unsealed	0
Asbestos Type	No Asbestos Detected	0

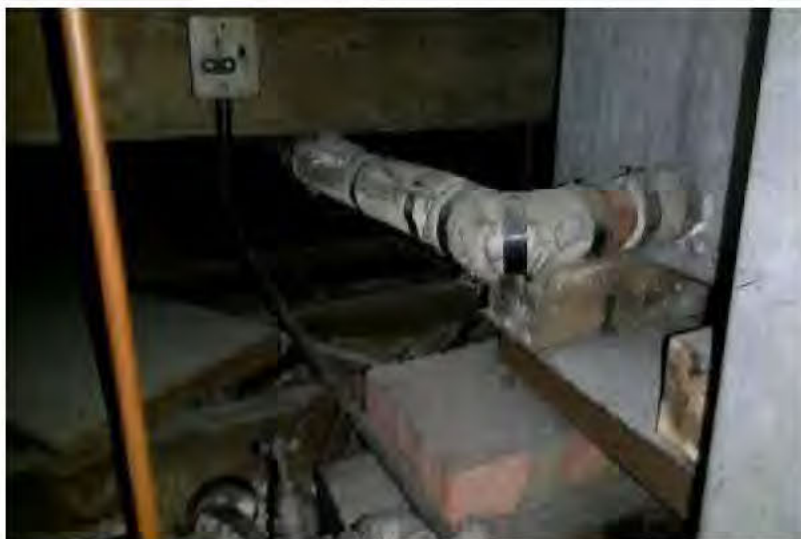
Inspection Number	140	Reference Number:	As Sample BB000284
Inspection / Sample	Visually similar to	Inspection Cross Reference / Visual I.D.	As Sample

Building	Apple Tree
Floor Level	Roof Void
Area / Room	1 Roof Space
Feature	Paper backing beneath fibreglass lagged pipework
Product Type	Asbestos Textiles/Paper
Extent Amount	35 m

Product Score	Medium Fibre Release - Asbestos insulating board, mill board, other low density insulation board, asbestos textiles, gaskets, rope and woven textiles, asbestos paper and felt	2
Extent of Damage	High Damage	3
Surface Treatment	Unsealed	2
Asbestos Type	Chrysotile	1

Recommendation	Remove if likely to be disturbed
----------------	----------------------------------

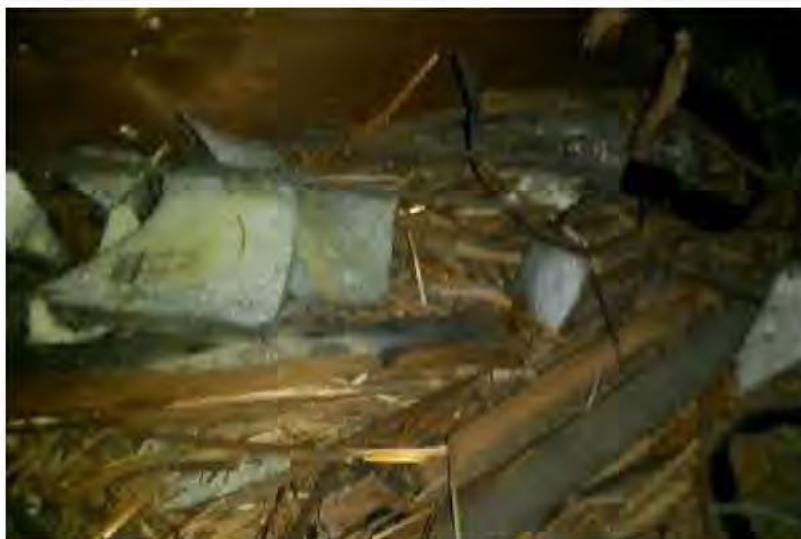
Inspection Number	141	Reference Number:	As Sample BB000284
Inspection / Sample	Visually similar to	Inspection Cross Reference / Visual I.D.	As Sample

Building	Apple Tree
Floor Level	Roof Void
Area / Room	1 Roof Space
Feature	Paper debris
Product Type	Asbestos Textiles/Paper
Extent Amount	10 m ²

Recommendation	Remove if likely to be disturbed
----------------	----------------------------------

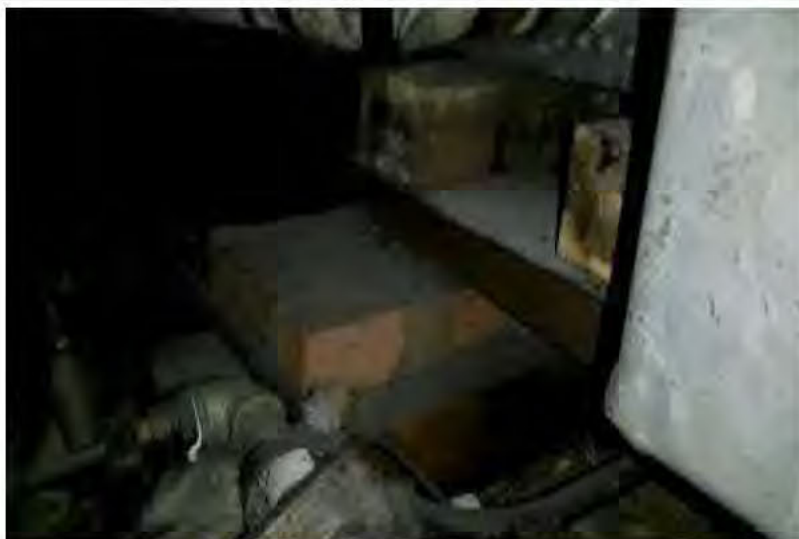
Inspection Number	143	Reference Number:	BB000291
Inspection / Sample	Sample taken	Inspection Cross Reference / Visual I.D.	N.A.D.I.S

Building	Apple Tree
Floor Level	Roof Void
Area / Room	1 Roof Space
Feature	Bitumen layer beneath water tank
Product Type	Well Bound Material
Extent Amount	8 m ²

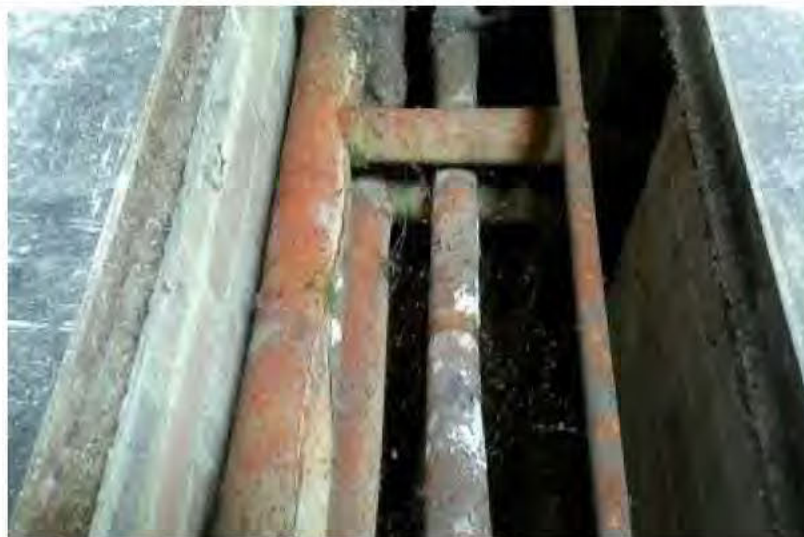
Inspection Number	144	Reference Number:	As Sample BB000284
Inspection / Sample	Visually similar to	Inspection Cross Reference / Visual I.D.	As Sample

Building	Apple Tree
Floor Level	Ground Floor
Area / Room	1 Entrance / Corridor
Feature	Paper beneath fibreglass lagged pipework within floor void
Product Type	Asbestos Textiles/Paper
Extent Amount	54 m

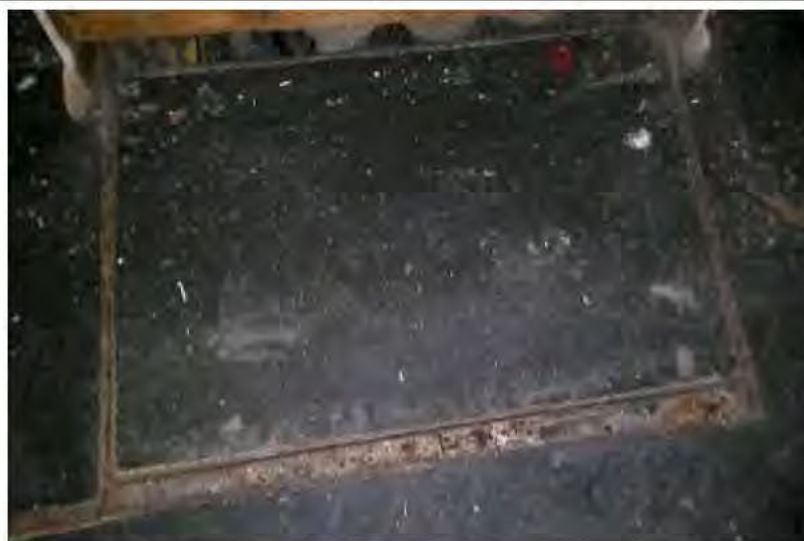
Inspection Number	145	Reference Number:	As Sample BB000284
Inspection / Sample	Visually similar to	Inspection Cross Reference / Visual I.D.	As Sample

Building	Apple Tree
Floor Level	Ground Floor
Area / Room	15 Corridor
Feature	Paper backing to fibreglass lagged pipework within floor void
Product Type	Asbestos Textiles/Paper
Extent Amount	16 m
