RE: Request for Information – RFI3321

TITLE HITCHIN HOSPITAL BEDFORD ROAD HITCHIN		(DRAFT)

Homes & Communities Agency
Site Name:	Hitchin Hospital	
Site ID:

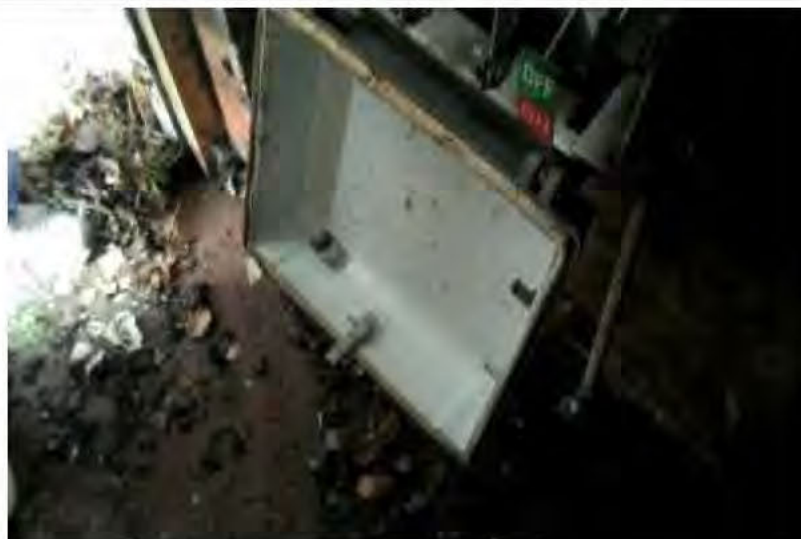
Inspection Number	146	Reference Number:	As Sample BB000250
Inspection / Sample	Visually similar to	Inspection Cross Reference / Visual I.D.	As Sample

Building	Apple Tree
Floor Level	Ground Floor
Area / Room	22 Electric Cupboard
Feature	Rope seals to electric boxes
Product Type	Asbestos Textiles/Paper
Extent Amount	8 m

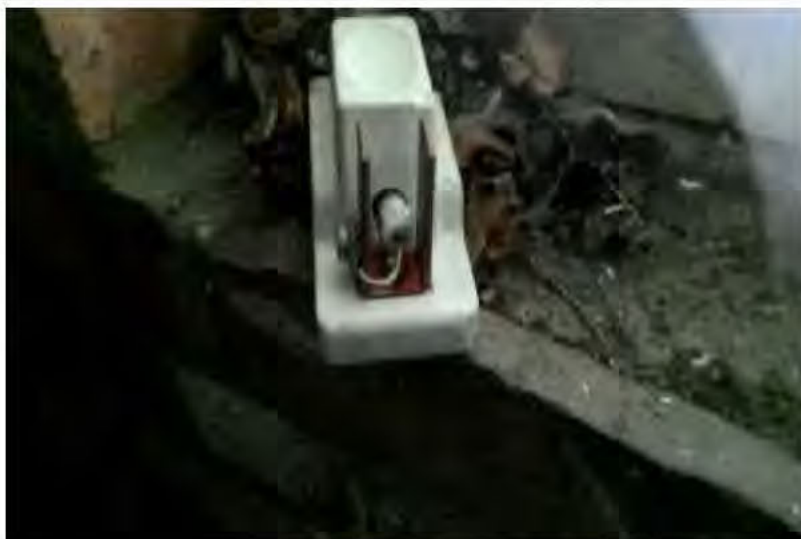
Inspection Number	147	Reference Number:	As Sample BB000286
Inspection / Sample	Visually similar to	Inspection Cross Reference / Visual I.D.	As Sample

Building	Apple Tree
Floor Level	Ground Floor
Area / Room	22 Electric Cupboard
Feature	Textiles within fuses
Product Type	Asbestos Textiles/Paper
Extent Amount	> 10 no.

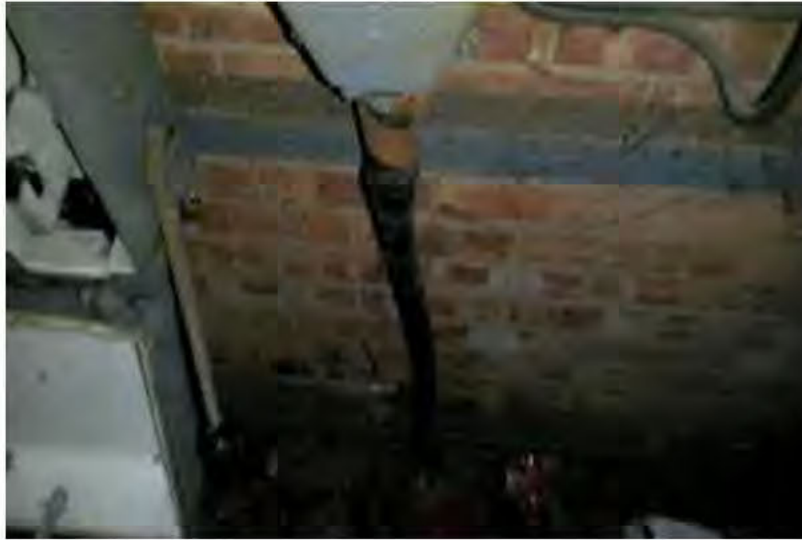
Inspection Number	148	Reference Number:	As Sample BB000268
Inspection / Sample	Visually similar to	Inspection Cross Reference / Visual I.D.	As Sample

Building	Apple Tree
Floor Level	Ground Floor
Area / Room	22 Electric Cupboard
Feature	Cable wrap
Product Type	Well Bound Material
Extent Amount	1 m

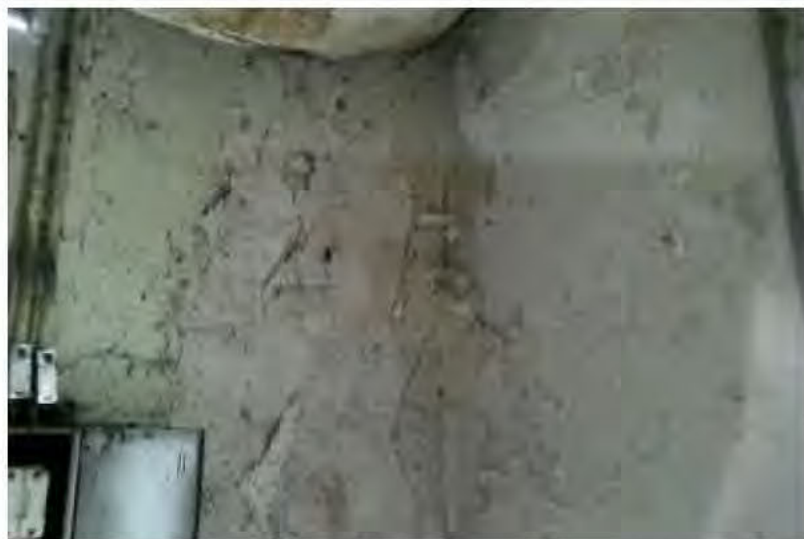
Inspection Number	149	Reference Number:	BB000292
Inspection / Sample	Sample taken	Inspection Cross Reference / Visual I.D.	N.A.D.I.S

Building	Apple Tree
Floor Level	Ground Floor
Area / Room	23 Boiler Room Store
Feature	Textured coating to walls
Product Type	Textured Coating
Extent Amount	16 m ²

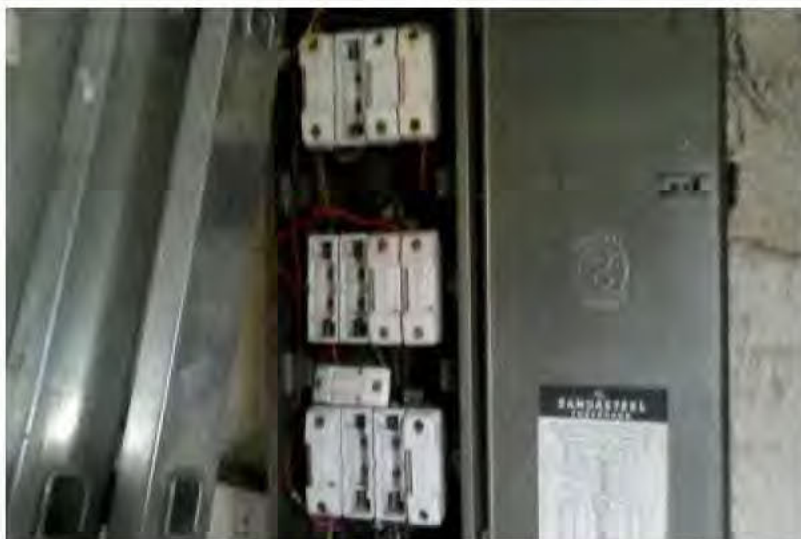
Inspection Number	150	Reference Number:	As Sample BB000286
Inspection / Sample	Visually similar to	Inspection Cross Reference / Visual I.D.	As Sample

Building	Apple Tree
Floor Level	Ground Floor
Area / Room	23 Boiler Room Store
Feature	Textiles within fuses
Product Type	Asbestos Textiles/Paper
Extent Amount	12 no.

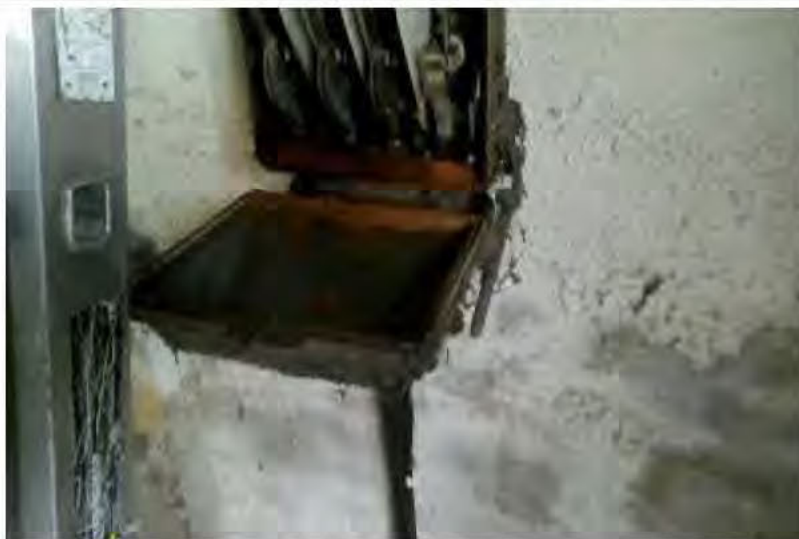
Inspection Number	151	Reference Number:	As Sample BB000250
Inspection / Sample	Visually similar to	Inspection Cross Reference / Visual I.D.	As Sample

Building	Apple Tree
Floor Level	Ground Floor
Area / Room	23 Boiler Room Store
Feature	Rope seal to fuse box
Product Type	Asbestos Textiles/Paper
Extent Amount	< 1 m

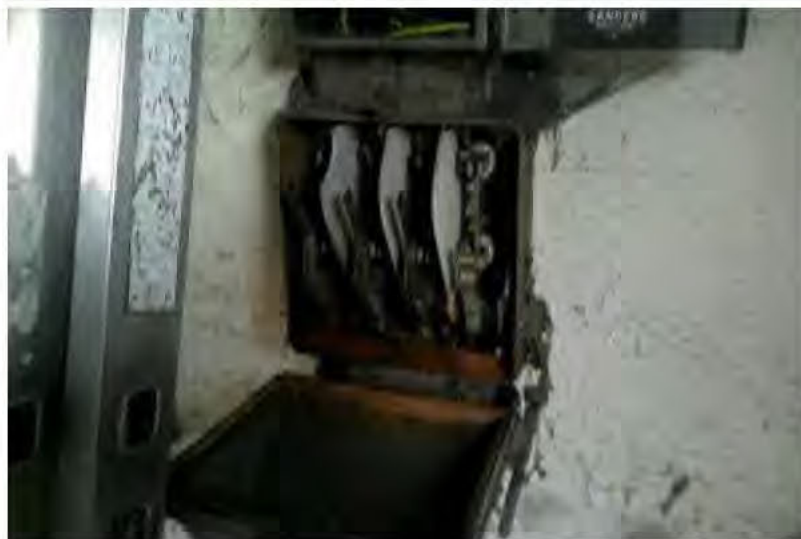
Inspection Number	152	Reference Number:	BB000293
Inspection / Sample	Sample taken	Inspection Cross Reference / Visual I.D.	Asbestos Identified

Building	Apple Tree
Floor Level	Ground Floor
Area / Room	23 Boiler Room Store
Feature	Flashguards to circuit breaker
Product Type	Asbestos Cement
Extent Amount	3 no.

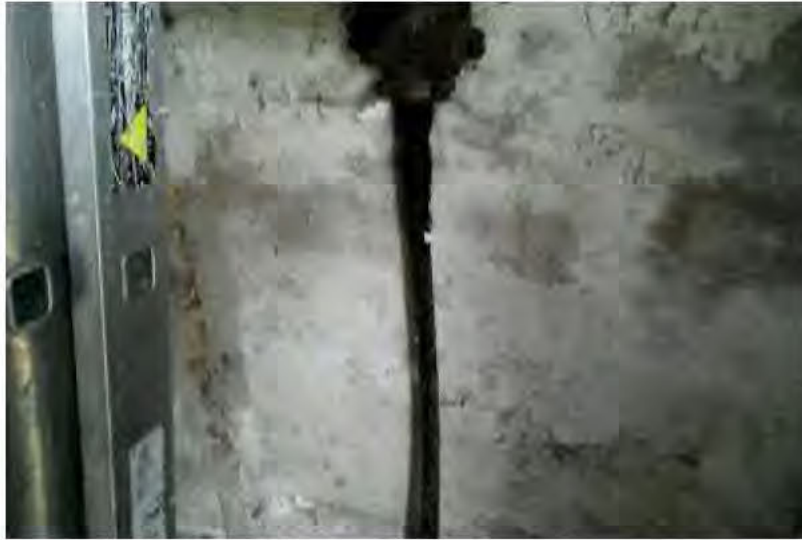
Inspection Number	153	Reference Number:	As Sample BB000268
Inspection / Sample	Visually similar to	Inspection Cross Reference / Visual I.D.	As Sample

Building	Apple Tree
Floor Level	Ground Floor
Area / Room	23 Boiler Room Store
Feature	Cable wrap
Product Type	Well Bound Material
Extent Amount	1 m

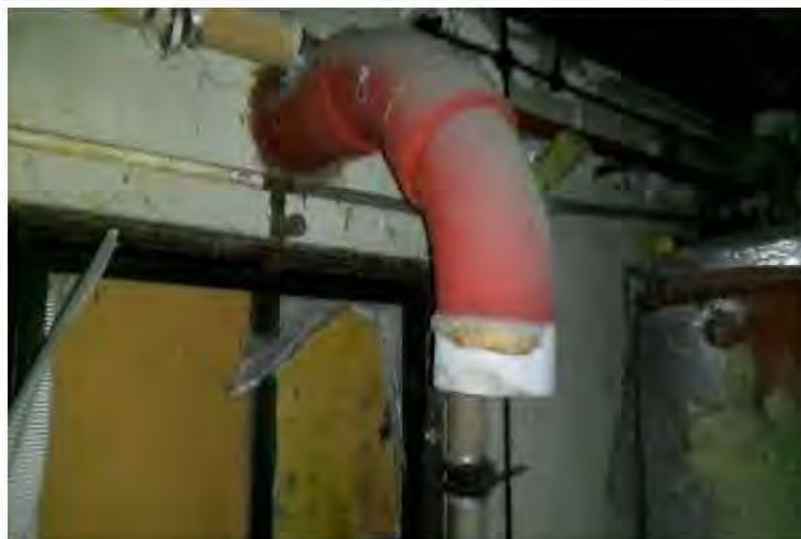
Inspection Number	154	Reference Number:	As Sample BB000295
Inspection / Sample	Visually similar to	Inspection Cross Reference / Visual I.D.	As Sample

Building	Apple Tree
Floor Level	Ground Floor
Area / Room	24 Boiler Room
Feature	Cement flue
Product Type	Asbestos Cement
Extent Amount	2 m

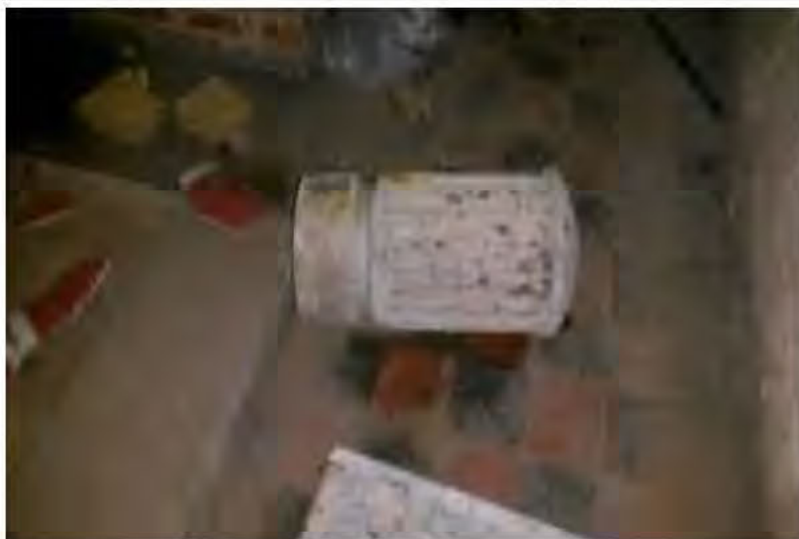
Inspection Number	155	Reference Number:	BB000295
Inspection / Sample	Sample taken	Inspection Cross Reference / Visual I.D.	Asbestos Identified

Building	Apple Tree
Floor Level	Ground Floor
Area / Room	24 Boiler Room
Feature	Cement cowl
Product Type	Asbestos Cement
Extent Amount	1 no.

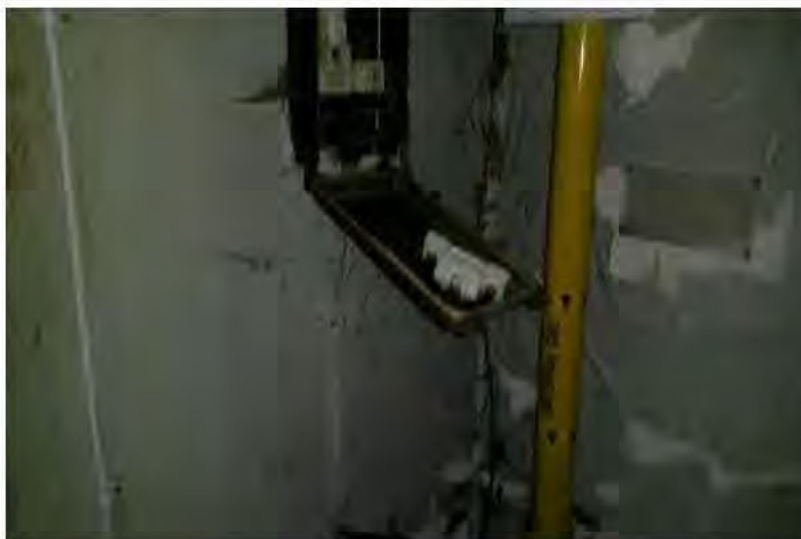
Inspection Number	156	Reference Number:	As Sample BB000286
Inspection / Sample	Visually similar to	Inspection Cross Reference / Visual I.D.	As Sample

Building	Apple Tree
Floor Level	Ground Floor
Area / Room	24 Boiler Room
Feature	Textiles within fuses
Product Type	Asbestos Textiles/Paper
Extent Amount	2 no.

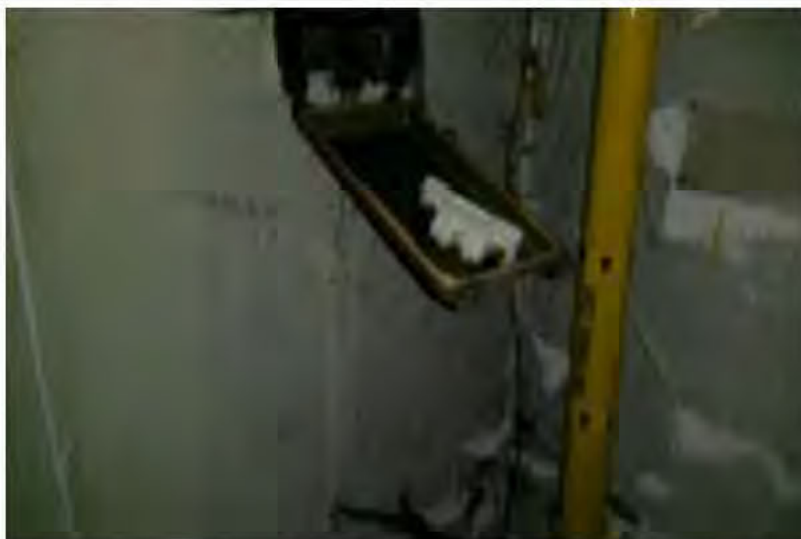
Inspection Number	157	Reference Number:	As Sample BB000250
Inspection / Sample	Visually similar to	Inspection Cross Reference / Visual I.D.	As Sample

Building	Apple Tree
Floor Level	Ground Floor
Area / Room	24 Boiler Room
Feature	Rope seal to electric boxes
Product Type	Asbestos Textiles/Paper
Extent Amount	2 no.

Product Score	Medium Fibre Release - Asbestos insulating board, mill board, other low density insulation board, asbestos textiles, gaskets, rope and woven textiles, asbestos paper and felt	2
Extent of Damage	Low Damage	1
Surface Treatment	Surface Sealed	1
Asbestos Type	Chrysotile	1

Recommendation	Remove if likely to be disturbed
----------------	----------------------------------

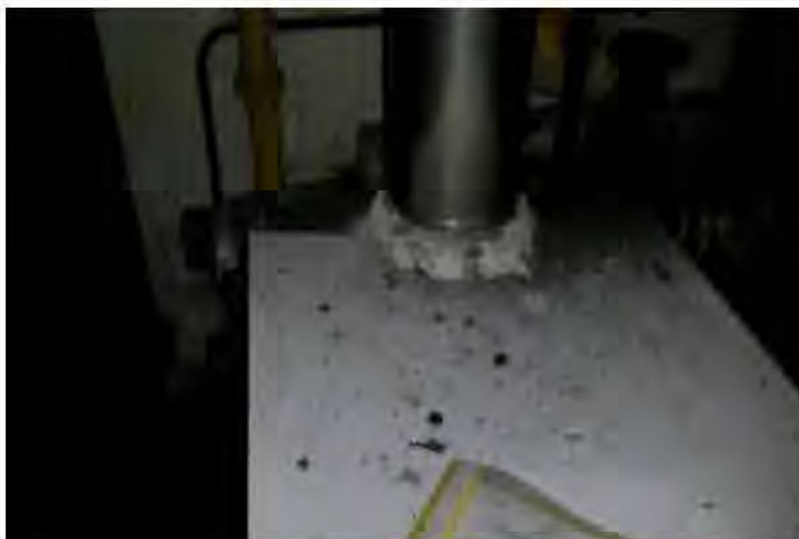
Inspection Number	158	Reference Number:	BB000296
Inspection / Sample	Sample taken	Inspection Cross Reference / Visual I.D.	Asbestos Identified

Building	Apple Tree
Floor Level	Ground Floor
Area / Room	24 Boiler Room
Feature	Debris to top of boiler
Product Type	Asbestos Insulation/Coating
Extent Amount	< 1 m ²

Product Score	High Fibre Release - Thermal insulation (e.g. pipe and boiler lagging) sprayed asbestos, loose asbestos, asbestos mattresses and packing	3
Extent of Damage	High Damage	3
Surface Treatment	Unsealed	3
Asbestos Type	Chrysotile	1

Recommendation	Remove if likely to be disturbed
----------------	----------------------------------

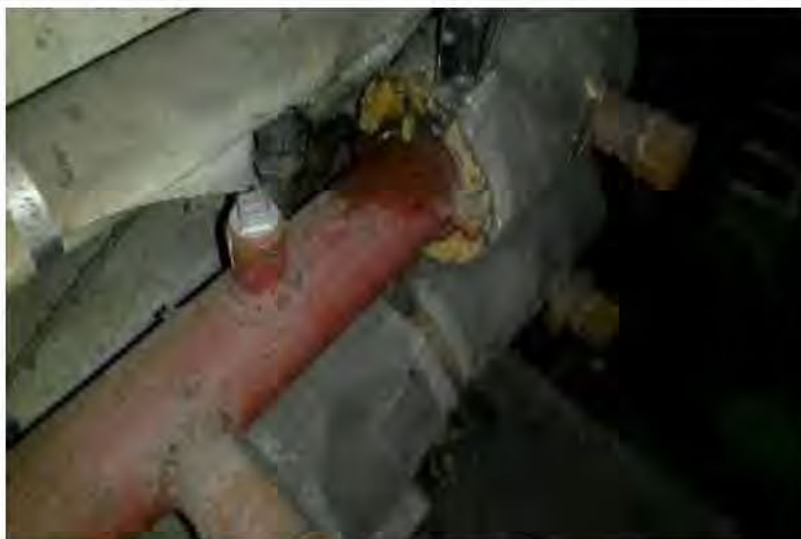
Inspection Number	160	Reference Number:	BB000298
Inspection / Sample	Sample taken	Inspection Cross Reference / Visual I.D.	N.A.D.I.S

Building	Apple Tree
Floor Level	Ground Floor
Area / Room	24 Boiler Room
Feature	Residue to pipework
Product Type	Insulation
Extent Amount	22 m

Product Score	High Fibre Release - Thermal insulation (e.g. pipe and boiler lagging) sprayed asbestos, loose asbestos, asbestos mattresses and packing	0
Extent of Damage	High Damage	0
Surface Treatment	Unsealed	0
Asbestos Type	No Asbestos Detected	0

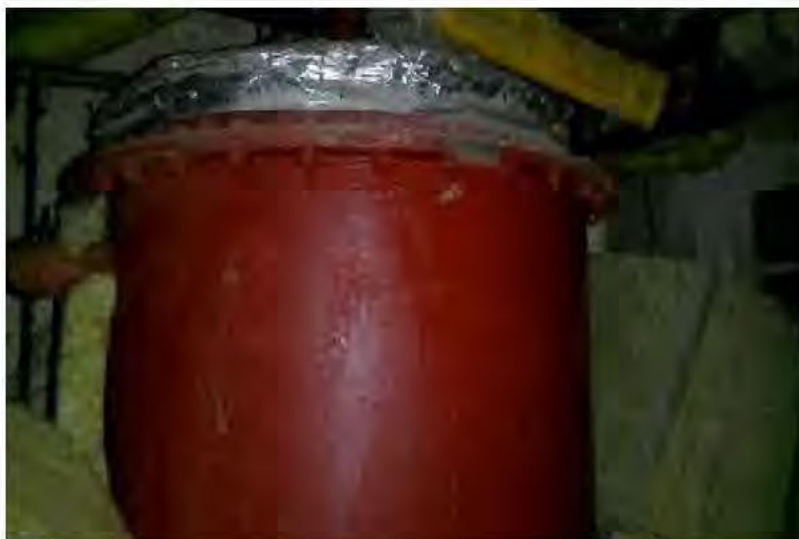
Inspection Number	161	Reference Number:	BB000299
Inspection / Sample	Sample taken	Inspection Cross Reference / Visual I.D.	N.A.D.I.S

Building	Apple Tree
Floor Level	Ground Floor
Area / Room	24 Boiler Room
Feature	Residue to water heater
Product Type	Insulation
Extent Amount	5 m ²

Product Score	High Fibre Release - Thermal insulation (e.g. pipe and boiler lagging) sprayed asbestos, loose asbestos, asbestos mattresses and packing	0
Extent of Damage	High Damage	0
Surface Treatment	Unsealed	0
Asbestos Type	No Asbestos Detected	0

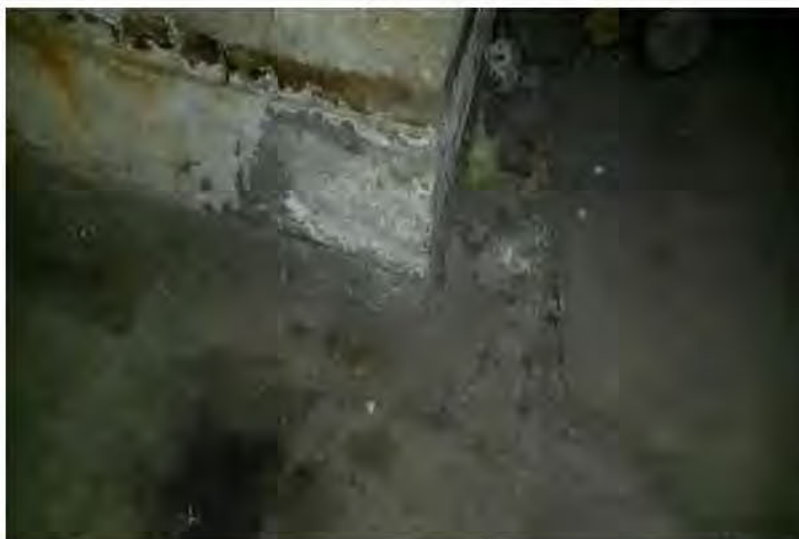
Inspection Number	162	Reference Number:	BB000300
Inspection / Sample	Sample taken	Inspection Cross Reference / Visual I.D.	Asbestos Identified

Building	Apple Tree
Floor Level	Ground Floor
Area / Room	24 Boiler Room
Feature	Debris to floor
Product Type	Asbestos Insulation/Coating
Extent Amount	12 m ²

Product Score	High Fibre Release - Thermal insulation (e.g. pipe and boiler lagging) sprayed asbestos, loose asbestos, asbestos mattresses and packing	3
Extent of Damage	High Damage	3
Surface Treatment	Unsealed	3
Asbestos Type	Chrysotile	1

Recommendation	Remove if likely to be disturbed
----------------	----------------------------------

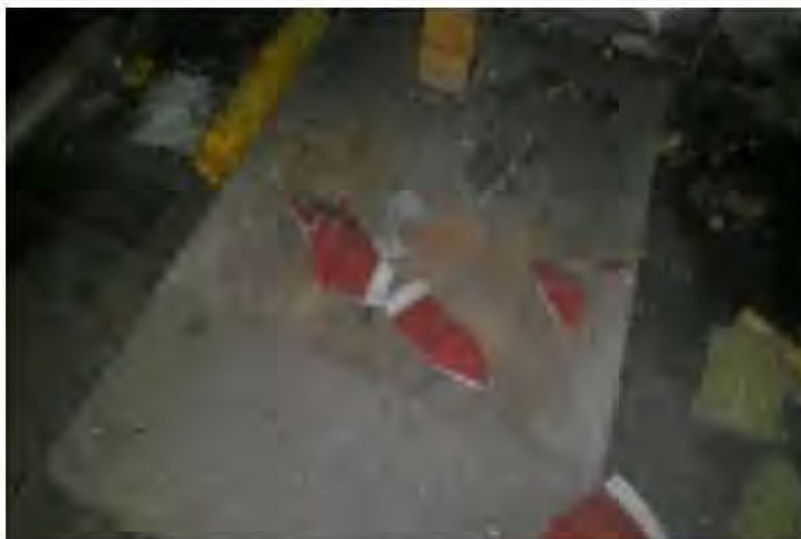
Inspection Number	164	Reference Number:	As Sample BB000294
Inspection / Sample	Visually similar to	Inspection Cross Reference / Visual I.D.	As Sample

Building	Apple Tree
Floor Level	Ground Floor
Area / Room	24 Boiler Room
Feature	Cement flue debris to floor
Product Type	Asbestos Cement
Extent Amount	1 m ²

Product Score	Low Fibre Release - Asbestos reinforced composites (plastics, resins, mastics, roofing felts, vinyl floor tiles, semi-rigid paits or decorative finishes, asbestos cement, etc.)	1
Extent of Damage	High Damage	3
Surface Treatment	Surface Sealed	1
Asbestos Type	Crocidolite (or unknown)	3

Recommendation	Remove if likely to be disturbed
----------------	----------------------------------

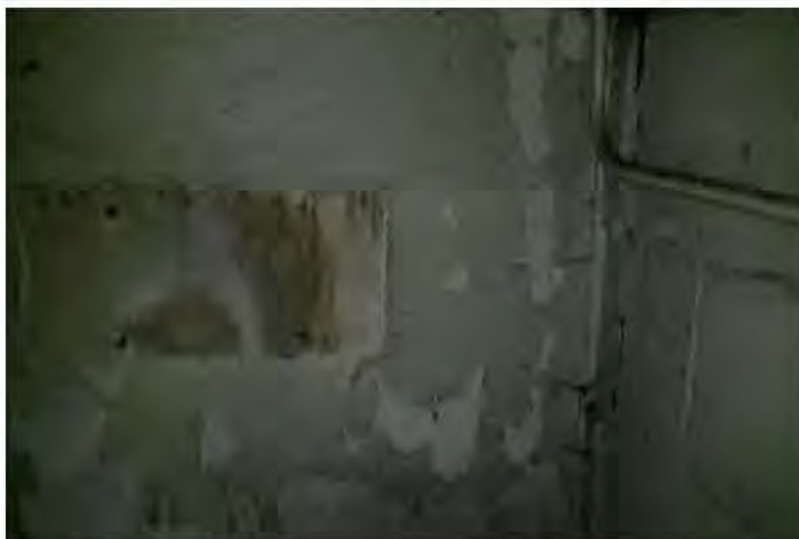
Inspection Number	165	Reference Number:	As Sample BB000292
Inspection / Sample	Visually similar to	Inspection Cross Reference / Visual I.D.	As Sample

Building	Apple Tree
Floor Level	Ground Floor
Area / Room	24 Boiler Room
Feature	Textured coating to walls
Product Type	Textured Coating
Extent Amount	18 m ²

Product Score	Low Fibre Release - Asbestos reinforced composites (plastics, resins, mastics, roofing felts, vinyl floor tiles, semi-rigid paits or decorative finishes, asbestos cement, etc.)	0
Extent of Damage	High Damage	0
Surface Treatment	Surface Sealed	0
Asbestos Type	No Asbestos Detected	0

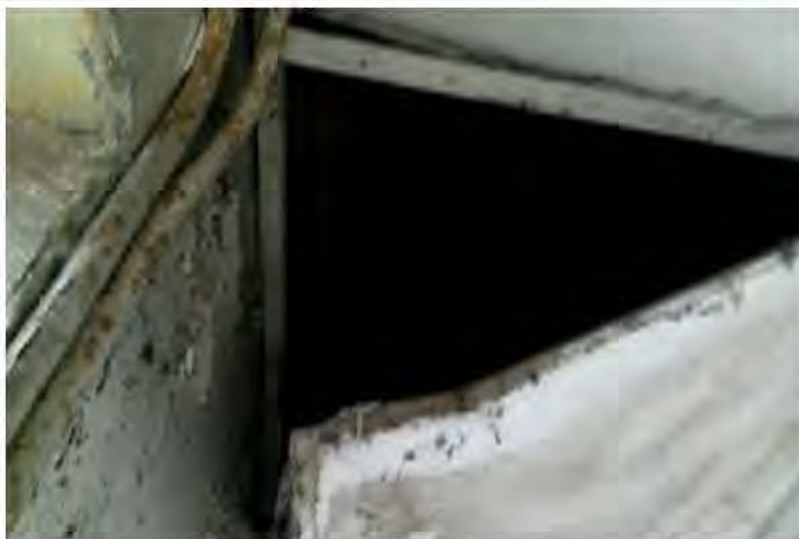
Inspection Number	166	Reference Number:	As Sample BB000289
Inspection / Sample	Visually similar to	Inspection Cross Reference / Visual I.D.	As Sample

Building	Apple Tree
Floor Level	Ground Floor
Area / Room	23 Boiler Room Store
Feature	Bitumen felt to underside of roof
Product Type	Well Bound Material
Extent Amount	18 m ²

Product Score	Low Fibre Release - Asbestos reinforced composites (plastics, resins, mastics, roofing felts, vinyl floor tiles, semi-rigid paits or decorative finishes, asbestos cement, etc.)	0
Extent of Damage	Low Damage	0
Surface Treatment	Completely Sealed	0
Asbestos Type	No Asbestos Detected	0

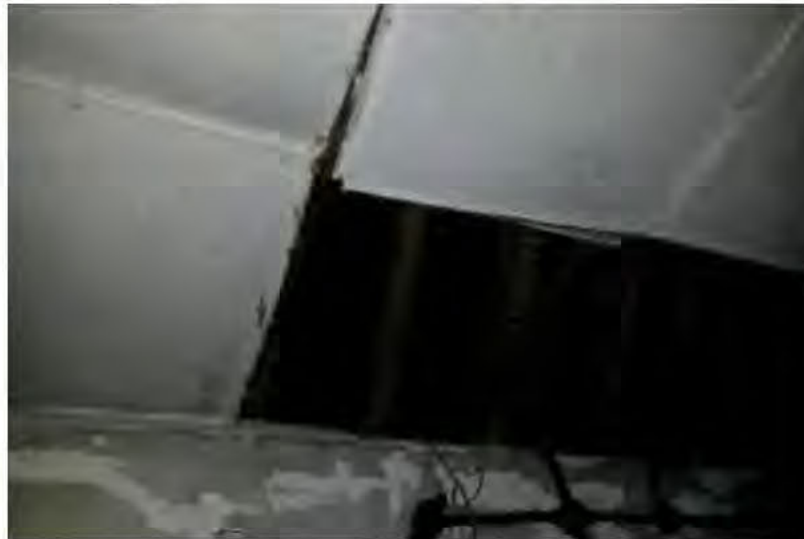
Inspection Number	167	Reference Number:	As Sample BB000289
Inspection / Sample	Visually similar to	Inspection Cross Reference / Visual I.D.	As Sample

Building	Apple Tree
Floor Level	Ground Floor
Area / Room	24 Boiler Room
Feature	Bitumen felt to underside of roof
Product Type	Well Bound Material
Extent Amount	18 m ²

Product Score	Low Fibre Release - Asbestos reinforced composites (plastics, resins, mastics, roofing felts, vinyl floor tiles, semi-rigid paits or decorative finishes, asbestos cement, etc.)	0
Extent of Damage	Low Damage	0
Surface Treatment	Completely Sealed	0
Asbestos Type	No Asbestos Detected	0

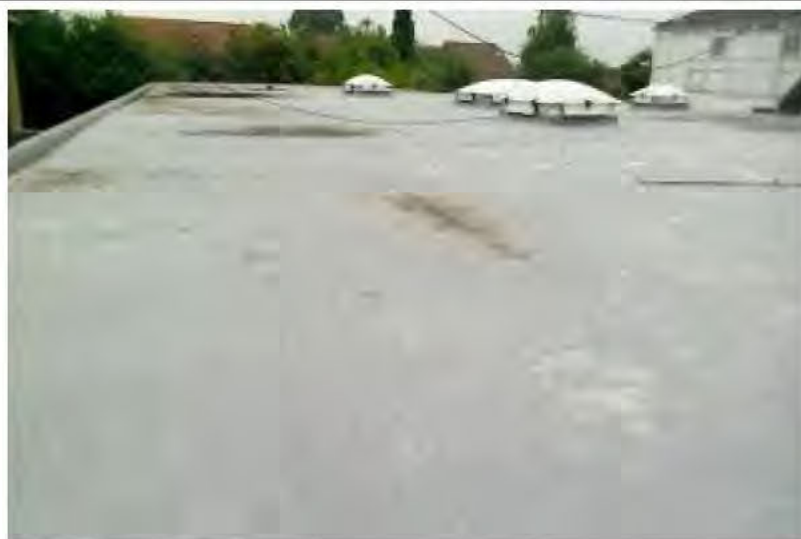
Inspection Number	168	Reference Number:	BB000302
Inspection / Sample	Sample taken	Inspection Cross Reference / Visual I.D.	N.A.D.I.S

Building	Apple Tree
Floor Level	External
Area / Room	1 External
Feature	Bitumen felt to flat roof
Product Type	Well Bound Material
Extent Amount	145 m ²

Product Score	Low Fibre Release - Asbestos reinforced composites (plastics, resins, mastics, roofing felts, vinyl floor tiles, semi-rigid paits or decorative finishes, asbestos cement, etc.)	0
Extent of Damage	Good Condition	0
Surface Treatment	Completely Sealed	0
Asbestos Type	No Asbestos Detected	0

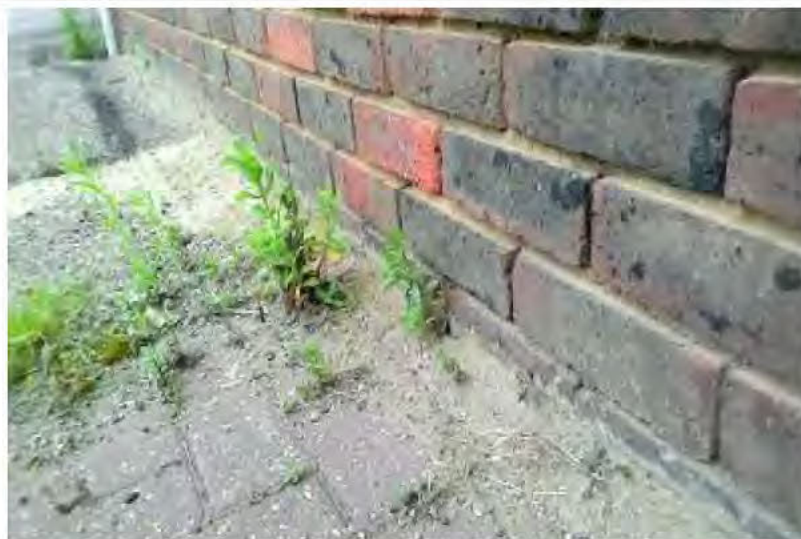
Inspection Number	169	Reference Number:	BB000303
Inspection / Sample	Sample taken	Inspection Cross Reference / Visual I.D.	N.A.D.I.S

Building	Apple Tree
Floor Level	External
Area / Room	1 External
Feature	Damp proof course
Product Type	Well Bound Material
Extent Amount	> 100 m

Product Score	Low Fibre Release - Asbestos reinforced composites (plastics, resins, mastics, roofing felts, vinyl floor tiles, semi-rigid paits or decorative finishes, asbestos cement, etc.)	0
Extent of Damage	Good Condition	0
Surface Treatment	Completely Sealed	0
Asbestos Type	No Asbestos Detected	0

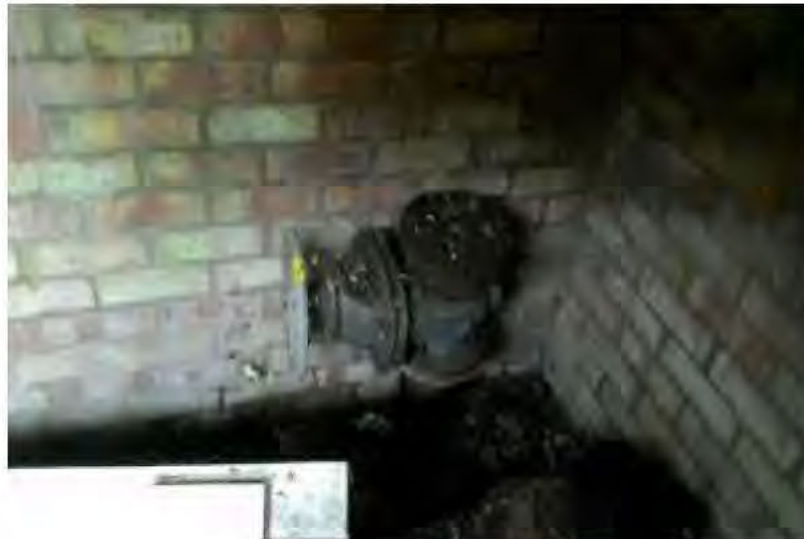
Inspection Number	170	Reference Number:	As Sample BB000297
Inspection / Sample	Visually similar to	Inspection Cross Reference / Visual I.D.	As Sample

Building	Apple Tree
Floor Level	External
Area / Room	2 Gas meter
Feature	Gaskets to pipework
Product Type	Asbestos Textiles/Paper
Extent Amount	5 no.

Product Score	Medium Fibre Release - Asbestos insulating board, mill board, other low density insulation board, asbestos textiles, gaskets, rope and woven textiles, asbestos paper and felt	2
Extent of Damage	Low Damage	1
Surface Treatment	Surface Sealed	1
Asbestos Type	Chrysotile	1

Recommendation	Remove if likely to be disturbed
----------------	----------------------------------

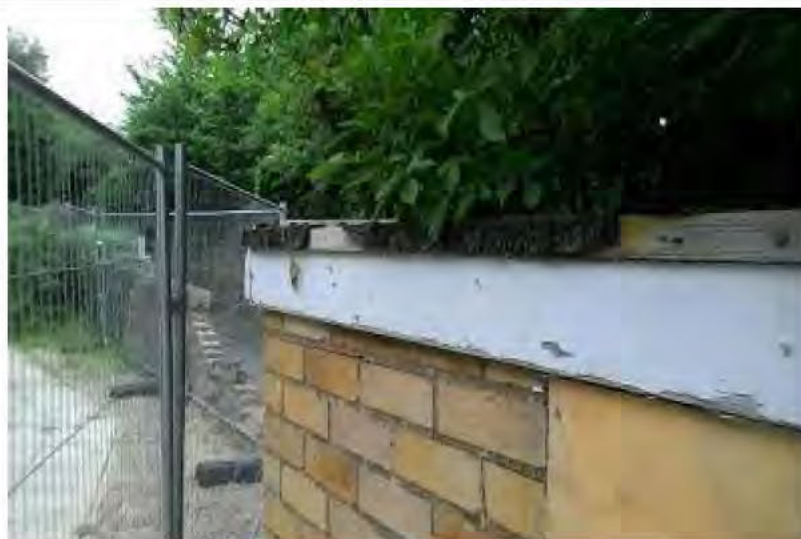
Inspection Number	171	Reference Number:	BB000304
Inspection / Sample	Sample taken	Inspection Cross Reference / Visual I.D.	N.A.D.I.S

Building	Apple Tree
Floor Level	External
Area / Room	2 Gas meter
Feature	Bitumen felt to flat roof
Product Type	Well Bound Material
Extent Amount	6 m ²

Product Score	Low Fibre Release - Asbestos reinforced composites (plastics, resins, mastics, roofing felts, vinyl floor tiles, semi-rigid paits or decorative finishes, asbestos cement, etc.)	0
Extent of Damage	Good Condition	0
Surface Treatment	Completely Sealed	0
Asbestos Type	No Asbestos Detected	0

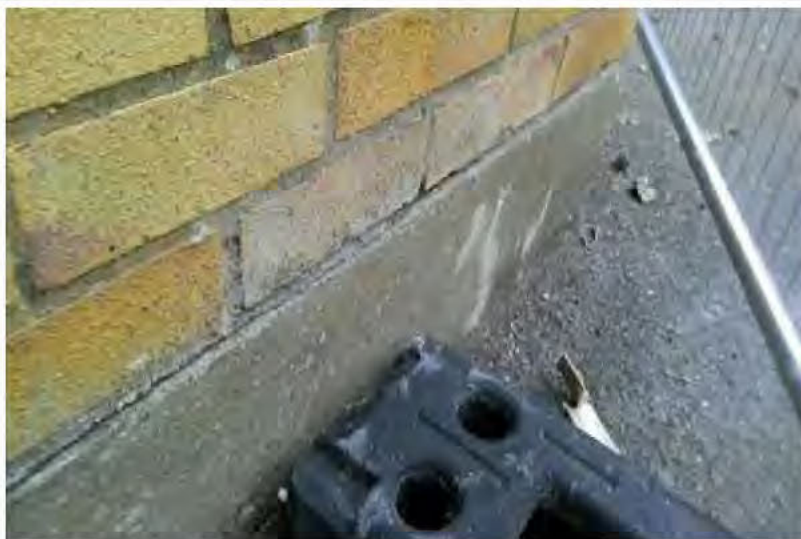
Inspection Number	172	Reference Number:	As Sample BB000303
Inspection / Sample	Visually similar to	Inspection Cross Reference / Visual I.D.	As Sample

Building	Apple Tree
Floor Level	External
Area / Room	2 Gas meter
Feature	Damp proof course
Product Type	Well Bound Material
Extent Amount	10 m

Product Score	Low Fibre Release - Asbestos reinforced composites (plastics, resins, mastics, roofing felts, vinyl floor tiles, semi-rigid paits or decorative finishes, asbestos cement, etc.)	0
Extent of Damage	Good Condition	0
Surface Treatment	Completely Sealed	0
Asbestos Type	No Asbestos Detected	0

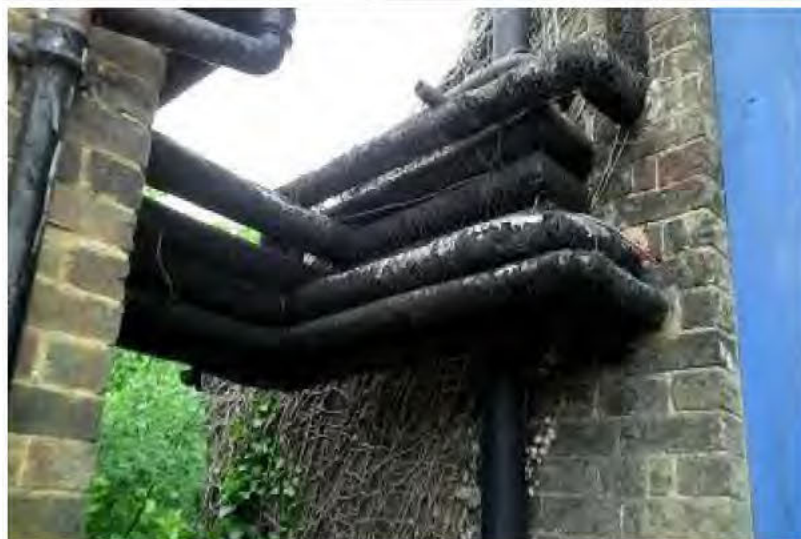
Inspection Number	173	Reference Number:	As Sample BB000298
Inspection / Sample	Visually similar to	Inspection Cross Reference / Visual I.D.	As Sample

Building	Apple Tree
Floor Level	External
Area / Room	1 External
Feature	Residues to pipework from boiler house
Product Type	Insulation
Extent Amount	18 m

Product Score	High Fibre Release - Thermal insulation (e.g. pipe and boiler lagging) sprayed asbestos, loose asbestos, asbestos mattresses and packing	0
Extent of Damage	High Damage	0
Surface Treatment	Unsealed	0
Asbestos Type	No Asbestos Detected	0

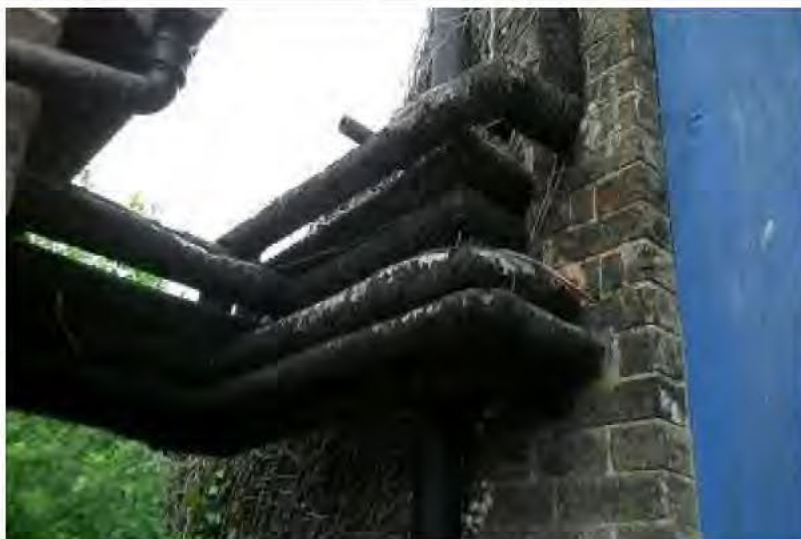
Inspection Number	174	Reference Number:	As Sample BB000284
Inspection / Sample	Visually similar to	Inspection Cross Reference / Visual I.D.	As Sample

Building	Apple Tree
Floor Level	External
Area / Room	1 External
Feature	Paper backing to fibreglass lagged pipework from boiler house
Product Type	Asbestos Textiles/Paper
Extent Amount	18 m

Product Score	Medium Fibre Release - Asbestos insulating board, mill board, other low density insulation board, asbestos textiles, gaskets, rope and woven textiles, asbestos paper and felt	2
Extent of Damage	Low Damage	1
Surface Treatment	Surface Sealed	1
Asbestos Type	Chrysotile	1

Recommendation	Remove if likely to be disturbed
----------------	----------------------------------

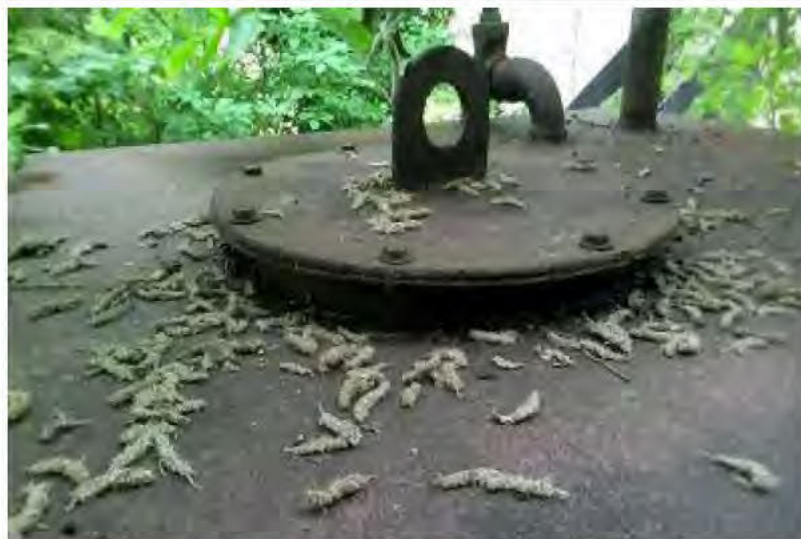
Inspection Number	175	Reference Number:	BB000305
Inspection / Sample	Sample taken	Inspection Cross Reference / Visual I.D.	N.A.D.I.S

Building	Laburnum House
Floor Level	External
Area / Room	3 Oil Tank
Feature	Gasket to top of tank
Product Type	Well Bound Material
Extent Amount	1 no.

Product Score	Low Fibre Release - Asbestos reinforced composites (plastics, resins, mastics, roofing felts, vinyl floor tiles, semi-rigid paits or decorative finishes, asbestos cement, etc.)	0
Extent of Damage	Good Condition	0
Surface Treatment	Completely Sealed	0
Asbestos Type	No Asbestos Detected	0

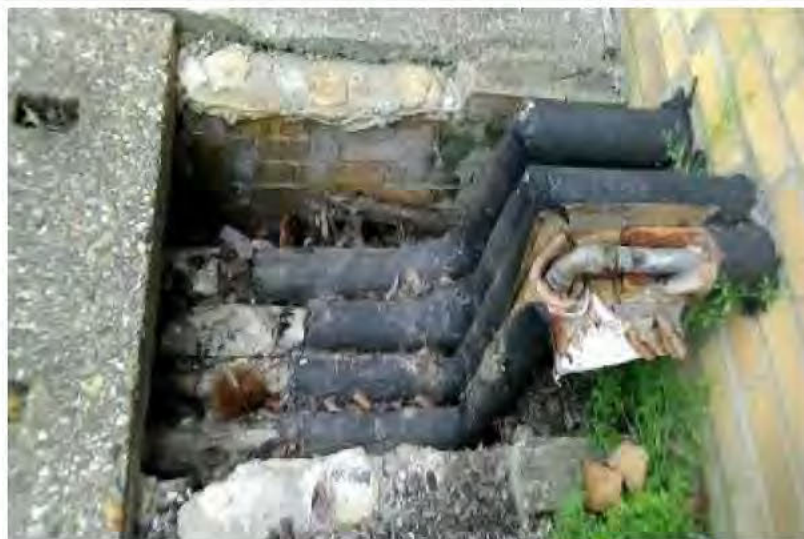
Inspection Number	176	Reference Number:	BB000306
Inspection / Sample	Sample taken	Inspection Cross Reference / Visual I.D.	N.A.D.I.S

Building	Laburnum House
Floor Level	External
Area / Room	1 Externals
Feature	Residues to rear pipework
Product Type	Insulation
Extent Amount	84 m

Product Score	High Fibre Release - Thermal insulation (e.g. pipe and boiler lagging) sprayed asbestos, loose asbestos, asbestos mattresses and packing	0
Extent of Damage	High Damage	0
Surface Treatment	Unsealed	0
Asbestos Type	No Asbestos Detected	0

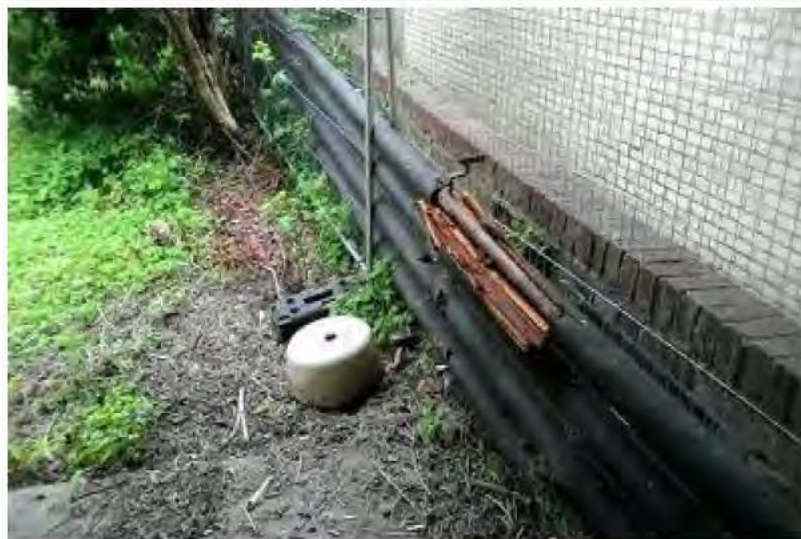
Inspection Number	177	Reference Number:	BB000307
Inspection / Sample	Sample taken	Inspection Cross Reference / Visual I.D.	N.A.D.I.S

Building	Laburnum House
Floor Level	External
Area / Room	1 Externals
Feature	Residue to rear pipework
Product Type	Insulation
Extent Amount	> 100 m

Product Score	High Fibre Release - Thermal insulation (e.g. pipe and boiler lagging) sprayed asbestos, loose asbestos, asbestos mattresses and packing	0
Extent of Damage	High Damage	0
Surface Treatment	Unsealed	0
Asbestos Type	No Asbestos Detected	0

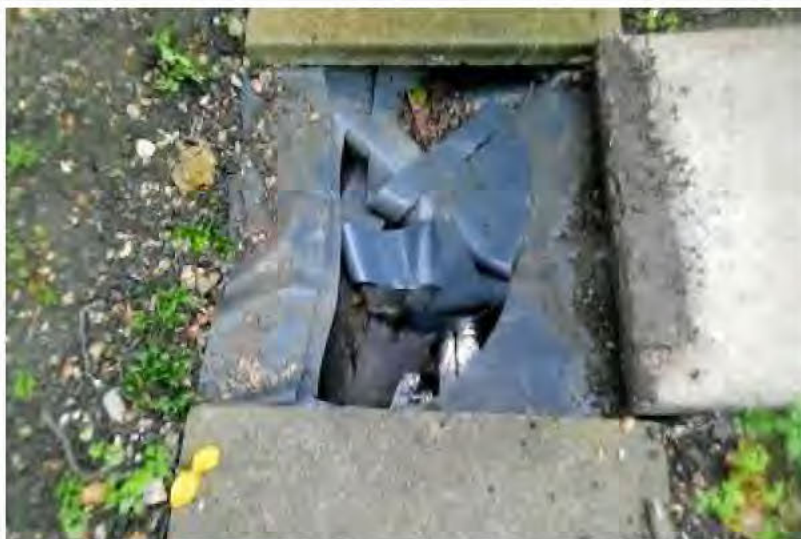
Inspection Number	178	Reference Number:	BB000308
Inspection / Sample	Sample taken	Inspection Cross Reference / Visual I.D.	N.A.D.I.S

Building	Laburnum House
Floor Level	External
Area / Room	1 Externals
Feature	Paper backing to rear pipework
Product Type	Textiles/Paper
Extent Amount	18 m

Product Score	Medium Fibre Release - Asbestos insulating board, mill board, other low density insulation board, asbestos textiles, gaskets, rope and woven textiles, asbestos paper and felt	0
Extent of Damage	High Damage	0
Surface Treatment	Unsealed	0
Asbestos Type	No Asbestos Detected	0

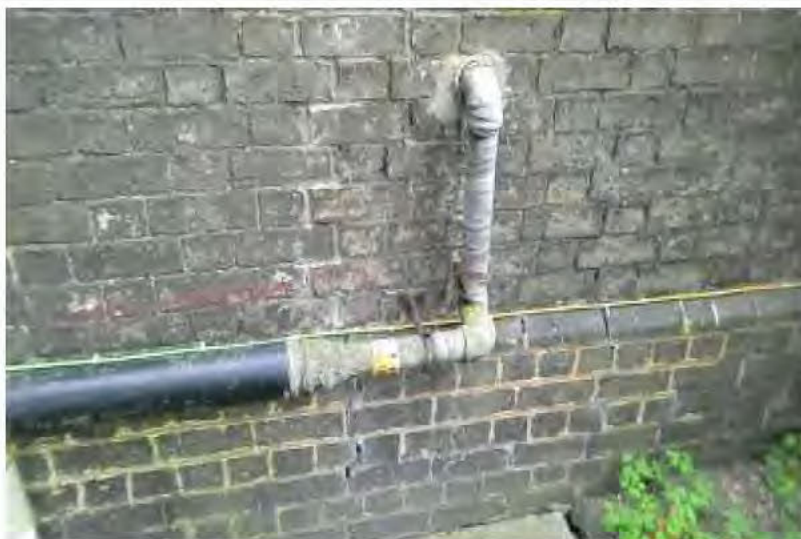
Inspection Number	179	Reference Number:	BB000309
Inspection / Sample	Sample taken	Inspection Cross Reference / Visual I.D.	N.A.D.I.S

Building	Laburnum House
Floor Level	External
Area / Room	1 Externals
Feature	Wrap to rear gas pipe
Product Type	Textiles/Paper
Extent Amount	2 m

Product Score	Medium Fibre Release - Asbestos insulating board, mill board, other low density insulation board, asbestos textiles, gaskets, rope and woven textiles, asbestos paper and felt	0
Extent of Damage	Low Damage	0
Surface Treatment	Unsealed	0
Asbestos Type	No Asbestos Detected	0

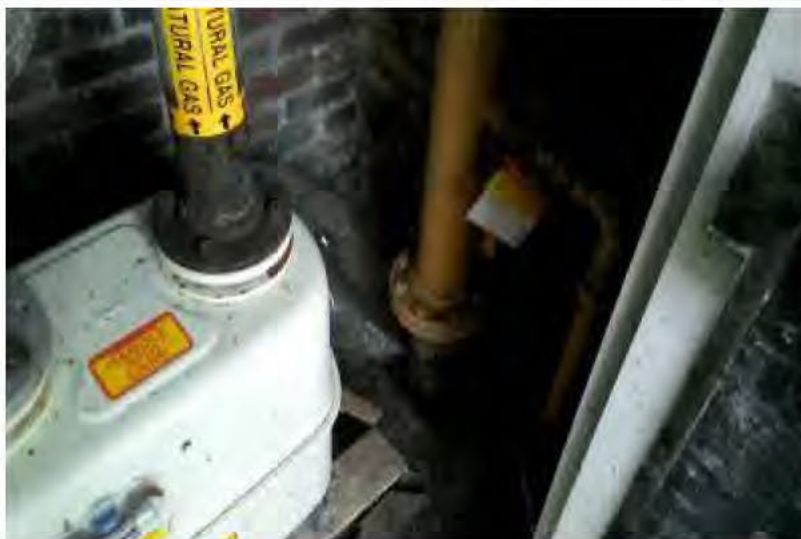
Inspection Number	180	Reference Number:	As Sample BB000297
Inspection / Sample	Visually similar to	Inspection Cross Reference / Visual I.D.	As Sample

Building	Laburnum House
Floor Level	External
Area / Room	2 Gas meter hut
Feature	Gaskets to pipework
Product Type	Asbestos Textiles/Paper
Extent Amount	2 no.

Product Score	Medium Fibre Release - Asbestos insulating board, mill board, other low density insulation board, asbestos textiles, gaskets, rope and woven textiles, asbestos paper and felt	2
Extent of Damage	Good Condition	0
Surface Treatment	Surface Sealed	1
Asbestos Type	Chrysotile	1

Recommendation	Remove if likely to be disturbed
----------------	----------------------------------
