# ***AAIB Bulletin***

***5/2021***

<b>Aircraft Type and Registration:</b>	BAe ATP, SE-MAO	
<b>No &amp; Type of Engines:</b>	2 Pratt & Whitney Canada PW126 turboprop engines	
<b>Year of Manufacture:</b>	1989 (Serial no: 2011)	
<b>Date &amp; Time (UTC):</b>	18 August 2020 at 0825 hrs	
<b>Location:</b>	After departure from Jersey Airport, Channel Islands	
<b>Type of Flight:</b>	Commercial Air Transport (Cargo)	
<b>Persons on Board:</b>	Crew - 2	Passengers - None
<b>Injuries:</b>	Crew - None	Passengers - N/A
<b>Nature of Damage:</b>	None	
<b>Commander's Licence:</b>	Airline Transport Pilot's Licence	
<b>Commander's Age:</b>	50 years	
<b>Commander's Flying Experience:</b>	14,500 hours (of which 100 were on type) Last 90 days - 60 hours Last 28 days - 30 hours	
<b>Information Source:</b>	AAIB Field investigation

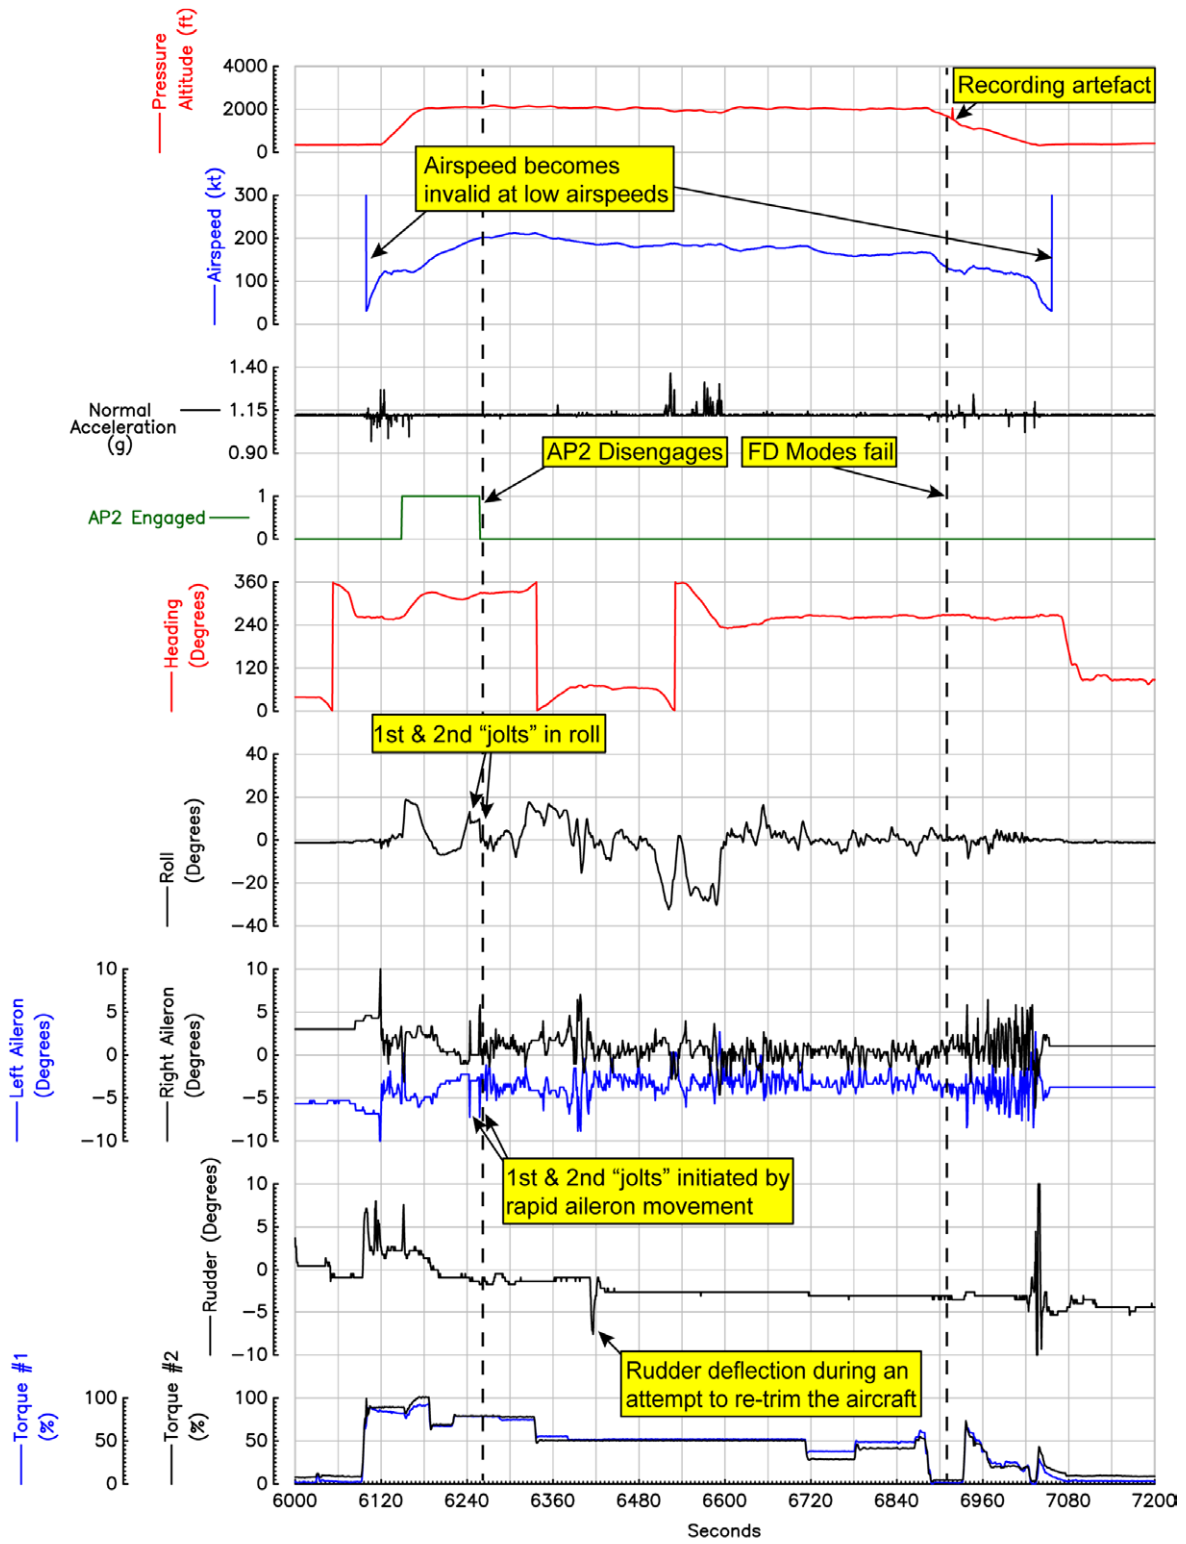
**Figure 2**  
Salient recorded parameters

The recorded data (Figure 2) shows that the aircraft, at approximately 2,000 ft, and 200 KIAS in a right turn passing through a heading of 330°, rolled 5° sharply to the left. Shortly afterwards, the aircraft again rolled sharply to the left, this time by 10°. At that time, the No 2 autopilot, which was engaged, automatically disconnected and a continuous calvary charge was recorded on the CVR. Each sharp roll to the left was preceded by the rapid movement of both ailerons in the correct sense to initiate the observed roll. No fluctuations were observed in the normal acceleration values recorded by the FDR to indicate that the aircraft was experiencing any notable turbulence.

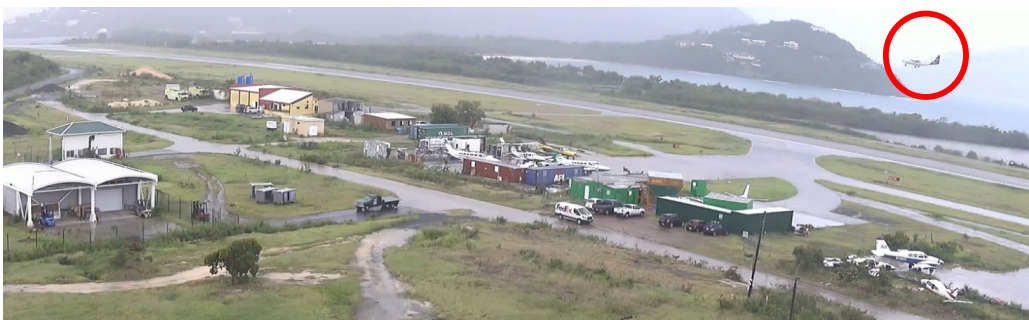
**Figure 9**  
CCTV looking West at time 1715:45 hrs

CCTV at the airfield captured N967FE approaching the airfield and the subsequent landing. Figure 8 shows the aircraft approaching from the east. Figures 9 and 10 shows the aircraft descending towards the western end of the runway. Figure 11 shows the touchdown with the aircraft banked to the right.

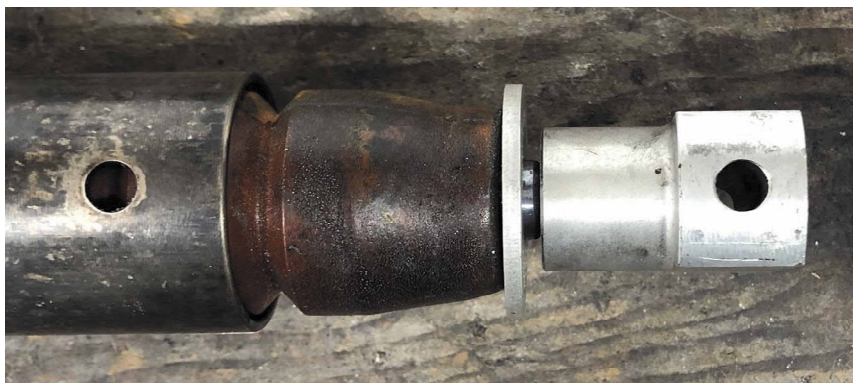
**Figure 2**

Example sliding tube, gas strut piston rod sleeve and bottom fitting with piston rod just visible as it enters the bottom fitting

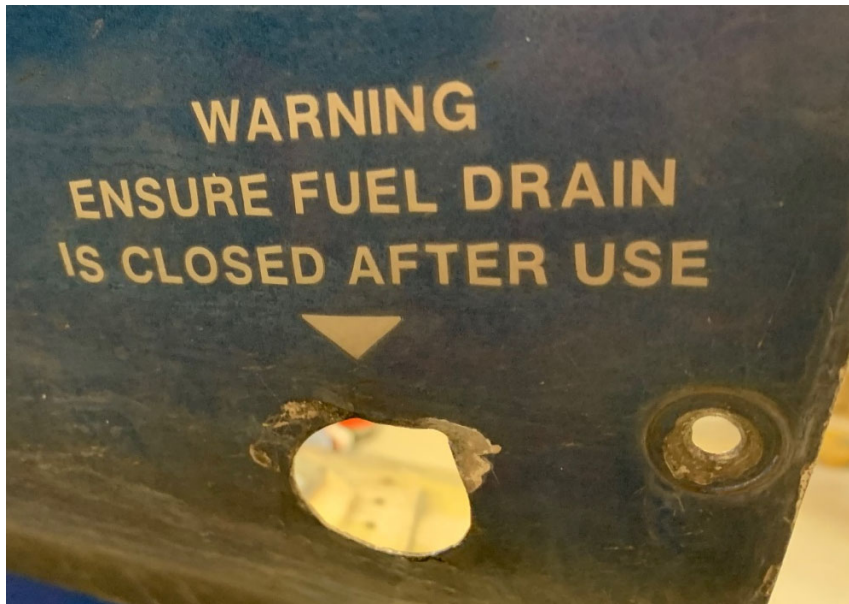
**Figure 3**

A subsequent accident, involving G-BHFL in November 1989<sup>3</sup>, appeared to have been caused by the same lockable gascolator drain problem. Since the drain locking feature was still present on G-BHFL, the AAIB reiterated its previous recommendation to modify such valves. In 1990 the CAA issued Emergency Airworthiness Directive (EAD) 001-02-90 which required affected aircraft to be placarded, alerting pilots to check the fuel drain was closed after use (Figure 3). G-BZDA was placarded in accordance with the EAD.

Placard wording introduced by EAD 001-02-90
