## ACCIDENT

<b>Aircraft Type and Registration:</b>	Replica Royal Aircraft Factory BE2c, G-AWYI
<b>No &amp; Type of Engines:</b>	1 De Havilland Gipsy Major Mk 10-1 piston engine
<b>Year of Manufacture:</b>	1969 (Serial no:1)
<b>Date &amp; Time (UTC):</b>	2 September 2020 at 1038 hrs
<b>Location:</b>	Sywell Aerodrome, Northamptonshire
<b>Type of Flight:</b>	Private
<b>Persons on Board:</b>	Crew - 1                      Passengers - None
<b>Injuries:</b>	Crew - 1 (Serious)      Passengers - N/A
<b>Nature of Damage:</b>	Severe damage to entire airframe
<b>Commander's Licence:</b>	Private Pilot's Licence
<b>Commander's Age:</b>	57 years
<b>Commander's Flying Experience:</b>	1,747 hours (of which 287 were on type) Last 90 days - 18 hours Last 28 days - 14 hours
<b>Information Source:</b>	Field Investigation

## Synopsis

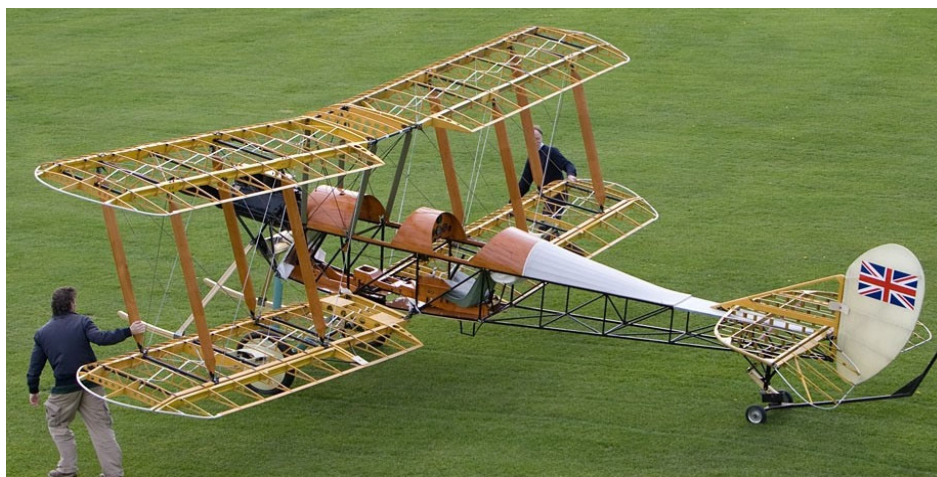
**Figure 10**

G-AWYI during its restoration

During the restoration, (Figure 10), the original design was modified to improve safety. Following structural load analysis, additional strengthening measures were taken. A four-point harness was added to the front and rear cockpit, additional control cables were added to the elevator control circuit, stronger bracing wires installed and structural strengthening to the tail section. The fin and rudder shapes and areas were altered to more closely replicate a BE2c, but no horn balance was fitted to the rudder. The original Tiger

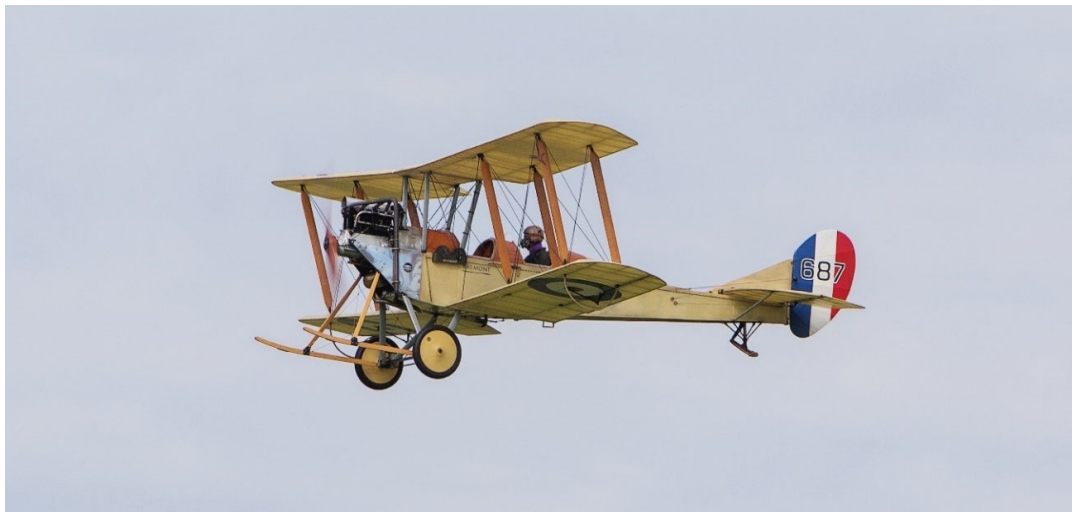
**Figure 11**

G-AWYI earlier during the accident flight  
(Used with permission and under copyright of the photographer)
