AIRCRAFT ACCIDENT REPORT 1/2021

Report on the serious incident to
Airbus A321-211, G-POWN
at London Gatwick Airport
on 26 February 2020

Air Accidents Investigation Branch

Published 4 May 2021

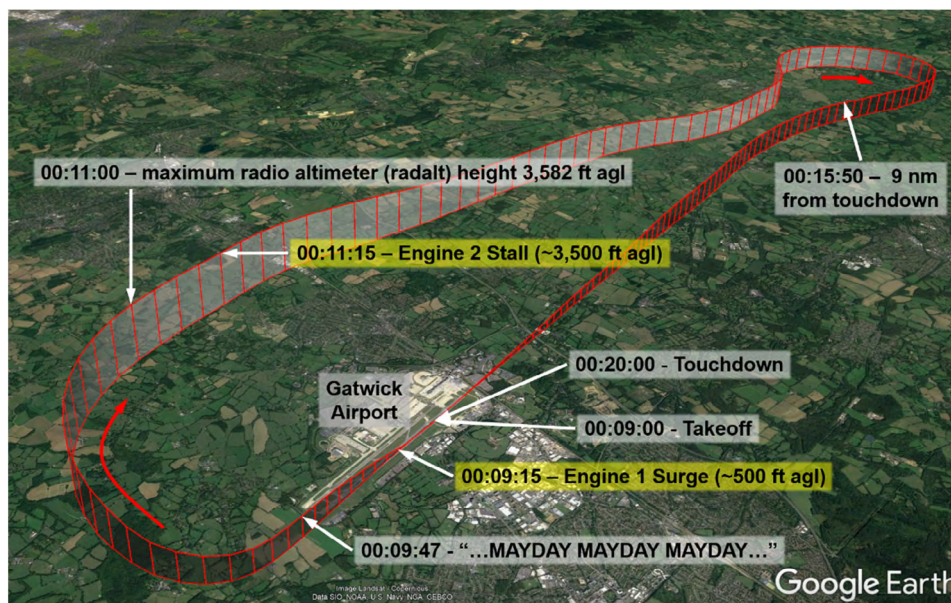
Figure 1

Crew A reported that at around 500 ft agl the No 1 engine began "banging and surging". Commander A recalled that the engine's control indications were fluctuating, and the aircraft was "yawing... and fishtailing... all over the place". There was no accompanying ECAM alert. Data recorded on the flight data recorder subsequently showed that the No 1 engine N_1 reduced below 40% for a period of approximately 25 seconds despite the thrust levers remaining in the FLEX/MCT²¹ detent.

Radar track of G-POWN with timing of significant events highlighted

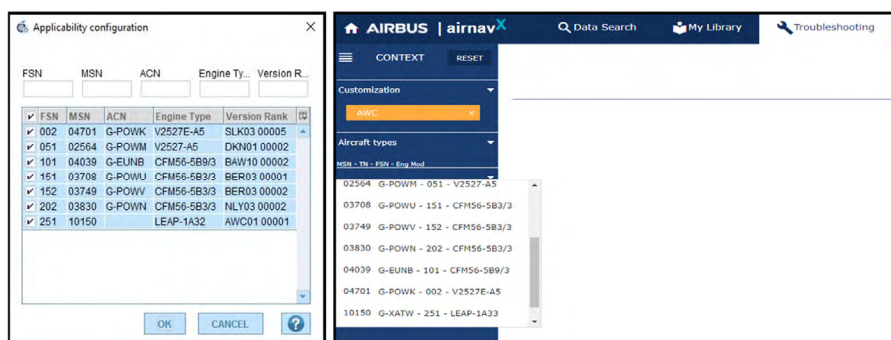
Figure 10 shows the filtering interfaces for AirN@v and airnav^x. In AirN@v, the filtering interface is accessed by clicking on the button highlighted in Figure 11. In airnav^x, the 'Context' interface is presented continuously and occupies a prominent position on the left of the screen. Figure 10 shows how the filtering box appeared in AirN@v on the computer that the line engineer used on the evening of the incident when it was examined during the investigation. The size of the box and the width of the columns are adjustable so that more, or less information is visible. Therefore, this image may not exactly represent what the line engineer saw at the time.

Filtering interface in AirN@v (left) and airnav^x (right) (courtesy Airbus)

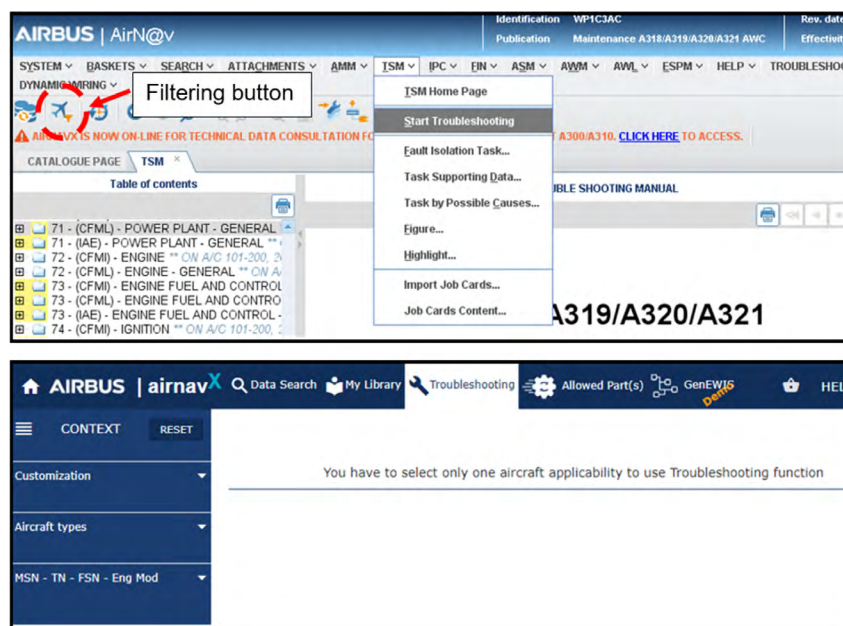
Figure 11

AirN@v and airnav^x offer various ways to search the TSM. The method to reach the appropriate task, described by the manufacturer in the TSM introduction, is to use the 'Start Troubleshooting' function in AirN@v and the 'Troubleshooting' tab in airnav^x (Figure 11). These both offer an intelligent search function where the engineer can input any fault codes generated by the aircraft in conjunction with other information such as crew observations. The applications then lead the engineer to the appropriate troubleshooting procedure(s). In airnav^x, the application forces the user to filter the data to the individual aircraft level before the 'Troubleshooting' function can be used.

Intelligent search functions – ‘Start Troubleshooting’ in AirN@v (above) and ‘Troubleshooting’ tab in airnav^x (below) (courtesy Airbus)

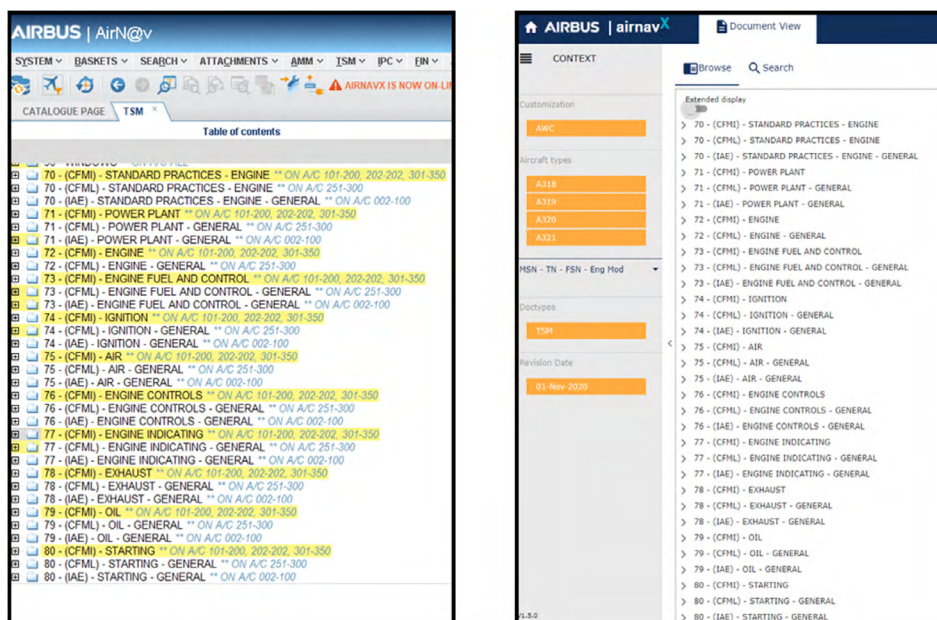
Another method, possible in both applications, is to browse the table of contents which is organised according to ATA codes (Figure 12). In AirN@v, the TSM table of contents is visible by default after accessing the TSM from the initial catalogue page. In airnav^x, two clicks are required to access this view. Figure 12 left shows how the table of contents appeared to the line engineer in AirN@v. Chapter 77 – (CFMI) relates to the CFM56 engines fitted to G-POWN. Chapter 77 – (CFML) relates to the LEAP engine and

Chapter 77 – (IAE) relates to the V2500 engine. Figure 12 right shows the equivalent part of the interface in airnav^x.

Table of contents in AirN@v (left) and airnav^x (right) showing options for Chapter 77 when data for the operator was not filtered for fleet serial number (courtesy Airbus)

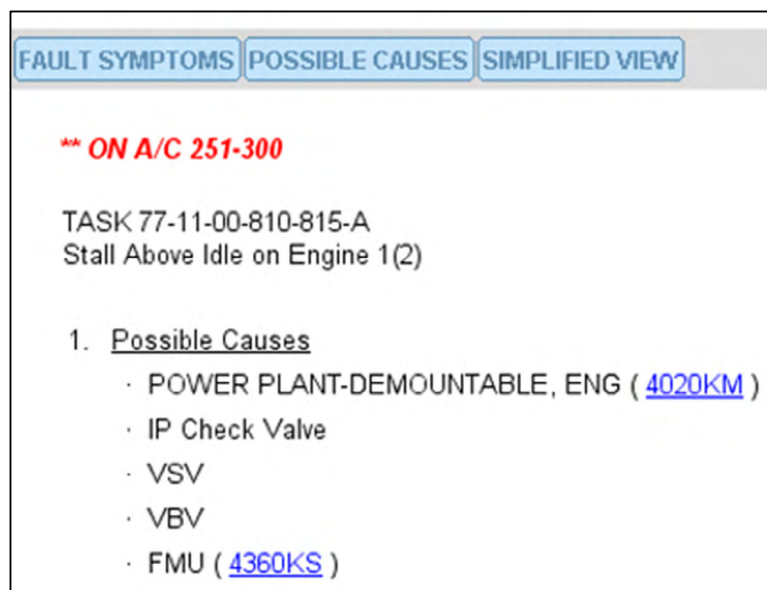
**Figure 14**

When a procedure was displayed on the screen within the AirN@v application, the fleet serial number was highlighted in red near the top (Figure 14). The custom at the Line AMO was to print a black and white PDF export of the procedure to use during the maintenance task. When printed, the first page of the procedure appeared as shown in Figure 15. The fleet serial number was grey and there was no identification on any page of the engine type the procedure applied to.

Appearance of procedure 77-11-00-810-815-A
Stall Above Idle on Engine 1(2) within the AirN@v application
 (courtesy Airbus)

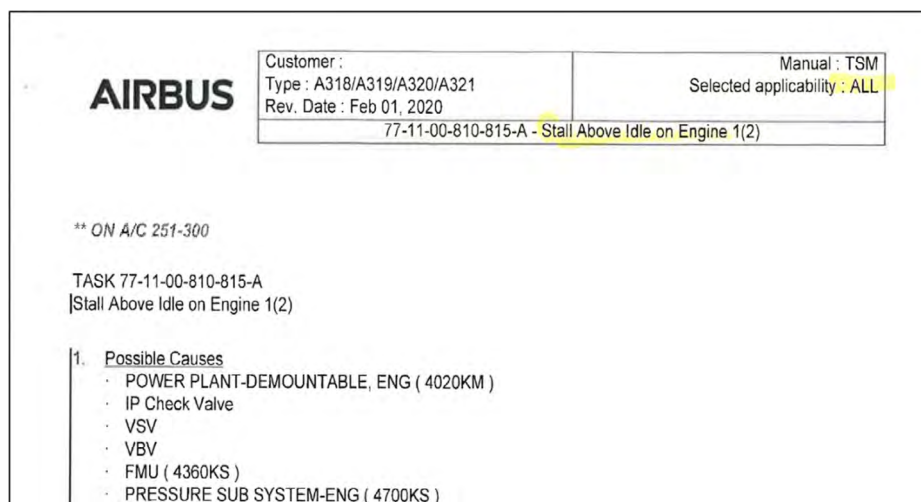
**Figure 15**

Scan of the procedure used by the Line AMO
 (courtesy Airbus)

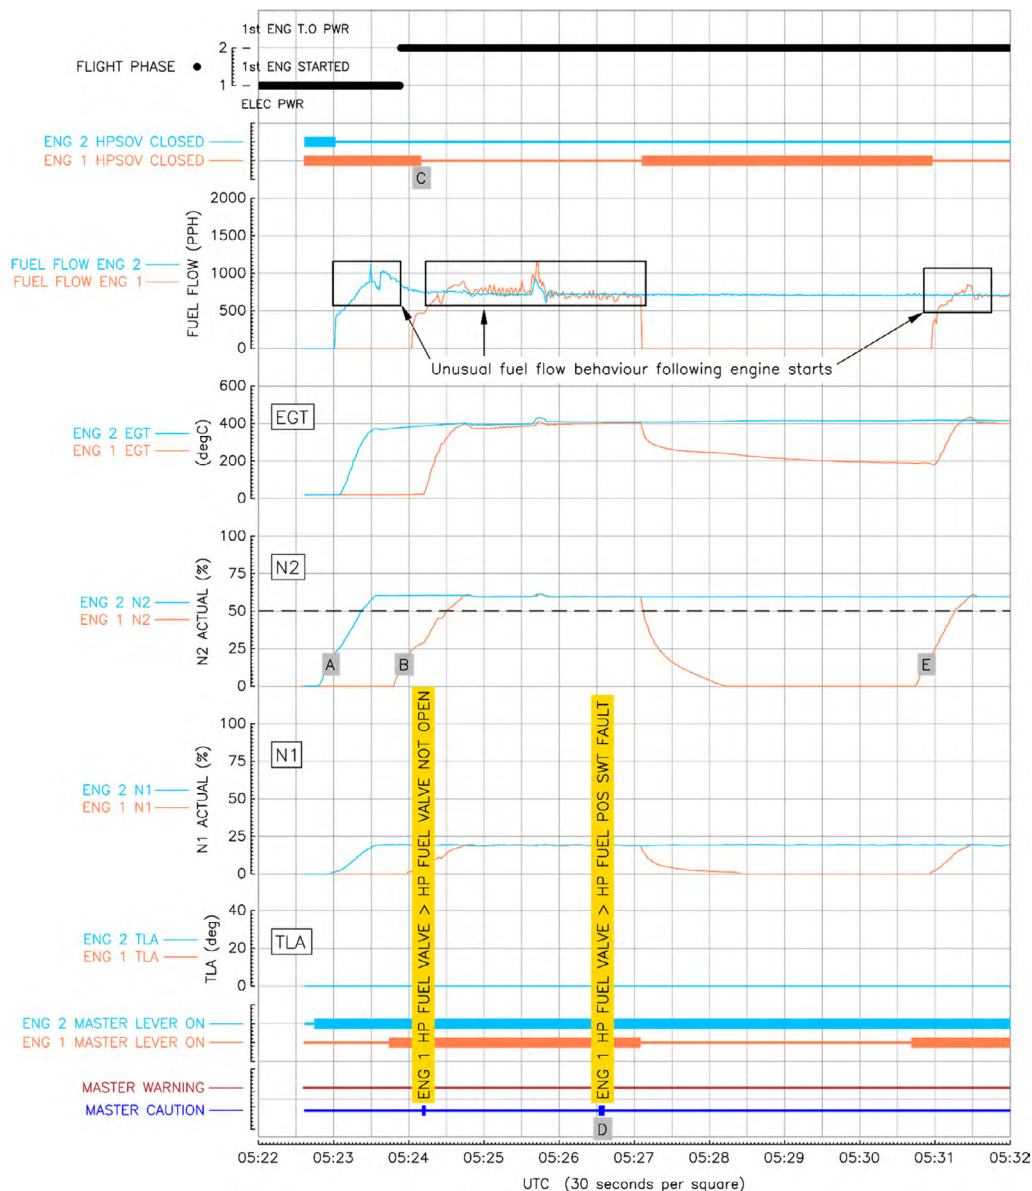
**Figure 18**

Figure 18 plots data for the engine starts for the flight from Stansted to Gatwick. The key points are labelled [A] through [E], the details of which are described in the following bullet points:

48 The aircraft manufacturer determined the nature of the alert from its analysis of the data. The alert indicates that the HP fuel valve failed to open within a defined period.

49 The aircraft manufacturer determined the nature of the alert from its analysis of the data. The alert is generated if the FADEC detects a switch position that is not consistent with the engine state: failed open with the engine below idle (ie $N_2 < \text{about } 60\%$) or failed closed with the engine at or above idle.

Stansted to Gatwick flight engine starts

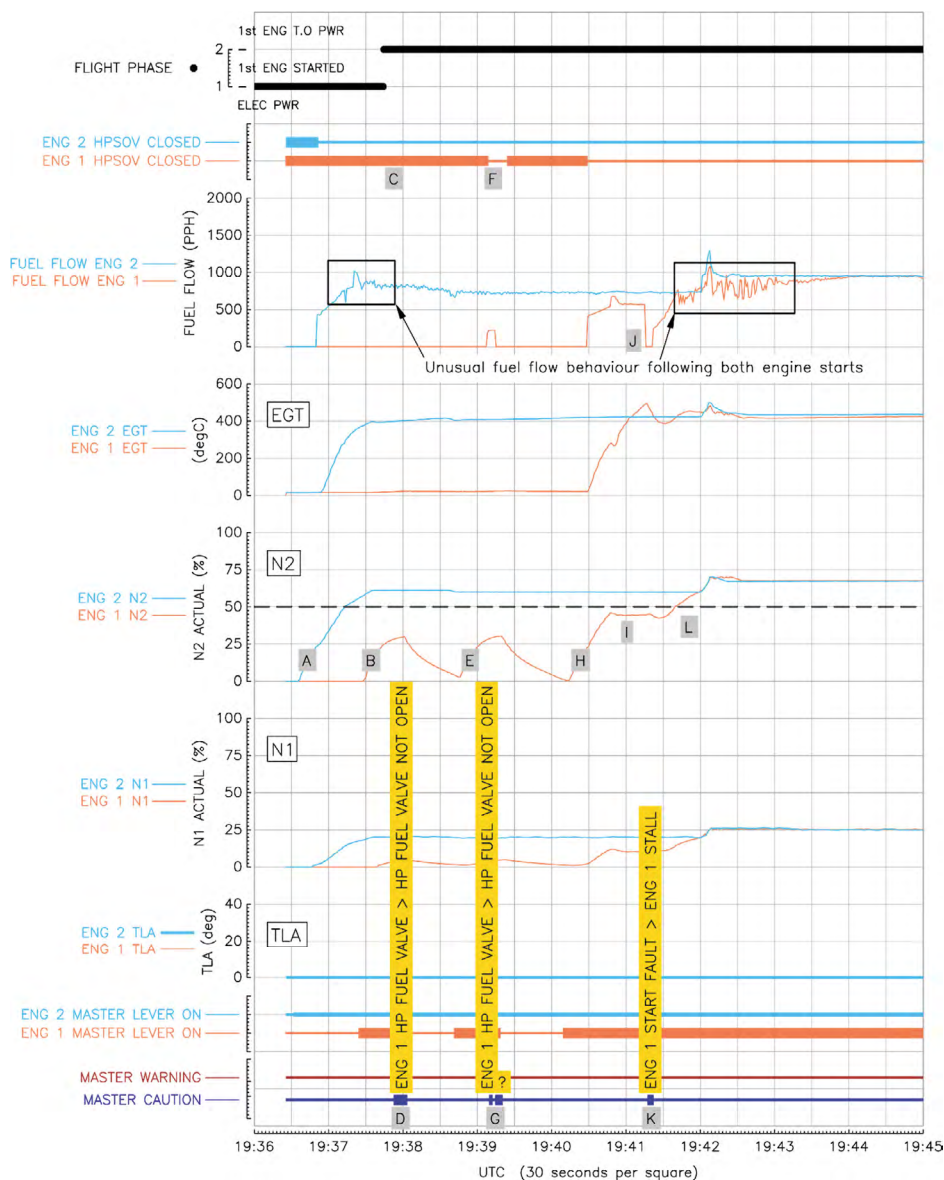
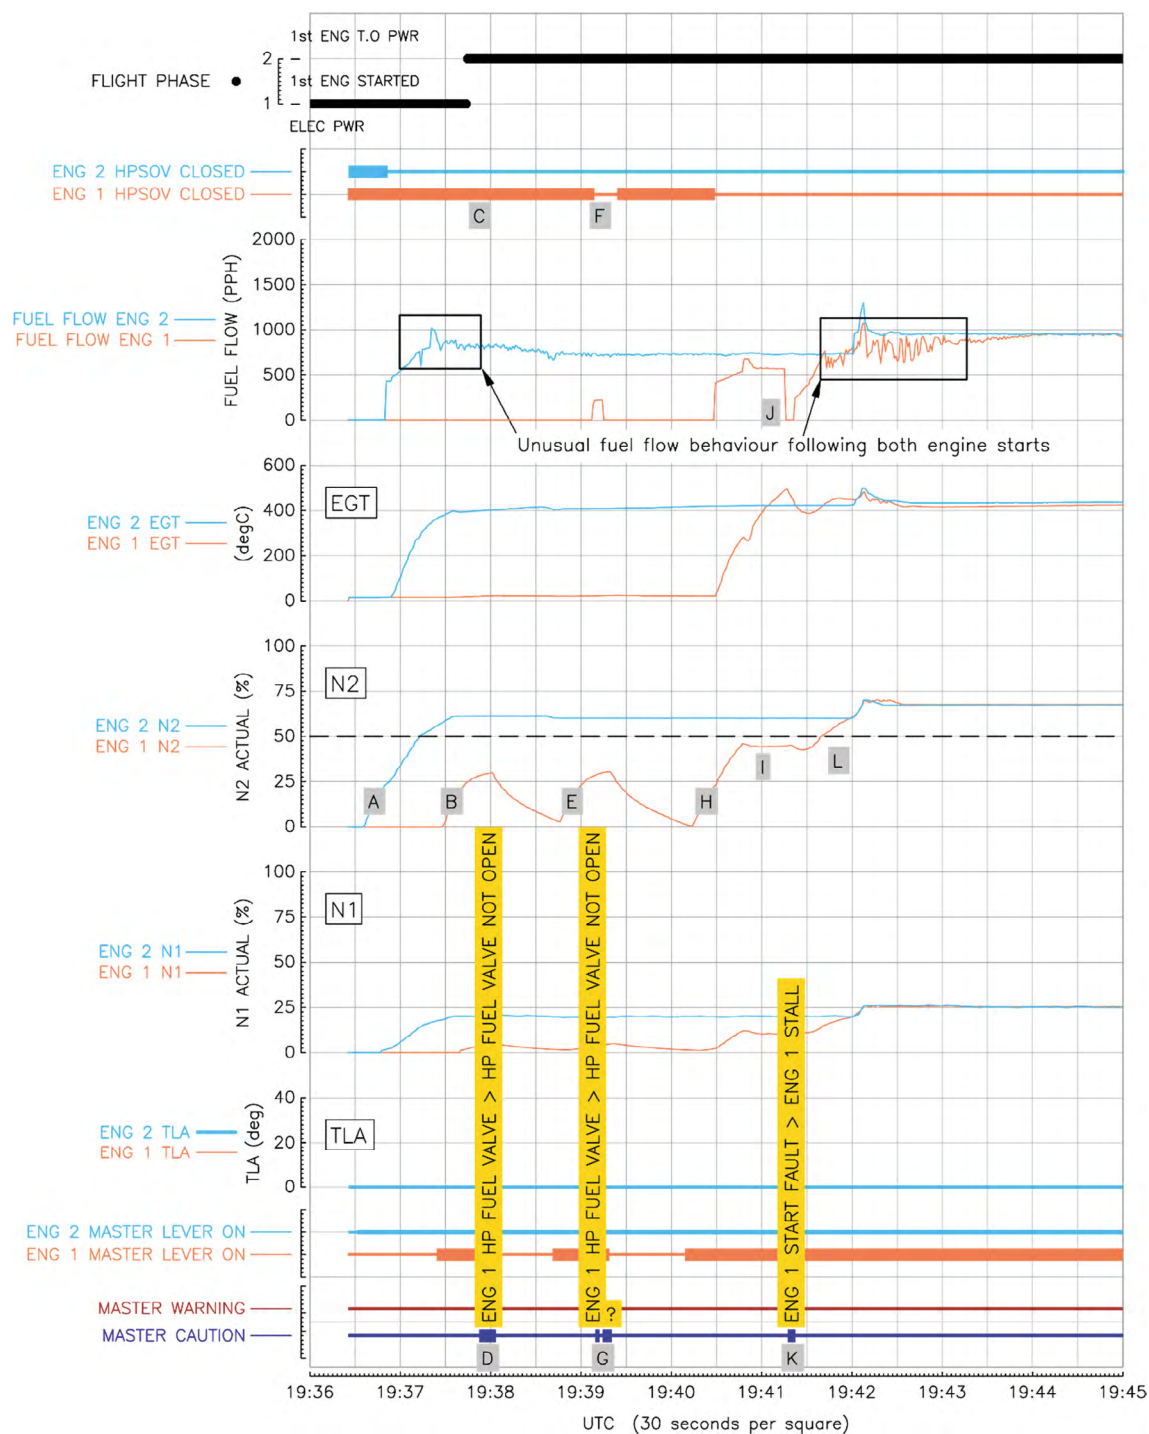
Figure 19 plots data for the engine starts for the flight from Krakow to Gatwick (the penultimate flight before the event flight). The key points are labelled [A] through [L] the details of which are described in the following bullet points:

7. 50 seconds later, by which time the N_1 and N_2 had again dropped to zero, the engine No 1 master switch was moved to ON for another start attempt (third cycle) [H].

8. As N_1 and N_2 increased, the fuel HPSOV opened and fuel began to flow. As the EGT passed about 280°C, the N_1 at about 10% and N_2 at about 46% stopped increasing [I]; however, the EGT continued to rise.

Krakow to Gatwick flight engine starts

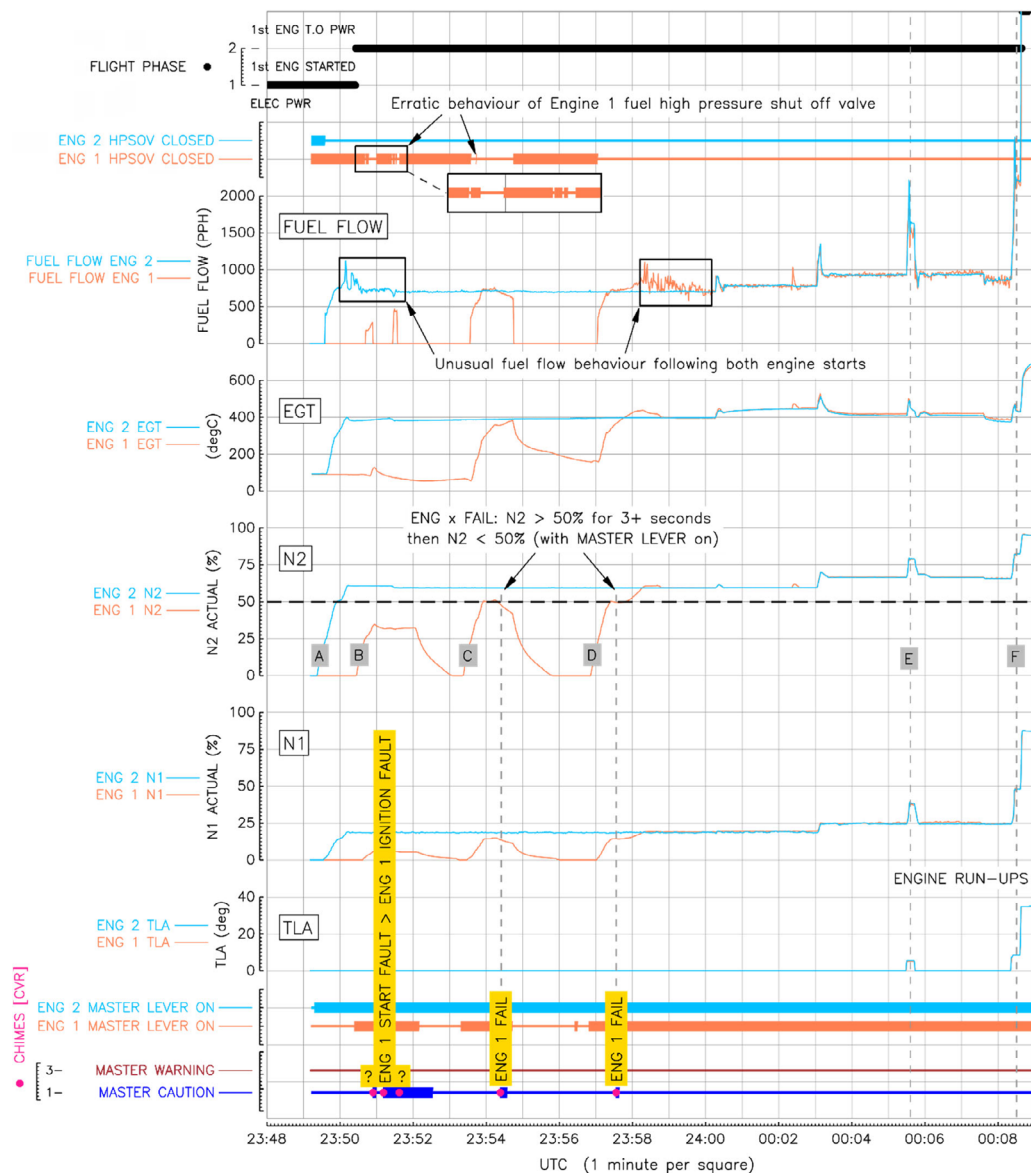
Figure 20 plots data for the engine starts for the event flight. The key points are labelled [A] through [F] the details of which are described in the following bullet points:

A third master caution (reason unknown) was issued 26 seconds after the second as the engine was attempting to start while the HPSOV remained closed (§1.11.3.5). The engine failed to start, and the crew moved the master switch to OFF.

3. Engine No 1 start initiated by the crew [C] (second cycle) during which the N_2 reached just over 50% for at least three seconds before dropping below 50%. This generated an ENG 1 FAIL message alert on the ECAM that prompted the crew to move the master switch to OFF.
4. Engine No 1 start initiated by the crew [D] (third cycle) during which the N_2 reached just over 50% for at least three seconds before dropping below 50%. This again generated an ENG 1 FAIL message alert on the ECAM, and just as the crew were about to move the master switch to OFF, the N_2 began to increase. The engine started successfully; however, the fuel flow exhibited unusual behaviour (highlighted) following the start compared to the normal behaviour.
5. Engine run ups were made to about 40% N_1 [E] at the runway holding point and to about 50% N_1 [F] just before takeoff.

Incident flight engine starts

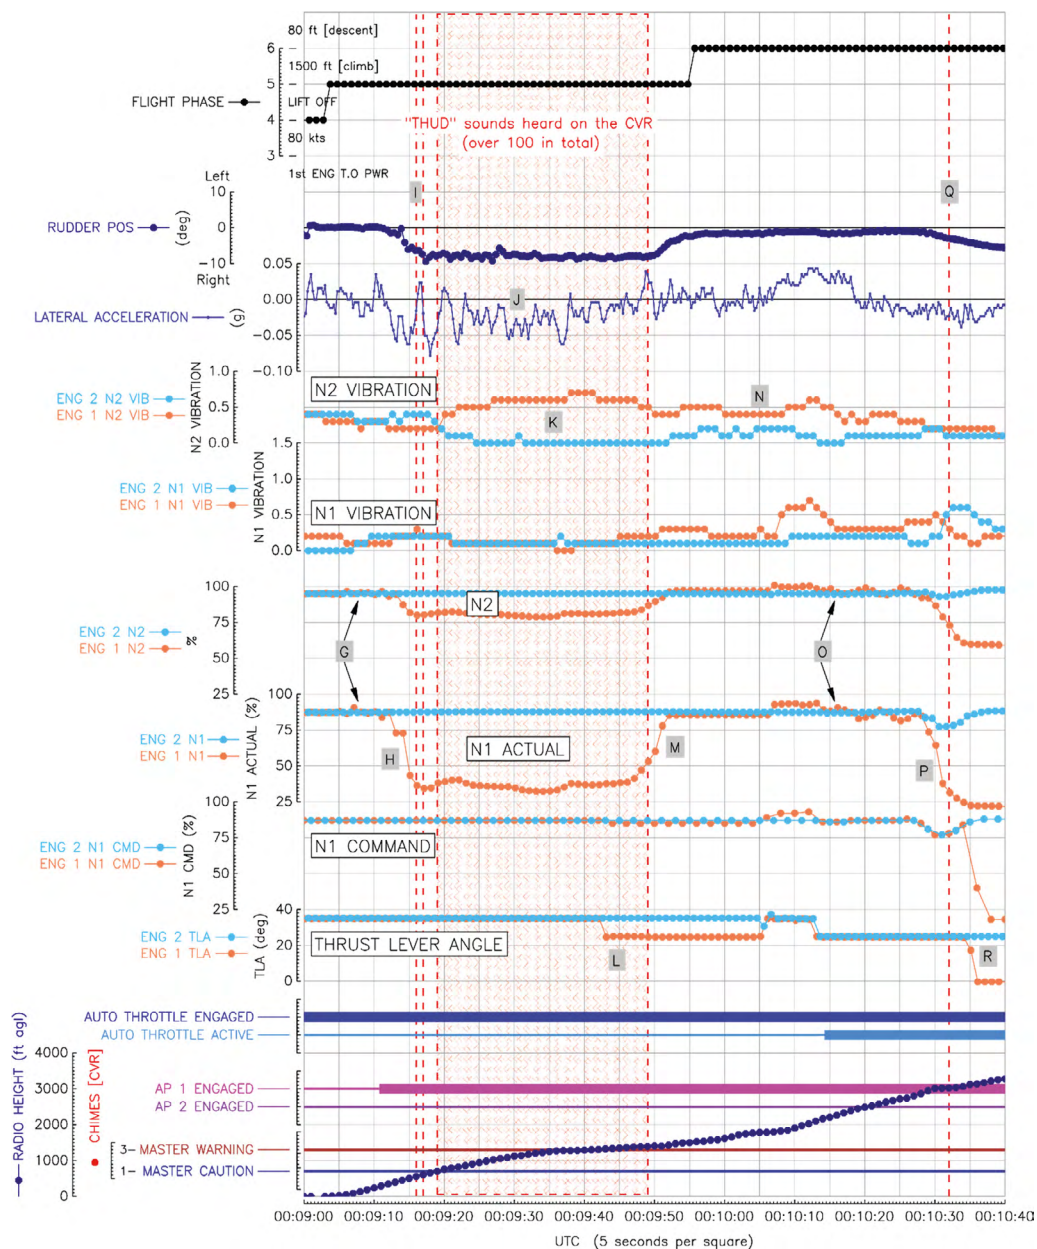
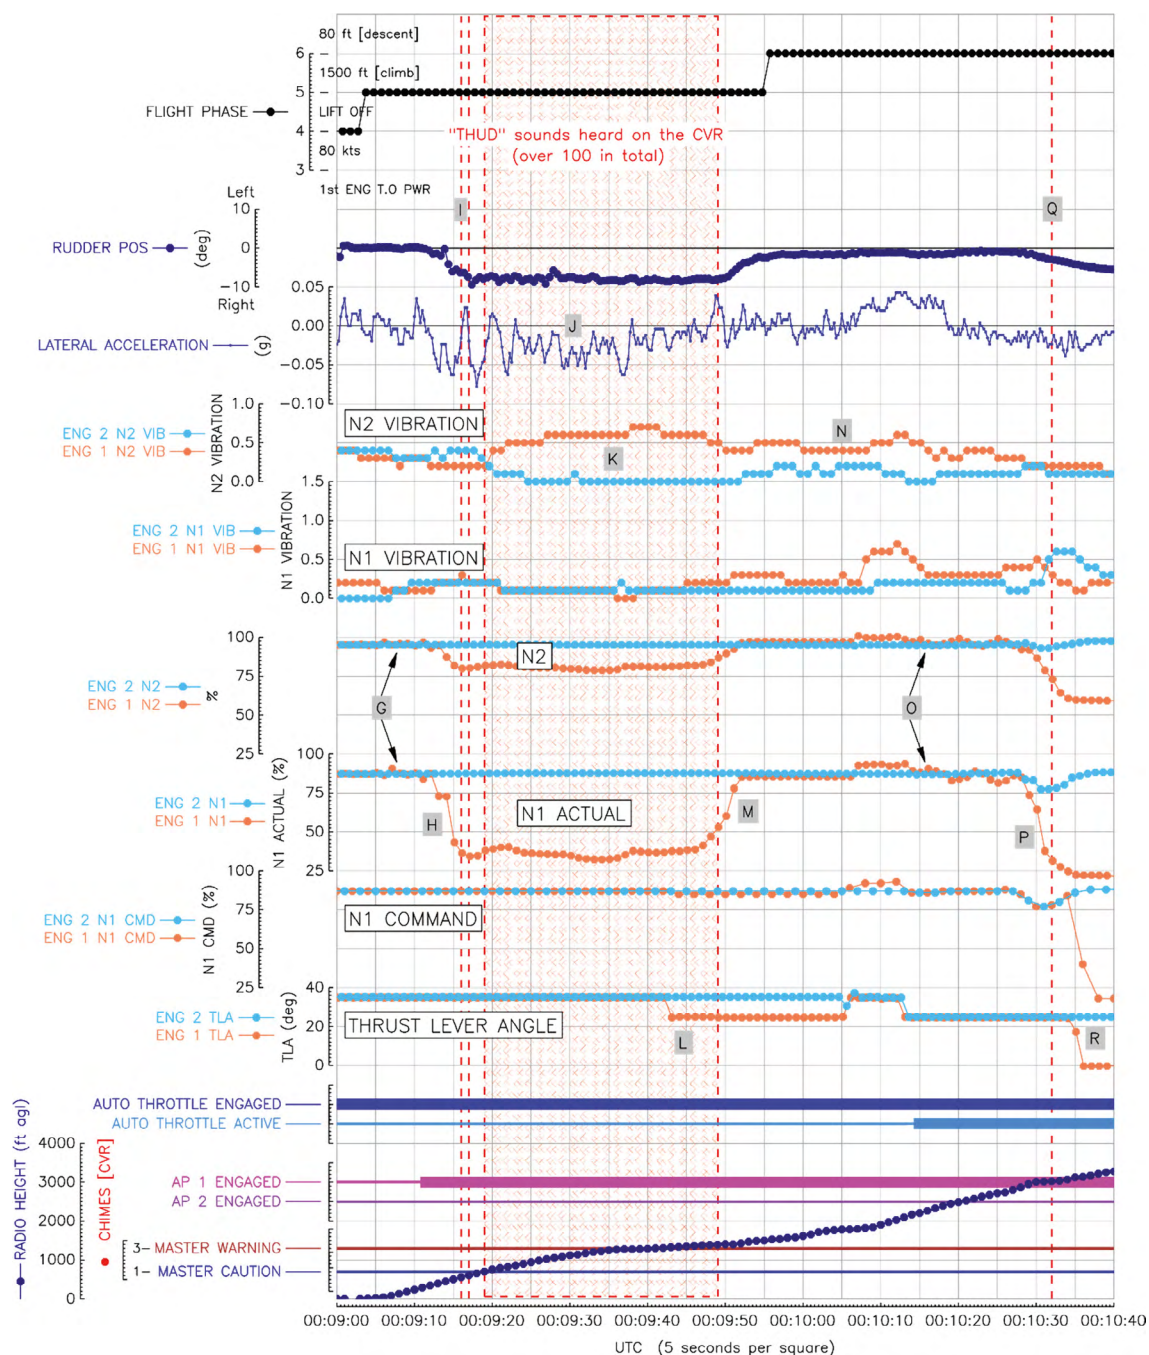
Figure 21

Figures 21 and 22 are an overview of the engine No 1 surge and the engine No 2 stall events during the incident flight. Again, note that the engine parameters are recorded once per second so transient behaviour of the engines is not captured. Also, during the downwind leg of the flight (Figure 22), of the 11 master cautions that were issued and heard on the CVR, only those relating to ECAM fault alerts are highlighted. The other master cautions relate to ECAM alerts providing operational information to the crew which are not recorded (§1.11.3). There were no master cautions issued during the climb phase (Figure 21) when the No 1 engine surged. This was because not all

Figure 21:

Overview of flight data from the incident (plot 1 of 2)

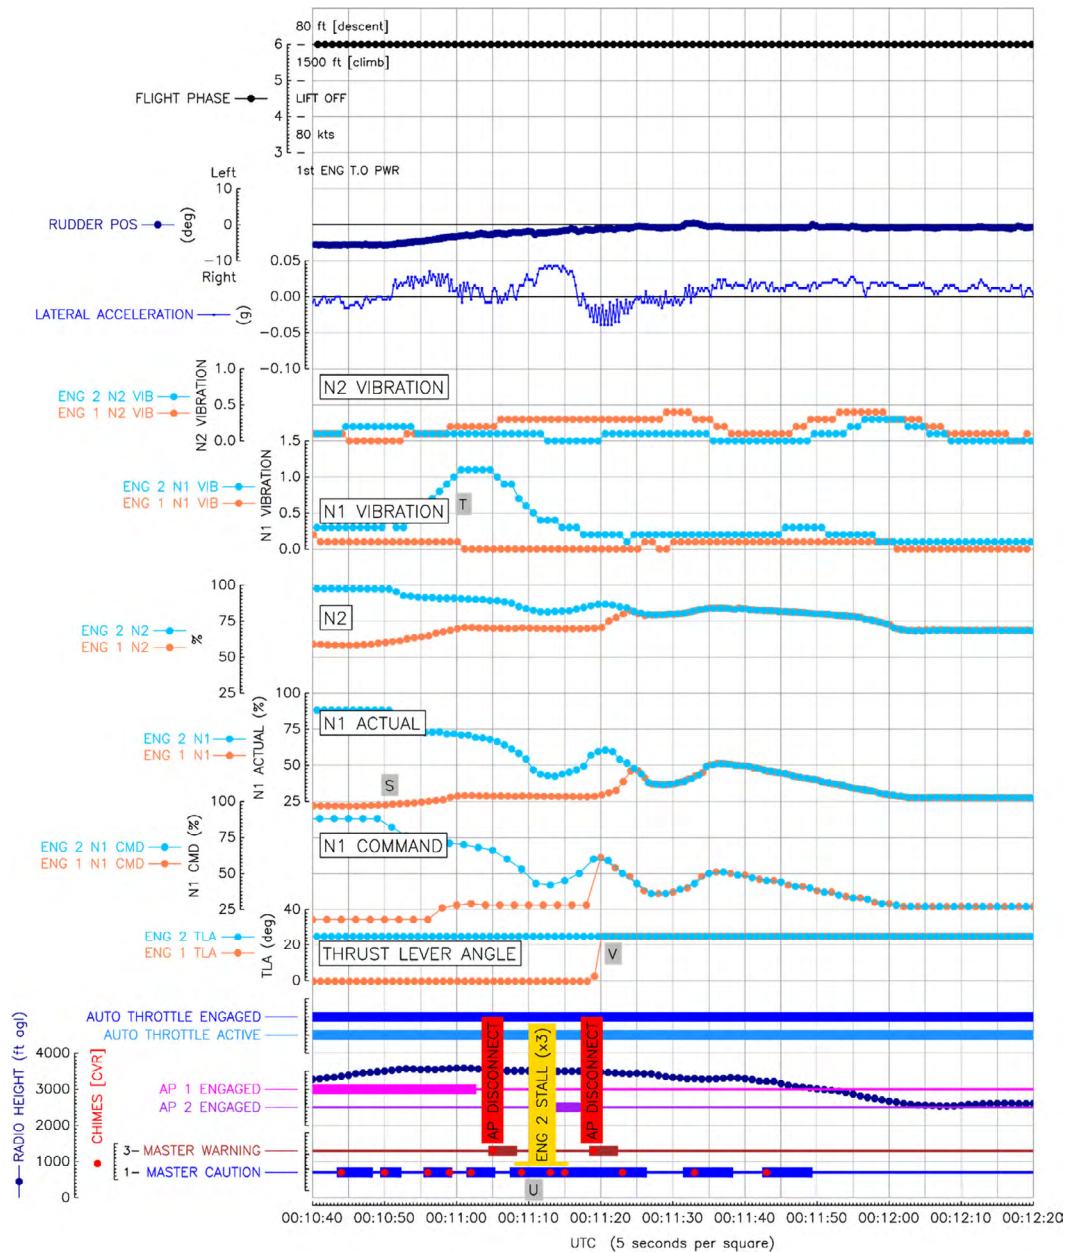
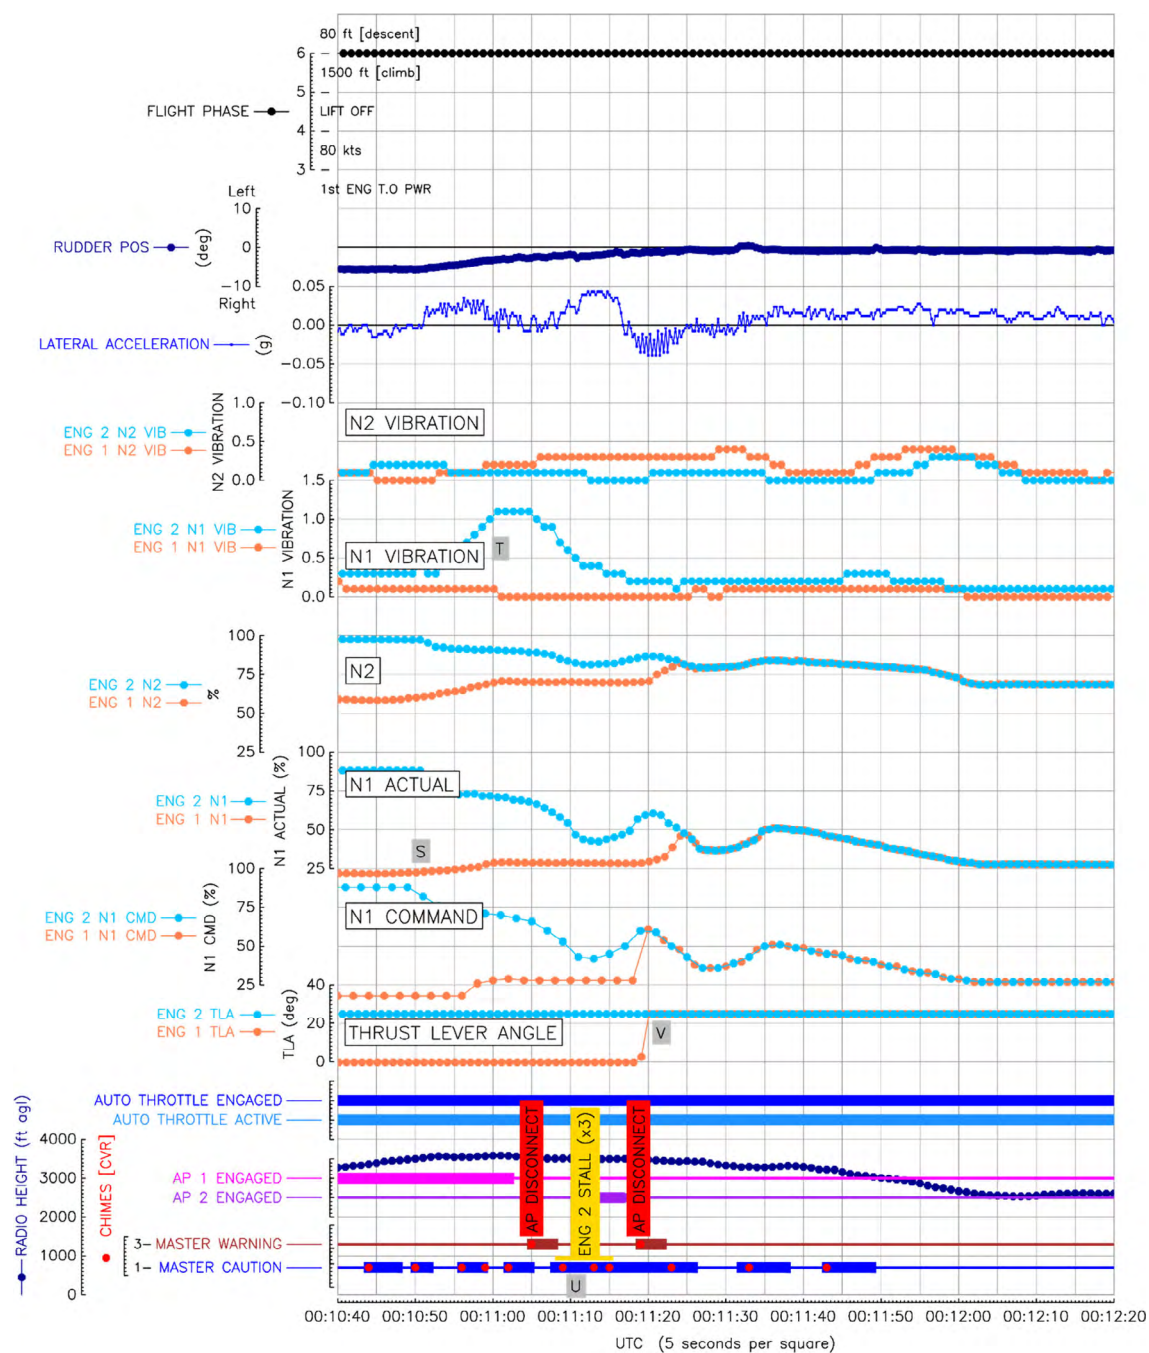
Figure 22

Figure 22:

14. As the engine No 2 N_1 vibration started to decrease back below 1.0, the first of three master cautions were issued corresponding to ENG 2 STALL message alerts on the ECAM [U]. The three alerts all happened within six seconds of each other. Autopilot 2 engaged shortly after the first engine stall alert and disengaged about three seconds after the third engine stall alert.

15. The engine No 1 throttle lever was returned to the position of the No 2 engine throttle lever [V]. The engine No 1 responded within a couple of seconds to match the N_1 and N_2 of engine No 2. No further engine events were recorded for the airborne portion of the flight.

Overview of incident flight data (plot 2 of 2)

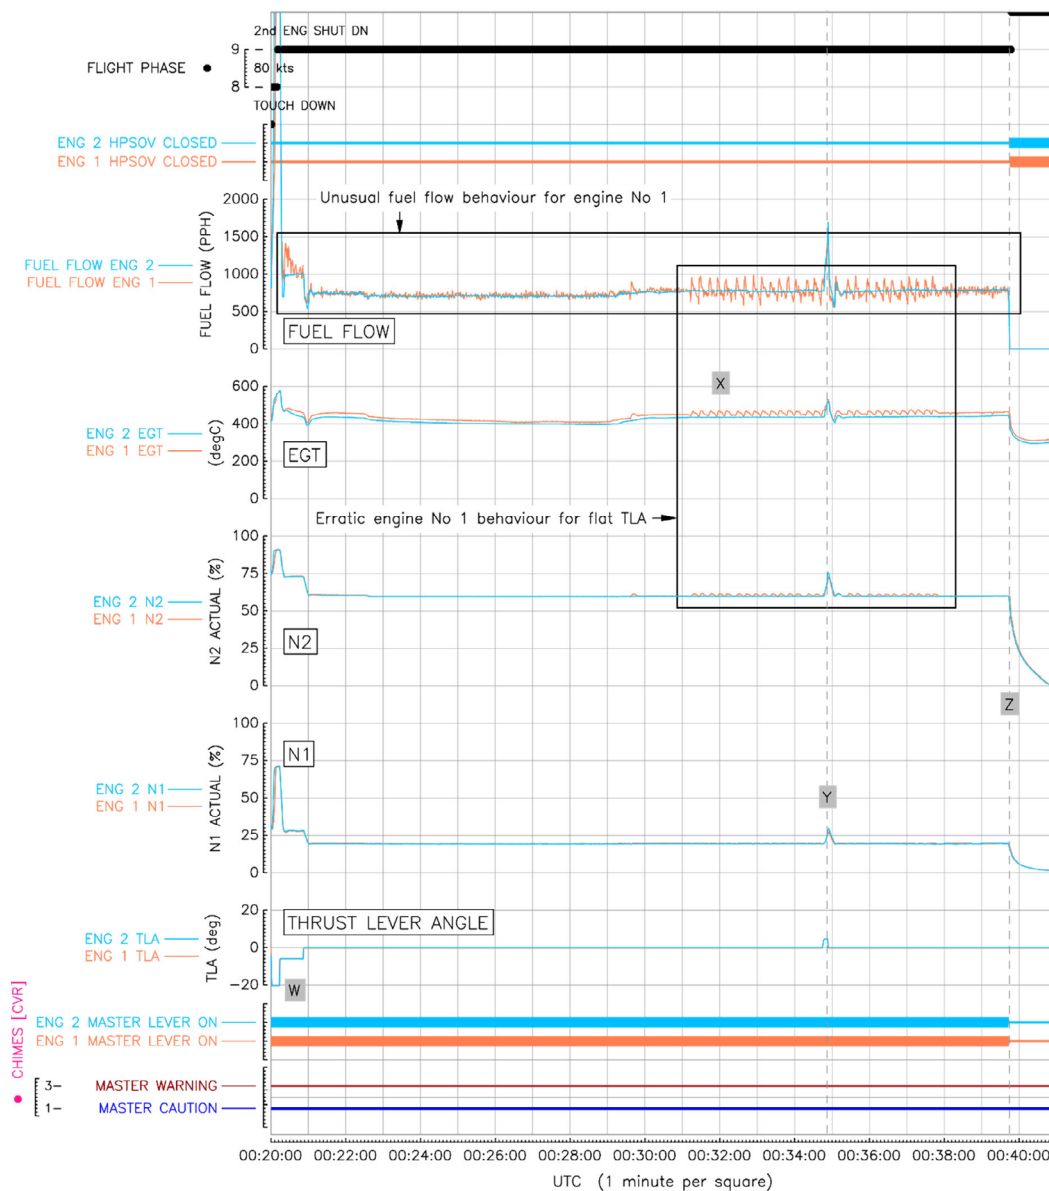
After stopping, Crew A noted the engine parameters seemed normal; however, the airport rescue and firefighting service (ARFFS) attending the aircraft heard unusual engine noises. Therefore, Crew A shut down both engines on the adjacent taxiway.

Figure 23 plots data for the engines post the event flight just prior to engine shutdown.

Post incident flight engine behaviour

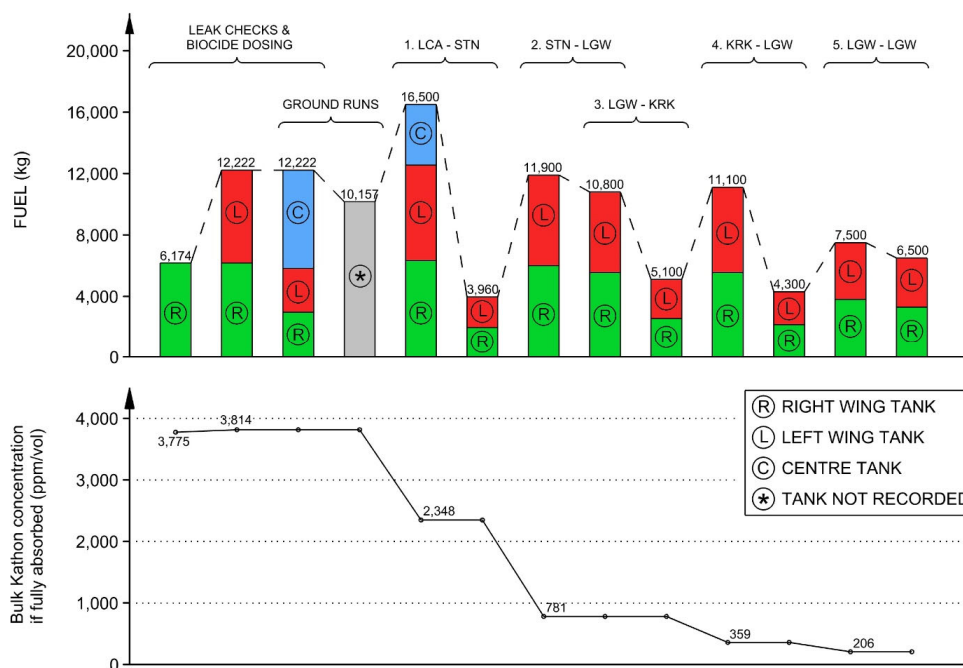
Records of the fuel uplifts, transfers between tanks and recorded fuel-on-board figures at the start and end of each flight sector were analysed to produce the data presented in Figure 36.

Research⁵⁷ has shown that dipropylene glycol, which forms 90% of the Kathon product, is soluble in Jet A fuel up to limiting values of between 6,600 ppm/vol at 5°C and 11,000 ppm/vol at 22°C. Figure 36 also shows the maximum Kathon concentration, in ppm/vol, if all the Kathon added during the biocide treatment had been fully mixed in the fuel.

Fuel quantity records and maximum possible Kathon concentration if it had been fully mixed
