AIRCRAFT ACCIDENT REPORT 1/2021

Report on the serious incident to
Airbus A321-211, G-POWN
at London Gatwick Airport
on 26 February 2020

Air Accidents Investigation Branch

Report on the serious incident to
Airbus A321-211, registration G-POWN
at London Gatwick Airport
on 26 February 2020

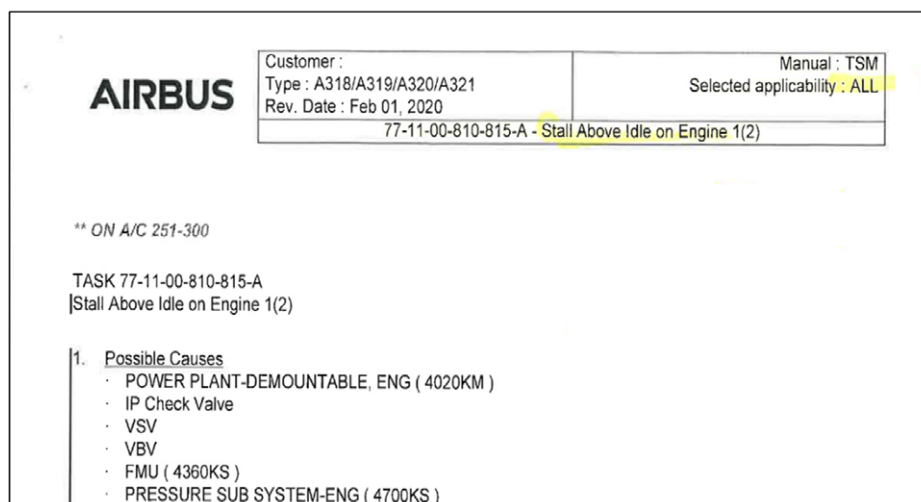
**Figure 15**

When a procedure was displayed on the screen within the AirN@v application, the fleet serial number was highlighted in red near the top (Figure 14). The custom at the Line AMO was to print a black and white PDF export of the procedure to use during the maintenance task. When printed, the first page of the procedure appeared as shown in Figure 15. The fleet serial number was grey and there was no identification on any page of the engine type the procedure applied to.

Scan of the procedure used by the Line AMO
(courtesy Airbus)

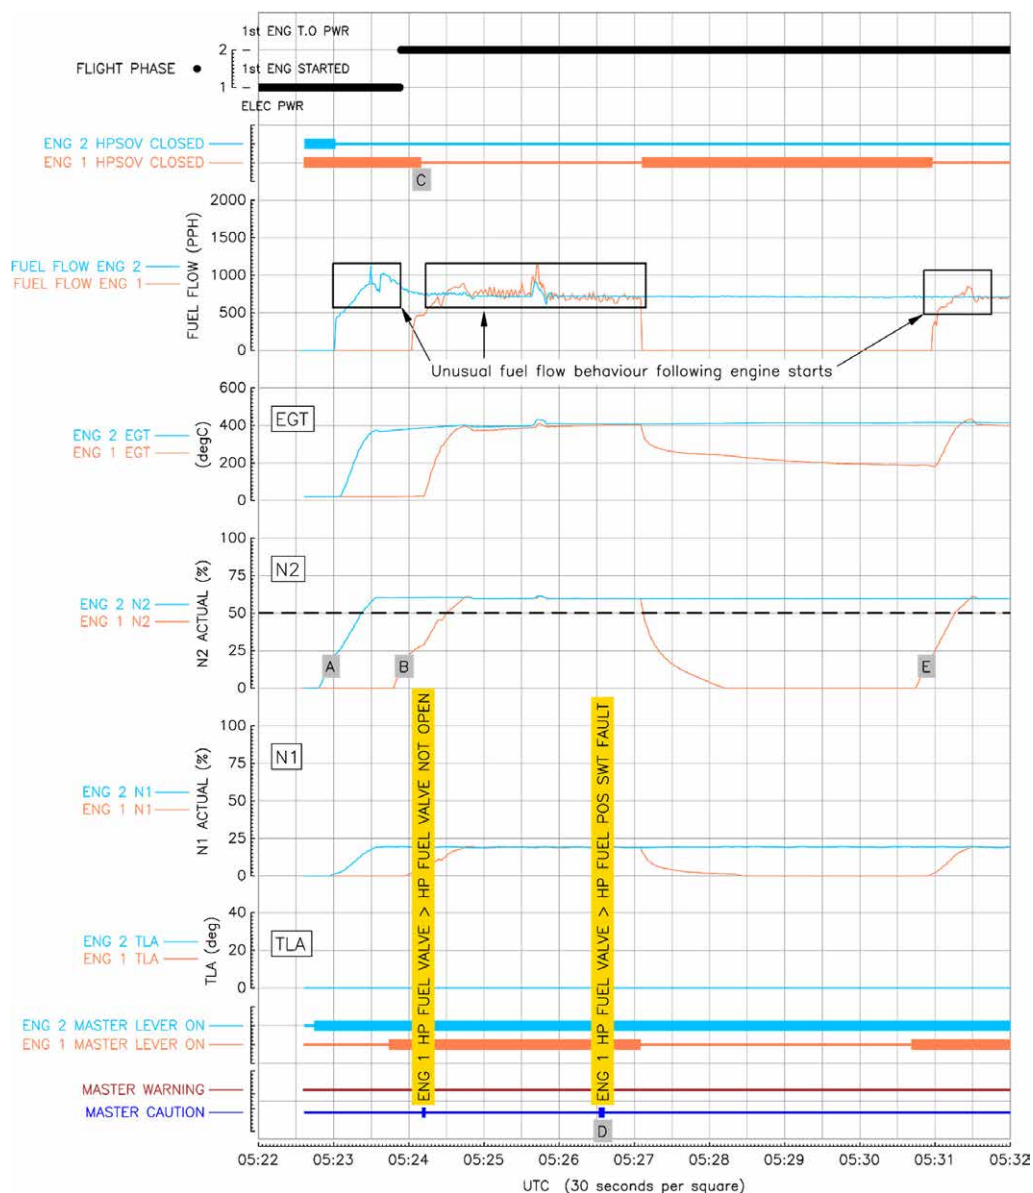
**Figure 18**

Figure 18 plots data for the engine starts for the flight from Stansted to Gatwick. The key points are labelled [A] through [E], the details of which are described in the following bullet points:

Stansted to Gatwick flight engine starts

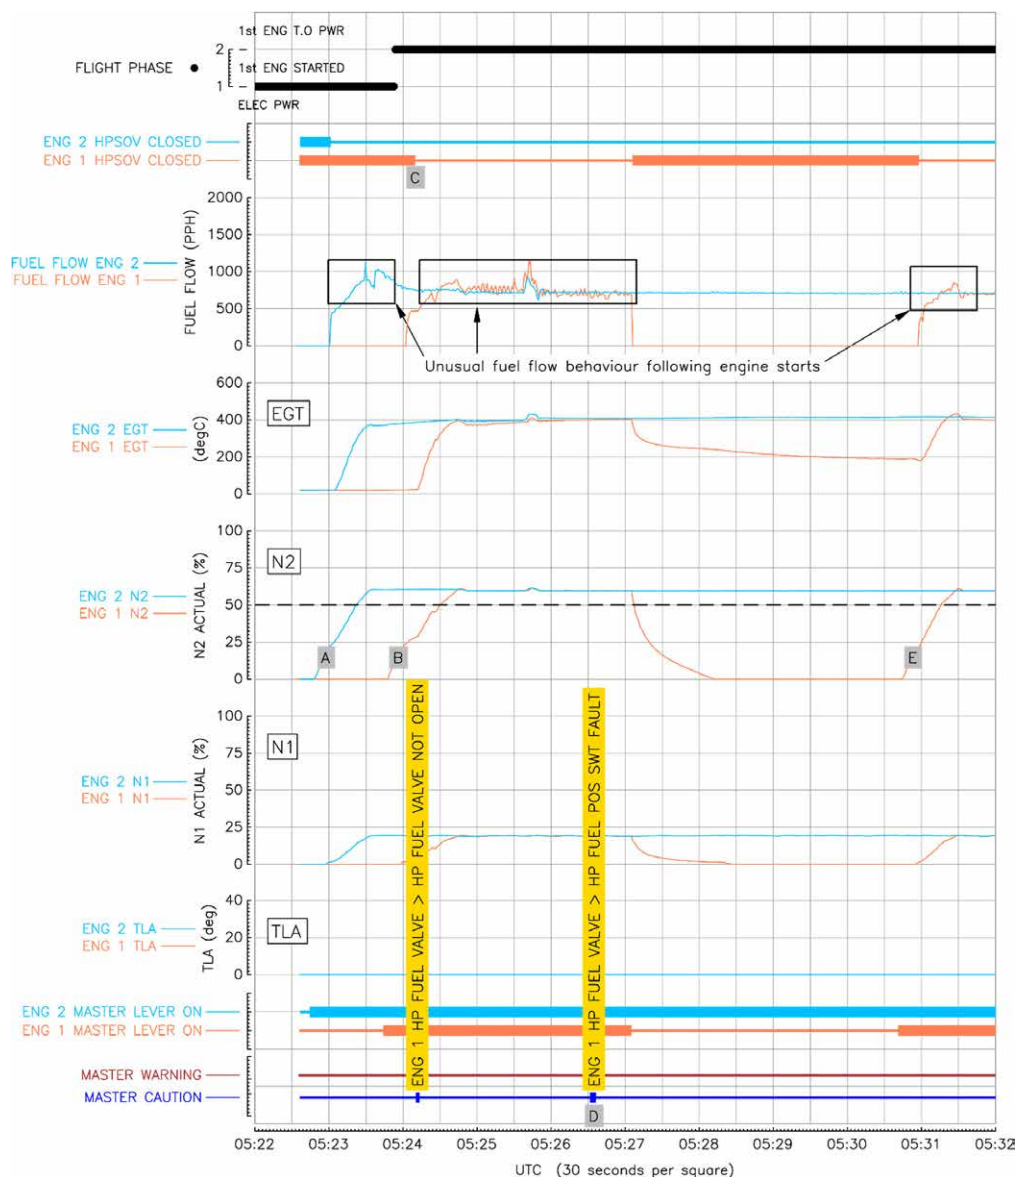
Figure 19 plots data for the engine starts for the flight from Krakow to Gatwick (the penultimate flight before the event flight). The key points are labelled [A] through [L] the details of which are described in the following bullet points:

7. 50 seconds later, by which time the N_1 and N_2 had again dropped to zero, the engine No 1 master switch was moved to ON for another start attempt (third cycle) [H].

8. As N_1 and N_2 increased, the fuel HPSOV opened and fuel began to flow. As the EGT passed about 280°C, the N_1 at about 10% and N_2 at about 46% stopped increasing [I]; however, the EGT continued to rise.

Krakow to Gatwick flight engine starts

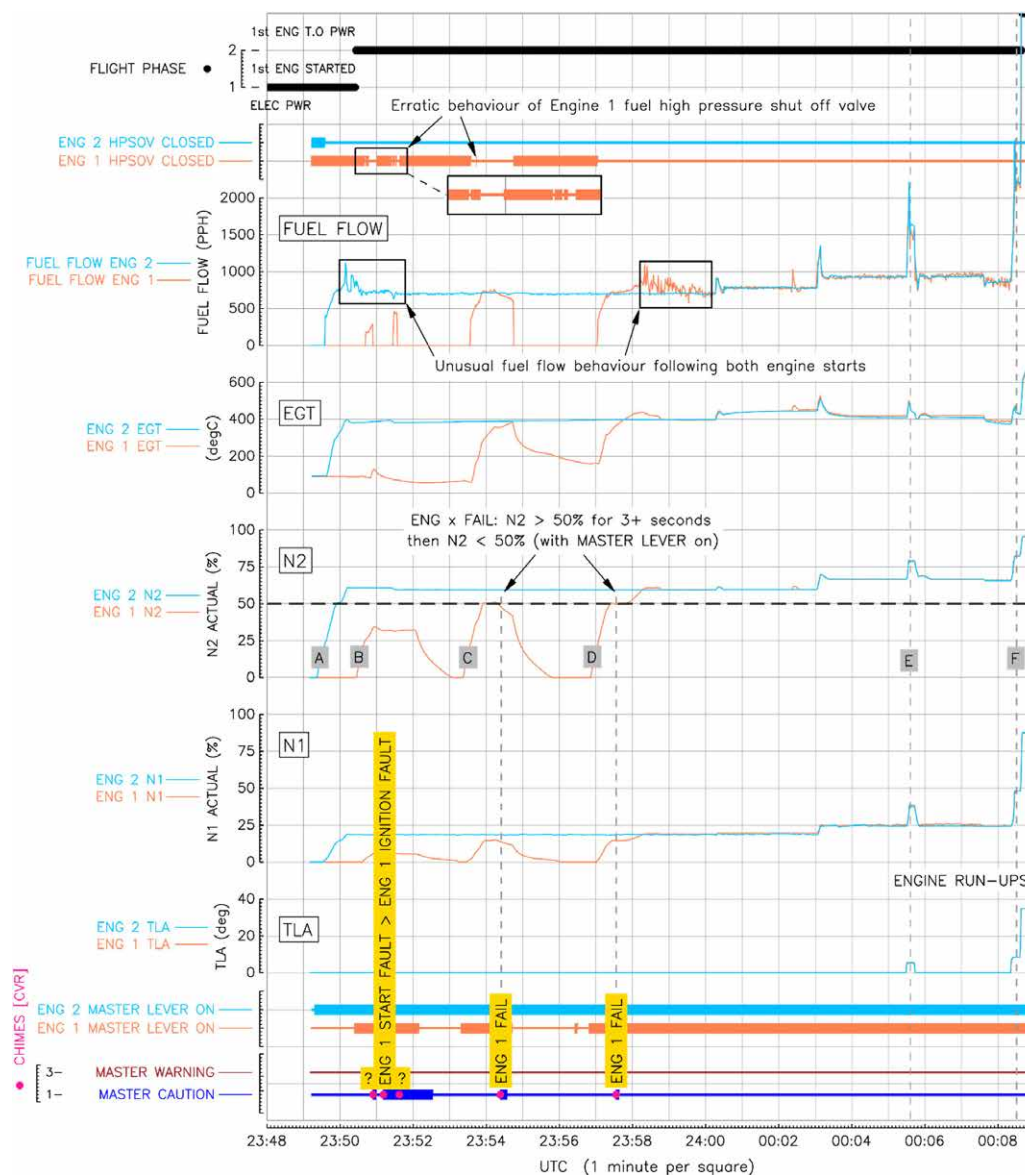
Figure 20 plots data for the engine starts for the event flight. The key points are labelled [A] through [F] the details of which are described in the following bullet points:

A third master caution (reason unknown) was issued 26 seconds after the second as the engine was attempting to start while the HPSOV remained closed (§1.11.3.5). The engine failed to start, and the crew moved the master switch to OFF.

3. Engine No 1 start initiated by the crew [C] (second cycle) during which the N_2 reached just over 50% for at least three seconds before dropping below 50%. This generated an ENG 1 FAIL message alert on the ECAM that prompted the crew to move the master switch to OFF.
4. Engine No 1 start initiated by the crew [D] (third cycle) during which the N_2 reached just over 50% for at least three seconds before dropping below 50%. This again generated an ENG 1 FAIL message alert on the ECAM, and just as the crew were about to move the master switch to OFF, the N_2 began to increase. The engine started successfully; however, the fuel flow exhibited unusual behaviour (highlighted) following the start compared to the normal behaviour.
5. Engine run ups were made to about 40% N_1 [E] at the runway holding point and to about 50% N_1 [F] just before takeoff.

Incident flight engine starts

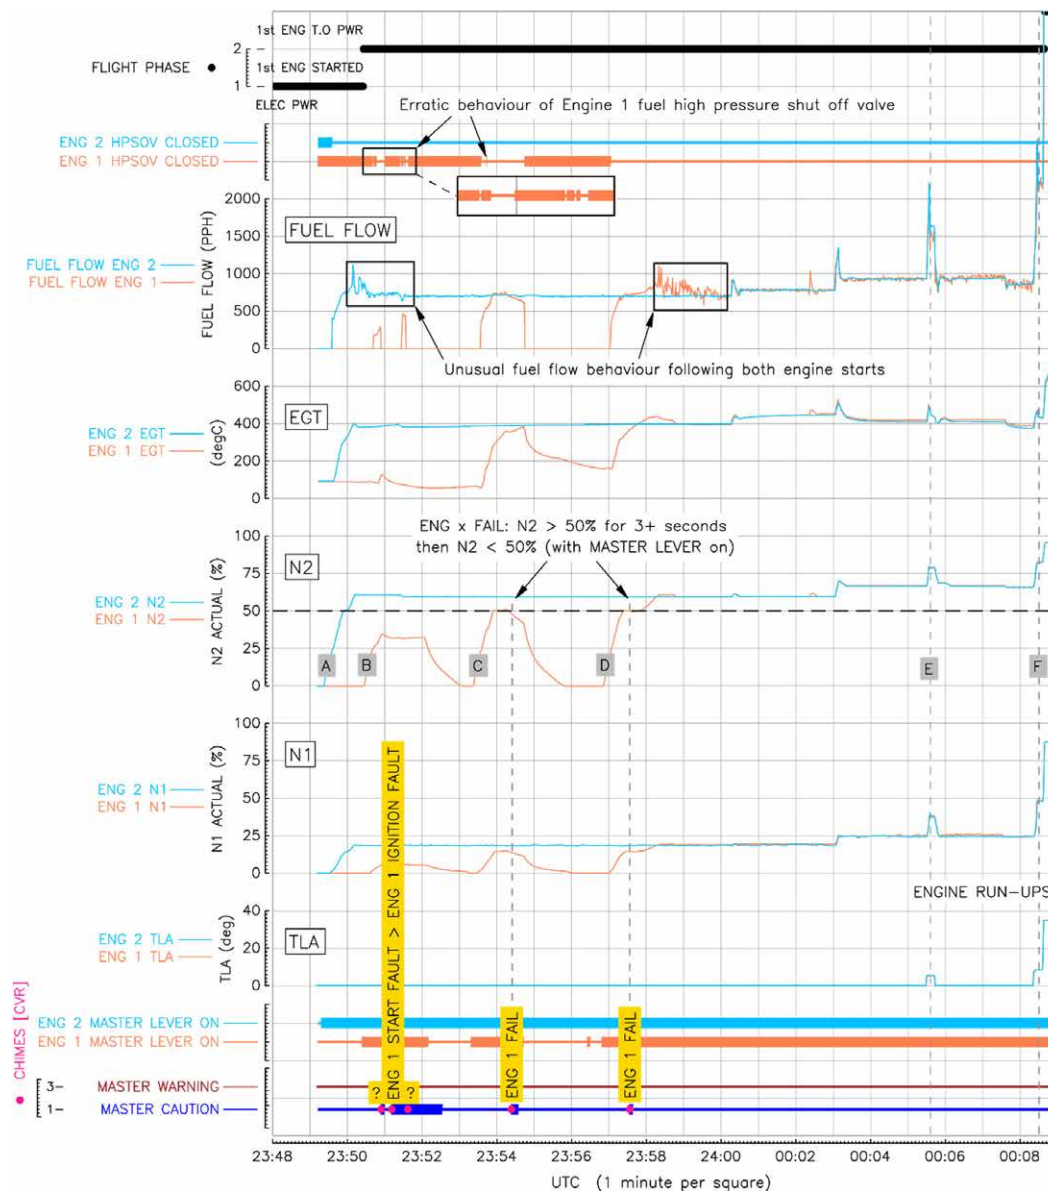
Figure 21

Figures 21 and 22 are an overview of the engine No 1 surge and the engine No 2 stall events during the incident flight. Again, note that the engine parameters are recorded once per second so transient behaviour of the engines is not captured. Also, during the downwind leg of the flight (Figure 22), of the 11 master cautions that were issued and heard on the CVR, only those relating to ECAM fault alerts are highlighted. The other master cautions relate to ECAM alerts providing operational information to the crew which are not recorded (§1.11.3). There were no master cautions issued during the climb phase (Figure 21) when the No 1 engine surged. This was because not all

Overview of incident flight data (plot 1 of 2)

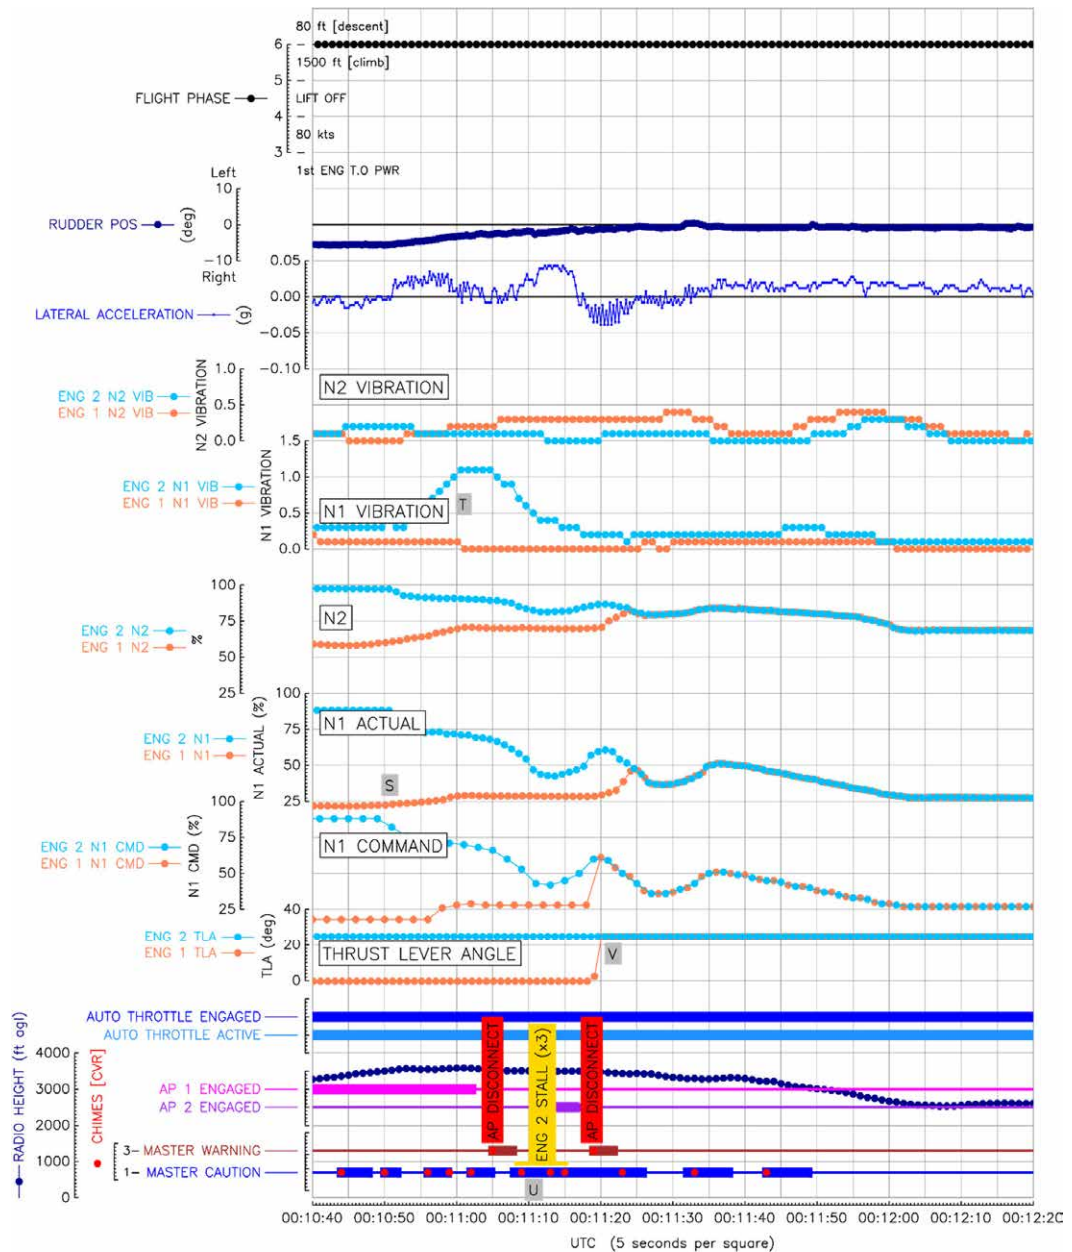
Figure 22

14. As the engine No 2 N_1 vibration started to decrease back below 1.0, the first of three master cautions were issued corresponding to ENG 2 STALL message alerts on the ECAM [U]. The three alerts all happened within six seconds of each other. Autopilot 2 engaged shortly after the first engine stall alert and disengaged about three seconds after the third engine stall alert.

15. The engine No 1 throttle lever was returned to the position of the No 2 engine throttle lever [V]. The engine No 1 responded within a couple of seconds to match the N_1 and N_2 of engine No 2. No further engine events were recorded for the airborne portion of the flight.

Overview of incident flight data (plot 2 of 2)

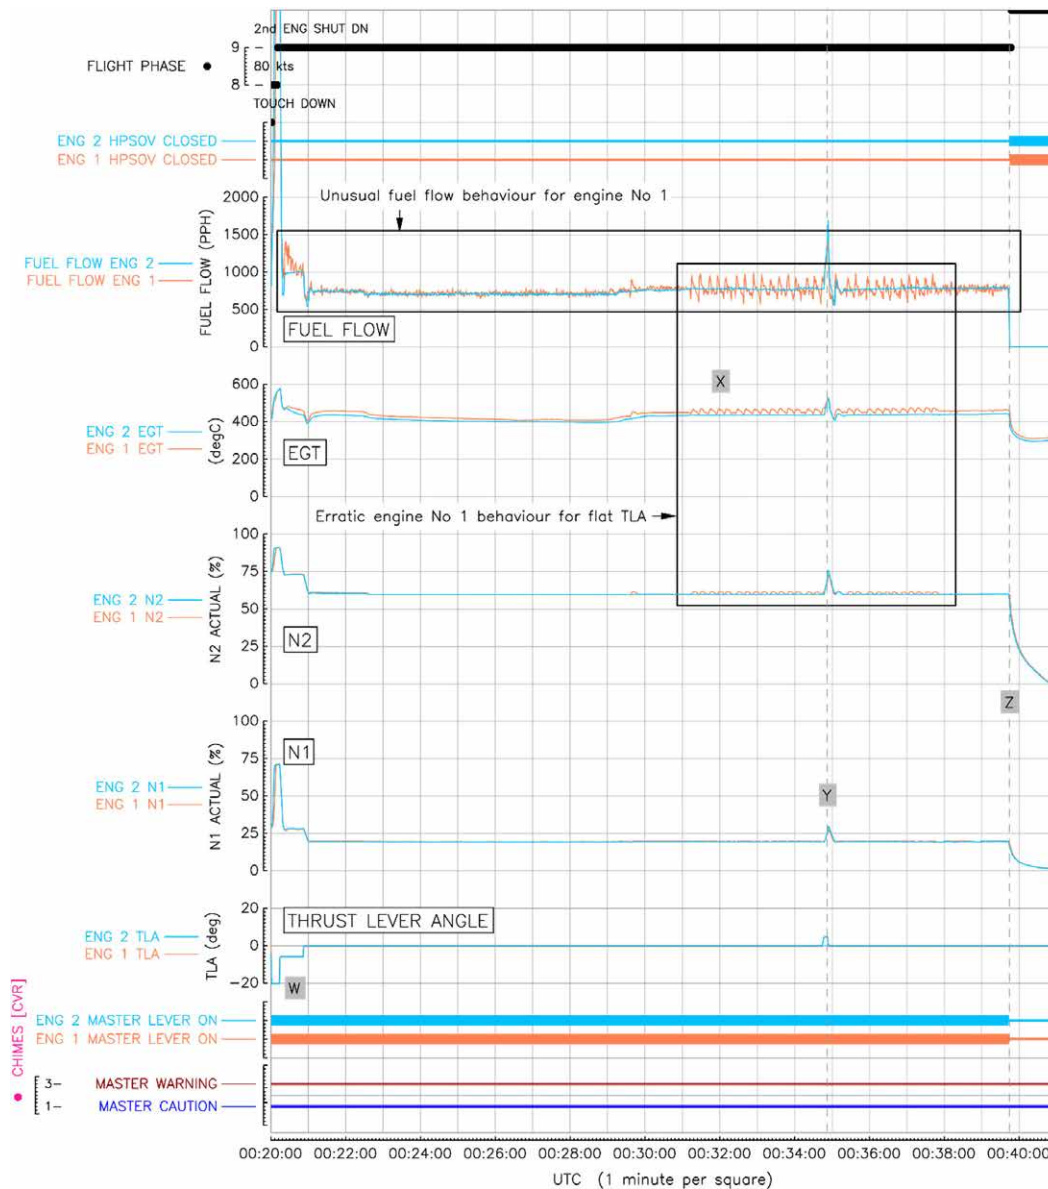
Figure 23 plots data for the engines post the event flight just prior to engine shutdown.

Post incident flight engine behaviour
