Report on the investigation of the
fatal accident to a crew member on board
the scallop dredger

Olivia Jean (TN35)

north-east of Aberdeen, Scotland

28 June 2019

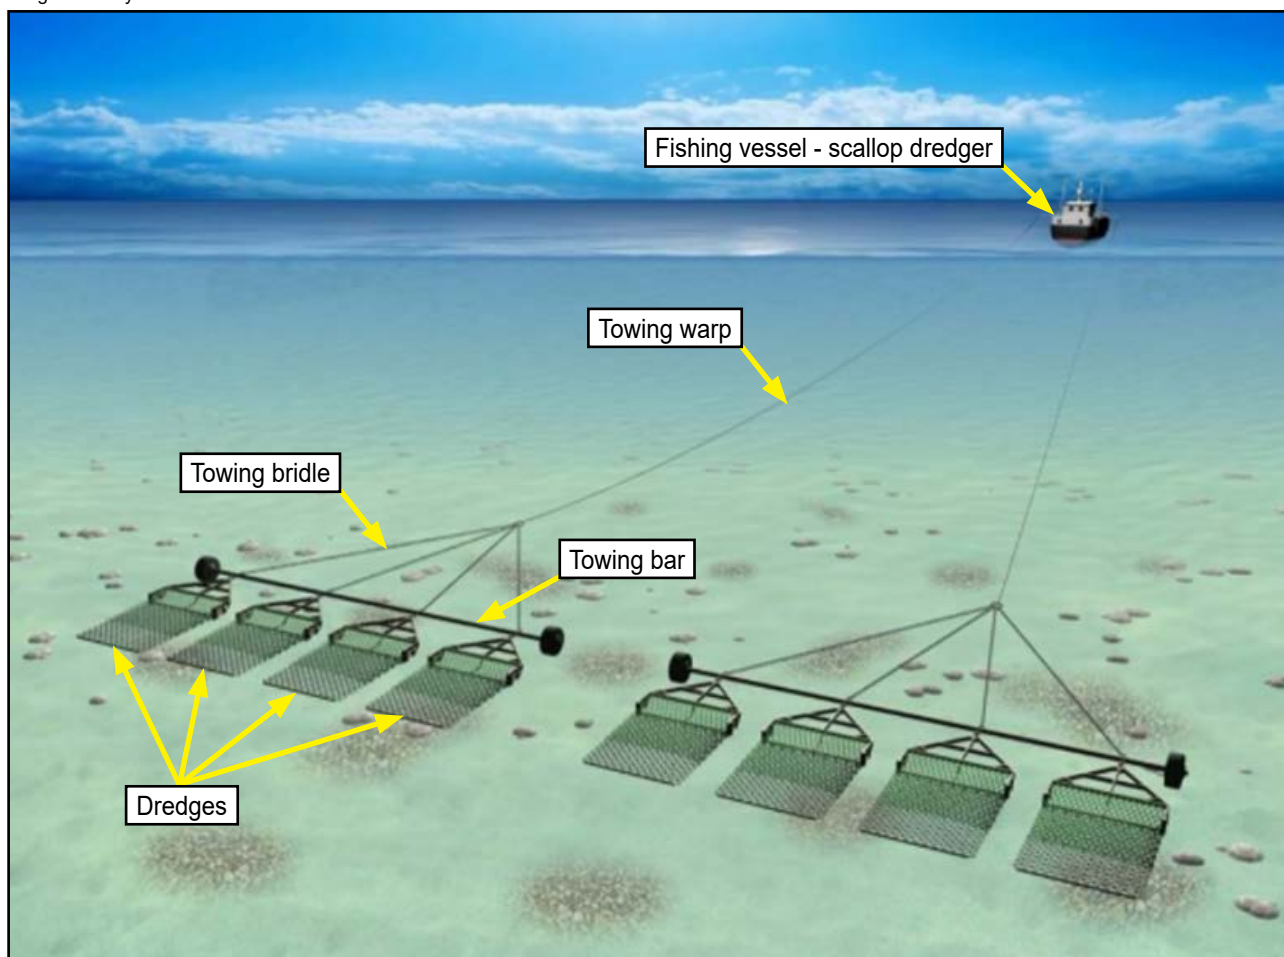
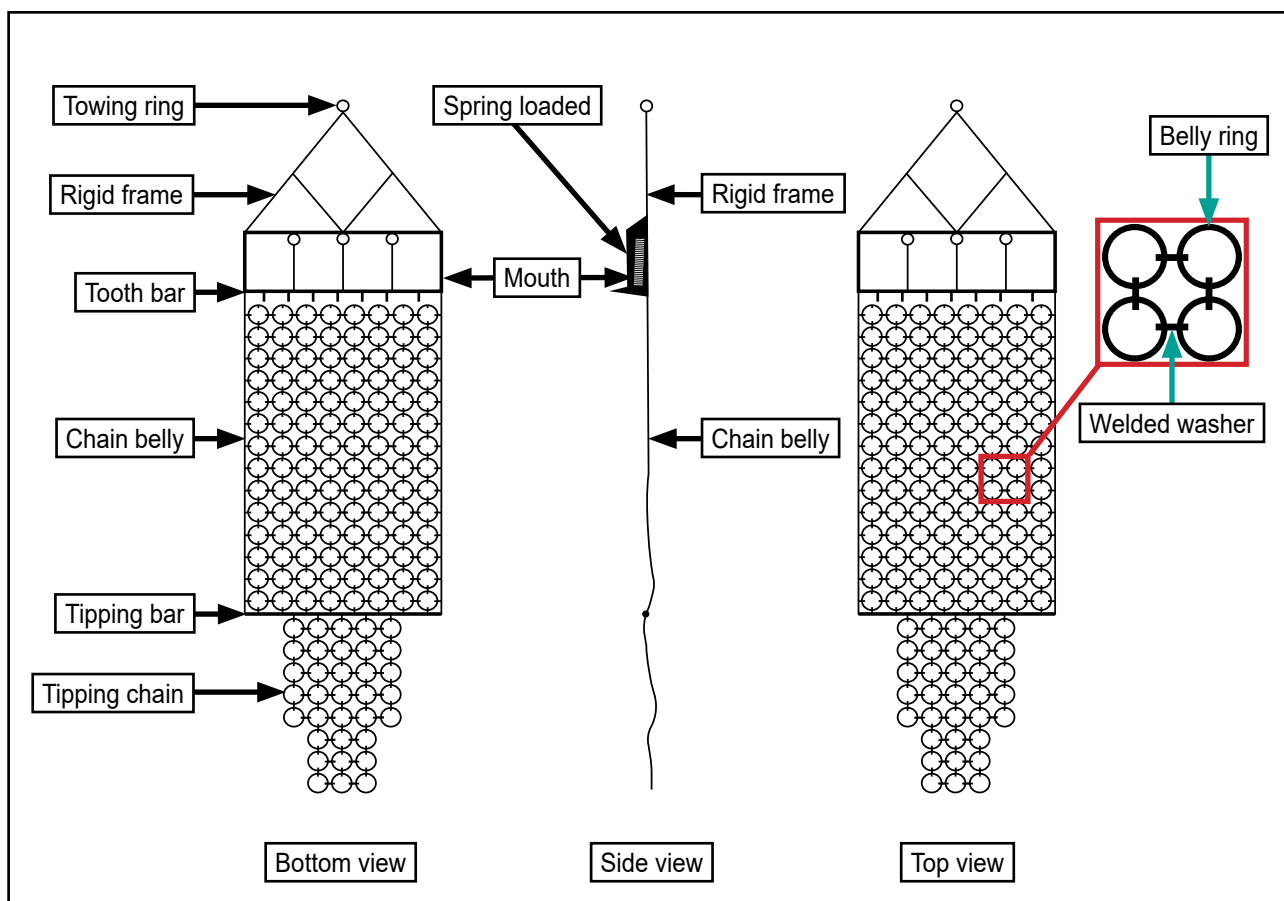
Figure 1: Dredge gear

Dredging for scallops involves a series of dredges being dragged along the seabed behind a towing bar (**Figure 1**). *Olivia Jean*'s dredges each consisted of a rigid triangular frame, a spring-loaded toothed bar and collecting bags. The spring-loaded toothed bars raked through the seabed and flipped the scallops into the collecting bags. Each collecting bag, known as a 'belly', was made up of interlinked steel rings and welded washers that formed a chain mesh. The action of dragging the belly across the seabed caused the steel rings and washers to wear, and therefore, the bellies needed to be inspected regularly and changed periodically.

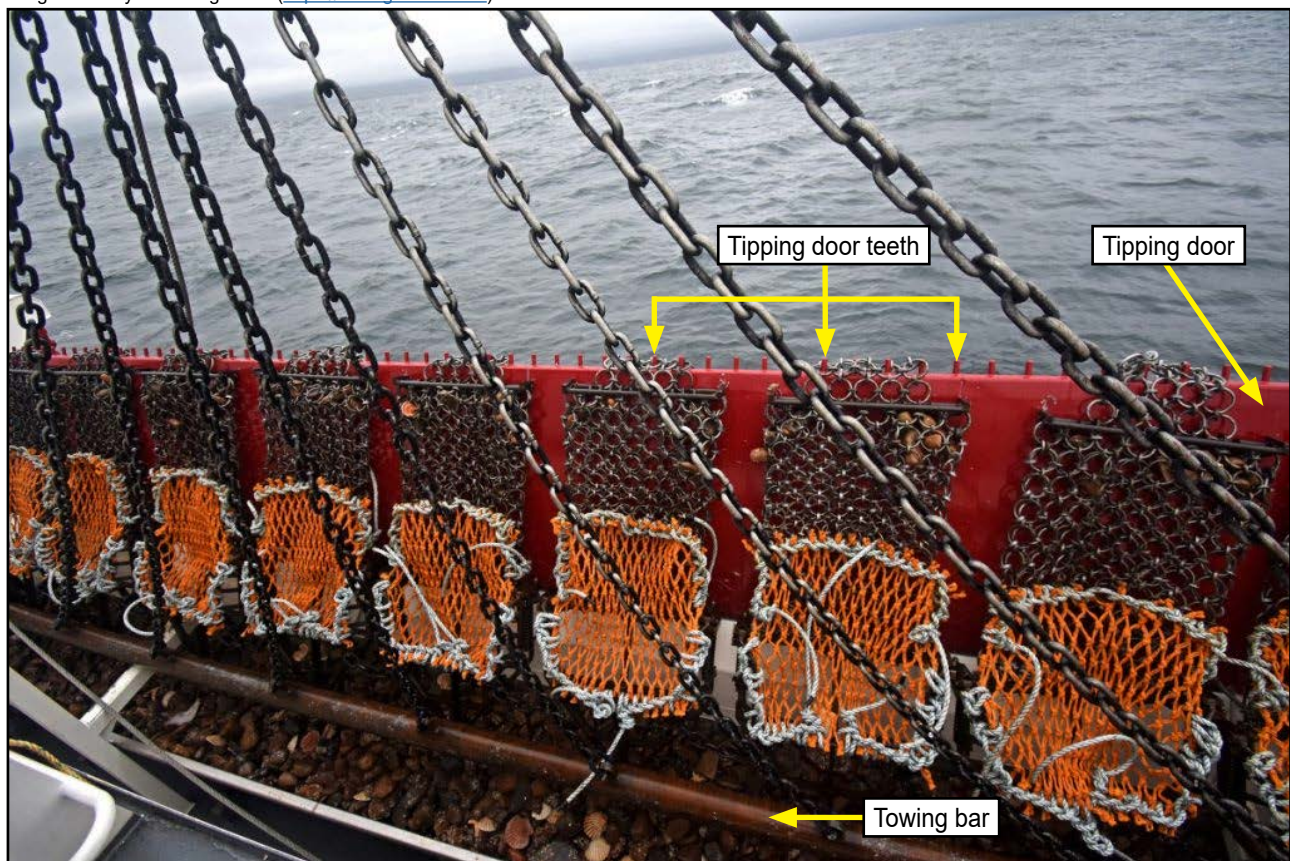
Figure 2: Tipping doors and catch conveyor (similar arrangement)

Olivia Jean was fitted with hydraulically operated outer hull tipping doors, which were designed to mechanically invert the dredges and empty the scallops onto the vessel's catch conveyors (**Figure 2**). As the dredge gear was hoisted out of the water and alongside the vessel, the crew attached securing chains to the forward and aft ends of the towing bars to hold them steady and away from the tipping doors. The securing chains were shackled to pad eyes on the deck and attached to the towing bars by hooks. When the tipping doors started to rotate, the teeth that ran along their bottom outer edge engaged with the dredge bag tipping rings. As the dredges began to invert, the towing bars simultaneously lowered into their deck crutches. *Olivia Jean*'s dredge gear winches and tipping doors were controlled from a central console in the wheelhouse.

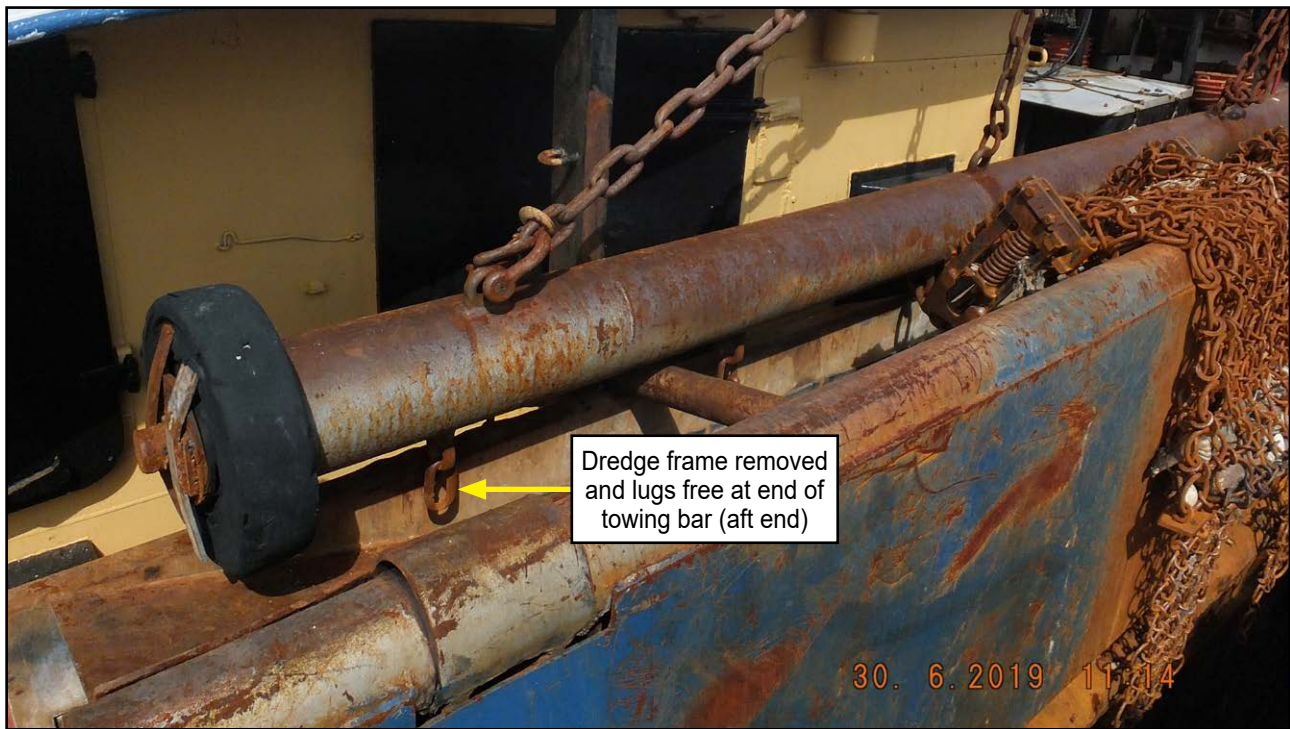
Figure 7: Towing bar with dredge frames removed (aft end)

Olivia Jean's towing bars stretched the length of the main working deck, from the forecastle to just aft of the wheelhouse. They were designed to tow up to 18 conventional dredges, but to comply with regulations for dredging in Scottish waters the number of dredges had been reduced to 14 per side. This was achieved by removing two dredges at either end of the towing bars, leaving their attachment rings free (**Figure 7**). It was these unused rings at the forward end of the towing bar that became snagged on the tipping door teeth.
