**SERIOUS INCIDENT**

<b>Aircraft Type and Registration:</b>	Cessna C208B Super Cargomaster, N967FE	
<b>No &amp; Type of Engines:</b>	1 Pratt & Whitney PT6A-114A turboprop engine	
<b>Year of Manufacture:</b>	1988	
<b>Date &amp; Time (UTC):</b>	23 September 2020 at 1716 hrs	
<b>Location:</b>	Terrance B Lettsome International Airport, Tortola, British Virgin Islands	
<b>Type of Flight:</b>	Commercial Air Transport (Cargo)	
<b>Persons on Board:</b>	Crew - 1	Passengers - None
<b>Injuries:</b>	Crew - None	Passengers - N/A
<b>Nature of Damage:</b>	Damage to both main wheels and to the right landing gear leg fairing and baggage pod	
<b>Commander's Licence:</b>	Commercial Pilot's Licence	
<b>Commander's Age:</b>	55 years	
<b>Commander's Flying Experience:</b>	1,878 hours (of which 174 were on type) Last 90 days - 143 hours Last 28 days - 44 hours	
<b>Information Source:</b>	AAIB Field Investigation

**Synopsis**

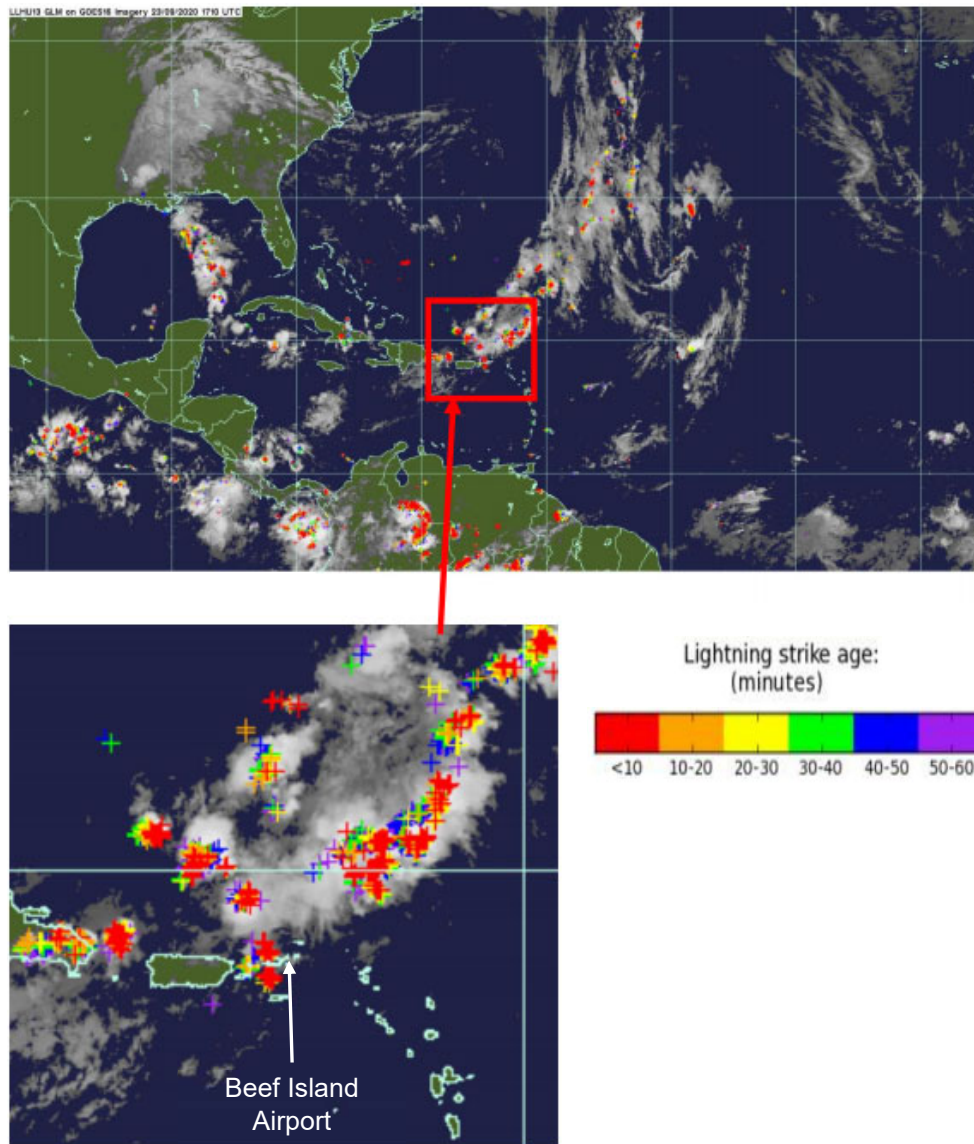
**Figure 12**

Satellite image of the Caribbean with Lightning activity overlaid valid at 1710 hrs

Figure 12 shows a satellite image displaying a band of cloud with embedded thunderstorm activity extending from the mid-Atlantic towards the Caribbean, the majority of the activity remained to the north of the British Virgin Islands, but there were several active thunderstorms surrounding the territory at 1710 hrs. Figure 13 shows a radar image valid at 1710 hrs, obtained from the US weather radar situated in San Juan (140 km to the west of the accident site). The bright echoes on the radar picture indicates heavy showers over both the British and US Virgin Islands. These showers correlate well with the areas of thunderstorm and lightning activity in Figure 12.

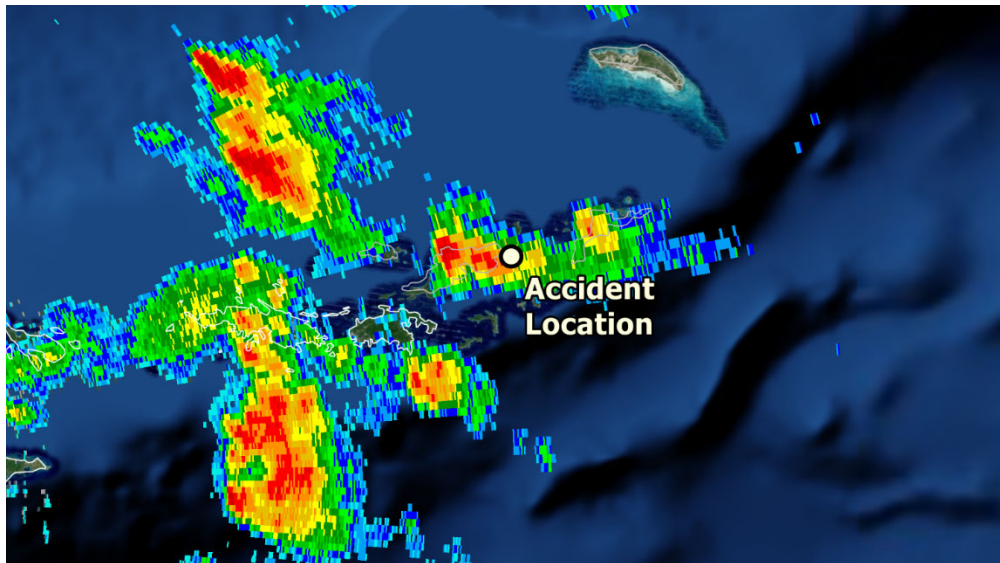
**Figure 13**

Radar image valid at 1710 hrs
