## ACCIDENT

<b>Aircraft Type and Registration:</b>	DJI Phantom 4 RTK (UAS, registration n/a)	
<b>No &amp; Type of Engines:</b>	4 electric motors	
<b>Year of Manufacture:</b>	2020 (Serial no: 0V2GDC6RA30246)	
<b>Date &amp; Time (UTC):</b>	2 December 2020 at 1209 hrs	
<b>Location:</b>	Newtongrange, Dalkeith, Midlothian	
<b>Type of Flight:</b>	Commercial Operations (UAS)	
<b>Persons on Board:</b>	Crew - N/A	Passengers - N/A
<b>Injuries:</b>	Crew - N/A	Passengers - N/A
<b>Nature of Damage:</b>	Damage to motors, propellers, arms, landing gear and fuselage	
<b>Commander's Licence:</b>	Other	
<b>Commander's Age:</b>	50 years	
<b>Commander's Flying Experience:</b>	98 hours (of which 98 were on type) Last 90 days - 5 hours Last 28 days - 2 hours	
<b>Information Source:</b>	AAIB Field Investigation

## Synopsis

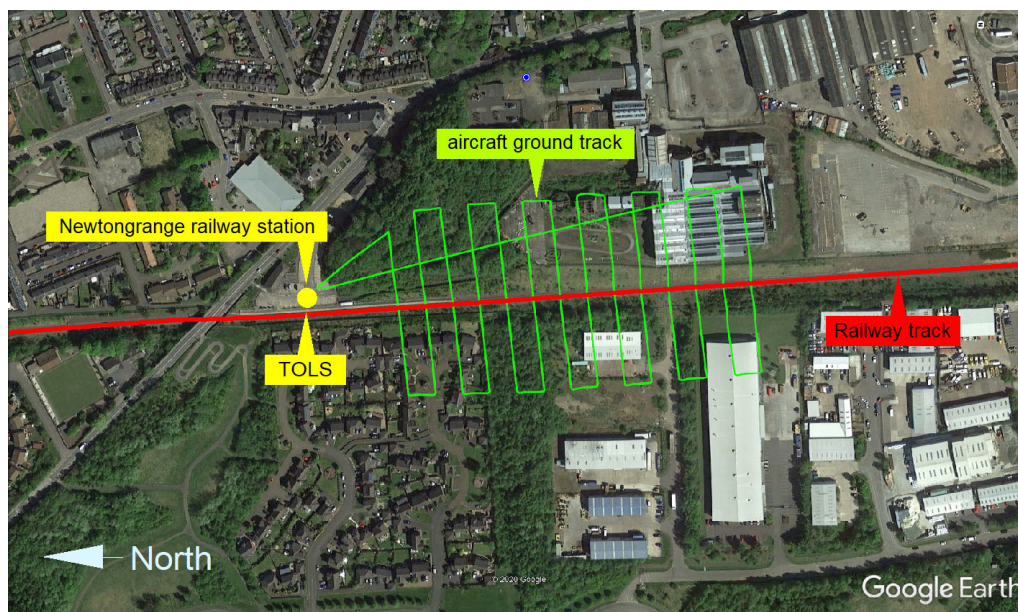
**Figure 1**

The propellers were refitted to the aircraft and a flight lasting about 20 minutes was successfully completed. The battery was then replaced with a fully charged unit before the aircraft took off at 1149 hrs for the next flight (Figure 1). This included overflying the railway track, adjacent industrial buildings, and a housing estate at a height of about 55m (180 ft) agl before landing back at the TOLS at 1200 hrs.

Aircraft ground track prior to the accident flight  
© 2020 Google, Image © Maxar Technologies
