AAIB Bulletin

6/2021

Published 10 June 2021

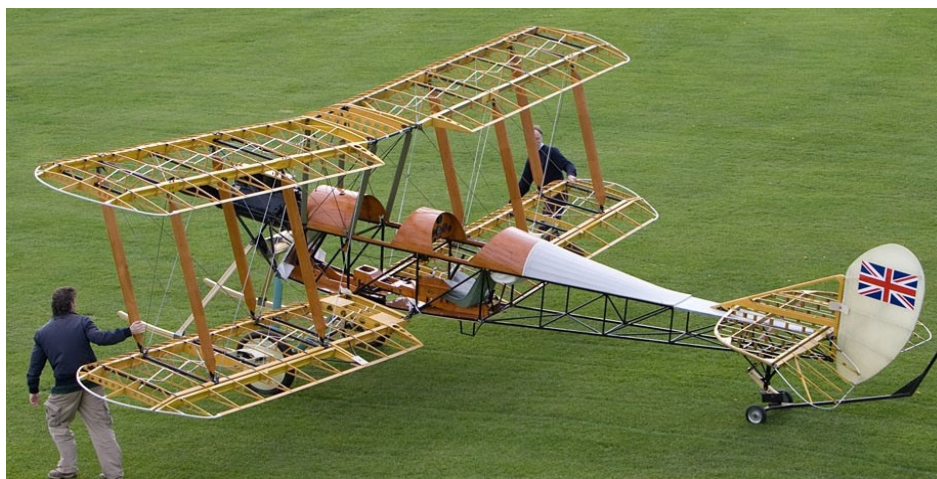
Figure 10

G-AWYI during its restoration

During the restoration, (Figure 10), the original design was modified to improve safety. Following structural load analysis, additional strengthening measures were taken. A four-point harness was added to the front and rear cockpit, additional control cables were added to the elevator control circuit, stronger bracing wires installed and structural strengthening to the tail section. The fin and rudder shapes and areas were altered to more closely replicate a BE2c, but no horn balance was fitted to the rudder. The original Tiger

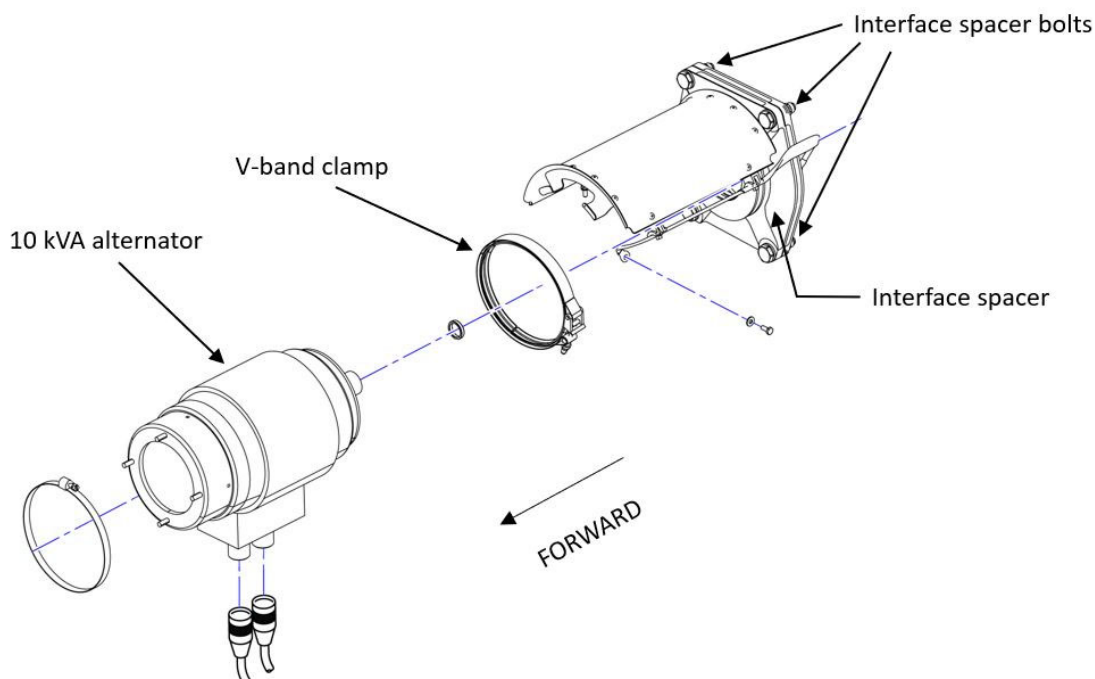
Figure 1

The exchange of the MGB accessory equipment took place in the operator's maintenance hangar with both MGBs mounted in transport stands, which provided good access for the work carried out. A Part-66 B1 licenced aircraft engineer (LAE), who was type-rated on the EC175, removed the alternator from the old LAGB, together with its V-band clamp and interface spacer as an assembly, by unfastening the four bolts that attach the interface spacer to the LAGB (Figure 1).

10 kVA alternator, V-band clamp and interface spacer (image used with permission of Airbus Helicopters)

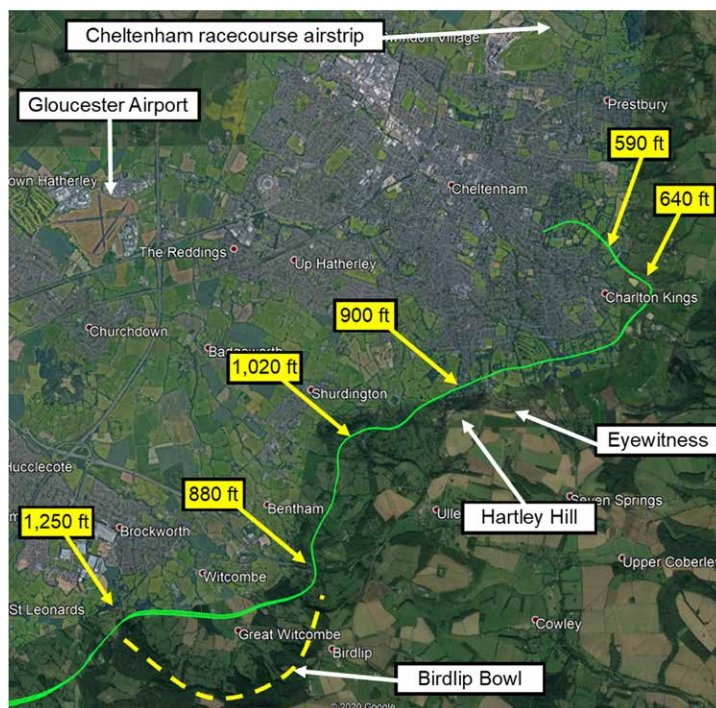
Figure 3

He also reported that there was very little lift to be found as the glider tracked north-eastwards along the ridge. Crossing the 'Birdlip bowl'¹ to the east of Gloucester (Figure 3) they experienced significant "sink," losing over 350 ft in 1.8 nm.

Overhead view of G-CFST's track and approximate navigation logger-derived altitudes (©2020 Google)

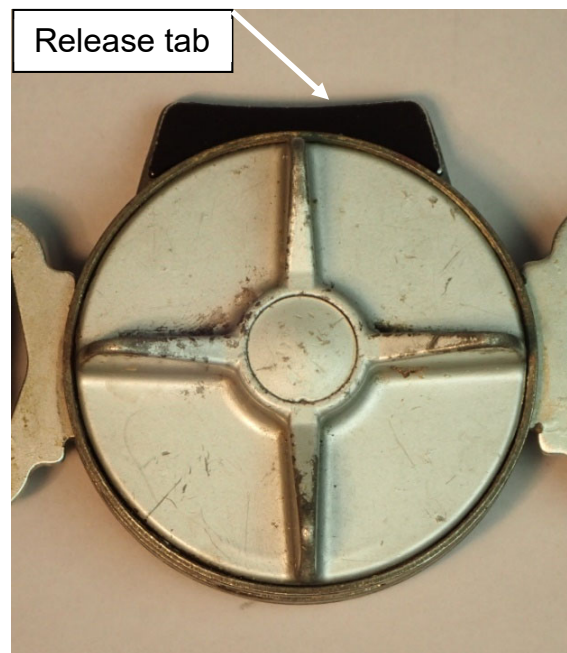
Figure 8
Seat harness QRF

Both seats are equipped with a four-point harness. A rotary buckle, also known as a quick release fitting (QRF), is incorporated as part of the right lap strap. Turning the QRF in either direction simultaneously releases both shoulder straps and the left lap strap. A rectangular tab at the 12 o'clock position on the QRF allows the wearer to release only the shoulder straps, by hooking a thumb or finger behind the tab and pushing forward (Figure 8).

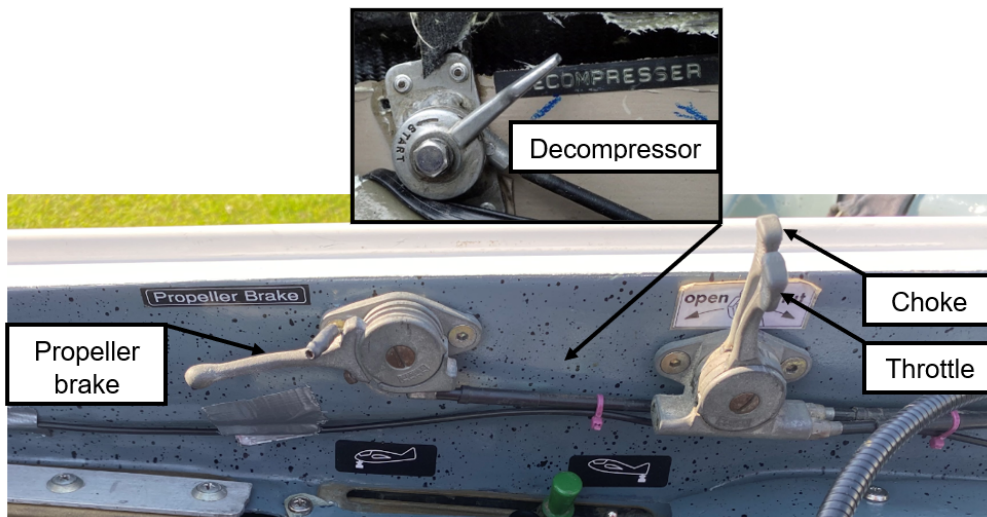
**Figure 10**

The cable-operated throttle, choke and propeller brake are actuated by levers mounted on the right side of the cockpit wall. A pull-start handle mounted in the right footwell, operates an impulse starter. G-CFST's engine had been retrofitted with a cable-operated decompressor valve to assist engine starting, removing the need to use the engine pull-start handle in flight (Figure 10).

Engine controls on another ASH 25 E (main image) showing position of decompressor lever on G-CFST (inset)

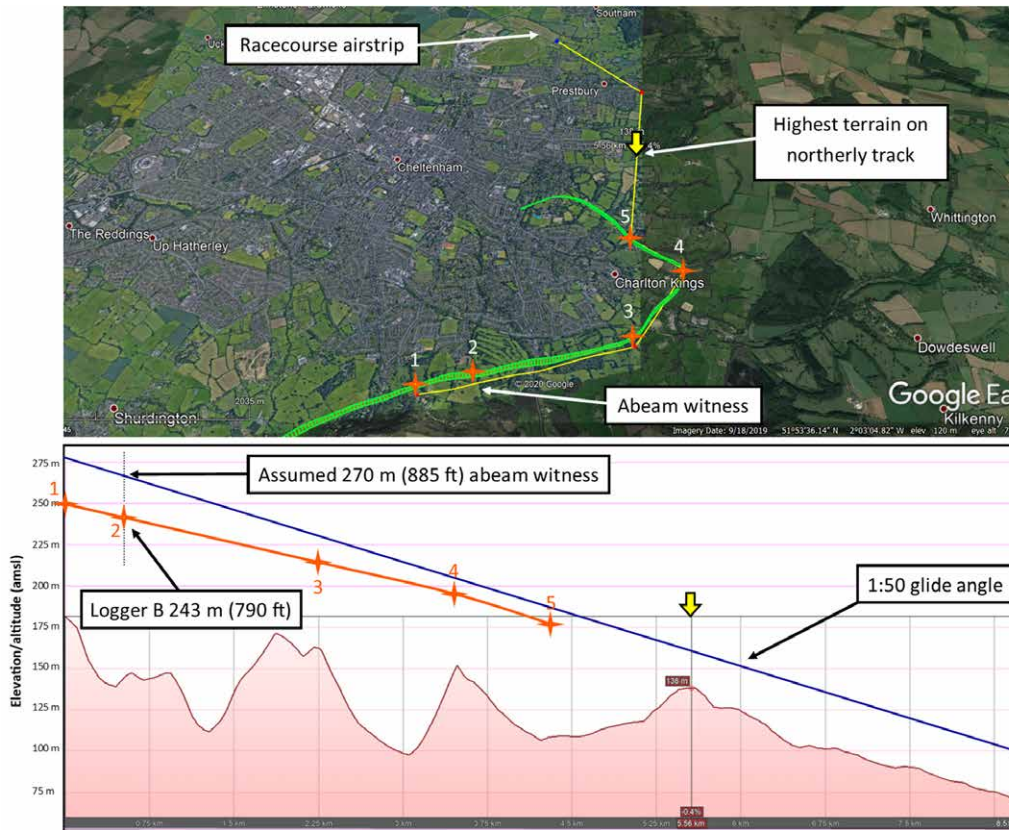
Figure 18

The passenger considered it probable that the pilot expected, even if the ridge wasn't working well, that he would have enough height to reach the racecourse for a field landing. A simplistic comparison of the notional glide performance of G-CFST is included at Figure 18. This shows that from an assumed altitude of 885 ft (270 m) abeam the witness on Hartley Hill, a 1:50 glide path would have been sufficient to maintain terrain clearance when following the hypothetical yellow track line to the racecourse. This calculation does not take account of obstacles, such as buildings or trees, on the flightpath or of any head or tailwind component. Data from the loggers placed the aircraft just below 800 ft passing the witness. The five logger-derived altitude reference points depicted in orange indicate that, likely due to a tailwind, G-CFST was achieving a greater than 1:50 glide ratio around the bowl before the engine was deployed.

From Point 5 on the graphic, while the racecourse airstrip was theoretically in range, the pilot had no contingency height in reserve. Heading north from Point 5 would have looked daunting, requiring descent from approximately 230 ft agl towards hostile²⁸ rising ground. Terrain clearance at the highest ground elevation on track would likely have been less than 100 ft. From that point, with the terrain gradient approximating close to 1:50, and without factoring in trees and buildings en route, unless it found additional lift, the glider would have been at ultra-low-level for the remainder of the flight (Figure 19).

Glide angle and terrain elevation profile comparison (Image ©2020 Google)

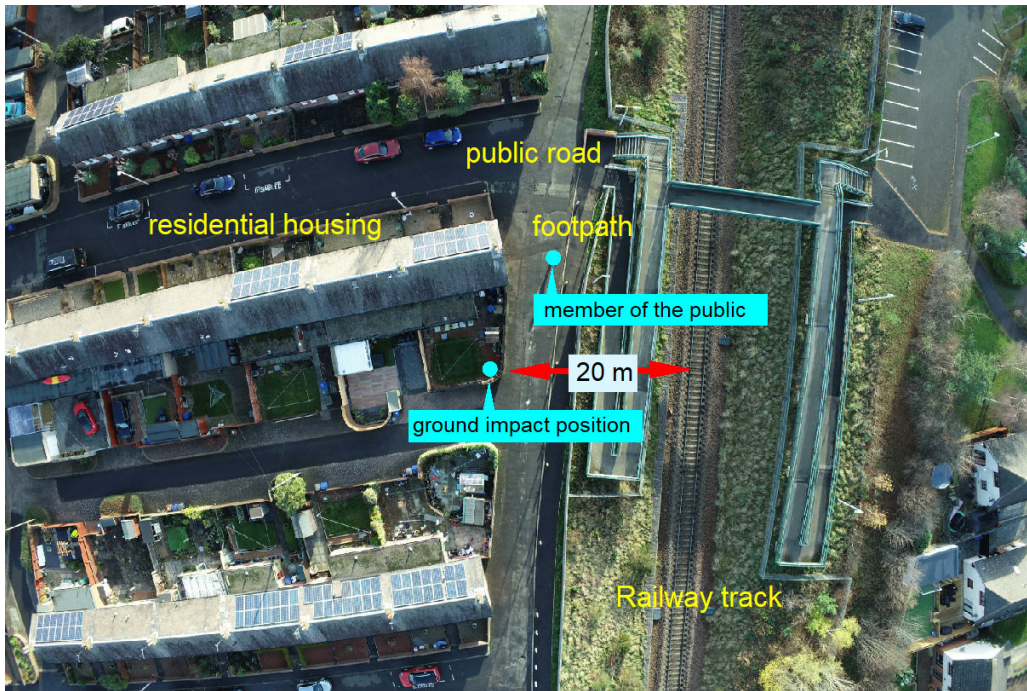
Figure 3

The pilot and observer subsequently found the aircraft in the rear garden of a terrace house (Figure 3) about 20 m from the railway track and below where the loss of control had occurred. The house was part of a large, densely populated housing estate and there were no people in the garden when the accident occurred. However, when the overhead image (Figure 3) was taken, a member of the public was 10 m from where the aircraft subsequently struck the ground.

Image captured by the aircraft shortly before the loss of control

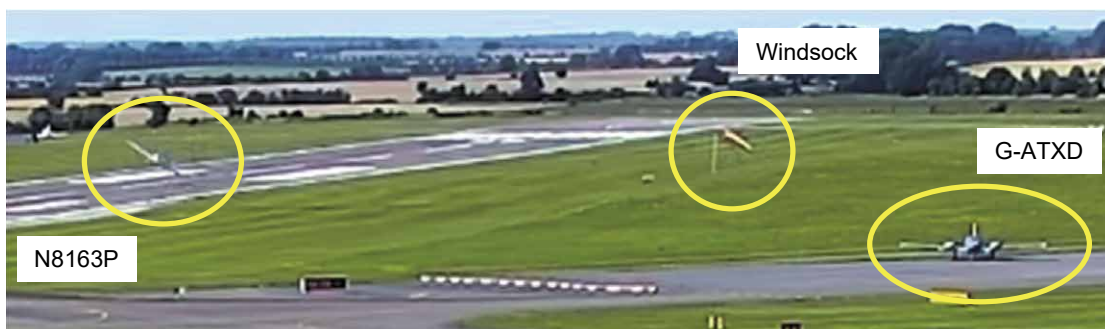
**Figure 5**

From a CCTV recording, the attitude of N8163P appeared normal as it crossed the threshold when it then appeared to fly parallel with the runway. As it reached the first set of touchdown markers the left wing dropped and contacted the edge of the runway before the aircraft settled on its landing gear on the grass (Figure 5). The aircraft continued to travel across the grass on a heading approximately 45° to the left of the runway heading.

Still from CCTV footage of N8163P as the left wing dropped

As the pilot checked the rate of descent to delay touching down, it is likely that it was the handling of the aircraft at low speed, while countering the effects of the crosswind, that resulted in the loss of control. The CCTV recording and abrasions to the wing tip show that the left wing struck the runway before the aircraft touched down on the grass. It is possible that the damage to the propeller occurred at this time, but it more likely occurred after the left main landing gear collapsed.

This accident highlights the importance of making an early decision to go-around and to allow sufficient time for aircraft landing ahead to clear the runway. On this occasion clearance to land at ‘the pilot’s discretion’ was not given until the aircraft reached the threshold. Following the loss of control, the wing tip struck the ground and the pilot would not have known the extent of the damage to the aircraft; therefore, it would have been a safer option to stay on the ground.

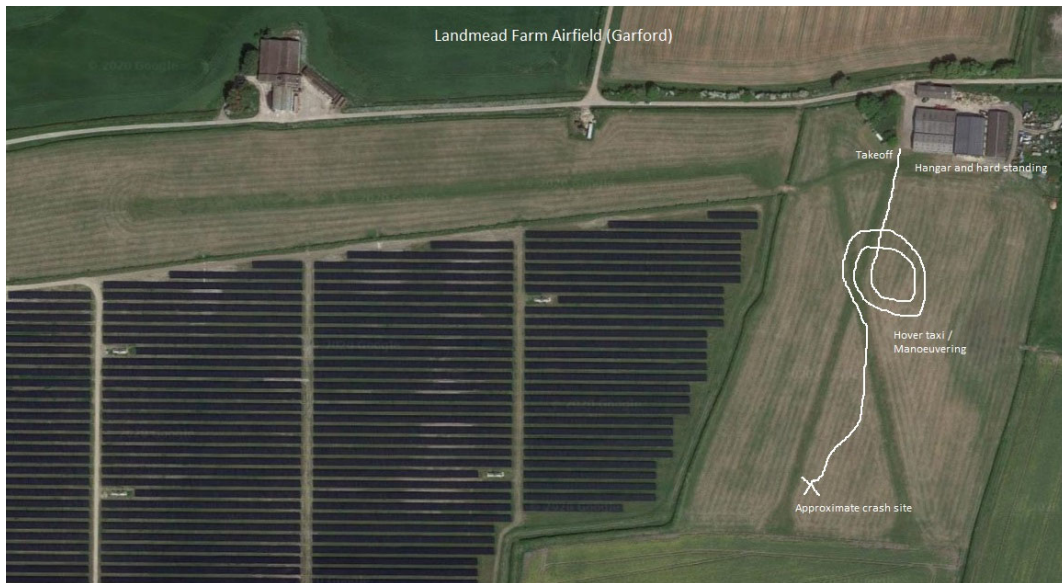
Figure 1

The pilot provided a sketch of the crash site relative to the departure point, shown in Figure 1.

Flightpath and crash site location sketch provided by the pilot
