Rail Accident Investigation Branch

Rail Accident Report

**Track worker struck by train near Roade,
Northamptonshire
8 April 2020**

Report 03/2021
June 2021

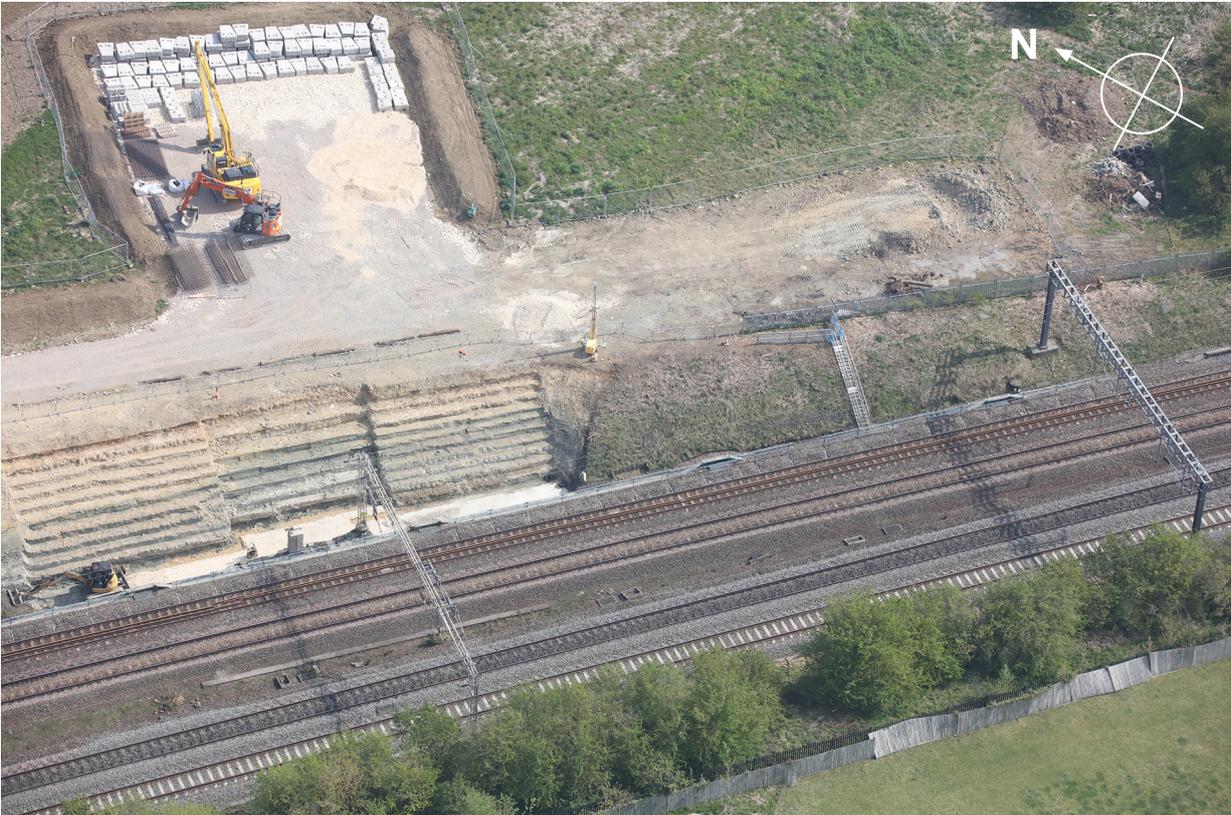
Figure 2: Aerial view of location

- 9 The eastern side of the cutting at Roade had been identified as requiring work to improve its condition, because of features that posed a safety risk to the railway. These included a steep slope which was showing signs of soil creep, toe bulging (movement of material at the base of the cutting) and rabbit burrow damage. The work involved removing excess material from the slopes either side of the overbridge, and the installation of interlocking pre-cast concrete blocks to stabilise the slopes. The site was divided into two areas of work, one either side of the overbridge.
