## ACCIDENT

<b>Aircraft Type and Registration:</b>	Robinson R44 Clipper I, G-CLIO	
<b>No &amp; Type of Engines:</b>	1 Lycoming O-540-F1B5 piston engine	
<b>Year of Manufacture:</b>	2000 (Serial no: 742)	
<b>Date &amp; Time (UTC):</b>	17 December 2020 at 1530 hrs	
<b>Location:</b>	Private landing site, Holmfirth, North Yorkshire	
<b>Type of Flight:</b>	Private	
<b>Persons on Board:</b>	Crew - 1	Passengers - 2
<b>Injuries:</b>	Crew - 1 (Minor)	Passengers - 2 (Minor)
<b>Nature of Damage:</b>	Tail rotor shaft fractured, tail rotor damaged, damage to skids and belly of the aircraft	
<b>Commander's Licence:</b>	Private Pilot's Licence	
<b>Commander's Age:</b>	50 years	
<b>Commander's Flying Experience:</b>	108 hours (of which 108 were on type) Last 90 days - 2 hours Last 28 days - 1 hour	
<b>Information Source:</b>	Aircraft Accident Report Form submitted by the pilot and further enquiries by the AAIB

## Synopsis

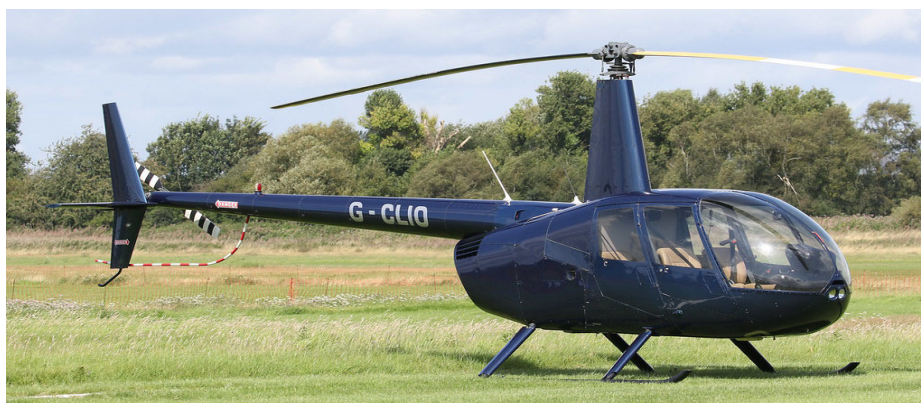
**Figure 3**

The Robinson R44 Clipper I<sup>1</sup> (Figure 3) is a four-seat light helicopter powered by a single Lycoming O-540, six-cylinder, carburetted piston engine. The carburettor system features a heat assist function to adjust carburettor heat mechanically as the collective lever is raised or lowered, which is designed to improve safety and reduce pilot workload.

G-CLIO  
(Image used with permission)
