# **Annual Safety Review 2020**

Air Accidents Investigation Branch  
Farnborough House  
Berkshire Copse Road  
Aldershot  
Hampshire  
GU11 2HH.

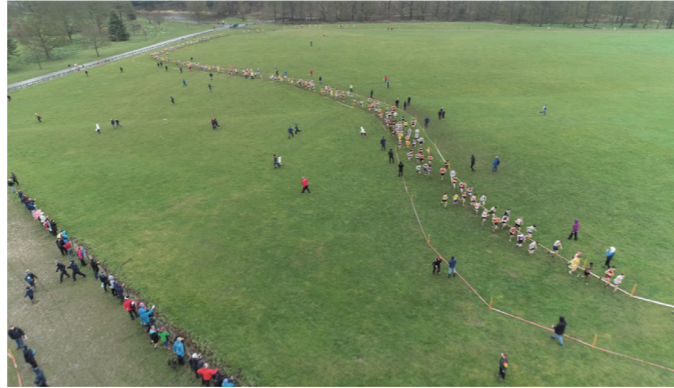
The DJI Matrice 210 small unmanned aircraft was being operated commercially to record video footage of an outdoor athletics event. The pilot started to position the aircraft back towards the landing site due to an increase in the rainfall. The pilot then saw the aircraft “wobble” slightly and as it neared the landing site it flipped over before descending rapidly to the ground from a height of about 3 m (10 ft). No one was injured. During the accident flight the aircraft had been operating at heights of up to about 30 m (100 ft) near to, and above people on the ground. This investigation reviewed other similar accidents and the risk of injury to people on the ground. Two Safety Recommendations were made to the UK CAA.

Footage captured one minute before the accident

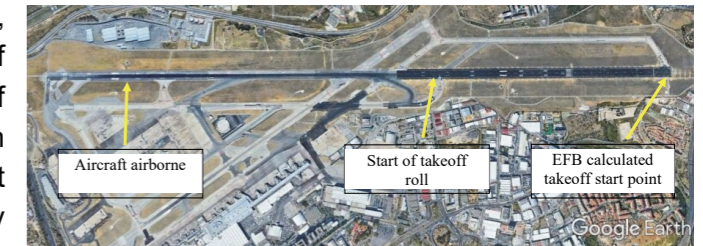
Image of Lisbon Airport showing the calculated and actual takeoff points

The aircraft took off from Taxiway U5 with performance calculated for the full runway length. The takeoff distance available from U5 was 1,395 m less than that used for the performance calculation, and the aircraft passed the upwind end of the runway at 100 ft aal. The operator had another identical event 14 days later.

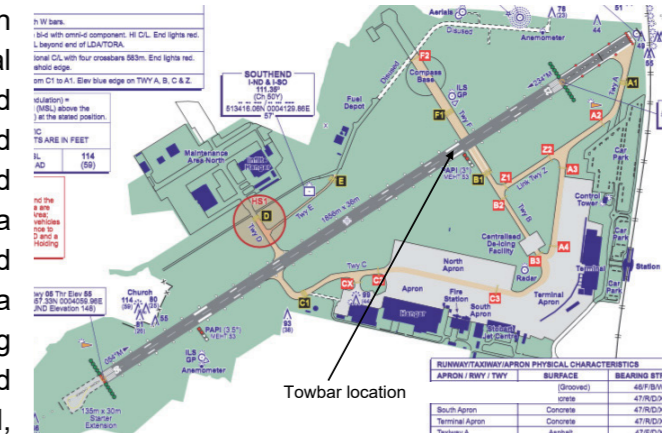
An Embraer 145 landing at London Southend Airport ran over a general aviation towbar which had been dropped on the runway. No damage was caused to the aircraft. The investigation found that the towbar had fallen from a Cessna 210 which departed Southend Airport 30 minutes before. The Cessna pilot had likely been distracted during his pre-flight checks by an earlier road traffic incident in which he was involved, and had inadvertently left the towbar attached.

London Southend Airport Chart showing approximate location the towbar was found

One Safety Recommendation has been made to the CAA to improve the visibility of general aviation ground equipment.

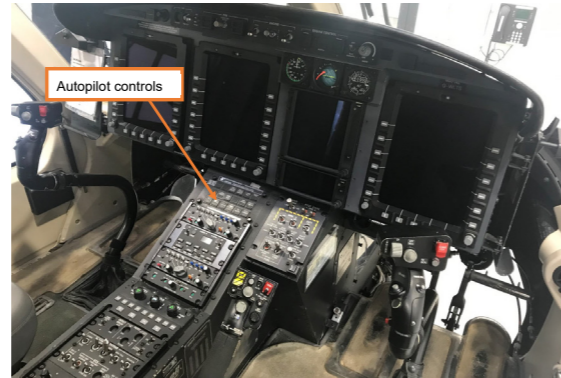
The report considers two events which occurred while the pilot was conducting a Power Assurance Check. In one, an un-commanded yaw pedal movement caused a rapid rotation of the helicopter through two and a half complete rotations; in the other, a trim runaway was contained by the pilot. The trim runaway was found to be an unknown feature of the Automatic Flight Control System logic.

Autopilot control panel

Following these events, safety action was taken by the helicopter manufacturer and Transport Canada to help crews respond to a yaw trim runaway and to address the underlying causal factor. Also, the flight recorder manufacturer improved the way it reported the results of CVR recording inspections.

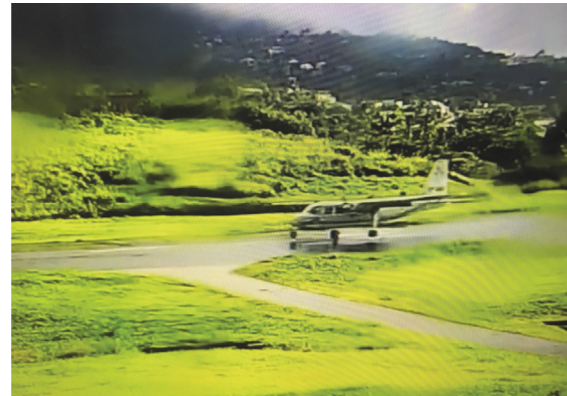
VP-MNI at the point of touchdown on Runway 10

No aircraft defects were found that would have contributed to the outcome. The touchdown groundspeed was 79 kt, which was higher than appropriate, either because the approach was flown at an airspeed greater than the normal 65 kt, or because of a significant change in windspeed and direction during the approach. This, combined with a wet runway and skidding, resulted in the aircraft requiring more distance to stop than was available on the runway. Three Safety Recommendations are made regarding aircraft operation, access for rescue and firefighting vehicles, and a means of arresting aircraft that overrun the runway.

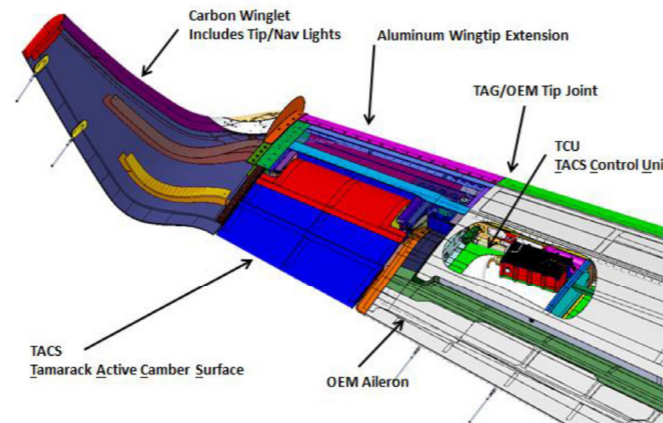
The aircraft had been modified with a system intended to enhance its performance, which included supplementary control surfaces designed to deflect symmetrically and automatically to alleviate gust loads. Shortly after takeoff, an electrical failure in this system caused one of these control surfaces to deploy separately, causing an uncommanded roll. The resulting aircraft upset caused the pilot significant surprise and difficulty in controlling the aircraft.

Cessna 525 wing with ATLAS installed

The pilot was not aware of supplementary procedures associated with the modification. The procedures did not adequately characterise the significance of the system failure, nor address the failure in all anticipated flight conditions. Certification flight tests of the system did not reveal the severity of possible outcomes. The 'Aircraft Safety and Certification Reform Act 2020' underway in the USA will review existing assumptions on pilot recognition and response.

It is recommended that Tamarack Aerospace Group amend the ATLAS inoperative in flight procedure to ensure actions are specified that are relevant in all anticipated flight conditions.

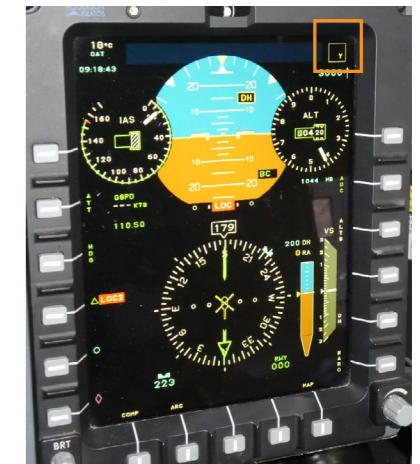
The first event on 15 June 2018 occurred during a PAC when the pilot's feet were clear of the pedals. The yaw trim actuator operated but the pedals could not move because of a restriction, and so the actuator wound up the artificial feel spring instead. When the restriction cleared, the pedals 'snapped' to full deflection as the spring unwound, increasing tail rotor thrust and causing the helicopter to rotate rapidly to the left through two and a half revolutions. The investigation did not determine the cause of the trim runaway or the pedal restriction.

Yaw out-of-detent indication

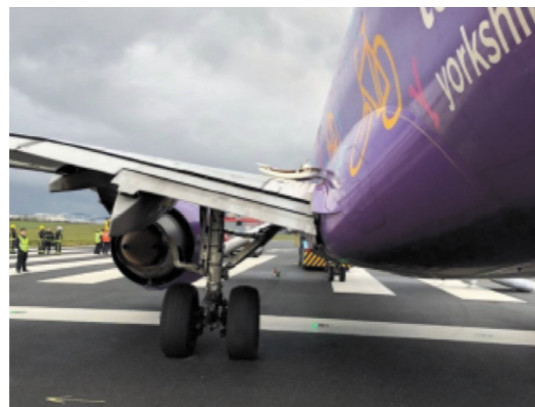
Drop to the ground from wing trailing edge with flaps in flap 1 setting

Due to the order in which the emergency evacuation vital actions were performed, the flaps had insufficient time to travel to the selected position. This resulted in an increased drop to the ground for passengers evacuating via the overwing exits, with many reluctant to jump or slide off the wing. Additionally, despite the presence of a marked exit route on the wing with a non-slip surface, many passengers who exited via the overwing exits were uncertain where to go once out of the aircraft. Both of these factors increased the time taken for emergency evacuation to be completed.

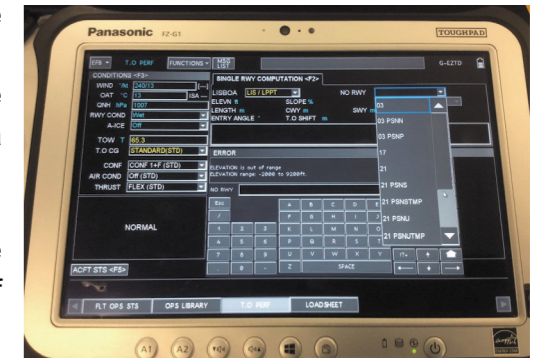
EFB dropdown menu showing the all the intersections available

Both aircraft took off using incorrect performance data for the intersection used. In each case, a selection error was made in the EFB which led the crew to believe that they had calculated performance information for a departure from S1 when in fact they had selected the full length of the runway. In both cases, the procedural barrier of cross-checking the runway distance against the aerodrome ground chart failed to prevent to error. Human performance limitations mean it is difficult for pilots to recognise and react to reduced performance (acceleration) once the takeoff has begun, so robust adherence to procedures is a key defence against such incidents occurring.

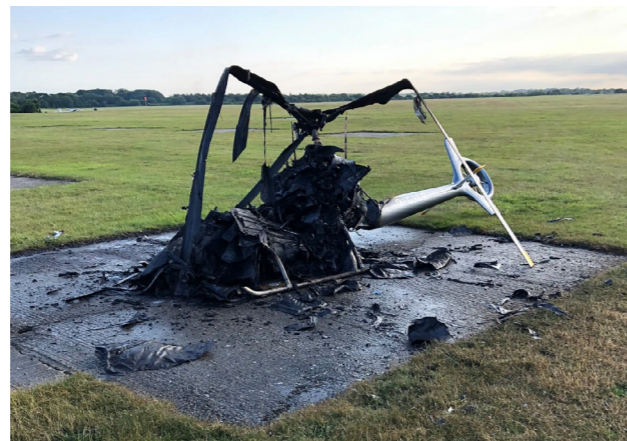
The helicopter caught fire shortly after landing because the heat generated from a short circuit in the engine compartment ignited a nearby carbon fibre structure. The short circuit was made between the cable that connected the output of the alternator to the starter relay and the aluminium air baffle through which the cable passed. It is likely that the cable clips that should have held the cable as it passed through the baffle were either not present or, most likely, incorrectly fitted. The upward movement of the engine as a result of the clutch disengagement was sufficient to allow the unsecured cable to contact the unprepared edge of the aluminium baffle, allowing the insulation to be cut and initiate the short circuit.

G-CILR prior to being moved

As a result of this investigation the helicopter manufacturer issued a service bulletin to instruct operators to inspect for correct installation of the cable clips and has also completed a redesign of the clips to ensure they cannot be fitted incorrectly.

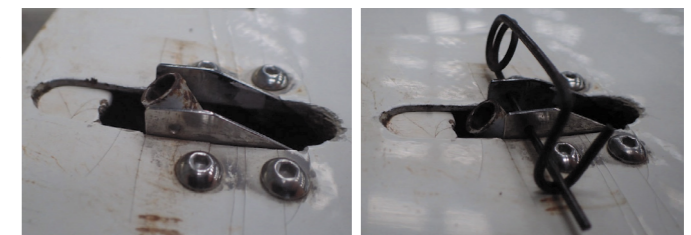
The investigation determined that the tailplane had not been correctly attached when the glider was rigged and this condition was not detected prior to the flight. Several possible mis-rigging scenarios were identified during the investigation, but the precise manner in which the tailplane had been mis-rigged could not be determined.

Locking lever when tailplane attached (left image) and when locked with safety pin inserted (right image)

Two Safety Recommendations are made relating to communication for glider launching and detecting incorrect alignment of tailplane locking features. In addition, the gliding club has undertaken several safety actions regarding launch signalling and detection of incorrect tailplane locking on other Standard Cirrus gliders.

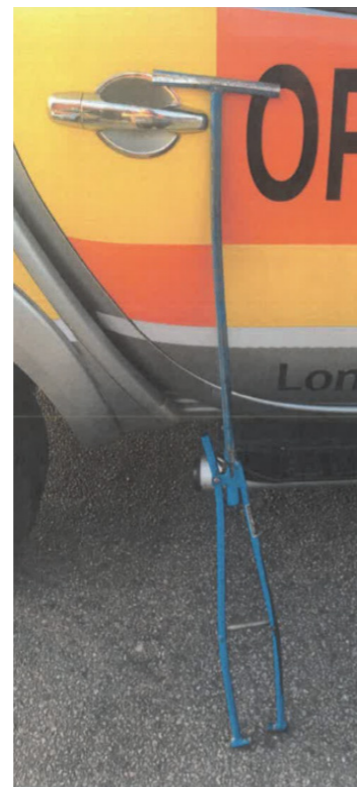
A general aviation towbar was inadvertently left attached to an aircraft because the pilot had been distracted by an earlier stressful event during his journey to the airport. The towbar dropped onto the runway during the departure and remained there for approximately 30 minutes, during which two other aircraft used the runway and a runway inspection was completed. A landing aircraft then ran over it. The towbar was inconspicuous because it did not have any reflective or other high visibility markings.

Towbar recovered from the runway

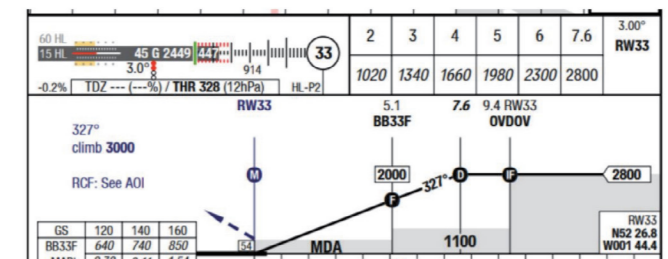
The aircraft did not maintain the correct vertical profile because the pilots were not sure when to commence the final descent. The depiction of the descent profile on charts provided by the operator may have contributed to this uncertainty.

Extract from operator's chart for RNAV approach to Runway 33 at Birmingham

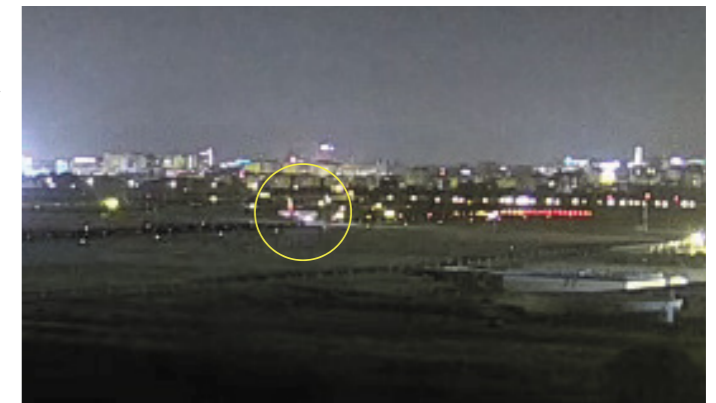
The aircraft took off using incorrect performance data for the intersection used. A selection error was made in the EFB calculation which led the crew to believe that they had calculated performance information for a departure from S1 when in fact they had selected the full length of the runway. In this case, as in the two previous identical incidents, the final barrier of checking the runway distance in the performance calculation against the aerodrome ground chart failed to prevent the error. Human performance limitations mean it is difficult for pilots to recognise and react to the performance error once the takeoff has begun, so robust adherence to procedures is a key defence against such incidents occurring.

CCTV screenshot showing G-EZWE just after reaching  $V_1$

The aircraft operator moved onto a newer software version for performance calculations in December 2019 which gives a pictorial representation of the runway. They also worked with the data supplier to change the menu for intersection selections for Lisbon Airport to eliminate any confusion over which position refers to the full runway length.

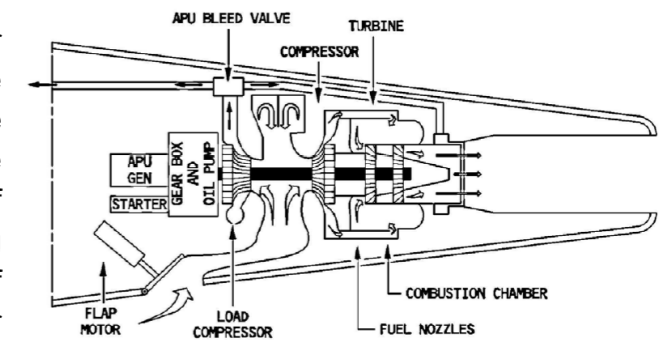
APU schematic

While it has not been possible to positively identify the compound that was responsible for the fumes and odours experienced in G-EUYB, or any of the other recent events, a number of common factors have been identified. The majority of events occurred after the aircraft had been parked or operated in precipitation. The fumes become apparent during the later stages of the descent, sometimes preceded by a minor event during the climb phase. The generation of fumes appears to be transient; they dissipate rapidly and leave no detectable trace. No link between changes to engine power or changes in other system settings and the generation of fumes was identified.

The operator and aircraft manufacturer have taken action to try to reduce the number of events, which includes; the development of detailed maintenance procedures to identify the source of fumes, changes to flight crew operating procedures and the evaluation of modifications to enhance cabin air recirculation filtration systems.

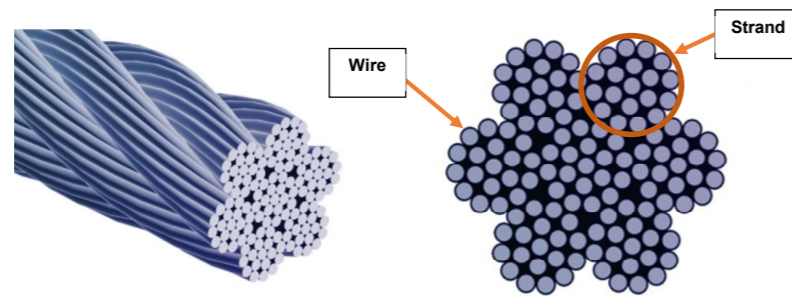
The most probable reason for the aileron cable breaking was that its strength had reduced as a result of wear leading to the failure of individual wires within the cable. The cable failed where it passed over a pulley on the rear wing spar where

Construction of the control cable

dirt accumulates which can penetrate into the strands and form an abrasive compound. This can accelerate the normal rate of cable wear. Post-modification cables are available which have a sleeve fitted over the susceptible section to prevent the ingress of dirt. The investigation established that the inspection procedure in the AMM would not have detected the damage to individual wires that run inside the cable.

- The aircraft manufacturer reviewed the periodic cable inspection procedure and advised that they would amend the procedure to increase the likelihood of identifying cable damage. They also stated that they would issue an All Operators Message to highlight this serious incident and the changes to the inspection procedure.
- The aircraft manufacturer advised that it would provide literature to operators to monitor for unresponsive ailerons using their Flight Data Monitoring Programmes.

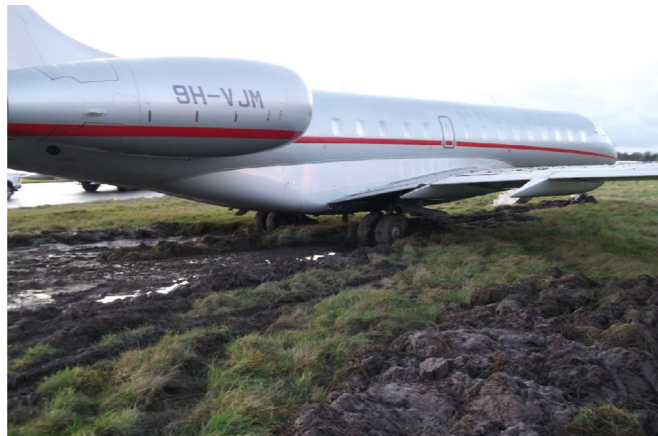
9H-VJM on the soft ground

As a result of a fault, the NWS went into free caster shortly after touchdown. During the subsequent landing roll, directional control of the aircraft was lost, and the aircraft departed the right side of the runway and onto the grass. The commander, in applying left rudder to try to keep the aircraft straight, had inadvertently applied some right braking. As the aircraft slowed, full left rudder was unable to counteract the effect of this braking.

- In its Training Syllabus for 2020 the operator has included a failure of the NWS system after landing as a preferred malfunction

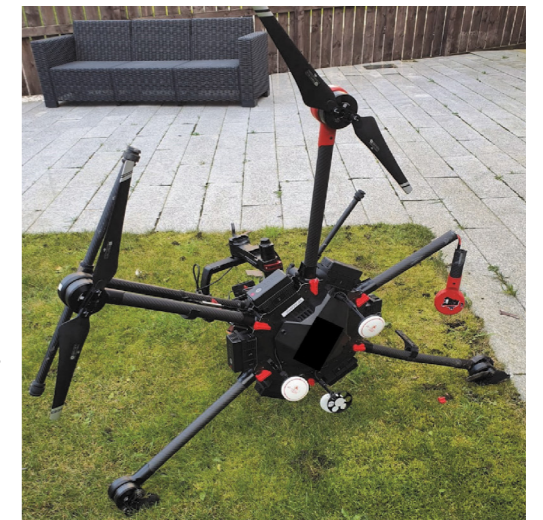
The aircraft after falling into the garden

The pilot was required to take manual control of the aircraft following the loss of its automated flight modes due to signal interference. However, no manual control inputs were made, and the aircraft subsequently drifted with the wind until it collided with a house roof and fell to the ground. No persons were injured.

Operators holding a PfcO issued by the CAA are not currently required to practise routinely for emergencies or demonstrate the ability to fly their aircraft in a degraded flight mode. These skills are perishable but, as this accident shows, they may be needed at any time; it is important that they are maintained to prevent a risk of injury to people or damage to property. To address this, one Safety Recommendation has been made to the CAA.

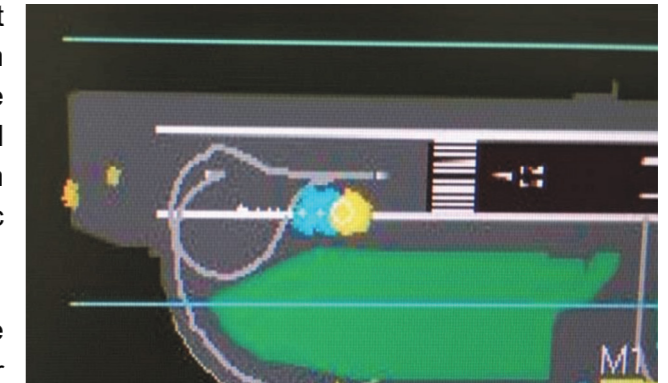
The aircraft began taking off on the edge stripe of Runway 23R at Manchester after lining up via intersection J1. The sun's glare on the wet runway, and the orientation, dimensions and slope of the intersection and runway surfaces, contributed to the pilot misidentifying the centreline. The rolling takeoff reduced his opportunity to check the aircraft's position.

Image of SMR at the commencement of D-COLT's takeoff roll

As a result of this and a previous similar event, the airport authority is implementing several safety actions to assist pilots lining up at J1.

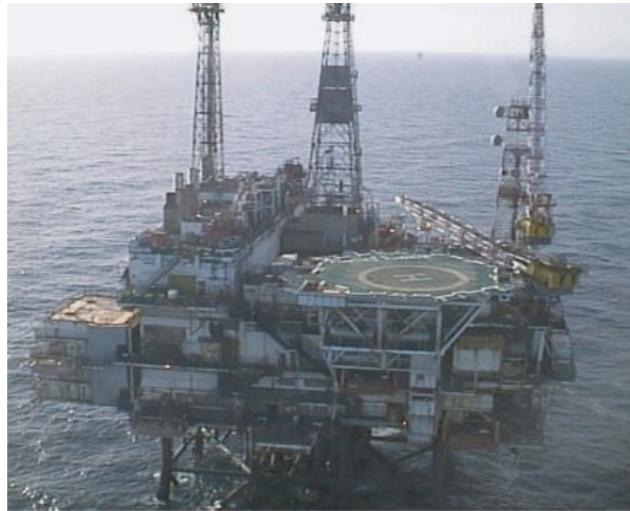
The pilots landed the helicopter on the Forties Charlie (40C) platform having misidentified it as the destination platform (40D). Controls in place at the time proved inadequate to break the confirmation bias of the pilots.

Forties Charlie (40C) platform

Discussion between the pilots about the position of the crane on the 40C platform probably resulted in them switching their attention incorrectly to this platform and away from the 40D platform. The crane was not stowed on either platform, so did not serve as a distinguishing feature.

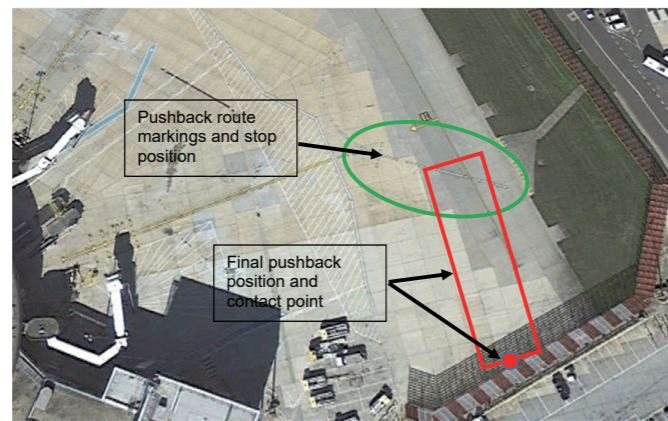
G-CKWB was parked on Stand 38 at London Gatwick Airport. The aircraft was loaded, with the doors closed ready to depart for its flight to the USA. Permission was granted by the ground controller for the aircraft to push back and start engines at 0910 hrs. The aircraft was pushed back using the incorrect line and as a result the aircraft tail cone struck the blast screen.

Final pushback position

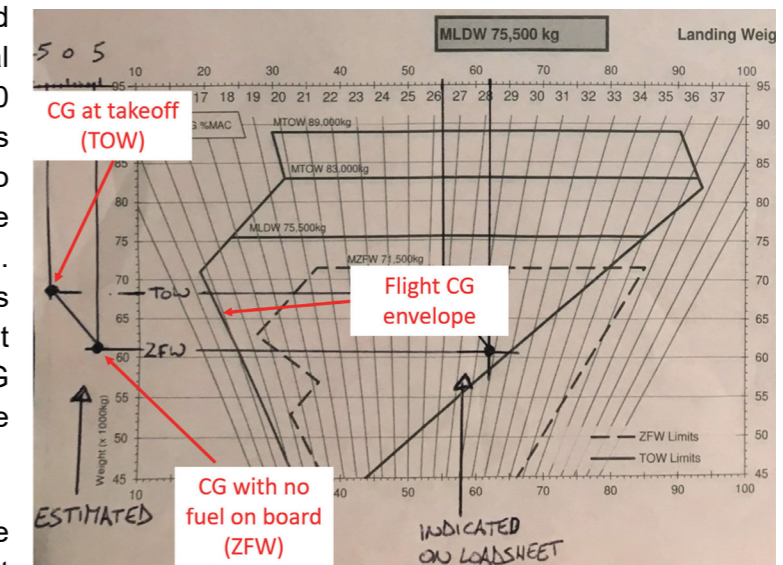
The incident occurred due to the aircraft change from an A320 to an A321 not being notified to both OHD and PSD. As a result, the passengers were seated at the front of the aircraft, placing the CG outside the forward limit of the operating envelope. The effect of this was that, at rotation, the aircraft appeared to the crew not to respond as expected to the normal side stick control inputs due to the forward CG. The PF required almost maximum aft control input and the PM selected TOGA thrust before the aircraft nose lifted. The crew analysed the problem but considered that an incorrect stabiliser setting, taken from the load sheet, had caused the problem. Only at the top of the descent for the destination did it become apparent that the passengers had possibly been incorrectly distributed in the cabin. The crew did not experience any unusual control response during the approach and landing.

The A321 Load and Trim Sheet that would have resulted on the incident flight

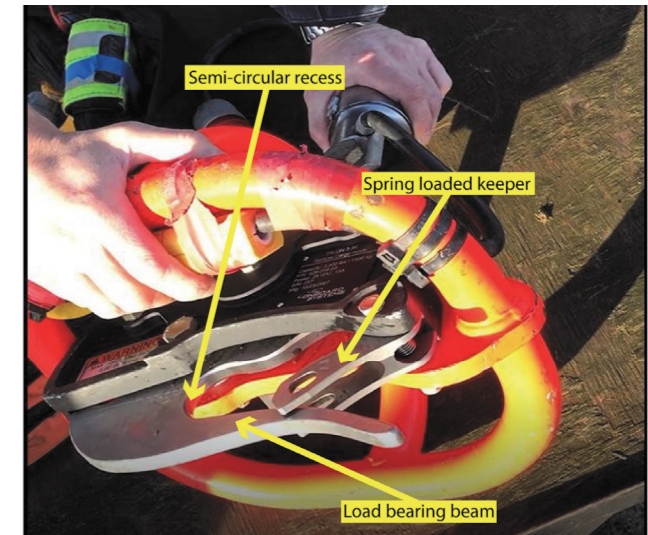
The most probable cause for the inadvertent release of the load was that the load had not been positioned correctly across the hook's load bearing beam when the load was hooked on. At this time, the client's employee, although having been trained in underslung load lifting operations, was working alone and was not being directly supervised. However, an intermittent fault could not be ruled out as an alternative cause for the release.

The spring-loaded keeper hook fitted to G-PDGF

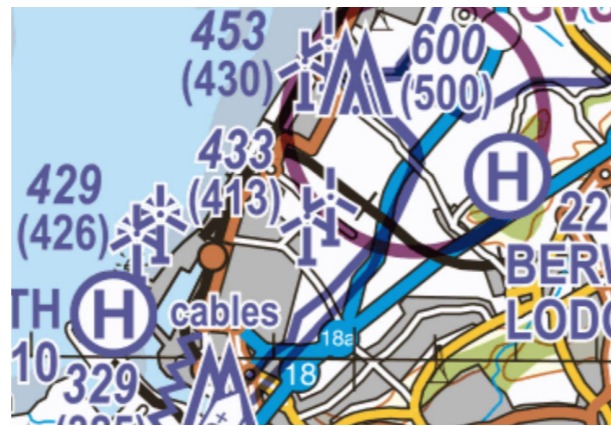
For a UAS pilot flying visual line of sight with the aircraft, tall obstacles may be obvious to see but their actual height is difficult to assess visually. All known ground obstacles greater than 300 ft in height are shown on aeronautical charts. These charts, and apps that use the same obstacle database, are one source of accurate information, and provide a clear indication of areas to avoid flying a UAS if limited to flying not above 400 ft. However, for obstacles less than 300 ft, UAS pilots will need to determine their accurate heights from other sources.

Extract from the CAA 250K aeronautical chart with the wind turbines at the sewage works in the centre of the image

UAS pilots are responsible for flying their aircraft within the limitations imposed by their CAA Permission and so must ascertain the accurate height of any hazard or obstacle near the planned flightpath.

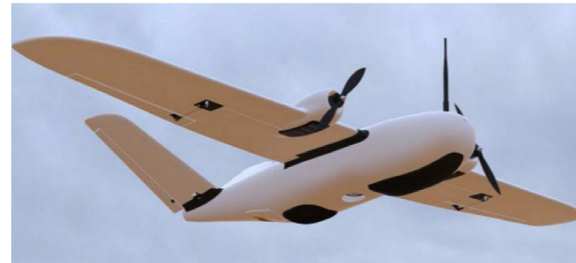
General view of the Believer UAS

The safety pilot erroneously turned the transmitter off before the automatic control system was activated and before the instruction to turn the transmitter off had been issued.

- Operations were reviewed to minimise the period where a UAS is under manual control. The UAS is now launched in a revised automatic mode where the safety pilot can apply control inputs to correct the flight path if appropriate. The safety pilot can also disable the automatic flight control system and take full control of the UAS in the event of an emergency.
- The fail-safe logic has been reviewed and modified so that settings are automatically configured depending on the status of the UAS.
- The operator has reviewed their fatigue risk management strategy and is introducing limitations with respect to permissible crew working times and a requirement for crew members to consider their well-being and declare themselves fit for operation during every flight briefing. The operator is updating their operations manual accordingly.

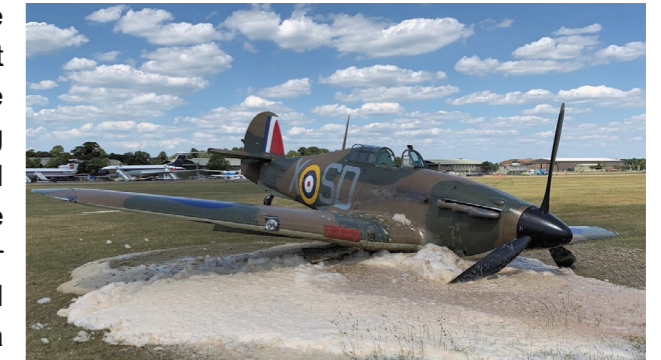
G-HRLI after the accident and application of fire-suppressing agent

The crosswind on landing induced a turn to the right. The reported application of brake and an absence of tail-down elevator coincided with the aircraft bouncing and pitching forward on the hard, undulating runway surface, aggravating the effects of the swing. In the absence of effective control inputs to oppose the swing, the aircraft began to slide sideways, eventually causing the landing gear to collapse. The pilot considered that his lack of relevant currency may have reduced his ability to anticipate and make appropriate control inputs on landing.

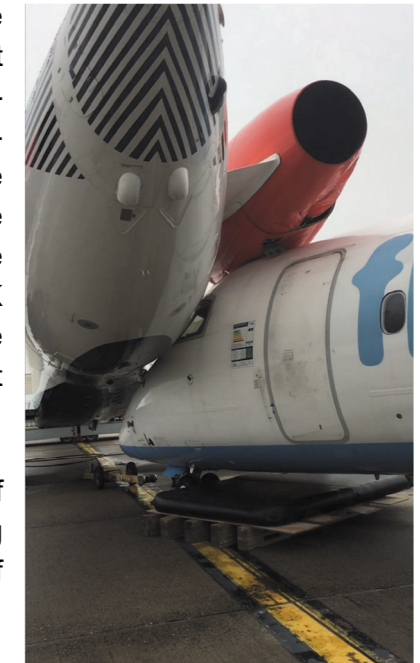
G-JECK rolled across Taxiway D from its parking position and struck G-SAJS because the nosewheel chocks had been inadvertently removed, and the hydraulic pressure in the park brake accumulator had depleted over several days to the point where it was unable to prevent the aircraft from moving on the 1° slope.

G-JECK and G-SAJS during recovery

- Reminded its sub-contracted ground handling companies that permission must be obtained from the aircraft commander before removing chocks.
- Reiterated that chocks are to remain fitted until either a tug had been attached to the aircraft or, when self-manoeuvring, that nosewheel chocks remain fitted until permission has been given to remove them.
- Recommended that pilots check during their walkaround that chocks had not been inadvertently removed.

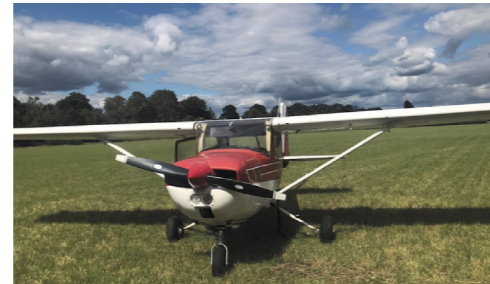
As the aircraft approached Blackbushe Airport the engine lost power and the pilot made a precautionary landing in a field. There was no damage to the aircraft and neither occupant was injured.

G-CSBM after the precautionary landing

- The flying club have reminded pilots of the importance of only using the dipstick calibrated for the aircraft they are flying.

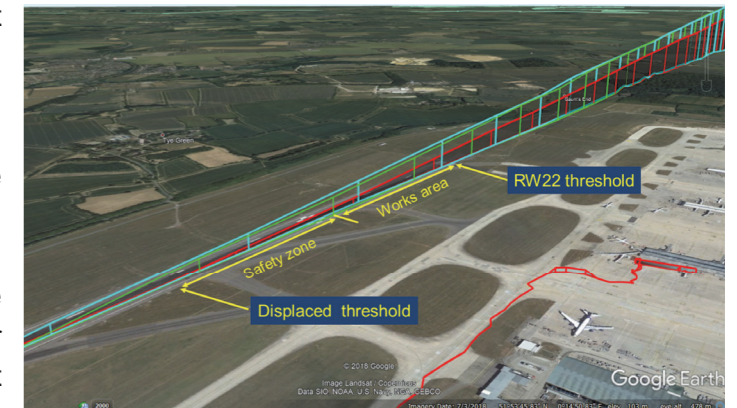
The pilots of YL-LCQ had not realised that a revised approach was required and flew the standard RNAV arrival. Radar data indicated that the aircraft was low over the works area and touched down close to the displaced threshold. Temporary approach plates were available to the pilots in their electronic flight bags (EFB), but the stated work in progress (WIP) active periods on the temporary airfield chart were incorrect. ATC had made repeated references to the displaced threshold and the RNAV22C arrival during the period when YL-LCQ was on the terminal controller's frequency.

Comparative radar traces  
(YL-LCQ trace in red)

After the incident, the operator highlighted the WIP implications to all their pilots operating from STN. The chart manufacturer reviewed their processes to address the issues which had resulted in incomplete information being presented on the temporary airfield chart.
