Annual Safety Review 2020

Air Accidents Investigation Branch
Farnborough House
Berkshire Copse Road
Aldershot
Hampshire
GU11 2HH.

Foreword

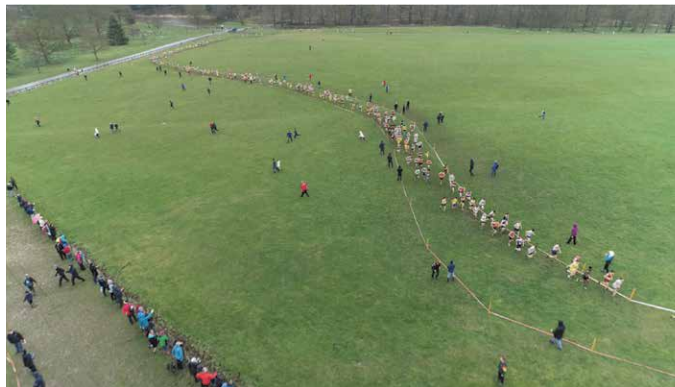
The DJI Matrice 210 small unmanned aircraft was being operated commercially to record video footage of an outdoor athletics event. The pilot started to position the aircraft back towards the landing site due to an increase in the rainfall. The pilot then saw the aircraft “wobble” slightly and as it neared the landing site it flipped over before descending rapidly to the ground from a height of about 3 m (10 ft). No one was injured. During the accident flight the aircraft had been operating at heights of up to about 30 m (100 ft) near to, and above people on the ground. This investigation reviewed other similar accidents and the risk of injury to people on the ground. Two Safety Recommendations were made to the UK CAA.

Footage captured one minute
before the accident

Safety Recommendation 2020-001

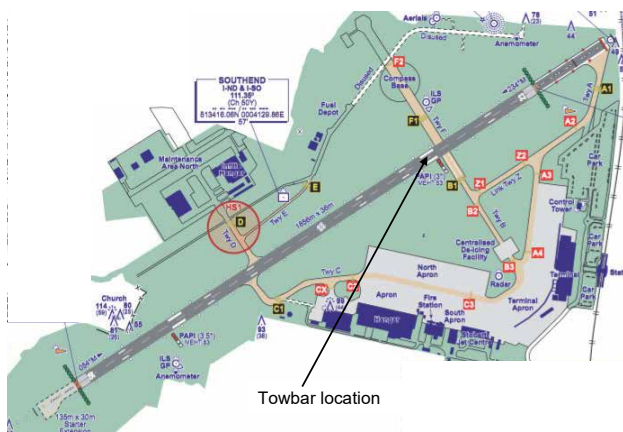
An Embraer 145 landing at London Southend Airport ran over a general aviation towbar which had been dropped on the runway. No damage was caused to the aircraft. The investigation found that the towbar had fallen from a Cessna 210 which departed Southend Airport 30 minutes before. The Cessna pilot had likely been distracted during his pre-flight checks by an earlier road traffic incident in which he was involved, and had inadvertently left the towbar attached.

London Southend Airport Chart showing approximate location the towbar was found

One Safety Recommendation has been made to the CAA to improve the visibility of general aviation ground equipment.

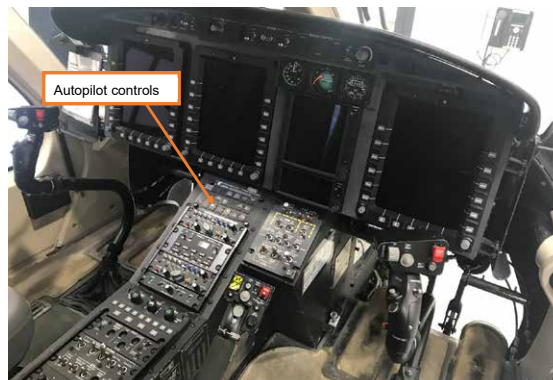
Autopilot control panel

The report considers two events which occurred while the pilot was conducting a Power Assurance Check. In one, an un-commanded yaw pedal movement caused a rapid rotation of the helicopter through two and a half complete rotations; in the other, a trim runaway was contained by the pilot. The trim runaway was found to be an unknown feature of the Automatic Flight Control System logic.

Following these events, safety action was taken by the helicopter manufacturer and Transport Canada to help crews respond to a yaw trim runaway and to address the underlying causal factor. Also, the flight recorder manufacturer improved the way it reported the results of CVR recording inspections.

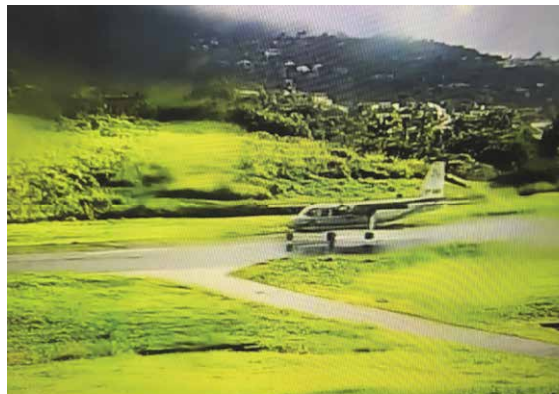
The aircraft was flying from Antigua to Montserrat, which was experiencing a heavy rain shower. After the shower had passed the aircraft made a normal approach in a light tailwind to Runway 10, which was still wet from the rain. The pilot made a positive touchdown and applied appropriate braking but was unable to stop the aircraft. The pilot steered the aircraft to the right but it skidded through 180° and departed the level surface of the airfield backwards, down a steep incline at the end of the runway, before coming to a stop when the tail caught in the airport security fence. The pilot and passengers were able to exit the aircraft and the airport rescue and firefighting service responded promptly.

VP-MNI at the point of
touchdown on Runway 10

No aircraft defects were found that would have contributed to the outcome. The touchdown groundspeed was 79 kt, which was higher than appropriate, either because the approach was flown at an airspeed greater than the normal 65 kt, or because of a significant change in windspeed and direction during the approach. This, combined with a wet runway and skidding, resulted in the aircraft requiring more distance to stop than was available on the runway. Three Safety Recommendations are made regarding aircraft operation, access for rescue and firefighting vehicles, and a means of arresting aircraft that overrun the runway.

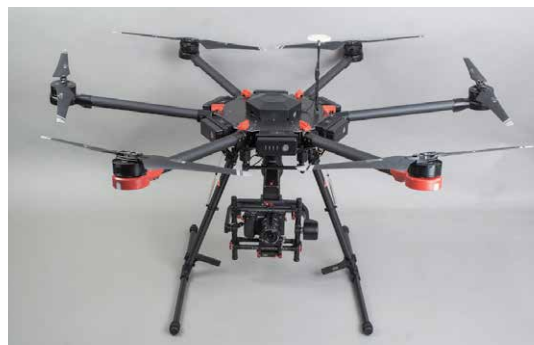
The UAS, a DJI M600 Pro, was being operated in an automated flight mode to survey a construction site when a GPS-compass error caused the aircraft to revert to a flight mode that required manual control. By the time that the pilot and observer realised that it was not responding to the return-to-home (RTH) function, visual line of sight was lost when the aircraft drifted with the wind beyond a line of trees. It subsequently collided with the roof of a house before falling into the property's rear garden. No persons were injured.

M600 series aircraft
The accident aircraft was fitted with three GPS antenna

The pilot, and the observer who was also a pilot, had operated UASs since 2018 and had the required permissions from the UK CAA. Both pilots had relied predominantly on the automated flight capability of their aircraft and had not, nor were required to have, practised for emergencies since completing their flying training in 2018. One Safety Recommendation is made to the UK CAA.

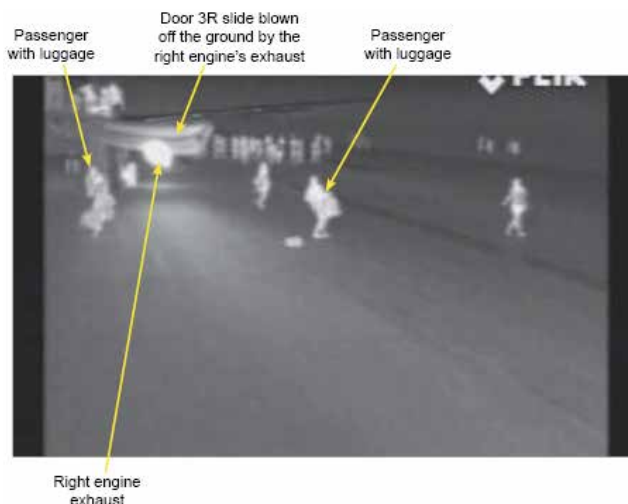
RFFS infrared CCTV showing some passengers leaving with baggage

The left engine experienced a contained failure following the rupture and release of several blades from the first stage of the high-pressure compressor. The investigation found that the blades fractured as a result of high-cycle fatigue loading which initiated in the dovetail (part of the blade root), due to a once-per-revolution aerodynamic excitation. An inlet guide vane lever arm had been improperly assembled which led to aerodynamic excitation of the passing blades and the resulting forces exceeded the design loads of the blades.

It is recommended that the European Union Aviation Safety Agency commission research to determine how to prevent passengers from obstructing aircraft evacuations by retrieving carry-on baggage.

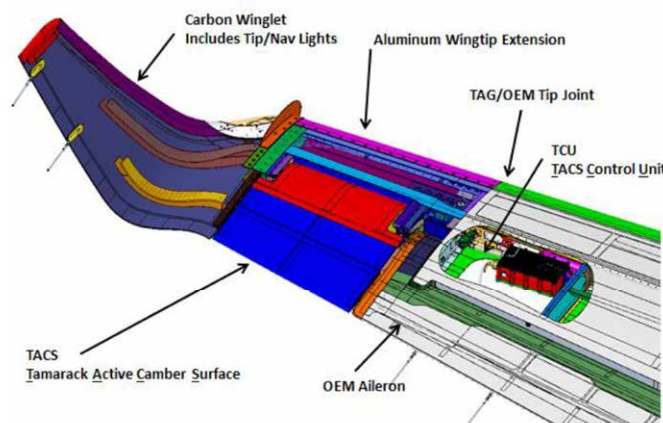
The aircraft had been modified with a system intended to enhance its performance, which included supplementary control surfaces designed to deflect symmetrically and automatically to alleviate gust loads. Shortly after takeoff, an electrical failure in this system caused one of these control surfaces to deploy separately, causing an uncommanded roll. The resulting aircraft upset caused the pilot significant surprise and difficulty in controlling the aircraft.

Cessna 525 wing with ATLAS installed

The pilot was not aware of supplementary procedures associated with the modification. The procedures did not adequately characterise the significance of the system failure, nor address the failure in all anticipated flight conditions. Certification flight tests of the system did not reveal the severity of possible outcomes. The 'Aircraft Safety and Certification Reform Act 2020' underway in the USA will review existing assumptions on pilot recognition and response.

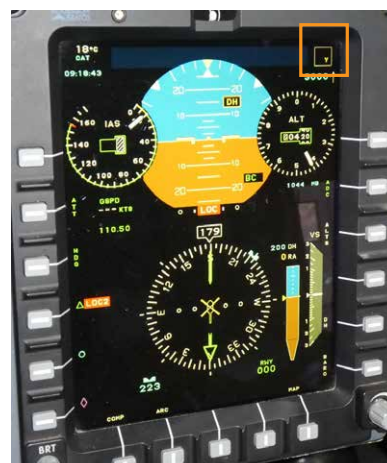
The first event on 15 June 2018 occurred during a PAC when the pilot's feet were clear of the pedals. The yaw trim actuator operated but the pedals could not move because of a restriction, and so the actuator wound up the artificial feel spring instead. When the restriction cleared, the pedals 'snapped' to full deflection as the spring unwound, increasing tail rotor thrust and causing the helicopter to rotate rapidly to the left through two and a half revolutions. The investigation did not determine the cause of the trim runaway or the pedal restriction.

Yaw out-of-detent indication

A similar yaw trim runaway on 2 January 2019 was controlled because the pilot's feet were resting on the pedals. The manufacturer determined that the AFCS logic meant that it was possible for pilots to inadvertently induce a yaw trim runaway and issued a revision to the RFM to reduce the risk of a recurrence. The manufacturer also undertook to address susceptibilities in the flight control system software identified during the investigation into these events.

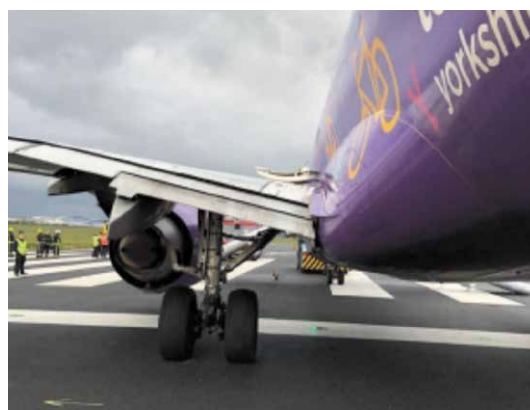
Drop to the ground from wing trailing edge with flaps in flap 1 setting

Due to the order in which the emergency evacuation vital actions were performed, the flaps had insufficient time to travel to the selected position. This resulted in an increased drop to the ground for passengers evacuating via the overwing exits, with many reluctant to jump or slide off the wing. Additionally, despite the presence of a marked exit route on the wing with a non-slip surface, many passengers who exited via the overwing exits were uncertain where to go once out of the aircraft. Both of these factors increased the time taken for emergency evacuation to be completed.

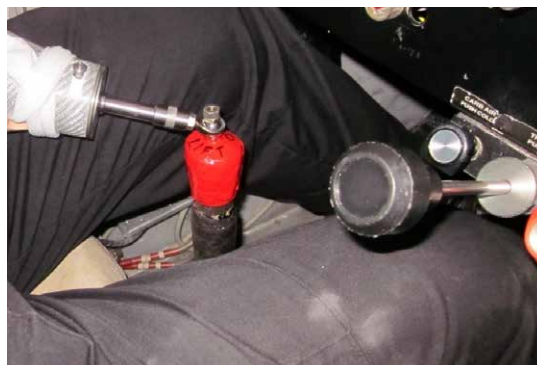
Prosthetic adapter in use

The aircraft landed heavily when the prosthetic adapter detached from the control column late in the approach and the pilot was unable to regain control before touchdown.

The pilot has since modified the interface between the prosthetic adapter and the aircraft control column. The UK CAA has amended the medical certification pathway for pilots with musculoskeletal disability to include an engineering assessment of interface between any prosthesis and the aircraft flying controls.

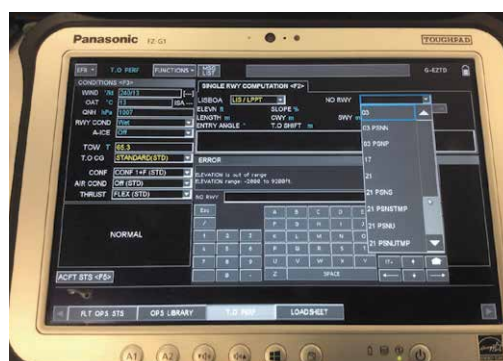
EFB dropdown menu showing the all the intersections available

Both aircraft took off using incorrect performance data for the intersection used. In each case, a selection error was made in the EFB which led the crew to believe that they had calculated performance information for a departure from S1 when in fact they had selected the full length of the runway. In both cases, the procedural barrier of cross-checking the runway distance against the aerodrome ground chart failed to prevent to error. Human performance limitations mean it is difficult for pilots to recognise and react to reduced performance (acceleration) once the takeoff has begun, so robust adherence to procedures is a key defence against such incidents occurring.

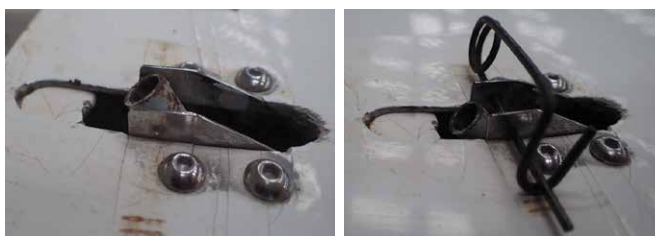
The investigation determined that the tailplane had not been correctly attached when the glider was rigged and this condition was not detected prior to the flight. Several possible mis-rigging scenarios were identified during the investigation, but the precise manner in which the tailplane had been mis-rigged could not be determined.

Locking lever when tailplane attached
(left image)
and when locked with safety pin inserted
(right image)

Two Safety Recommendations are made relating to communication for glider launching and detecting incorrect alignment of tailplane locking features. In addition, the gliding club has undertaken several safety actions regarding launch signalling and detection of incorrect tailplane locking on other Standard Cirrus gliders.

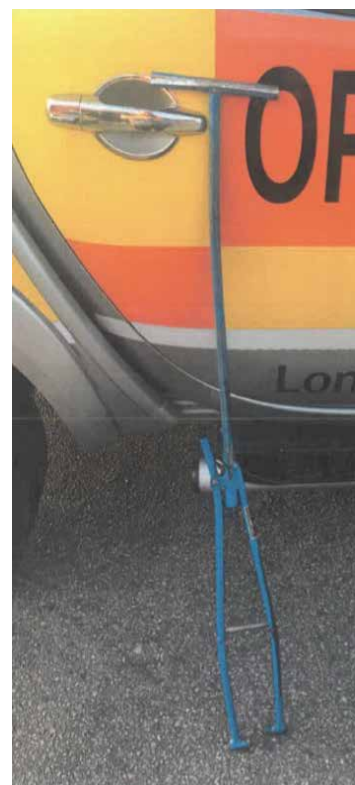
A general aviation towbar was inadvertently left attached to an aircraft because the pilot had been distracted by an earlier stressful event during his journey to the airport. The towbar dropped onto the runway during the departure and remained there for approximately 30 minutes, during which two other aircraft used the runway and a runway inspection was completed. A landing aircraft then ran over it. The towbar was inconspicuous because it did not have any reflective or other high visibility markings.

Towbar recovered
from the runway

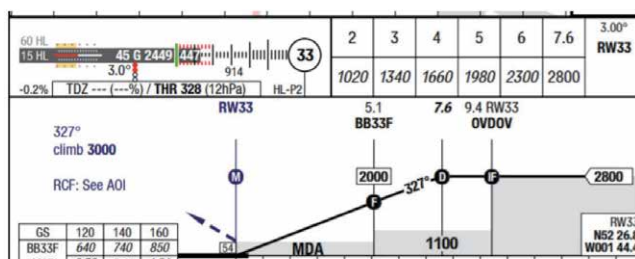
The aircraft did not maintain the correct vertical profile because the pilots were not sure when to commence the final descent. The depiction of the descent profile on charts provided by the operator may have contributed to this uncertainty.

Extract from operator's chart for RNAV approach to Runway 33 at Birmingham

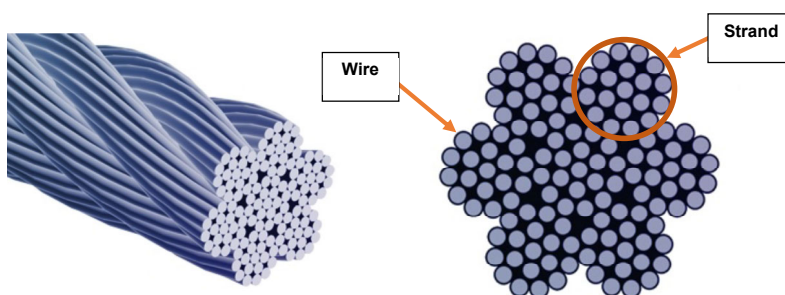
The most probable reason for the aileron cable breaking was that its strength had reduced as a result of wear leading to the failure of individual wires within the cable. The cable failed where it passed over a pulley on the rear wing spar where

Construction of the control cable

dirt accumulates which can penetrate into the strands and form an abrasive compound. This can accelerate the normal rate of cable wear. Post-modification cables are available which have a sleeve fitted over the susceptible section to prevent the ingress of dirt. The investigation established that the inspection procedure in the AMM would not have detected the damage to individual wires that run inside the cable.

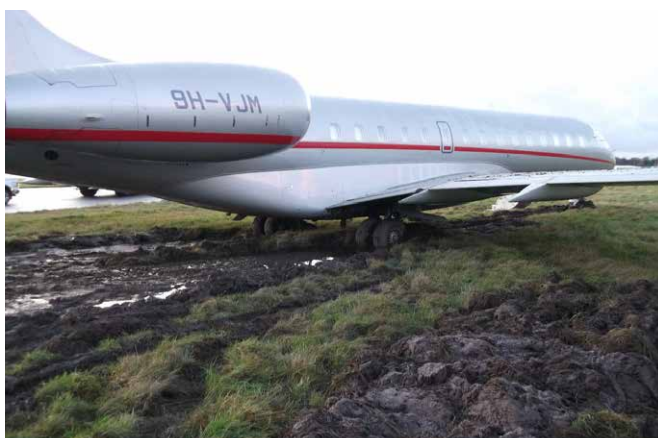
9H-VJM on the soft ground

As a result of a fault, the NWS went into free caster shortly after touchdown. During the subsequent landing roll, directional control of the aircraft was lost, and the aircraft departed the right side of the runway and onto the grass. The commander, in applying left rudder to try to keep the aircraft straight, had inadvertently applied some right braking. As the aircraft slowed, full left rudder was unable to counteract the effect of this braking.

'we would like to recommend all pilots, at the first occasion and when on the ground at parking on board of the airplane, to apply FULL rudder deflection. At full rudder deflection one should check if both brakes can be pushed. In addition, notice that the opposite rudder pedal moves physically closer to your body, if you feel the pressure of the closer pedal increasing and if you apply any unwanted brake pressure due to the position of your shoe on the pedal, the pedals/seating position should be adjusted. This should be checked in the normal seating position with the respective shoe position adopted for takeoff and landing.'

- In its Training Syllabus for 2020 the operator has included a failure of the NWS system after landing as a preferred malfunction

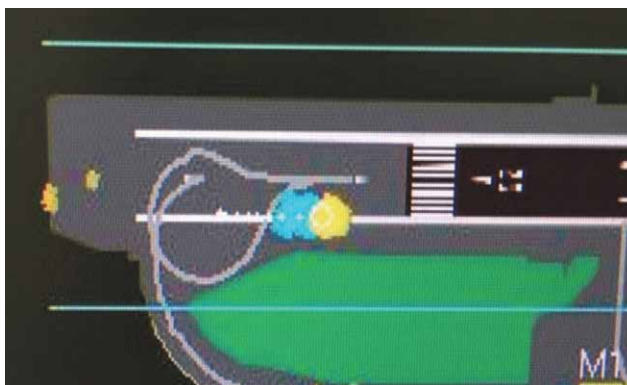
The aircraft began taking off on the edge stripe of Runway 23R at Manchester after lining up via intersection J1. The sun's glare on the wet runway, and the orientation, dimensions and slope of the intersection and runway surfaces, contributed to the pilot misidentifying the centreline. The rolling takeoff reduced his opportunity to check the aircraft's position.

Image of SMR at the commencement of D-COLT's takeoff roll

As a result of this and a previous similar event, the airport authority is implementing several safety actions to assist pilots lining up at J1.

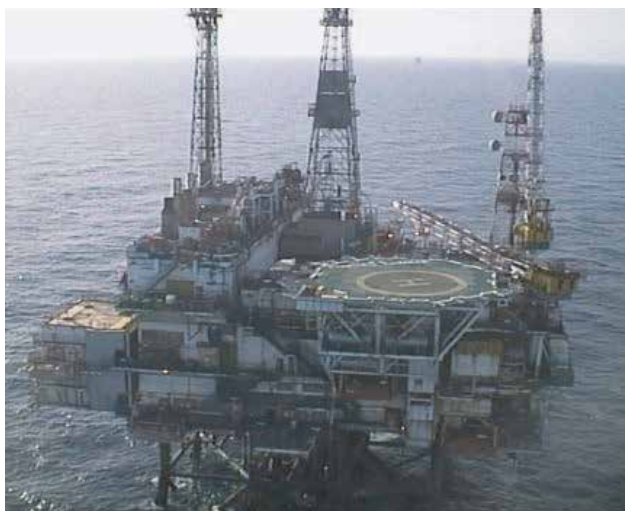
Discussion between the pilots about the position of the crane on the 40C platform probably resulted in them switching their attention incorrectly to this platform and away from the 40D platform. The crane was not stowed on either platform, so did not serve as a distinguishing feature.

Forties Charlie (40C) platform

The pilots' familiarity with the Forties field, the physical similarity of the platforms, and the identical approach and landing flight path to each of them served to reinforce their selection of the wrong deck.

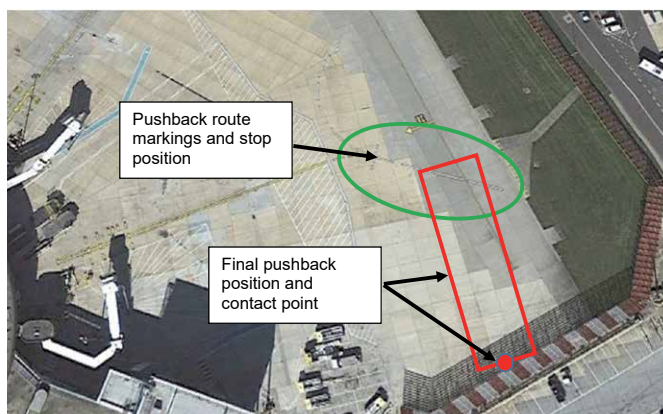
G-CKWB was parked on Stand 38 at London Gatwick Airport. The aircraft was loaded, with the doors closed ready to depart for its flight to the USA. Permission was granted by the ground controller for the aircraft to push back and start engines at 0910 hrs. The aircraft was pushed back using the incorrect line and as a result the aircraft tail cone struck the blast screen.

Final pushback position

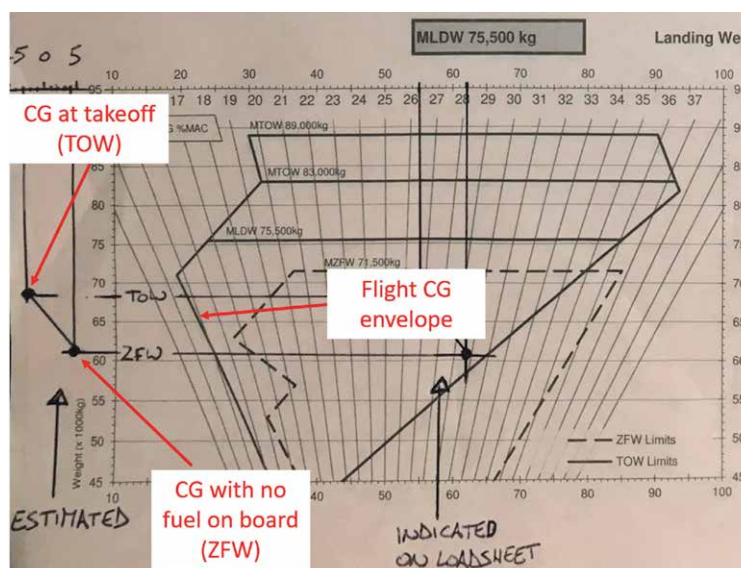
The A321 Load and Trim Sheet that would have resulted on the incident flight

The incident occurred due to the aircraft change from an A320 to an A321 not being notified to both OHD and PSD. As a result, the passengers were seated at the front of the aircraft, placing the CG outside the forward limit of the operating envelope. The effect of this was that, at rotation, the aircraft appeared to the crew not to respond as expected to the normal side stick control inputs due to the forward CG. The PF required almost maximum aft control input and the PM selected TOGA thrust before the aircraft nose lifted. The crew analysed the problem but considered that an incorrect stabiliser setting, taken from the load sheet, had caused the problem. Only at the top of the descent for the destination did it become apparent that the passengers had possibly been incorrectly distributed in the cabin. The crew did not experience any unusual control response during the approach and landing.

Following this event, the operator took action to: highlight this event to its staff and improve their understanding of the issues raised; and improve the flow of information between operational departments when there is a change of aircraft type to reduce the risk that a similar event would occur in the future.

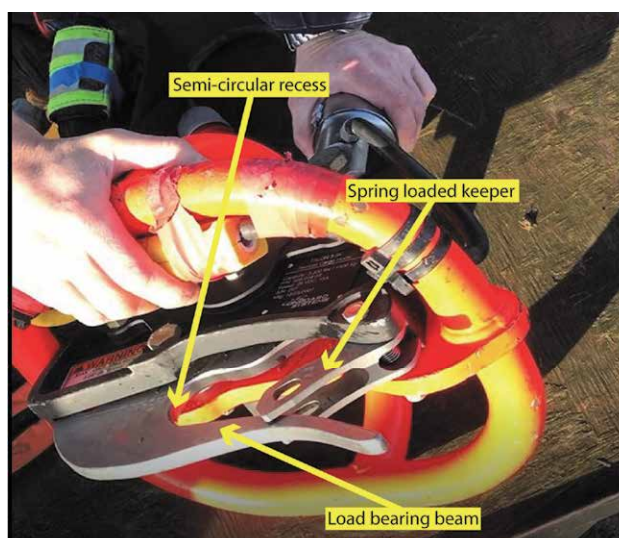
The most probable cause for the inadvertent release of the load was that the load had not been positioned correctly across the hook's load bearing beam when the load was hooked on. At this time, the client's employee, although having been trained in underslung load lifting operations, was working alone and was not being directly supervised. However, an intermittent fault could not be ruled out as an alternative cause for the release.

The spring-loaded keeper hook
fitted to G-PDGF

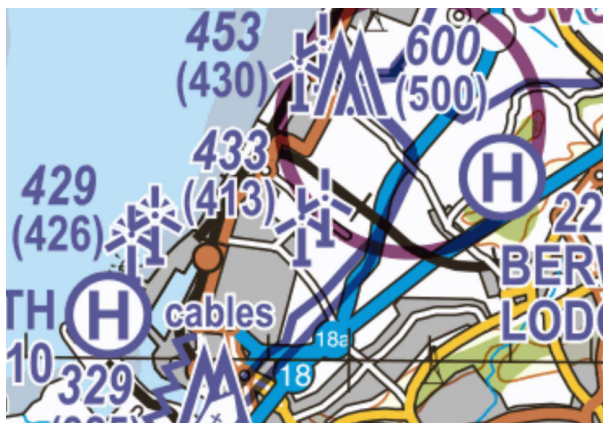
Extract from the CAA 250K aeronautical chart with the wind turbines at the sewage works in the centre of the image

For a UAS pilot flying visual line of sight with the aircraft, tall obstacles may be obvious to see but their actual height is difficult to assess visually. All known ground obstacles greater than 300 ft in height are shown on aeronautical charts. These charts, and apps that use the same obstacle database, are one source of accurate information, and provide a clear indication of areas to avoid flying a UAS if limited to flying not above 400 ft. However, for obstacles less than 300 ft, UAS pilots will need to determine their accurate heights from other sources.

UAS pilots are responsible for flying their aircraft within the limitations imposed by their CAA Permission and so must ascertain the accurate height of any hazard or obstacle near the planned flightpath.

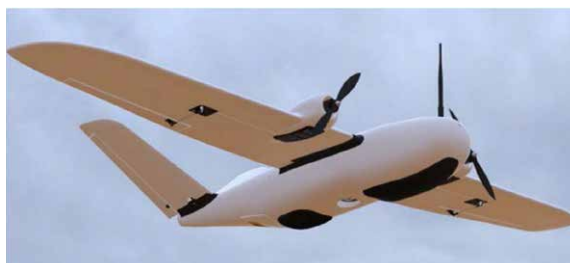
General view of the Believer UAS

The safety pilot erroneously turned the transmitter off before the automatic control system was activated and before the instruction to turn the transmitter off had been issued.

- Operations were reviewed to minimise the period where a UAS is under manual control. The UAS is now launched in a revised automatic mode where the safety pilot can apply control inputs to correct the flight path if appropriate. The safety pilot can also disable the automatic flight control system and take full control of the UAS in the event of an emergency.
- The fail-safe logic has been reviewed and modified so that settings are automatically configured depending on the status of the UAS.
- The operator has reviewed their fatigue risk management strategy and is introducing limitations with respect to permissible crew working times and a requirement for crew members to consider their well-being and declare themselves fit for operation during every flight briefing. The operator is updating their operations manual accordingly.

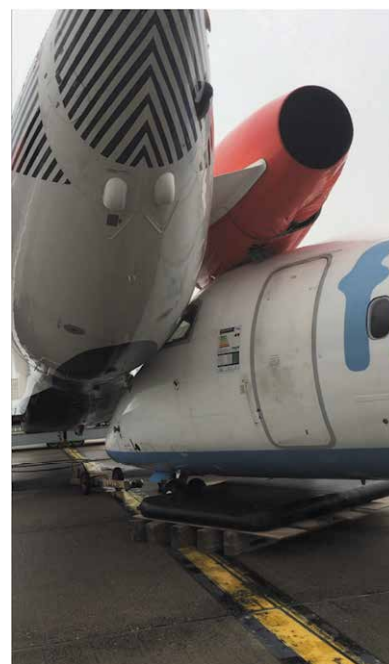
G-JECK rolled across Taxiway D from its parking position and struck G-Sajs because the nosewheel chocks had been inadvertently removed, and the hydraulic pressure in the park brake accumulator had depleted over several days to the point where it was unable to prevent the aircraft from moving on the 1° slope.

G-JECK and G-Sajs
during recovery

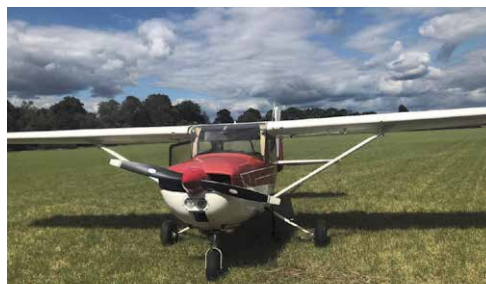
G-CSBM after the
precautionary landing

Through a desire to measure the fuel accurately the pilot had used the incorrect fuel dipstick leading him to overestimate the fuel onboard.

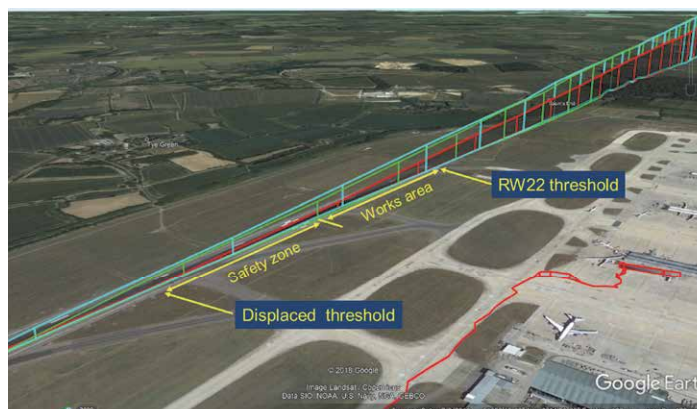
The pilots of YL-LCQ had not realised that a revised approach was required and flew the standard RNAV arrival. Radar data indicated that the aircraft was low over the works area and touched down close to the displaced threshold. Temporary approach plates were available to the pilots in their electronic flight bags (EFB), but the stated workinprogress (WIP) active periods on the temporary airfield chart were incorrect. ATC

Comparative radar traces
(YL-LCQ trace in red)
