# ***AAIB Bulletin***

***7/2021***

Published 8 July 2021

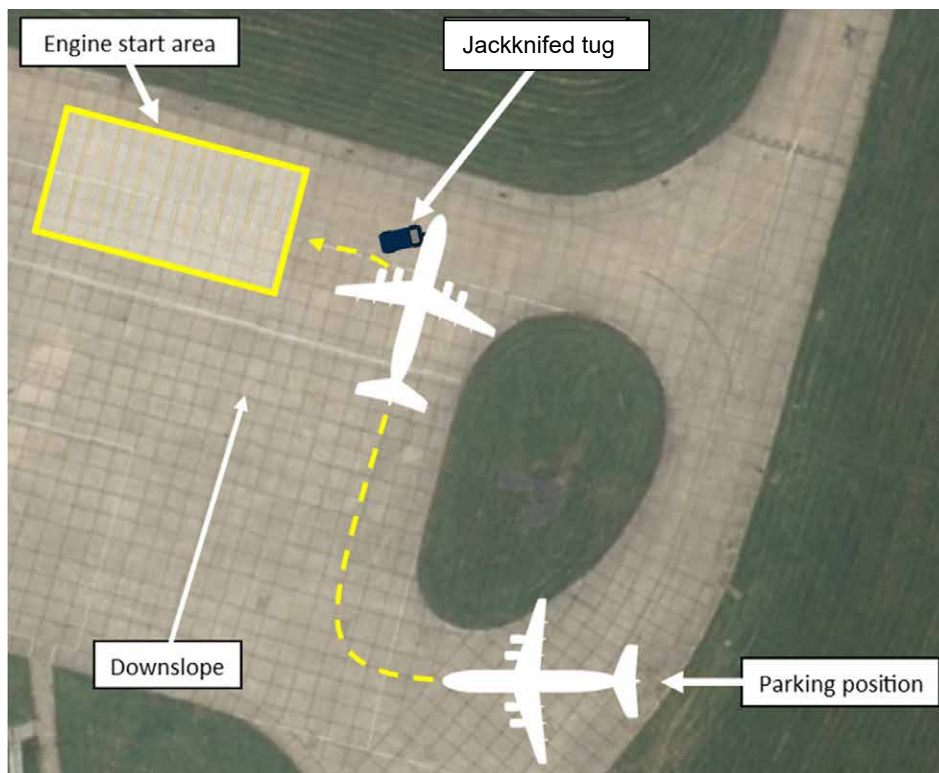
**Figure 1**

The crew boarded G-JOTR while it was parked on a taxiway, but airfield restrictions required it to be towed to a designated area on the apron for engine start (Figure 1). The towing route followed the edge of the apron, which was damp and downhill, and involved a 90° left turn to line up for start. A combination of unfamiliarity with a relatively new operating base, towing in reverse and difficulty interpreting "indistinct" taxiway markings meant the tug driver entered the left turn later than intended. The late entry made the turn excessively tight, and the tug lost traction on the damp surface and jackknifed. The resulting combination of a sharp towing angle and the aircraft's downhill momentum caused the towbar shear pin to break. The commander applied the brakes immediately on hearing "the sound of snapping metal" but was unable to prevent the aircraft rolling forward into the tug.

Approximate towing route and accident location  
(Image courtesy of Ordnance Survey © 2021 TomTom)

The operator's internal investigation report made several safety recommendations, including a review of towing procedures, enhanced driver training, the use of radios by towing teams and improvements to taxiway markings. The company also reviewed its apron risk assessment and towing was added to their audit plan.

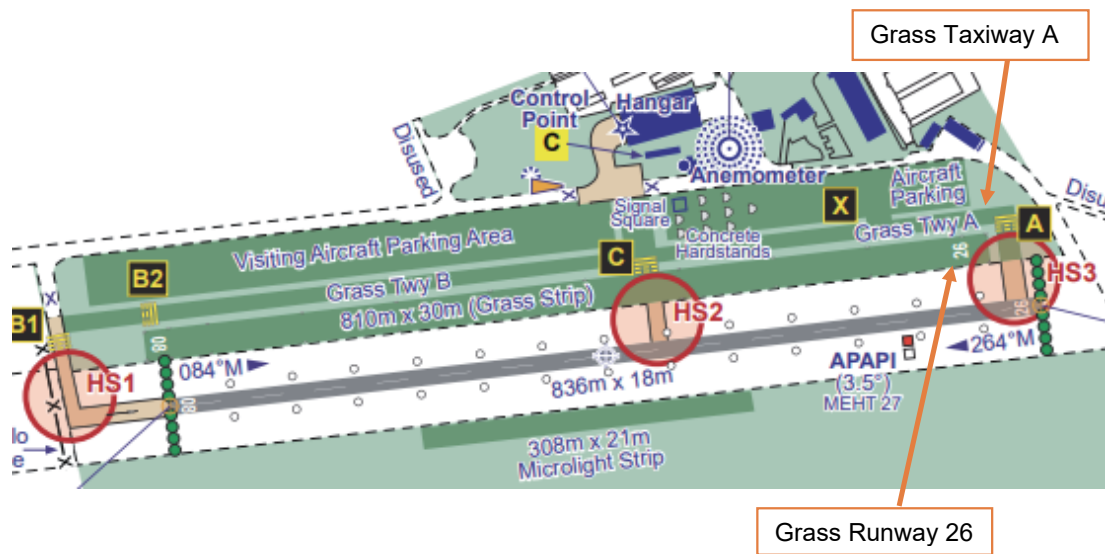
**Figure 1**

After encountering a gust of wind which displaced its final approach, the aircraft landed on unprepared ground beside the runway and completed its landing roll on an adjacent taxiway, without reported damage or injury. In deciding to continue the landing the pilot had applied what he considered to be a cautious interpretation of information regarding the conduct of go-arounds in this aircraft.

Extract from Shobdon's Aerodrome Chart<sup>2</sup>

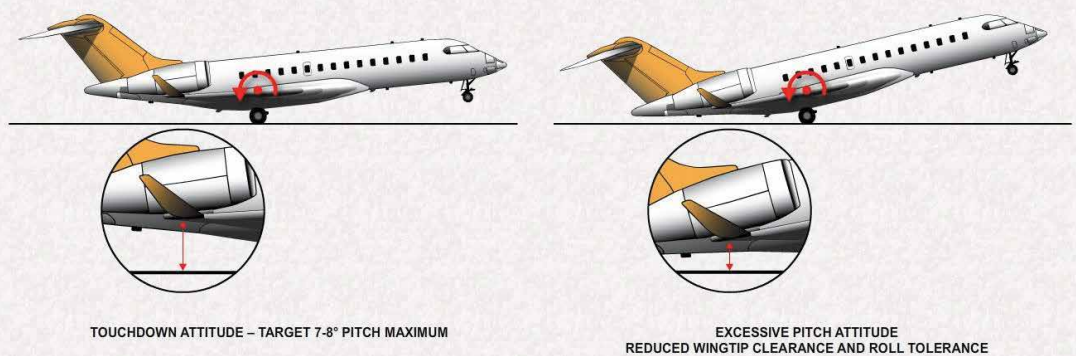
**Figure 3**

A diagram provided by the manufacturer illustrating the relationship between nose-up pitch and wingtip clearance is shown at Figure 3, along with the angle of bank at which the tip will contact the runway (with the wing on the ground but not producing lift (JIG), and in flight).

As pitch attitude increases in the flare the wing tip gets closer to the runway. At this stage, any roll input from wings level further reduces the clearance between the wing and runway.

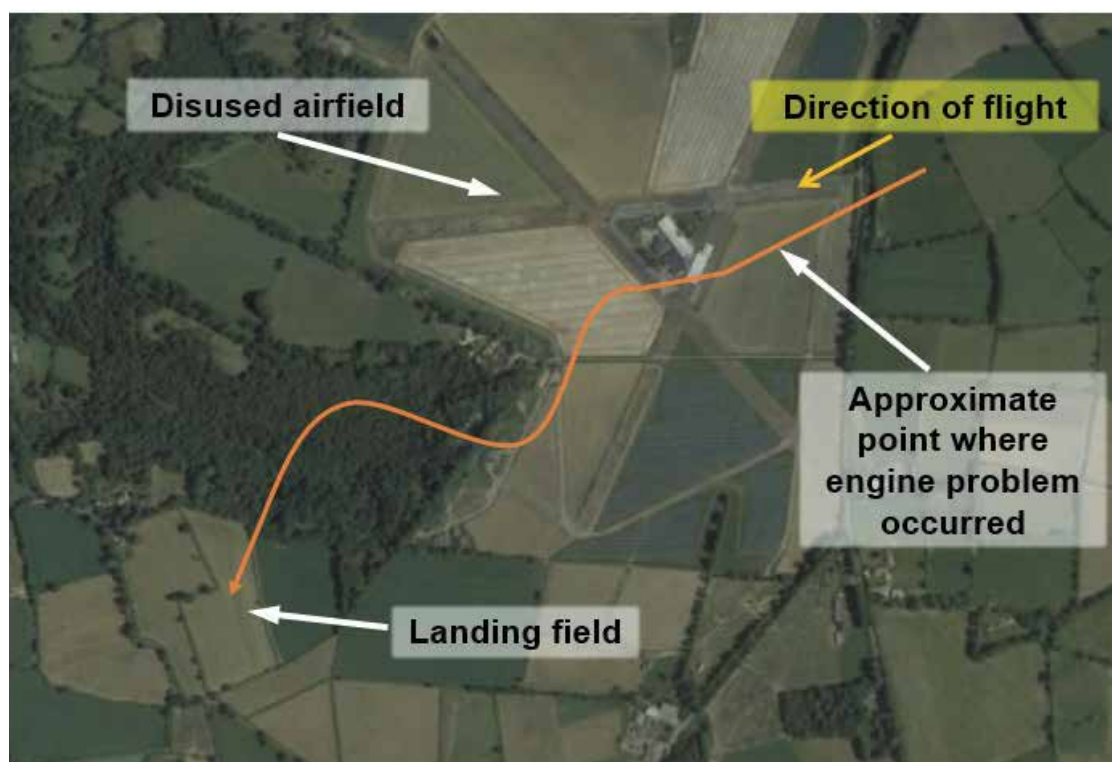
**Figure 1**

Forced landing options were limited because of surrounding obstructions and the characteristically high descent rate of the Stearman with a windmilling propeller<sup>3</sup>. However, Pilot A performed a curved approach to a nearby grass field (Figure 1), located around 5 nm north-east of Dunkeswell.

Approximate flight path reported by Pilot A  
(© Google 2021, Image © Landsat / Copernicus” for google earth)<sup>4</sup>

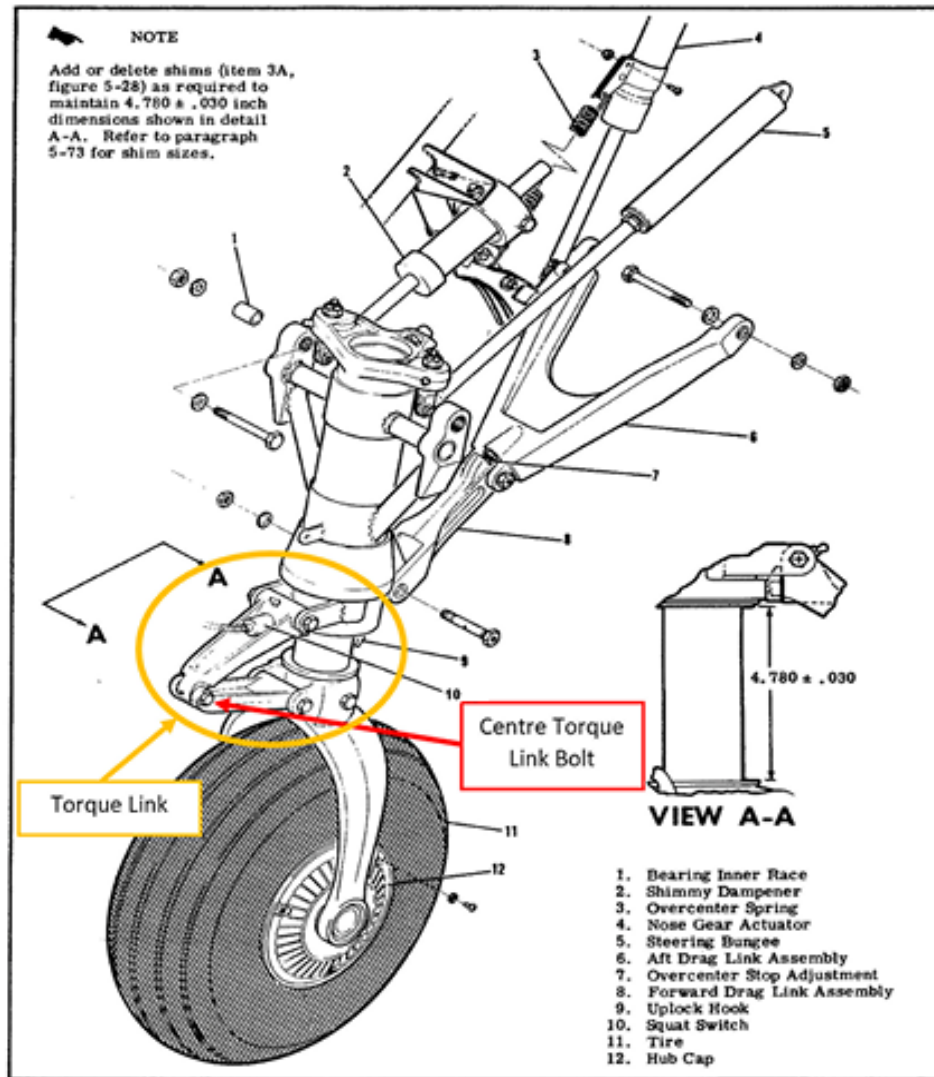
### Figure 3

After the landing a bolt was recovered from the runway which was identified as the nose gear centre torque link bolt. This bolt had been in contact with the runway surface after the nose gear collapse and as a result suffered significant damage. The nut from the bolt was also missing. There was also corresponding runway contact damage to the nose gear torque link. These were the only two parts of the nose gear that were found to have sustained damage, and they are shown in Figure 2. Their positions in the nose gear assembly are shown in Figure 3.

Figure 5-26. Nose Gear Installation

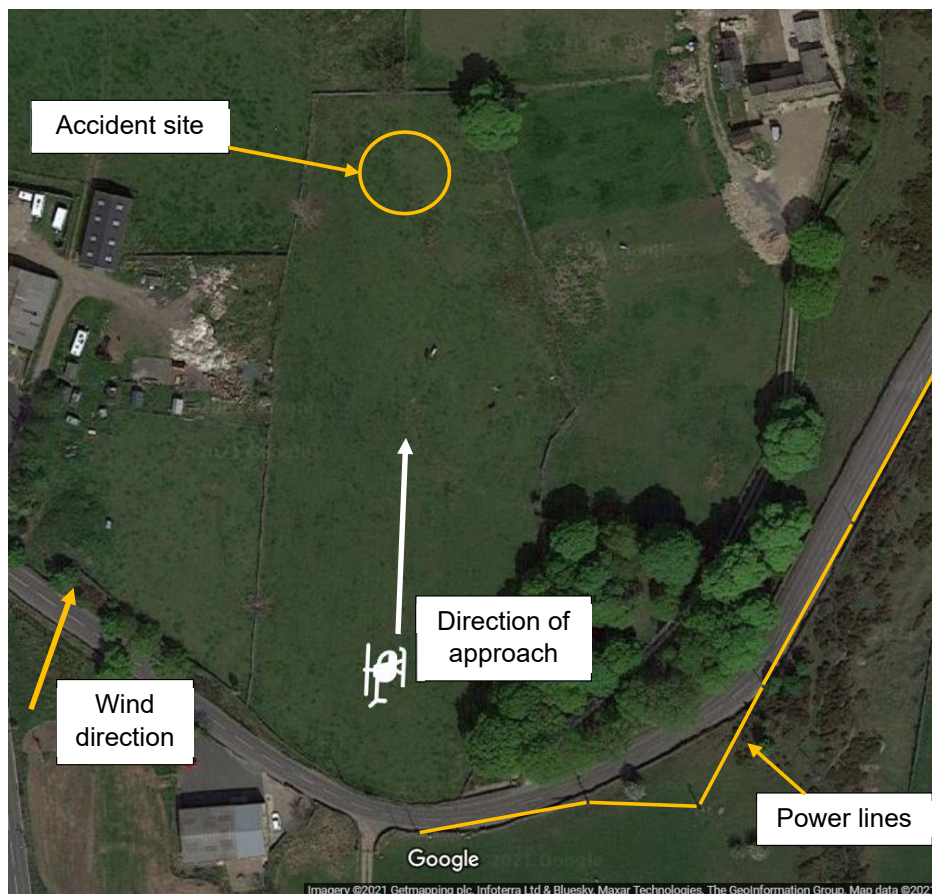
**Figure 1**

The aircraft had landed in a part of the field where the ground was undulating, sloping and boggy. To the east and west of the field were ridge lines with a wind turbine situated to the south and power lines positioned to the south and south-east (Figure 1).

Landing field showing power lines, wind direction and crash site
