# ***AAIB Bulletin***

***8/2021***

| Sikorsky S-92A | G-LAWX | 14-Oct-19 | 3 |

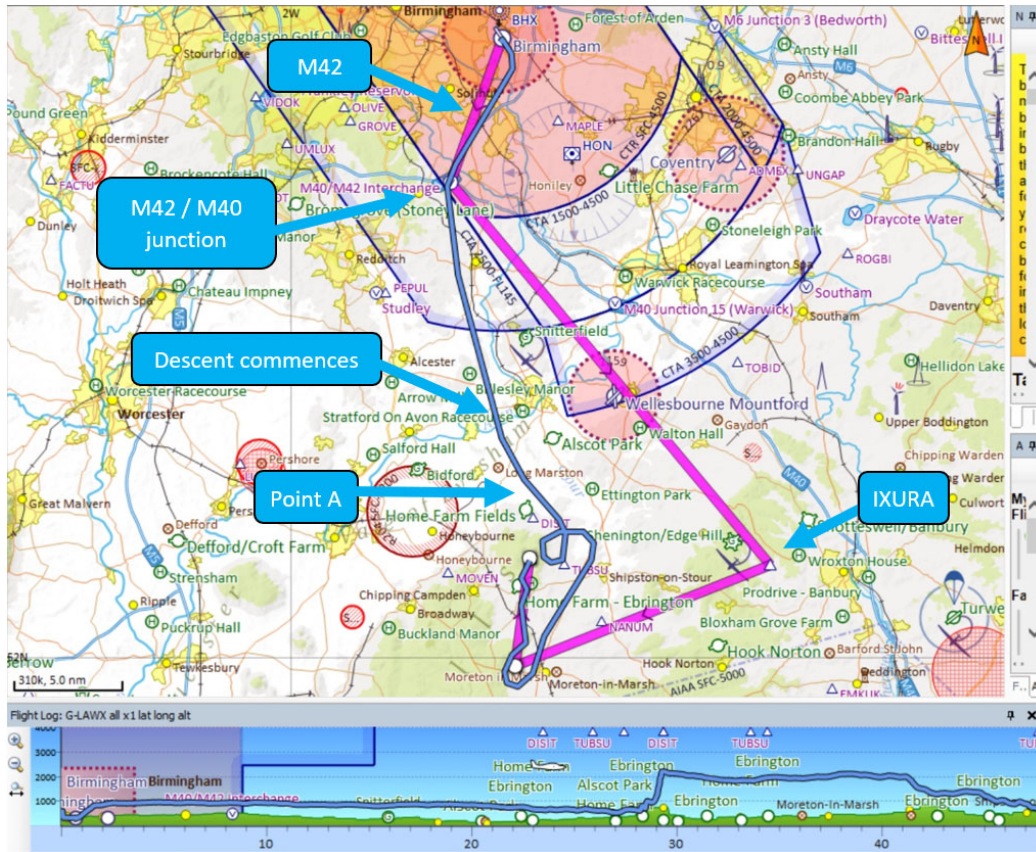
**Figure 1**

G-LAWX planned flight path (pink line) and actual flight path (blue line)  
Chart used with permission of SkyDemon. Not to be used for navigation.

After takeoff, the helicopter turned to the right and tracked along the M42 motorway for just over a minute, until reaching the M40 junction. During this phase, radio altitude ranged between 369 ft to 535 ft agl. The helicopter then turned towards the vicinity of the LS (Figure 1).

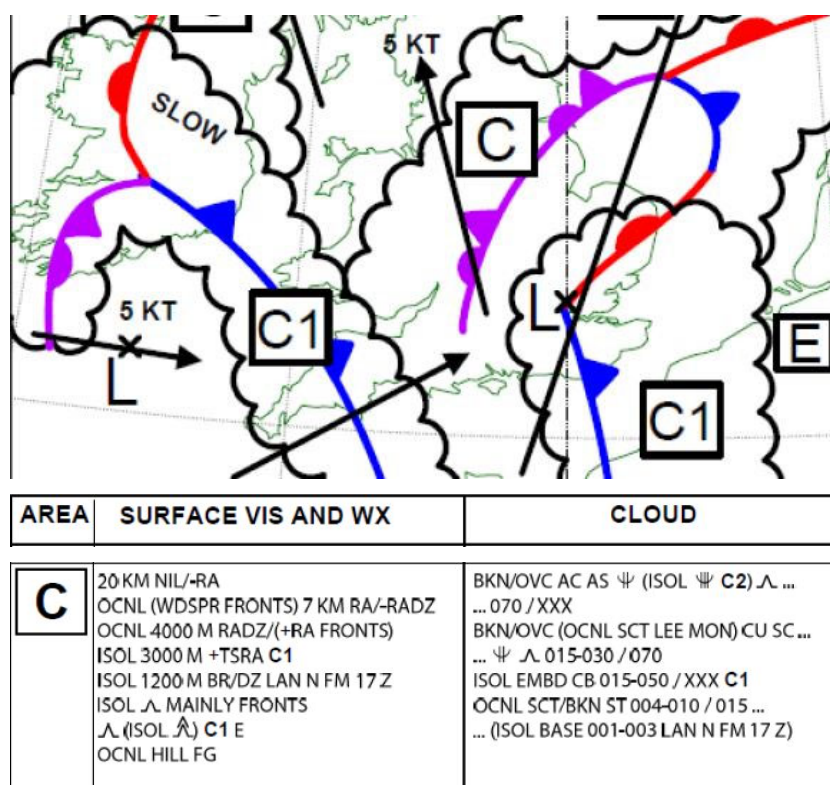
**Figure 5**

The area forecast (Figure 5) indicated that the overall situation for Area C would be very unsettled with a main cloud base between 1,500 and 3,000 ft amsl. Conditions would deteriorate in early evening in the vicinity of the occluded front, which was forecast to move north, affecting the area. At times, this would result in a cloud base across the area of 1,000 ft amsl but also with lower stratus down to 400 ft amsl. Visibility would also be reduced to 7 km in rain, occasionally deteriorating further to 4,000 m in heavier rain.

F215 for 1400-2300 UTC 14 October 2019

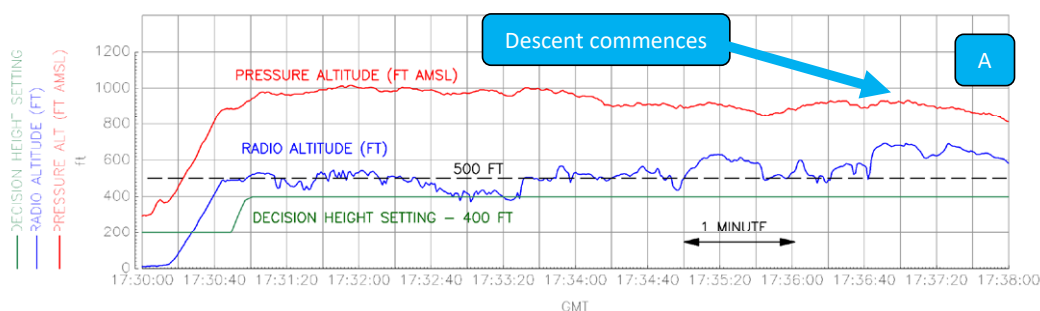
**Figure 9**

The altitude profile for the flight from takeoff to Point A in Figure 1 is shown in Figure 9. Parts of this flight were performed at a height of less than 500 ft agl. As the helicopter crossed the M40/M42 junction VRP, the CVR recorded a radalt alert “ALTITUDE, ALTITUDE” on five occasions in quick succession, which the commander acknowledged. At 1733:34 hrs, after one of the alerts, the commander stated, “CHECKED, CAN YOU BUG THAT DOWN.” The FDR recorded that the radalt alert value was not altered in response. Further radalt alerts were recorded on the CVR until at 1739:29 hrs, the pilot stated, ‘LET’S GO, BUG IT DOWN TO ONE FIFTY PLEASE.’ Ten seconds later, the FDR recorded the radalt alert value reducing to 150 ft. At 1737:36 hrs, the helicopter commenced a descent from an altitude of 890 ft (689 ft agl).

G-LAWX recorded pressure and radio altitude. Point A refers to location in Figure 1

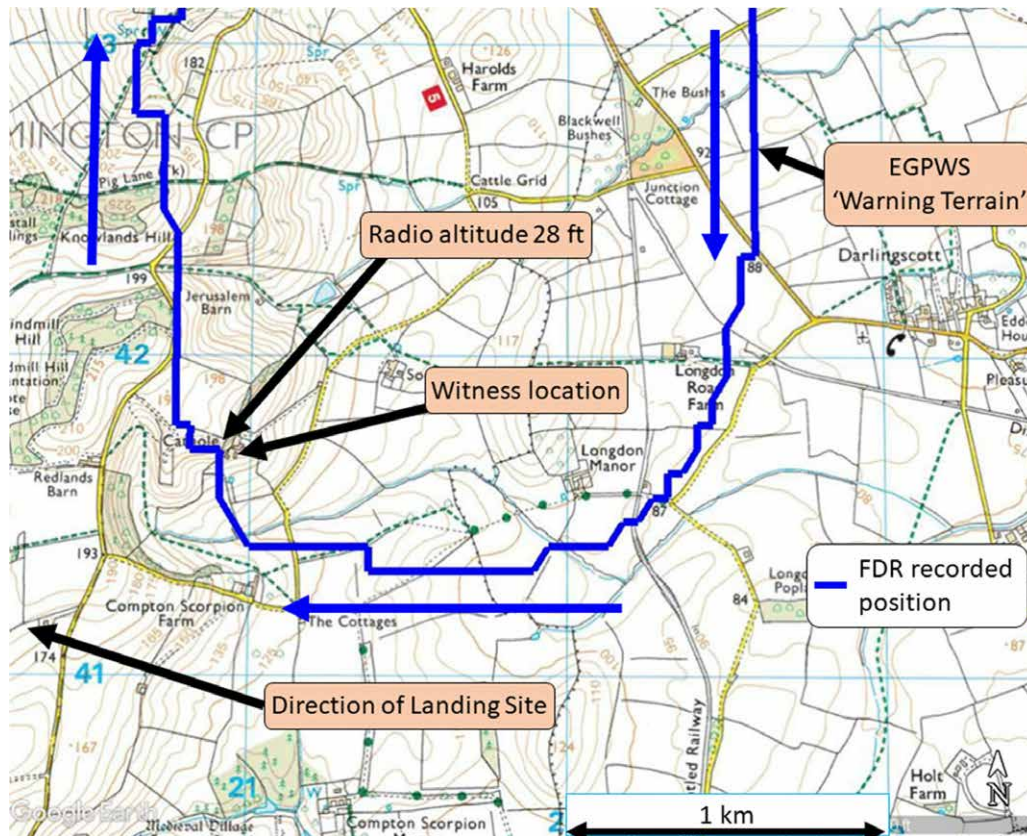
**Figure 11**

After the first EGPWS alert, the helicopter started a slow turn to the right. Just after the second EGPWS alert, it began tracking towards the LS (Figure 11)

G-LAWX incident flight track (terrain heights are in metres)  
© Crown copyright 2020 OS 0100015274

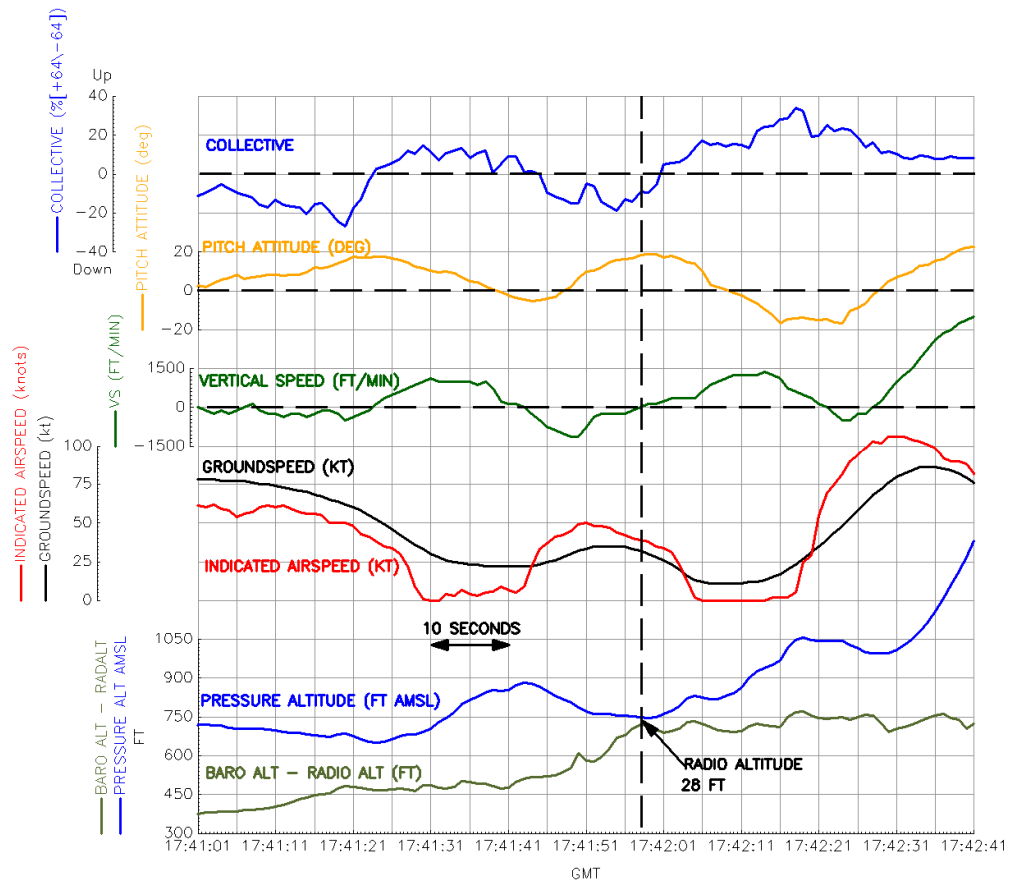
**Figure 12**

As the helicopter flew in a westerly direction, the pilot had right pedal applied throughout, yawing the helicopter gradually onto a more northerly heading. At 1741:21 hrs, the CVR recorded the co-pilot stating, “ONE MILE TO GO”. At 1741:25 hrs, the commander asked, “IS THAT THE HOUSE?” to which the co-pilot replied “LOOKS LIKE IT”. The helicopter had descended gradually to an altitude of 654 ft (186 ft agl) with a groundspeed of 49 kt and indicated airspeed of 35 kt. The helicopter continued to slow and yaw to the right but had started to climb because the commander had raised the pitch attitude to +18° (Figure 12).

G-LAWX FDR data for first approach

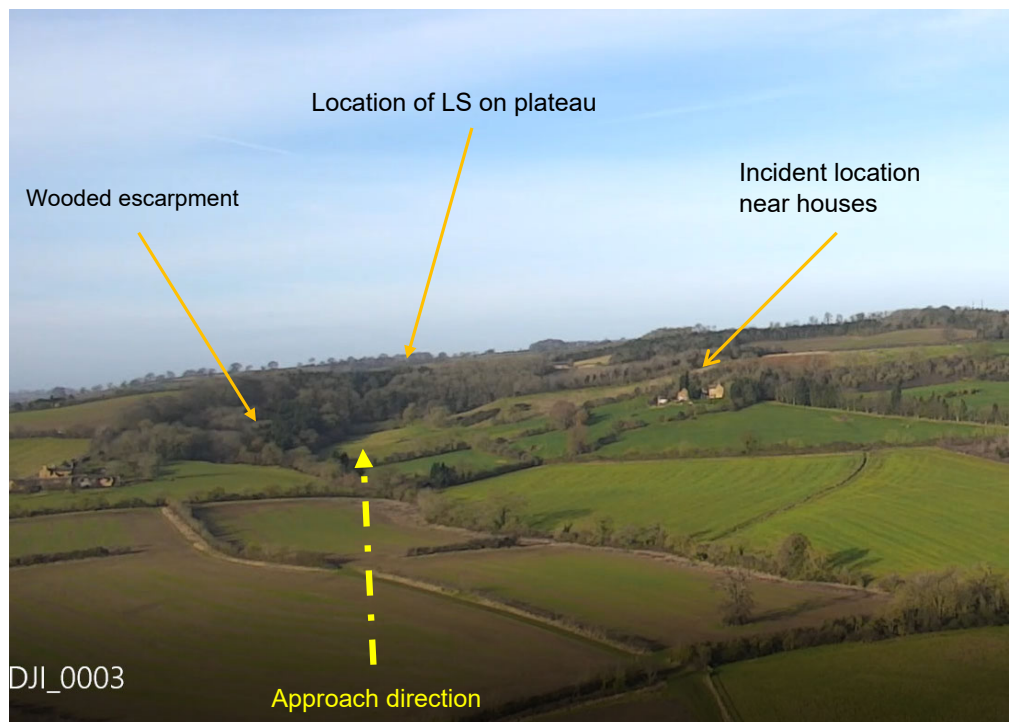
**Figure 15**

Approaching the LS from the east (Figure 15), there is a steep wooded escarpment below a plateau on which the landing site is situated. The helicopter came closest to the ground 1 km east of the LS and 600 ft to the north of the intended westerly approach path, near the top of a hill with an elevation of 650 ft amsl and a gradient of 15 - 20%.

View of the approach to the LS from the east.  
(This image does not show the conditions of reduced light and visibility present at the time of the serious incident.)

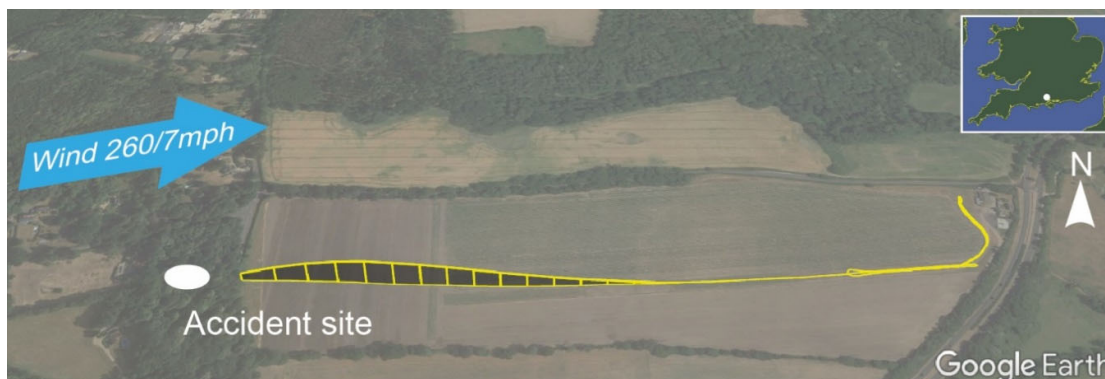
**Figure 3**

The accident flight log started at 1416 hrs (Figure 3). The aircraft taxied along the initial part of the runway and then backtracked to the east end of the runway. The takeoff started at 1433:08 hrs and the last recorded data point was 36 seconds later.

Oblique view of the accident flight

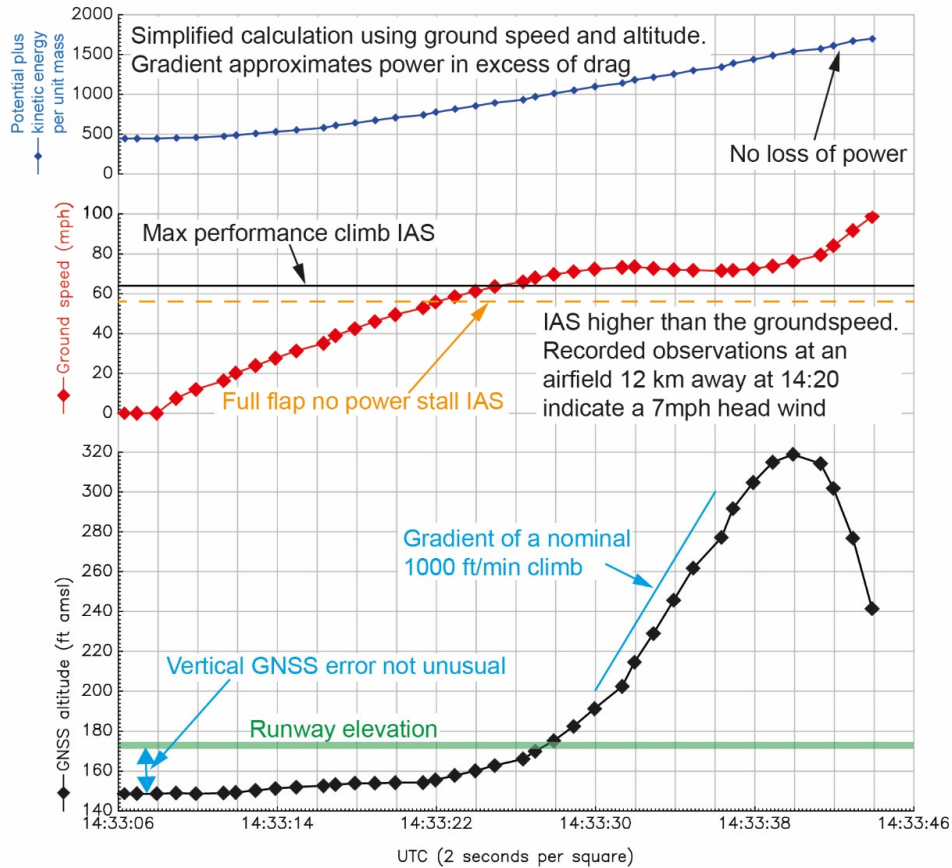
The data for the flight is shown in Figure 4. The aircraft initially climbed at approximately 1,000 ft/min with a ground speed of approximately 70 mph. Weather information, from Southampton Airport 12 km away, indicated a head wind of about 7 mph was present at the time. This indicates that the IAS was above that required for a maximum performance takeoff. The climb rate and speeds were as expected for the aircraft type and similar to previous takeoffs from that location recorded in the tablet.

The aircraft stopped climbing, peaked at approximately 150 ft agl and started descending. The aircraft accelerated in the descent. The energy of the altitude / speed profile in the descent indicates similar engine power was in use as that in the climb. The altitude / speed profiles of the previous takeoffs from the same runway indicated a similar amount of power being produced by the engine (Figure 5).

**Figure 4**  
Accident flight data

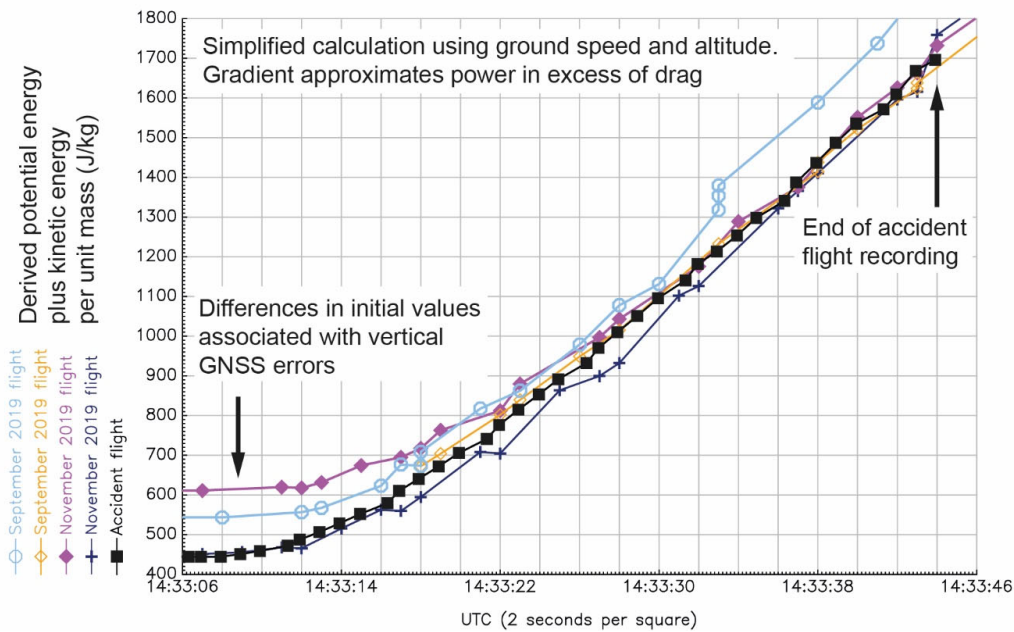
**Figure 5**  
Comparison of the power used during the accident flight takeoff with that used during previous takeoffs from the same location.

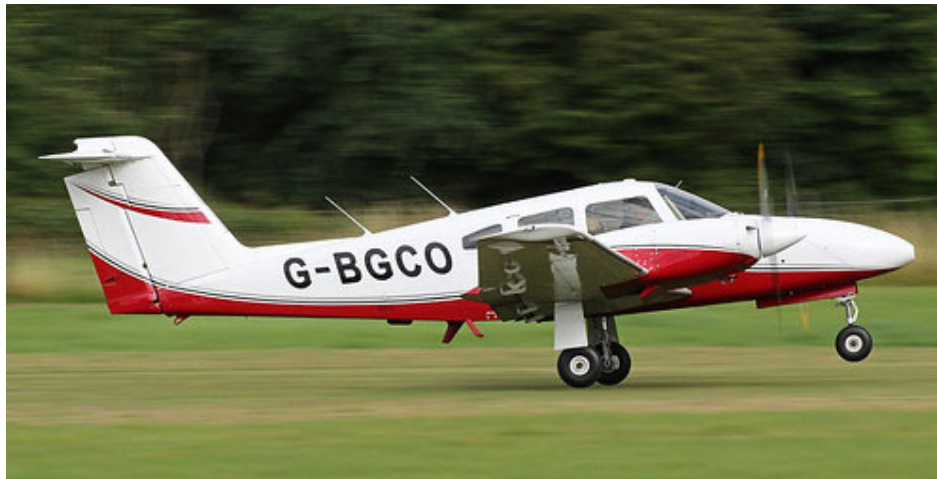
**Figure 1**

Both main landing gear legs indicated locked down with green indicator lights but the nose landing gear leg showed not locked with a gear unsafe indication. The pilot followed the POH checklist actions, which included recycling the landing gear selection and changing the indicator bulbs, but this did not resolve the problem. The pilot then recycled the landing gear selection using varying applications of positive and negative g in an effort to force the nose landing gear down. On every selection the nosewheel was seen to

travel using a mirror on the engine cowling, and on each occasion it appeared fully down although the gear unsafe indication remained. The aircraft was flown past the ATC tower for external observation and the nose landing gear appeared to be down. The landing gear emergency down lever was pulled but the indications remained, showing both main landing gear legs locked down but the nose landing gear not locked.

Piper PA-44-180 Seminole
