PART 1.4

Analysis and Findings

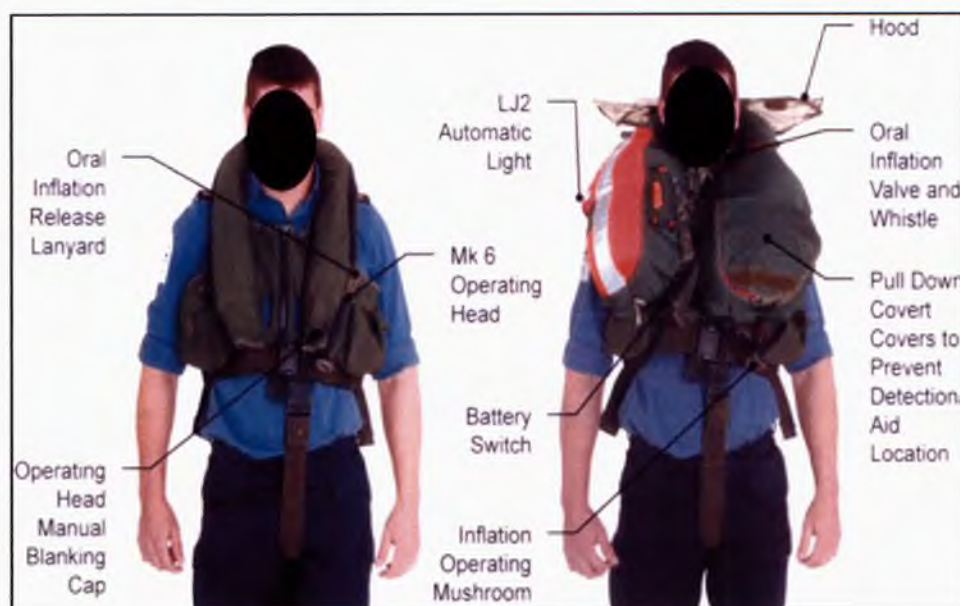
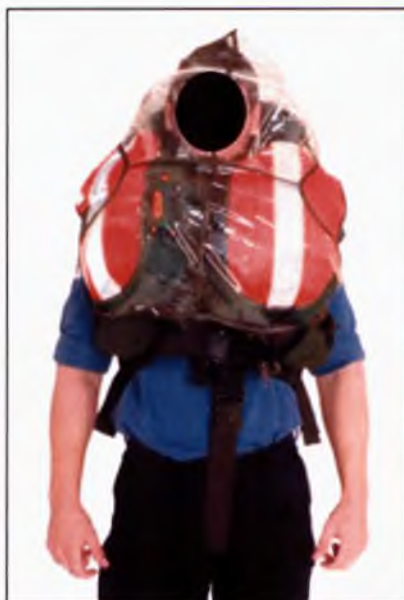
Figure 1.4.29 – Landing Craft Life Jacket (LCLJ) front view.

Figure 1.4.30 – Landing Craft Life Jacket (LCLJ) deployed and spray cover used – front view.

1.4.111. The LCLJ was worn by all crew members of LCVP 0338 and LCVP 0354 on the night of the accident. When Coxn A jumped into the sea it automatically inflated as expected and provided him buoyancy. The Panel assessed that the LCLJ worked as designed and therefore concluded that the operational capability of this life jacket was not in question. The Panel finds that the capability of the LCLJ was **not a factor** in the accident.

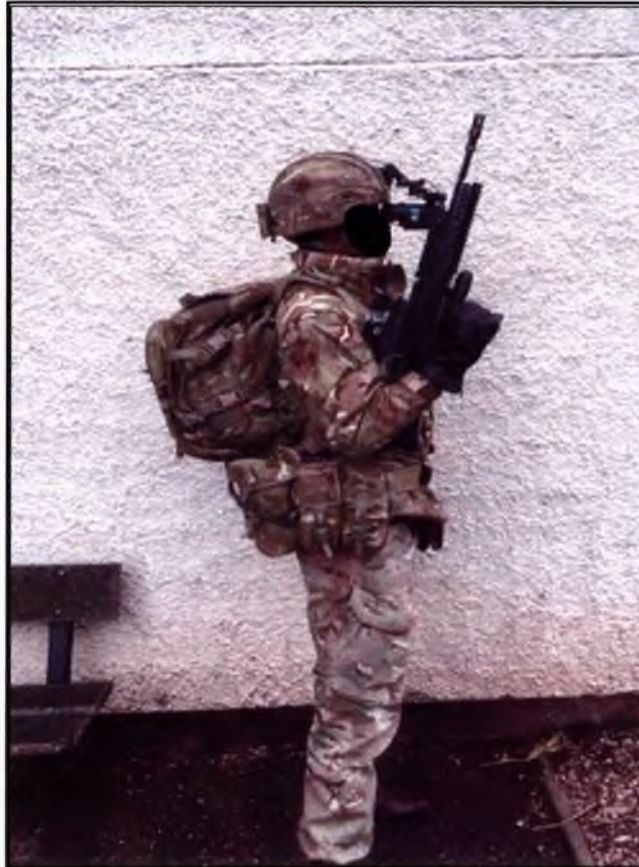
Figure 1.4.31 – A RM Recruit wearing similar Clothing and Equipment to the Recruits of 282 Troop at the time of the accident.

1.4.113. The Panel concluded that the quality and scale of the in-service military clothing and equipment as issued was appropriate for the activity being conducted. The Panel finds that the clothing and equipment worn and carried by the recruits was **not a factor**.

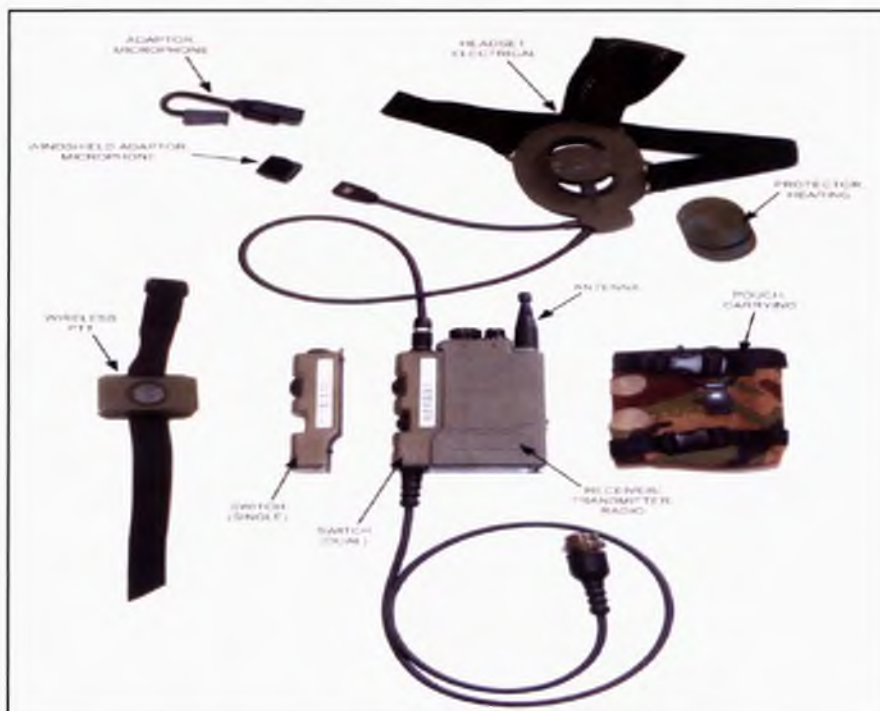
Figure 1.4.32 – Personal Role Radio and Ancillaries.

1.4.118. The Panel concluded that the in-service PRR was within its working parameters for use on both the craft and ashore on the evening of the accident. The Panel finds that the capability of the PRR was **not a factor**.

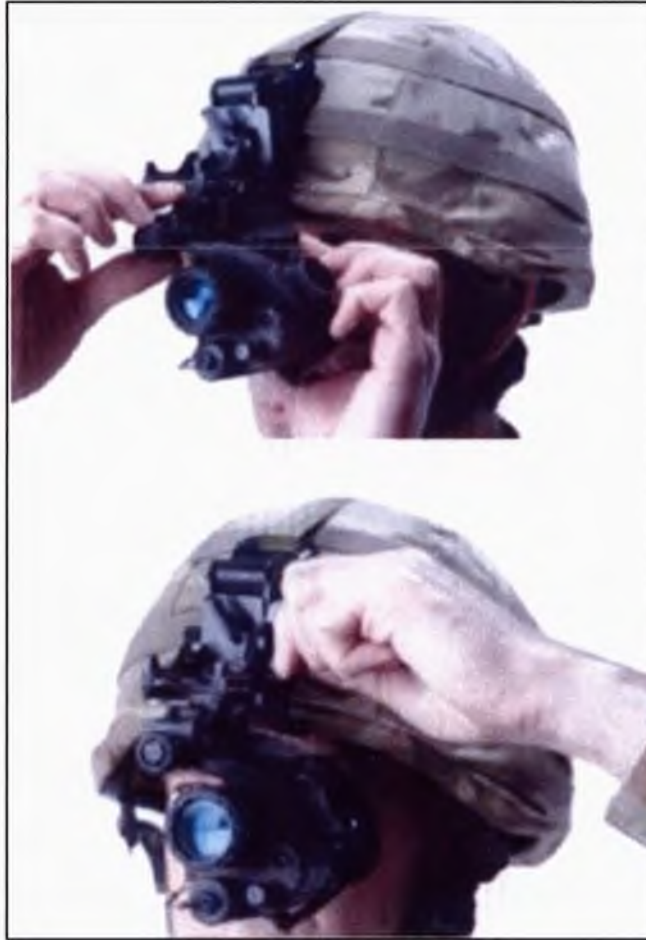
Figure 1.4.33 – In-Service Head Mounted Night Vision System.

1.4.121. The Panel assessed that, as individuals who used the HMNVS could recall events observed through the NVD, the HMNVS operated as expected and designed in the environmental conditions on the evening of the accident. The Panel concluded that the in-service HMNVS was within its working parameters for use on both the craft and ashore on the evening of the accident. The Panel finds that the capability of the HMNVS was **not a factor**.

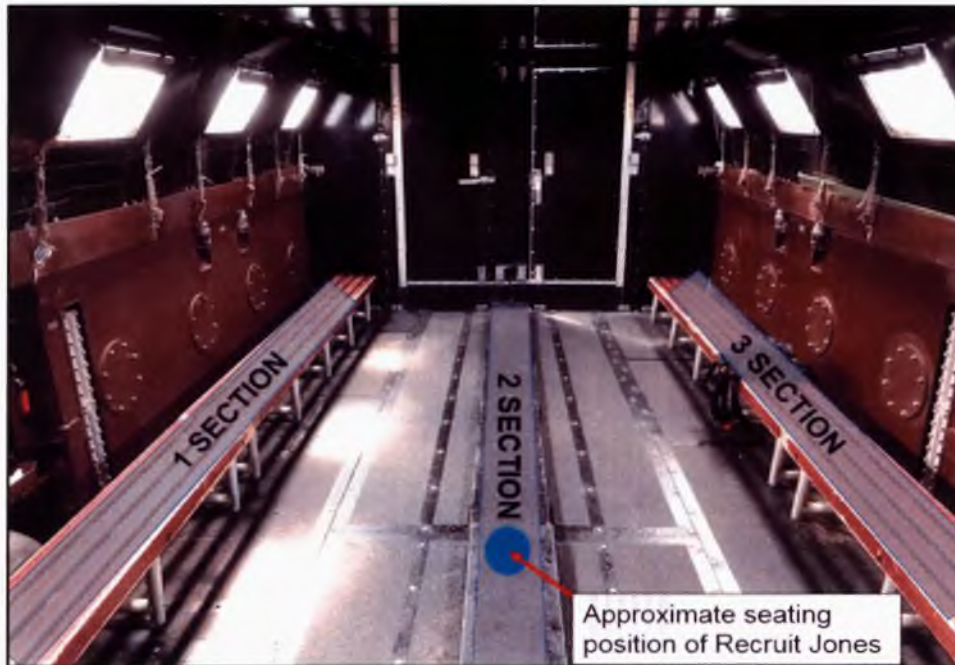
Figure 1.4.34 – 282 Troop Section Seated Positions inside the LCVP Canopy looking Forward.

1.4.241. 282 Tp's order of march onto the LCVP would have been correct if they had embarked and loaded through the rear canopy doors; this would have placed all three sections in the correct order of march on their respective benches. However, the Tp did not load through the rear canopy doors, as briefed, but entered the canopy through the forward canopy doors. The recruits of Section 3 who entered the canopy were in the wrong order for disembarkation. Sections 1 and 2 also entered the canopy but managed to end up in the right order and Recruit Jones was seated in the correct position. The recruits were joined by two of the Trg Team Cpls and the Tp Comd. Due to the cramped conditions within the Canopy area a number of 282 Tp recruits ended up sitting in non-recognised seating positions. One recruit sat on the floor on his daysack and another leaned against the rear starboard ladder.

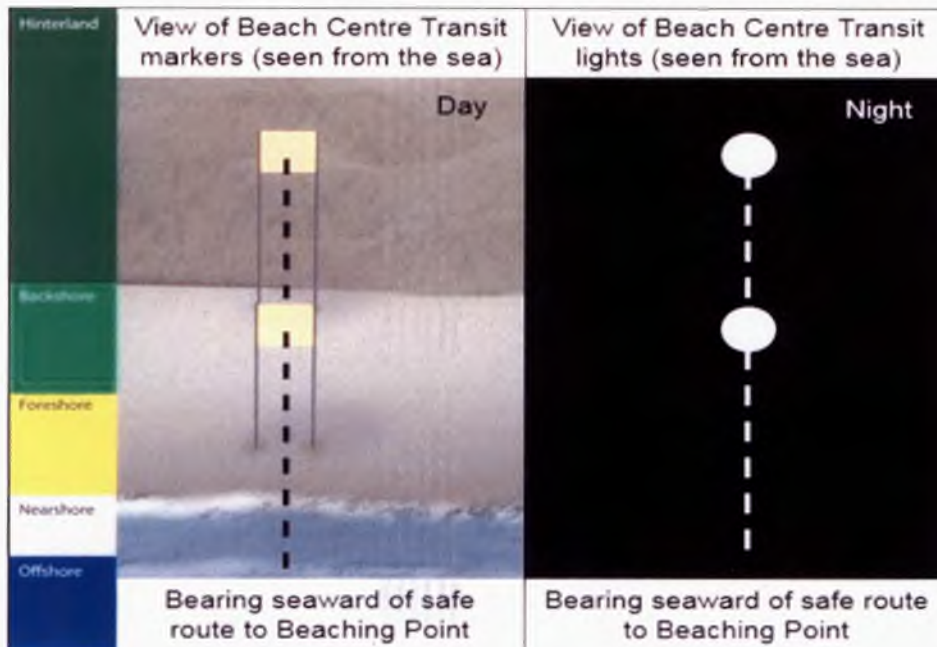
Figure 1.4.35 – Transit Markers for Day and Night showing a Safe Bearing.

1.4.263. The Panel opined that the absence of a planned route from the FRV to a designated landing point, compounded by the lack of transit markers on the beach, would have made it extremely difficult for a coxswain to conduct an accurate transit from the FRV to a specific landing point on the beach. The Panel concluded that the lack of this information and equipment on the beach would have made a coxswain's beaching task more difficult. The Panel finds this is an **other factor**.

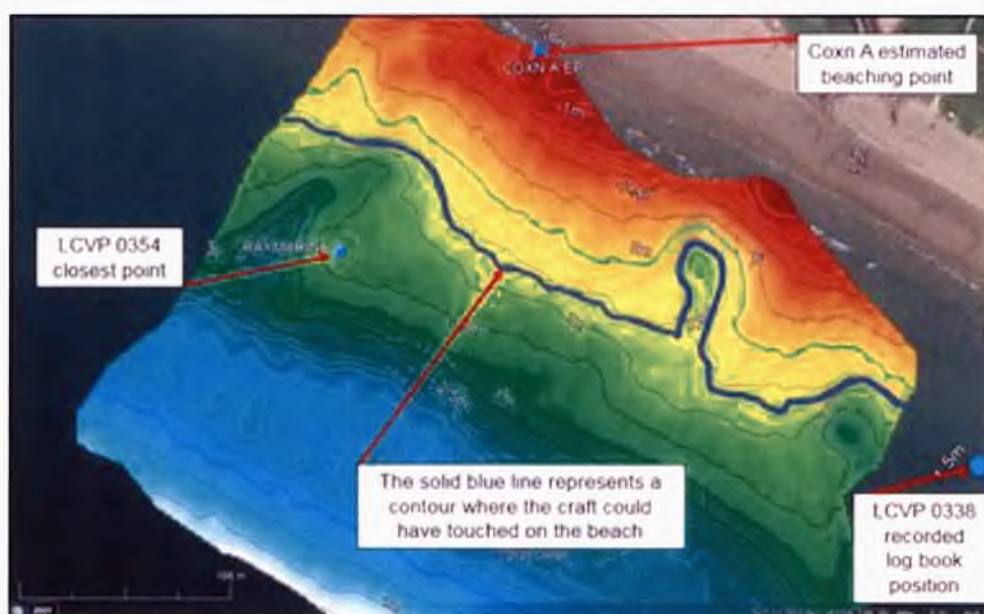
Figure 1.4.37 – Beaching Contour on Tregantle Beach.

1.4.275. The Panel determined that, based on the above information, it was certain that the craft was not in the position Coxn A estimated or in the position entered in LCVP 0338's Log Book by Crewman 1. Furthermore, using the known location of LCVP 0354 and the contour where LCVP 0338 could have touched the beach, it is very likely that LCVP 0338 beached somewhere on the highlighted red dashed line shown in Fig 1.4.38.
