ACCIDENT

Aircraft Type and Registration:	Cessna 185A Skywagon, G-BLOS	
No & Type of Engines:	1 Continental Motors Corp IO-470-F piston engine	
Year of Manufacture:	1962 (Serial no: 185-0359)	
Date & Time (UTC):	7 October 2020 at 1620 hrs	
Location:	Pauncefoot Airstrip, Romsey	
Type of Flight:	Private	
Persons on Board:	Crew - 1	Passengers - None
Injuries:	Crew - 1 (Serious)	Passengers - N/A
Nature of Damage:	Wings separated and significant fuselage damage	
Commander's Licence:	Private Pilot's Licence	
Commander's Age:	63 years	
Commander's Flying Experience:	395 hours (of which 42 were on type) Last 90 days - 5 hours Last 28 days - 0 hours	
Information Source:	AAIB Field Investigation

Synopsis

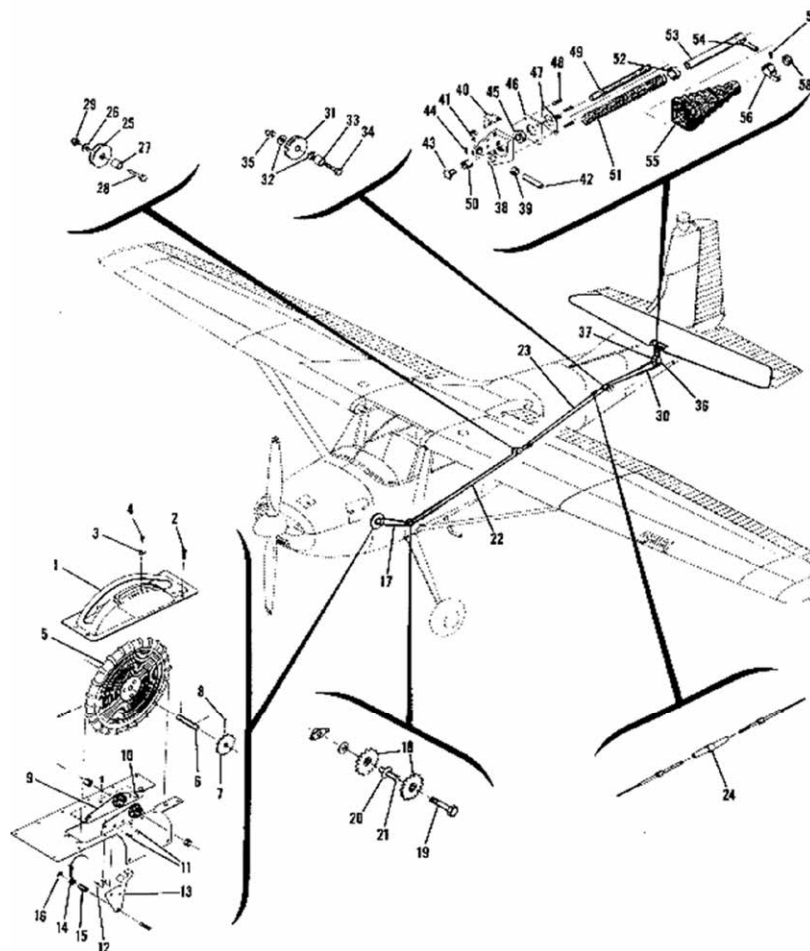
Figure 6
Tailplane trim system schematic

The aircraft is fitted with a tailplane trim system which consists of a continuous loop chain and cable assembly driven by a hand wheel mounted on the cockpit floor. Rotation of the trim wheel extends or retracts a pair of jackscrews which are driven by sprockets engaged on the chain section of the continuous loop. They are fixed to the fuselage structure and to brackets attached to the leading frame of the tailplane. The tailplane is pivoted at the rear and the jackscrews alter the angle of attack of the tailplane. A follow-up cable and spring assembly is attached to the tailplane and the elevator control rod to ensure the elevator conforms to the set tailplane trim position. Figure 6 shows a general arrangement of the tailplane trim system and Figure 7 shows the jackscrew assembly.
