## **A Condition Survey of the Archaeological Sites of the Cramber Tor Training Area**

County:	Devon
District:	West Devon
Parish:	Sheepstor, Walkhampton
NGR (Centre):	SX 593699
Surveyed:	Nov – Dec 2013
Contractor:	S Probert
Client:	Landmarc/Defence Infrastructure Organisation

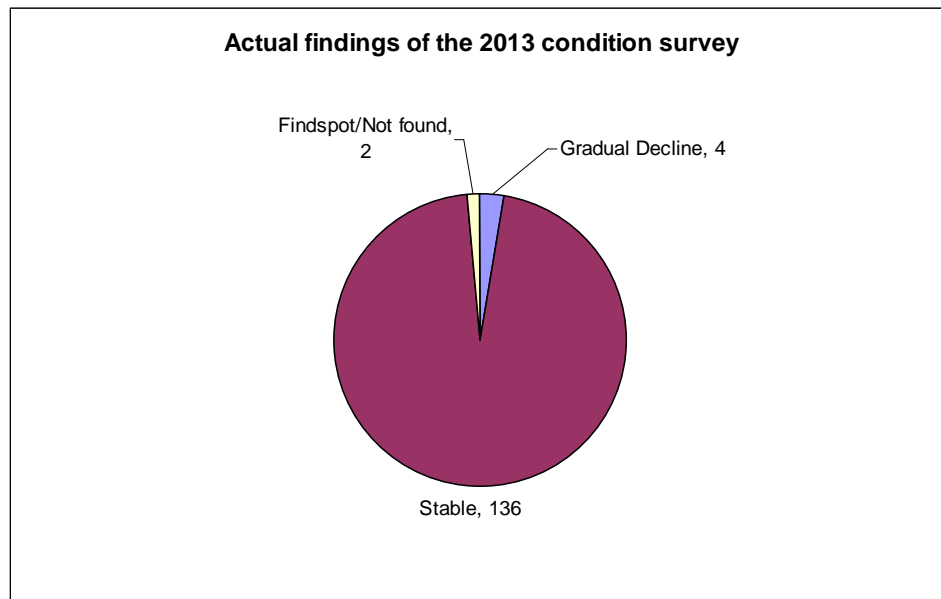
**Fig 1** *Actual findings of the 2013 Condition Survey*

The findings of the 2013 survey are summarised in Fig. 1 (actual numbers of monuments) and Fig. 2 (percentages). The number of stable monuments forms the bulk (136 monuments or 95.5%) of the sample while those in gradual decline constitute only 4 or 3%. There are no monuments deemed to be improving.

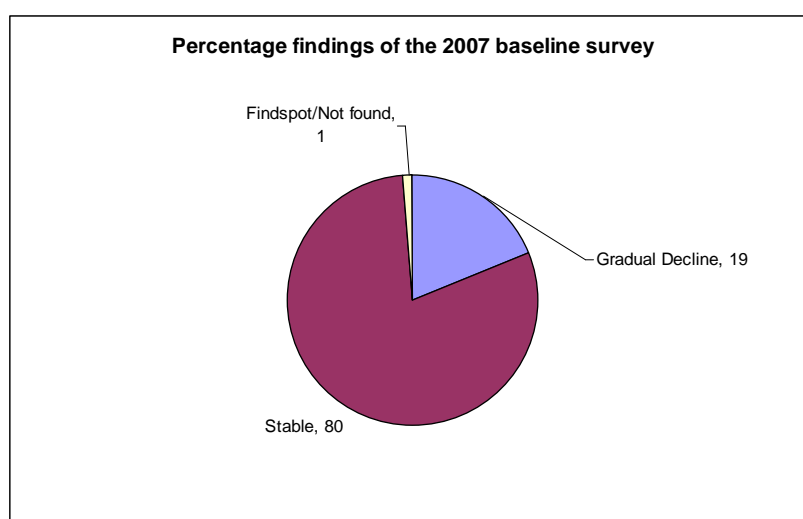
**Fig 11** *Percentage results of 2007 Baseline Survey*

The relative quantities of each condition type in the 2007 Baseline and 2013 Condition Surveys can be seen in Figs 11 and 12.

The figures appear to show an improvement in the condition of the heritage resource on the Cramber Tor Training Area, the stable category expanding to 95.5% of the total from a 2007 level of 80%. However, there has been no major change in land use or management. By its very nature the 2007 Baseline Survey had no prior assessment to draw upon therefore condition assessments were largely tentative. With the exception of extreme examples such as the cairns 438743 and 438589 the 2013 survey has served to qualify the 2007 data, removing the inevitable speculation and ambiguity. Subsequent assessments will be capable of quantifying changes in the state of the heritage resource. There is no apparent evidence of deliberate damage to the ruined farmsteads and 19<sup>th</sup> century mine structures suggested by the 2007 Baseline Survey while the decline recorded by the same survey in many sites such as the streamworks 1313092 and 1446222 is so negligible as to be irrelevant.

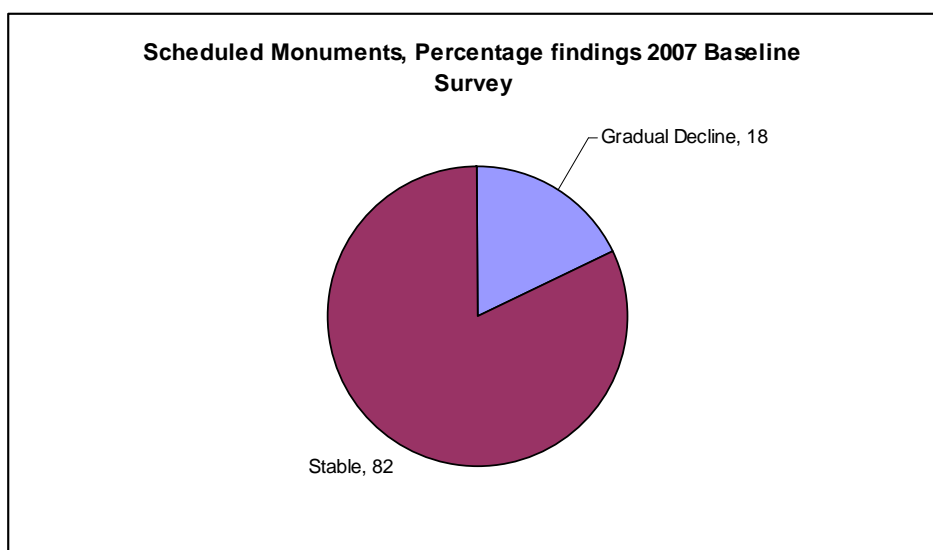
**Fig 15** *Relative stability of Scheduled Monuments, 2007 Baseline Survey*

Figs 15 and 16 display the percentage findings of the above data.

The Scheduled Monument data is an almost exact reflection of the overall dataset, displaying a marked decrease in the number of sites in Gradual Decline and a corresponding rise in the Stable category. Again, this can be attributed largely to the 'bedding in' of the 2007 data.
