**A Condition Survey of the Archaeological Sites of the Cramber
Tor Training Area, 2017**

County:	Devon
District:	West Devon
Parish:	Sheepstor, Walkhampton
NGR (Centre):	SX 593699
Surveyed:	April – May 2017
Contractor:	S Probert
Client:	Landmarc/Defence Infrastructure Organisation

A CONDITION SURVEY OF THE ARCHAEOLOGICAL SITES OF THE CRAMBER TOR TRAINING AREA, DEVON, 2017

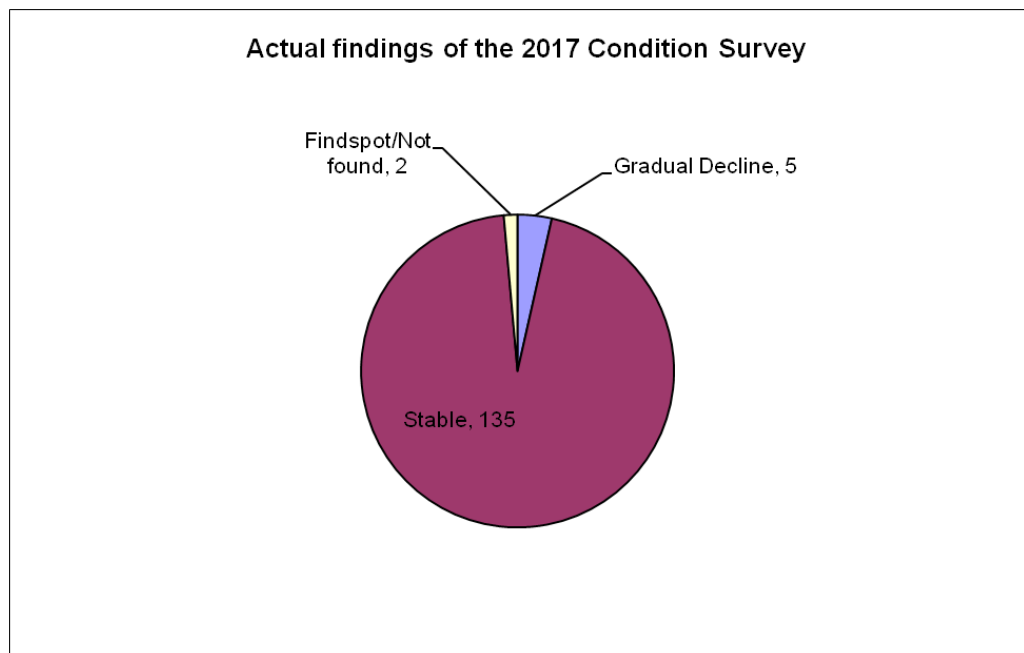
The findings of the 2017 survey are summarised in Fig. 1 (actual numbers of monuments) and Fig. 2 (percentages). The number of stable monuments forms the bulk (135 monuments or 95%) of the sample while those in gradual decline constitute only 5 or 3.5%. There are no monuments deemed to be improving.

Fig 1 *Actual findings of the 2017 Condition Survey*

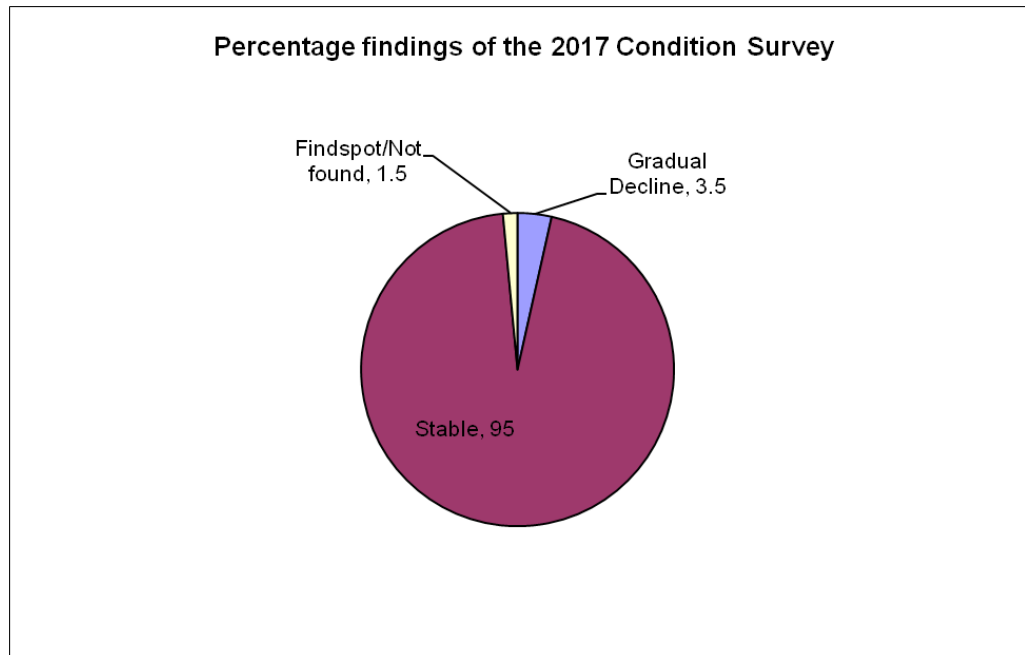
Fig 2 Percentage findings of the 2017 Condition Survey

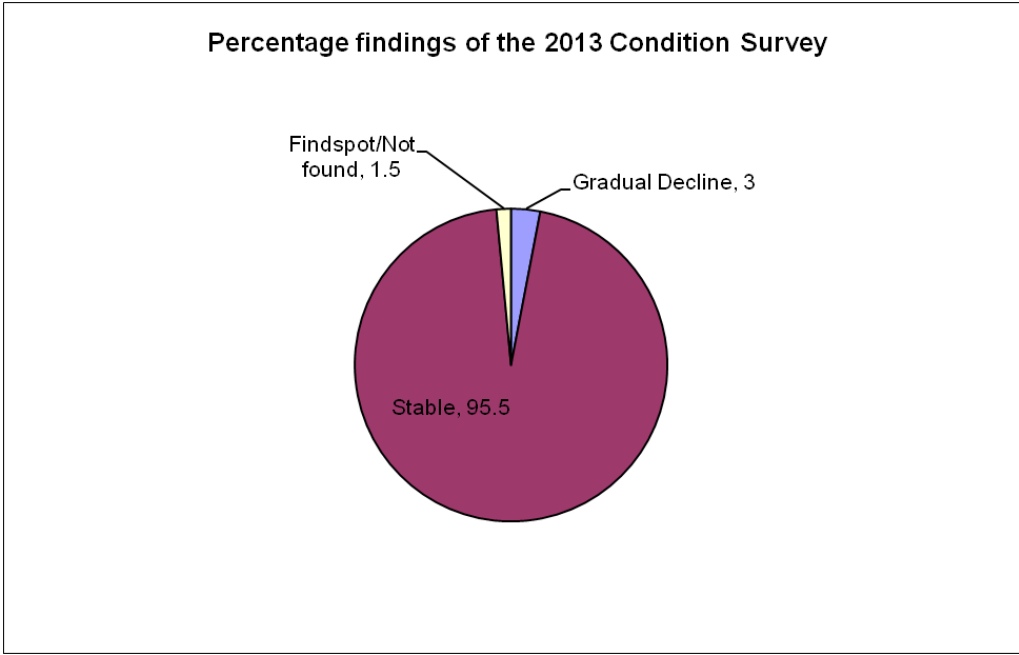
Fig 14 *Percentage results of 2013 Condition Survey*

The figures show a minimal decline in the condition of the heritage resource on the Cramber Tor Training Area, the Stable category decreasing slightly to 95% of the total from a 2013 level of 95.5%, the difference of a single site.

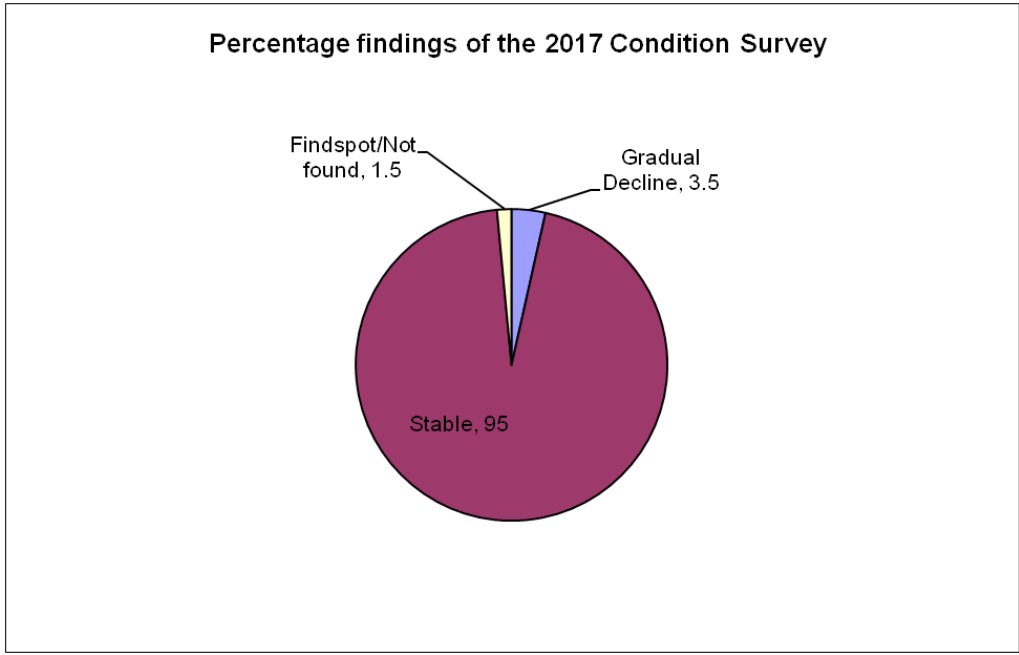
Fig 15 *Percentage results of 2017 Condition Survey*

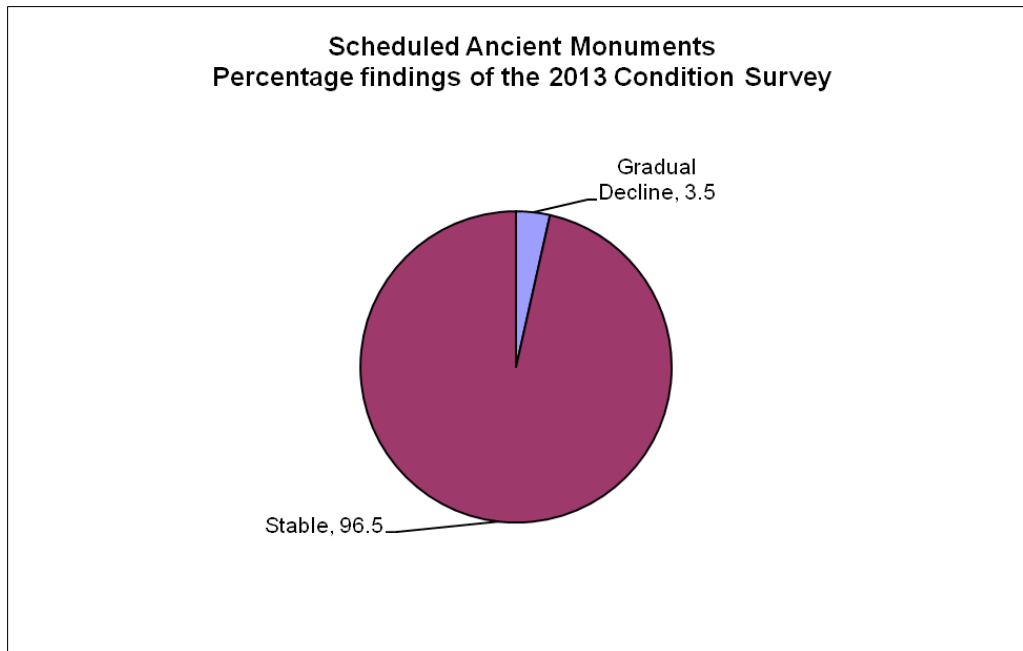
Fig 18 2013 Condition Survey, relative stability of Scheduled Monuments.

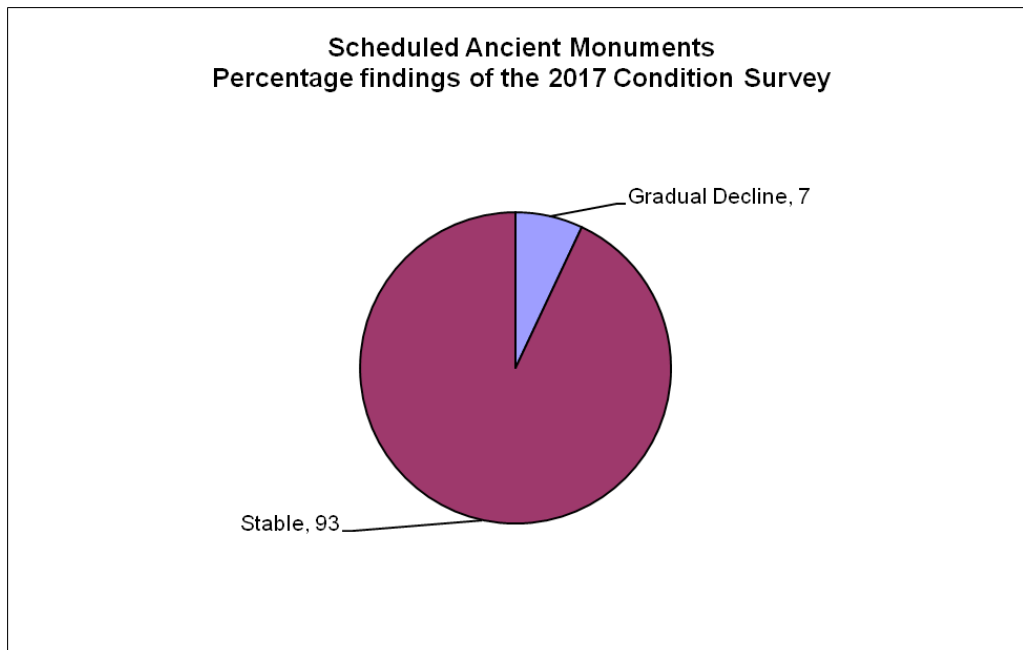
Fig 19 2017 Condition Survey, relative stability of Scheduled Monuments.

These data are an approximate reflection of the entire heritage resource. The sites considered to be in gradual decline have been described at length above (3.2.1) and are relatively easily remedied (3.2.4).
