AAIB Bulletin: 10/2021	G-INVN		AAIB-26839
ACCIDENT			
Aircraft Type and Registration:	Hawker Sea Fury T Mk.20, G-INVN		
No & Type of Engines:	1 Pratt & Whitney R2800-CB3 radial piston engine		
Year of Manufacture:	1951 (Serial no: 41H-636070)		
Date & Time (UTC):	4 August 2020 at 1518 hrs		
Location:	Harston, Cambridgeshire		
Type of Flight:	Private		
Persons on Board:	Crew - 1	Passengers -	1
Injuries:	Crew - 1 (Serious)	Passengers -	1 (Serious)
Nature of Damage:	Forward fuselage and wings detached from engine and tail section. Extensive internal engine damage		
Commander's Licence:	Air Transport Pilot's Licence		
Commander's Age:	47 years		
Commander's Flying Experience:	3,508 hours (of which 31 were on type) Last 90 days - 15 hours Last 28 days - 8 hours		
Information Source:	Field Investigation

During the aircraft's second flight following maintenance, its engine oil temperature rose and the oil pressure started to fluctuate. The engine then seized, forcing the pilot to make a landing in a field. The aircraft was extensively damaged and both occupants suffered serious injuries.

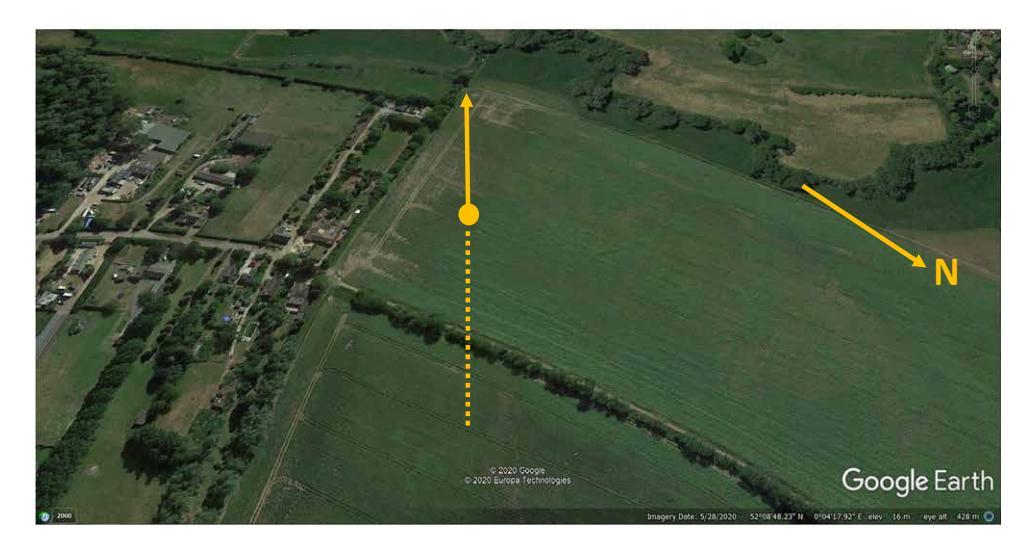
Figure 5 Accident location

The aircraft touched down mid-way across a smooth ploughed field travelling in a south-westerly direction and continued until it reached a dense hedgerow with trees (Figure 5). It did not slow significantly, travelling approximately 160 m, with the landing gear raised, over the dry hard earth. After the initial impact there was a second impact impression and thereafter a debris trail of small metallic items, remains of antennas and part of an engine mount.

The left wingtip struck the hedge first and caused the aircraft to rotate anti-clockwise (as viewed from above) whilst travelling along the hedge line. The aircraft came to rest in three pieces: the engine, the forward fuselage with wings, and the rear fuselage. The engine had detached from its mountings during the ground slide but was still attached to the airframe by several large-diameter electrical cables. The fuselage had broken just aft of the front windscreen, which coincided with the rear of the wing structure.

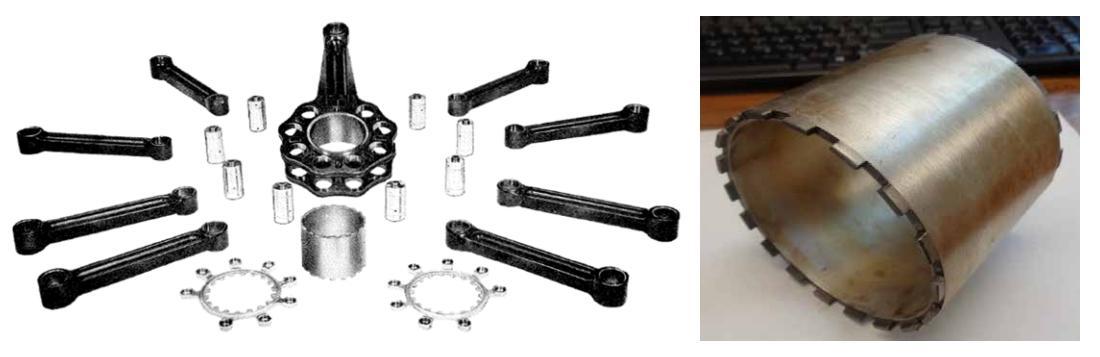
Figure 10

Each bank of nine pistons is connected to the crankshaft by a master connecting rod and eight link connecting rods (Figure 10). The master rod bearing and the eight link pins are held by two retaining plates. The master cylinder (in which the master rod is located) is No 8 in the front bank and No 9 in the rear bank. The master rod bearings are silver-plated steel plain bearings with a lead-indium coating on the internal bore. The crankpin bearing faces are nitrided to harden the surface, with case hardening approximately 0.76mm (0.030 inch) thick. During the engine overhaul in 2016, all the crankshaft bearings were inspected and the lead-indium coating on the two master rod bearings was re-plated.

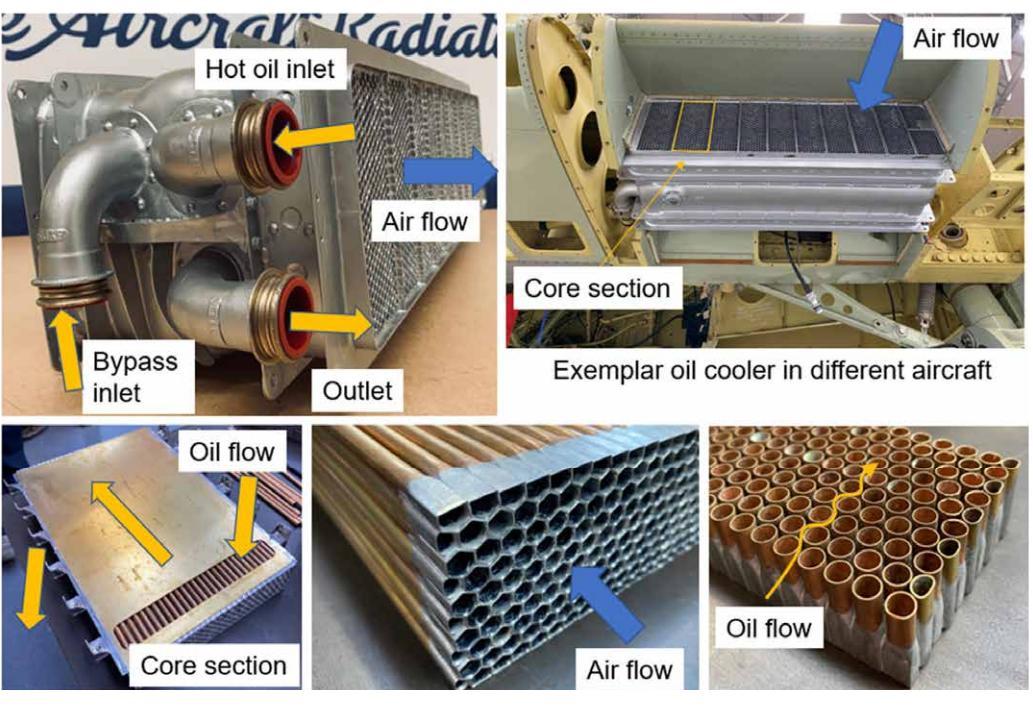
Figure 12 Oil cooler

An oil cooler was installed in the left wing root and used the airflow of forward flight to cool the oil (Figure 12). Air entered the cooler through a slot in the wing leading edge and passed through the cooler core, which was made up of 5.2 mm diameter copper alloy pipes. Heated airflow exited through the lower wing surface and was regulated by a movable flap. A cockpit switch allowed the flap to be manually opened, closed, switched off, or to operate automatically. The switch was sprung to OFF, in which the flap would remain in its current position, and it was necessary to hold it in either the OPEN or CLOSE position to manually adjust the flap. The switch was normally placed in AUTO. The flap was opened and closed by an electrical actuator and used a temperature sensor in the cooler outlet in the AUTO mode. The circuit was protected by a CB labelled 'OIL CLR'.

Several entries made in the aircraft maintenance log in 2019 referred to the oil cooler leaking. Each entry was closed stating that the cooler had been repaired. During annual maintenance in October 2019 it was noted that the cooler was leaking again. The cooler was removed and sent to a specialist to manufacture new core sections and replace them in the original frame. The cooler was then flushed and pressure tested to ensure integrity prior to completion. The rebuilt cooler was fitted in July 2020.
