Report on the investigation of  
the immobilisation and flooding of the dredger  
***Shearwater***  
after repeated collisions with the unmanned barge  
***Agem One***  
near Kinlochbervie, Scotland  
on 9 April 2020

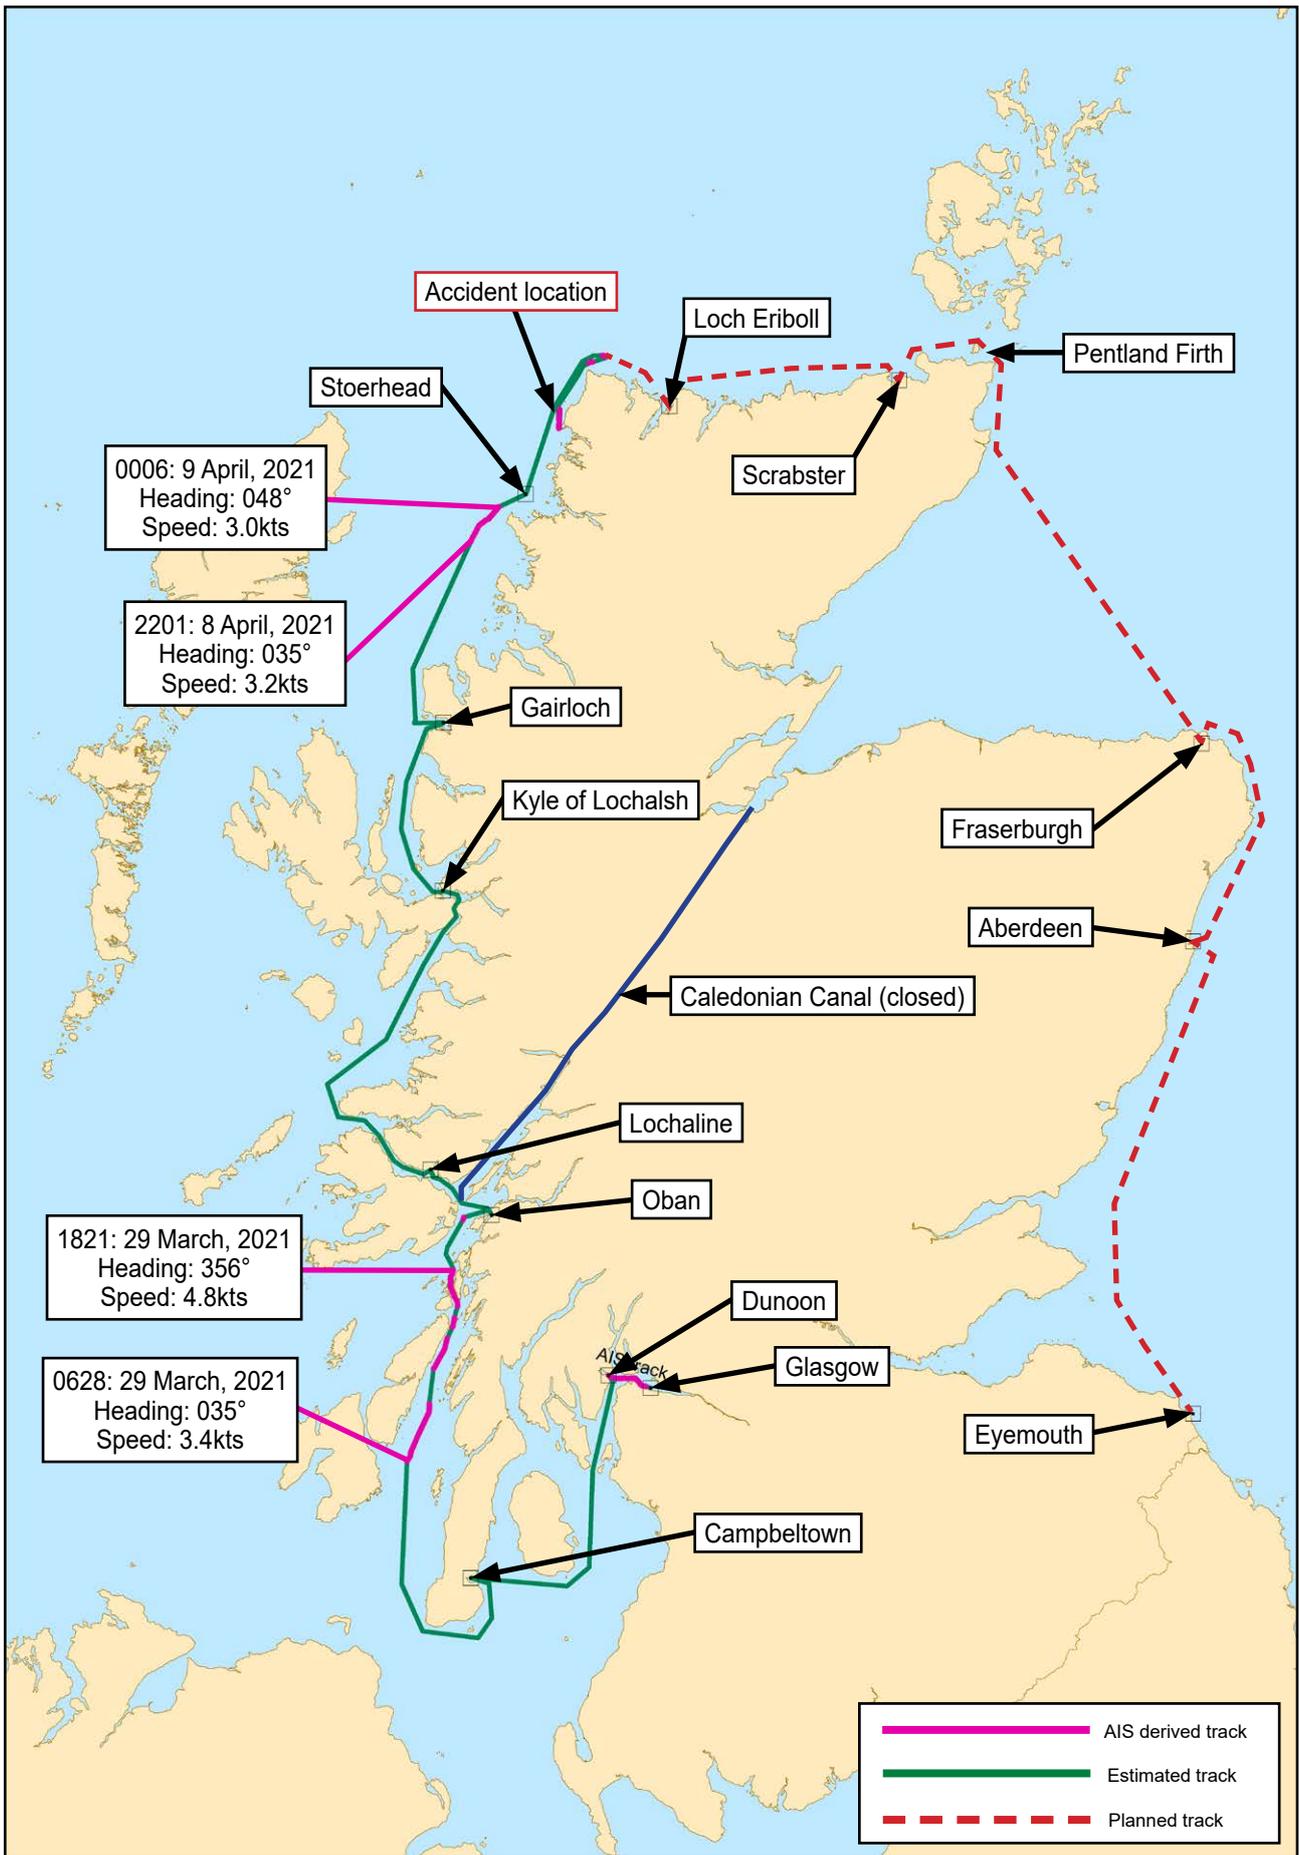
**Figure 1:** Overview of the actual passage, intended passage and accident location, including AIS data

On 25 March 2020, the grab hopper dredger *Shearwater*, towing the barge *Agem One*, departed from Glasgow, Scotland, intending to transit to Eyemouth, Scotland in a series of short passages (**Figure 1**). The purpose of the voyage was to reposition for the start of a new dredging contract. There were four persons on board *Shearwater*: the owner<sup>2</sup>, the master, an able-bodied seaman (AB) and an excavator driver. *Agem One* was laden with a 45 tonne (t) excavator. Prior to the accident, the dredger and barge stopped at Campbeltown, Oban, Lochaline (where a short period of dredging operations was conducted), Kyle of Lochalsh and Gairloch. At 0800 on 8 April 2020, *Shearwater* and *Agem One* left Gairloch and headed north towards Cape Wrath via a short stopover near Stoerhead (**Figure 1**).

*Shearwater* had completed a dredging contract in the river Clyde and the next contracts were in Lochaline, Isle of Mull, then Eyemouth, on the east coast of Scotland. The owner had previously used the Caledonian Canal to reposition *Shearwater* from one side of Scotland to the other (**Figure 1**). At the time of this planned passage, the Caledonian Canal was closed due to the COVID-19 pandemic.

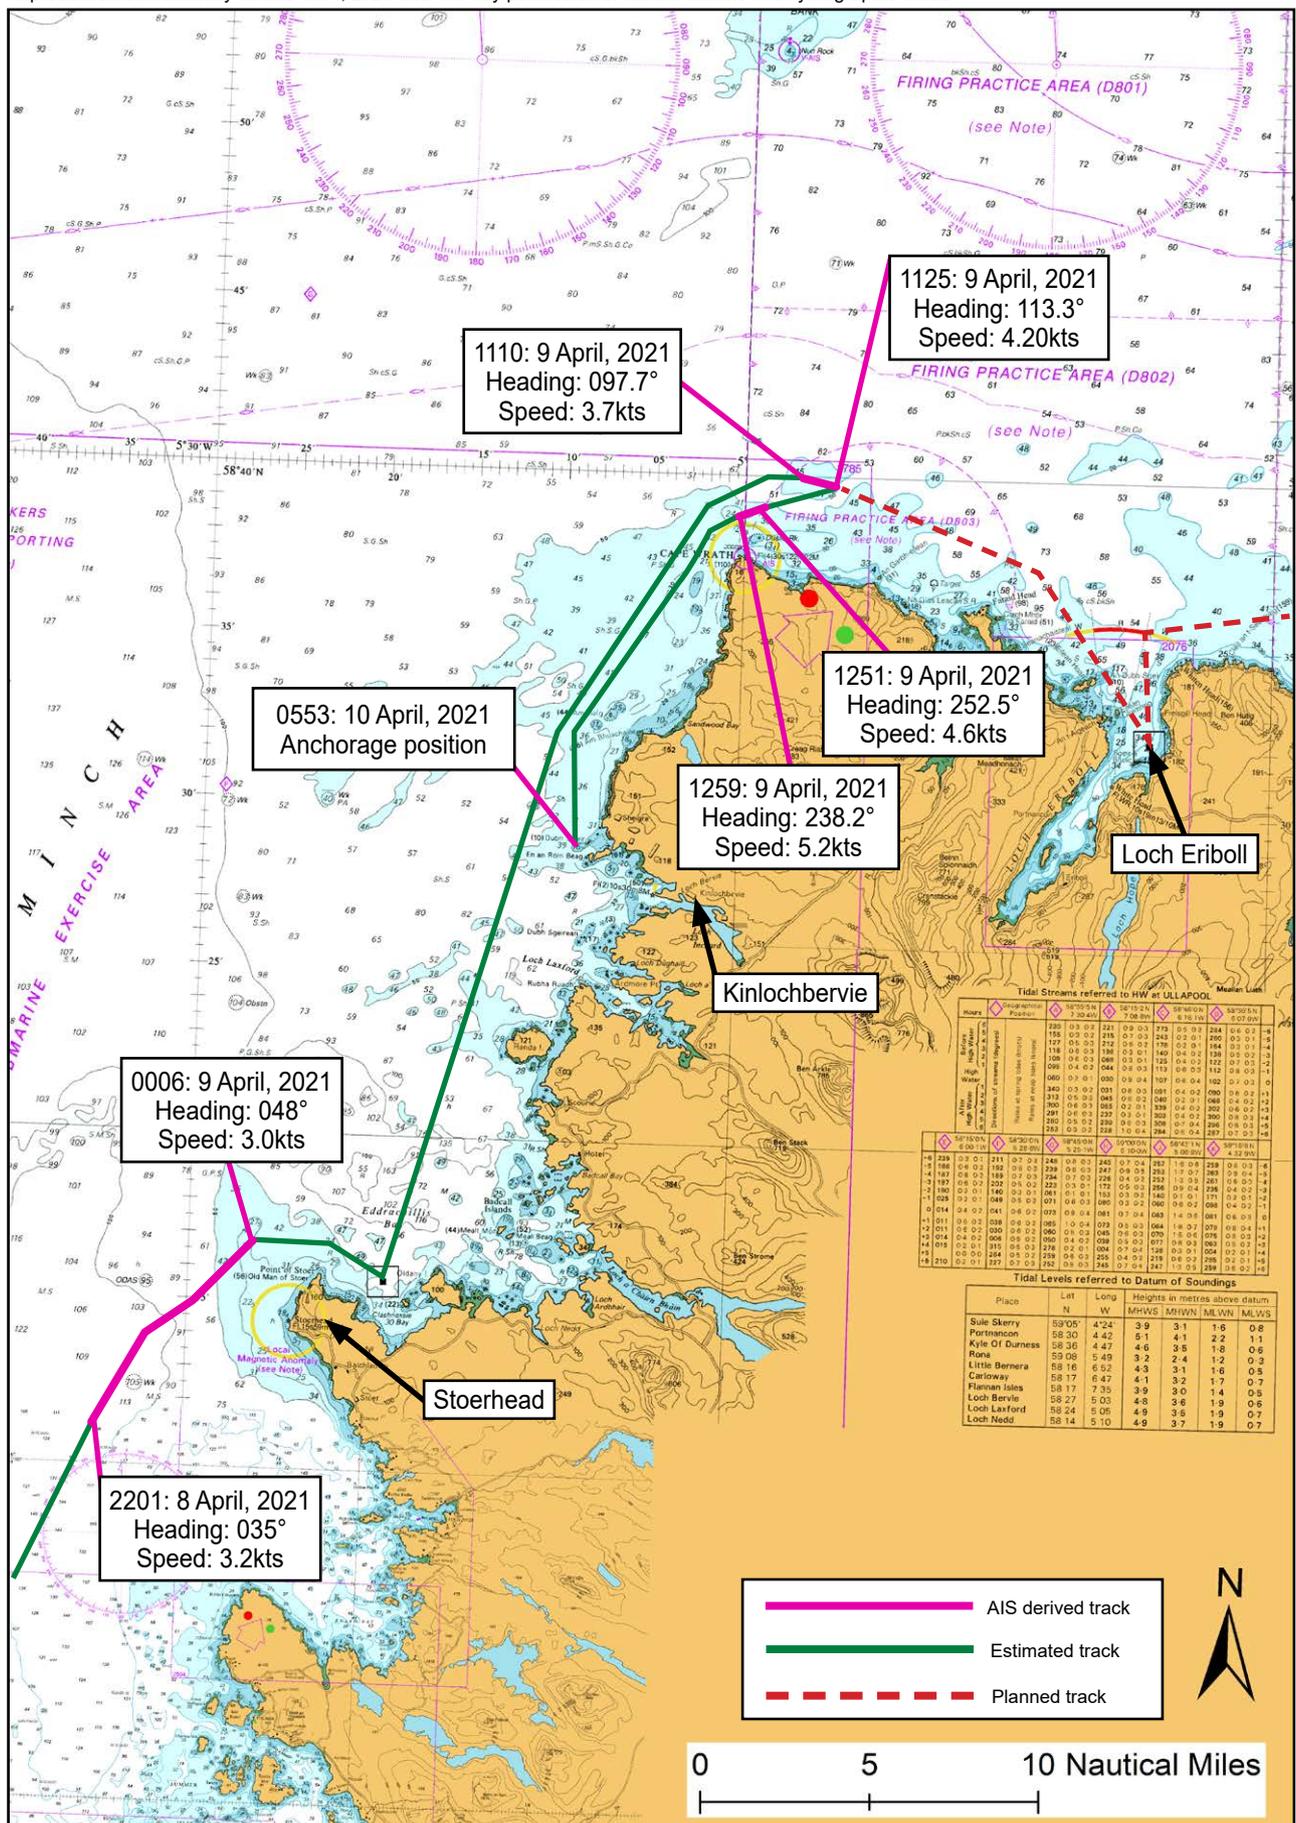
Figure 2: Passage of Shearwater and Agem One on the day of the accident, including AIS data

Early in the morning on 9 April 2020, *Shearwater* departed from Stoerhead for passage to Loch Eriboll (**Figure 2**). *Shearwater* was towing *Agem One* alongside (on the dredger's port side) and was proceeding at a speed of between 3 and 5.2 knots (kts). The master was on the bridge and in control of the vessel, and *Shearwater*'s owner was overseeing towing operations. *Shearwater* passed Cape Wrath at about 1030 (**Figure 2**) and started to encounter a long swell with a height of approximately 2.5 metres (m), causing *Agem One* to move heavily against the dredger's side. The alongside towing configuration was judged untenable by *Shearwater*'s owner who ordered that *Agem One* be moved to an astern tow.

At about 1900, *Shearwater* was just over 3 nautical miles (nm) west of Kinlochbervie (**Figure 2**) with *Agem One* back in an alongside towing arrangement. In this area, there was a moderate breeze, a short, choppy sea and good visibility. A decision was then taken to revert to an astern tow due to the narrow width of navigable water available in the approaches to Kinlochbervie.

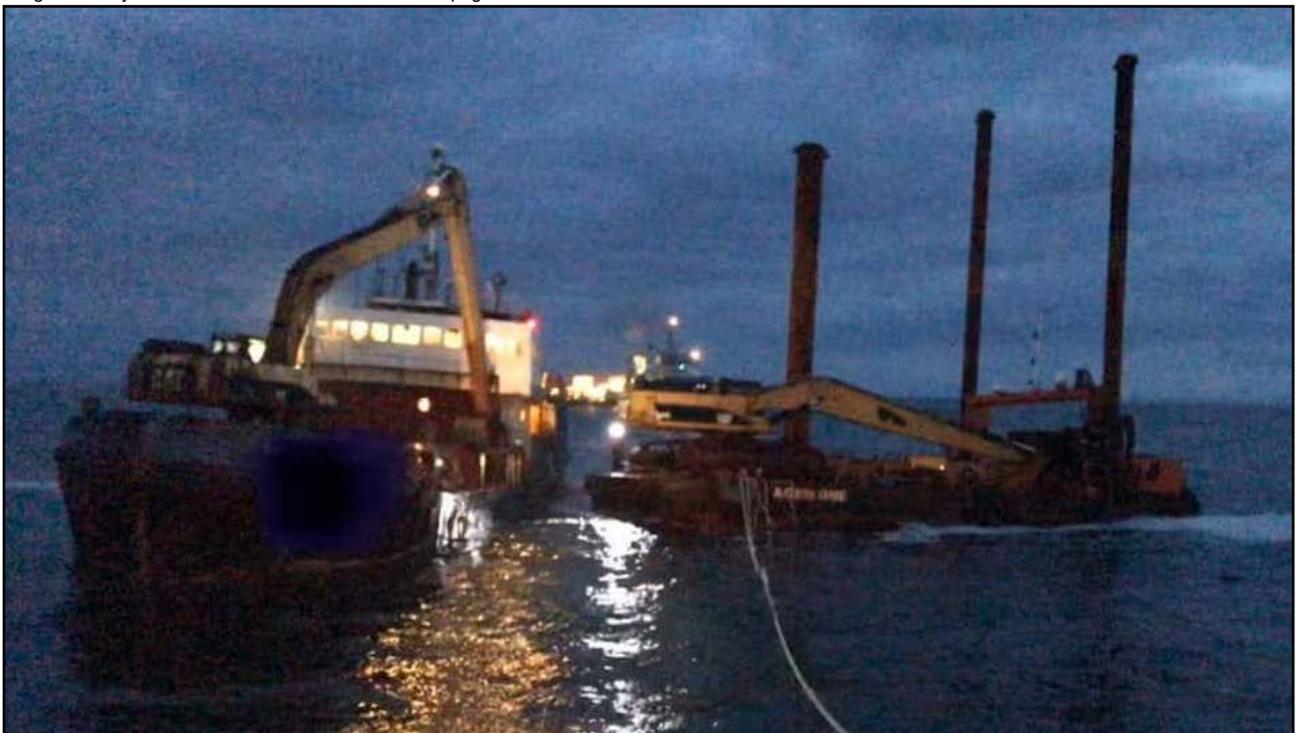
*Shearwater*'s crew tried to pump water out of the flooded port buoyancy space using the fixed bilge system but were unsuccessful, so rigged a portable electric submersible pump instead. The crew also attempted to stem the water ingress with rags and sealant. At 2204, the lifeboat located the drifting *Agem One* and commenced towing it back towards *Shearwater*. The lifeboat reached *Shearwater* at around 0130 on 10 April (**Figure 4**) and held position nearby awaiting the arrival of the ETV.

**Figure 4:** Lochinver lifeboat returning *Agem One* to *Shearwater*

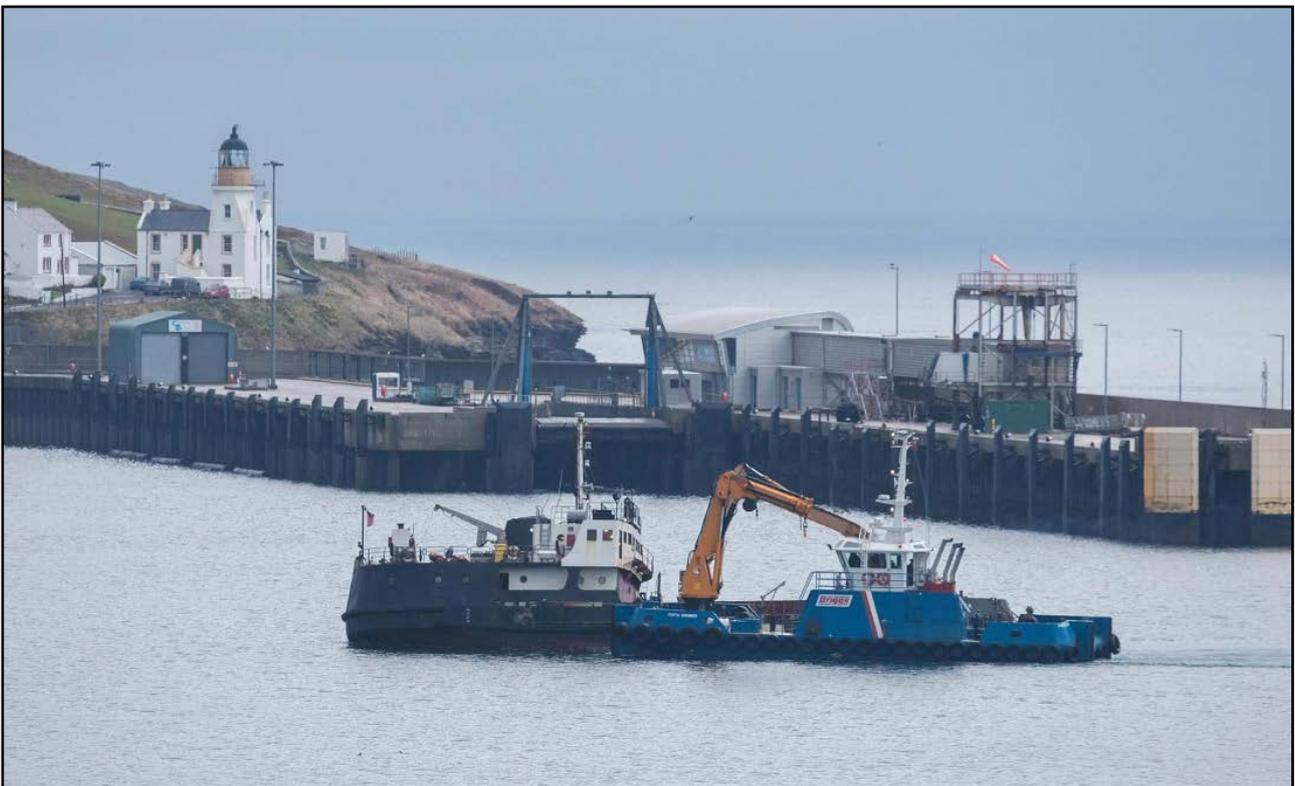
At 0512 on 11 April, when transiting the Pentland Firth, *Forth Drummer* reported that *Shearwater* was again taking on water and had developed a list of around 10 degrees. The tow to Aberdeen was aborted and *Shearwater* was taken into Scrabster (**Figure 5**). Following temporary repairs, the tow was resumed with a second tug, *Shuna*<sup>6</sup>, on 16 April. *Shearwater* entered Aberdeen harbour at around 0600 on 18 April and was taken to dry dock where an inspection found the towline wrapped around both propeller shafts (**Figure 6**), penetration and significant indentation to the port side shell plating and damage to the port shaft and gearbox. *Agem One* was undamaged following the accident and was left at Kinlochbervie anchored by its spud legs; it was eventually retrieved in December 2020.

**Figure 5:** *Shearwater* entering Scrabster harbour being towed alongside *Forth Drummer*

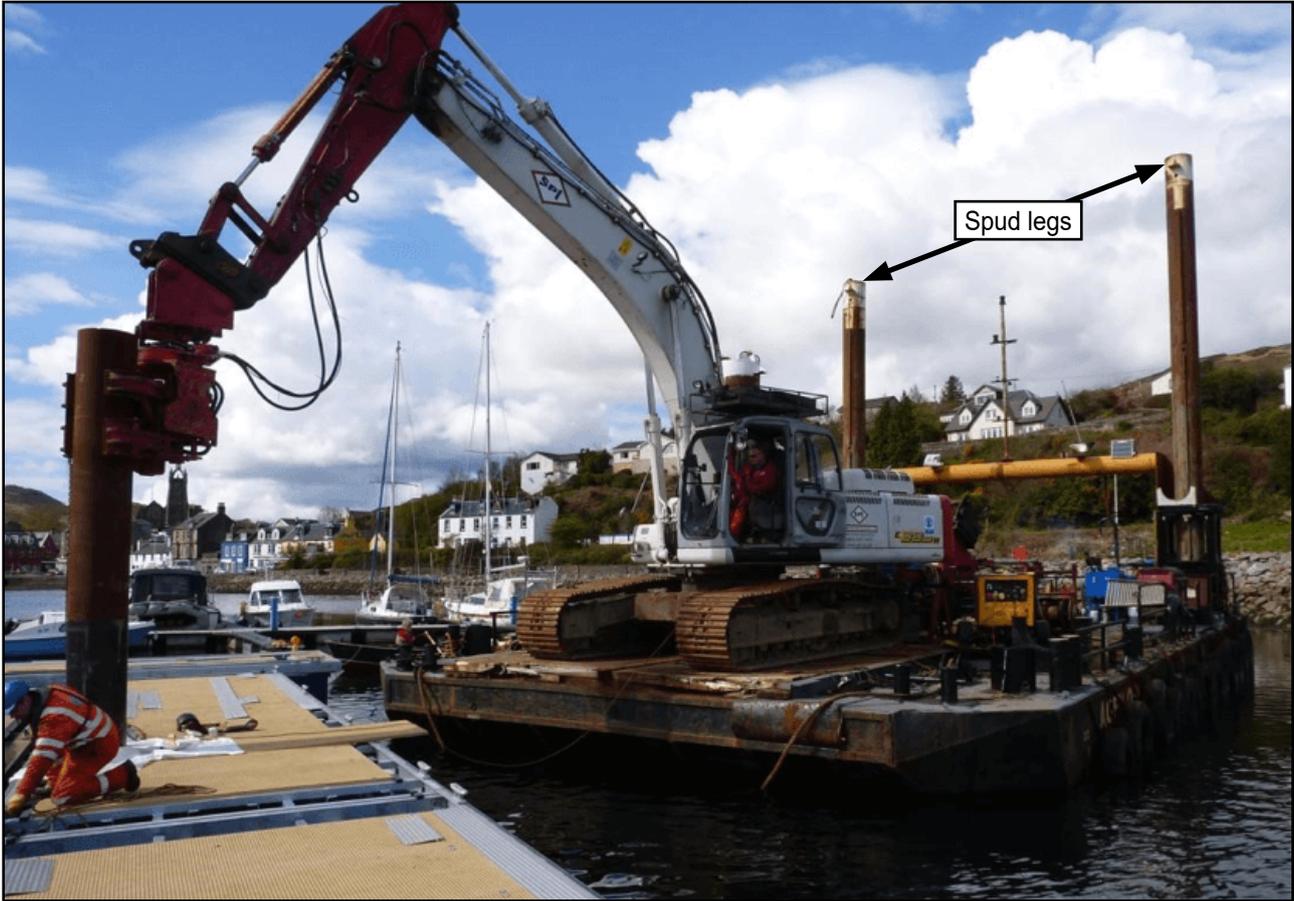
*Agem One* was a UK registered spud leg, catamaran barge built in 1992 (**Figure 8**). *Agem One* was owned by Offshore Workboats Limited and was operated by Northern Dredging under a charter agreement. This agreement required the charterer to use a 'tug of suitable size and capability' when towing the barge.

**Figure 8:** *Agem One* showing location of spud legs

*Agem One* could be fitted with different equipment according to the charterer's needs, and it had three spud legs that could be lowered to the seabed in shallow water to form a stable platform. At the time of the accident, *Agem One* was laden with an excavator weighing 45t, which was owned by Holy Loch Marina and leased to Northern Dredging.
