Rail Accident Investigation Branch

Rail Accident Report

**Fatal accident at Waterloo Underground station,
London
26 May 2020**

Report 05/2021
September 2021

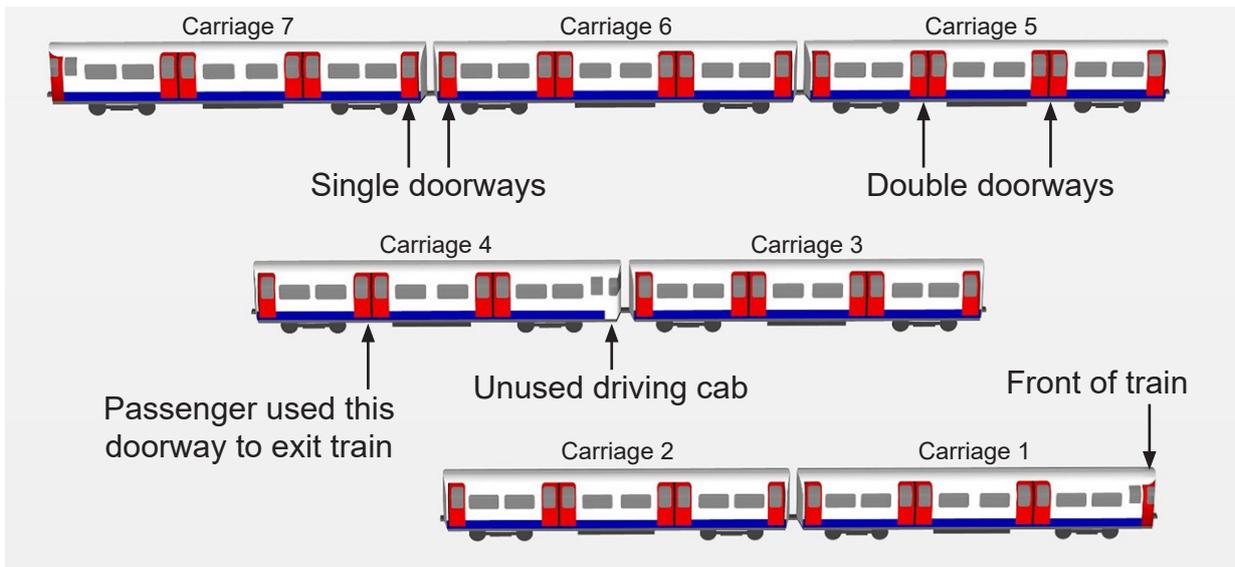
- 10 Both trains were formed of 1972 tube stock and consisted of 3-carriage and 4-carriage units operating as 7-carriage trains. Each carriage is about 16 metres long with two double doorways approximately one-third and two-thirds of the way along the carriage length, and single doorways at each end. The fourth carriage of the incident train incorporated a driving cab, so did not have a single doorway at the leading end (figure 4).

Figure 4: Arrangement of passenger saloon doors on 1972 tube stock trains
