**ACCIDENT**

<b>Aircraft Type and Registration:</b>	Head AX8-88B hot air balloon, G-TIMX	
<b>No &amp; Type of Engines:</b>	N/A	
<b>Year of Manufacture:</b>	2008 (Serial no: 384)	
<b>Date &amp; Time (UTC):</b>	20 April 2021 at 0905 hrs	
<b>Location:</b>	Welton, Daventry, Northamptonshire	
<b>Type of Flight:</b>	Private	
<b>Persons on Board:</b>	Crew - 1	Passengers - 2
<b>Injuries:</b>	Crew - None	Passengers - 1 (Serious) 1 (None)
<b>Nature of Damage:</b>	None	
<b>Commander's Licence:</b>	Private Pilot's Licence	
<b>Commander's Age:</b>	32 years	
<b>Commander's Flying Experience:</b>	407 hours (of which 70 were on type) Last 90 days - 4 hours Last 28 days - 4 hours	
<b>Information Source:</b>	Aircraft Accident Report Form submitted by the pilot

**Synopsis**

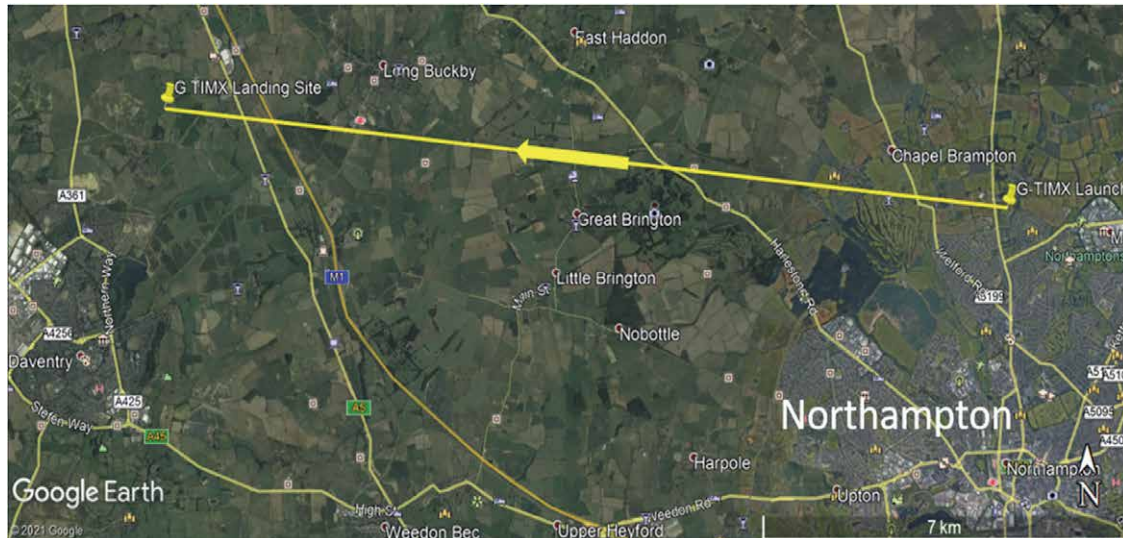
**Figure 1**

Approximate track of the balloon

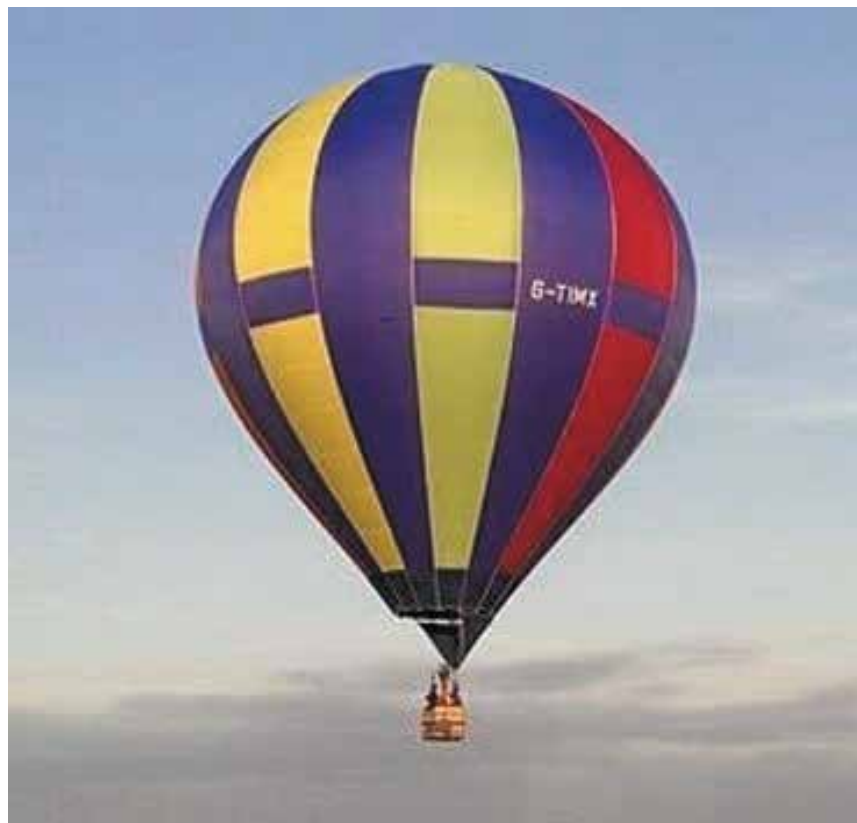
**Figure 4**  
Head AX8-88B

The balloon is a Head AX8-88B. It has a 90,000 ft<sup>3</sup> envelope with a diameter of 57 ft, and when inflated is 72 feet 8 inches tall, including the basket. An image of the balloon is shown in Figure 4.
