Published 11 November 2021

<b>Aircraft Type and Registration:</b>	Bell 407, N120HH	
<b>No &amp; Type of Engines:</b>	1 Rolls-Royce M250-C47B turboshaft engine	
<b>Year of Manufacture:</b>	2005 (Serial no: 53661)	
<b>Date &amp; Time (UTC):</b>	24 June 2020 at 1219 hrs	
<b>Location:</b>	Long Marston, Stratford-upon-Avon, Warwickshire	
<b>Type of Flight:</b>	Private	
<b>Persons on Board:</b>	Crew - 1	Passengers - 1
<b>Injuries</b>	Crew - None	Passengers - None
<b>Nature of Damage:</b>	Helicopter destroyed by post-impact fire	
<b>Commander's Licence:</b>	Private Pilot's Licence (Helicopter)	
<b>Commander's Age:</b>	45 years	
<b>Commander's Flying Experience:</b>	16,900 hours (of which 475 were on type) Last 90 days - 7 hours Last 28 days - 2 hours	
<b>Information Source:</b>	AAIB Field Investigation

The investigation found that the engine suffered an uncontained failure of the gas producing turbine disc due to insufficient oil reaching the bearings as a result of an oil leak. Due to the extensive damage to the helicopter it was not possible to determine the cause of the oil leak.

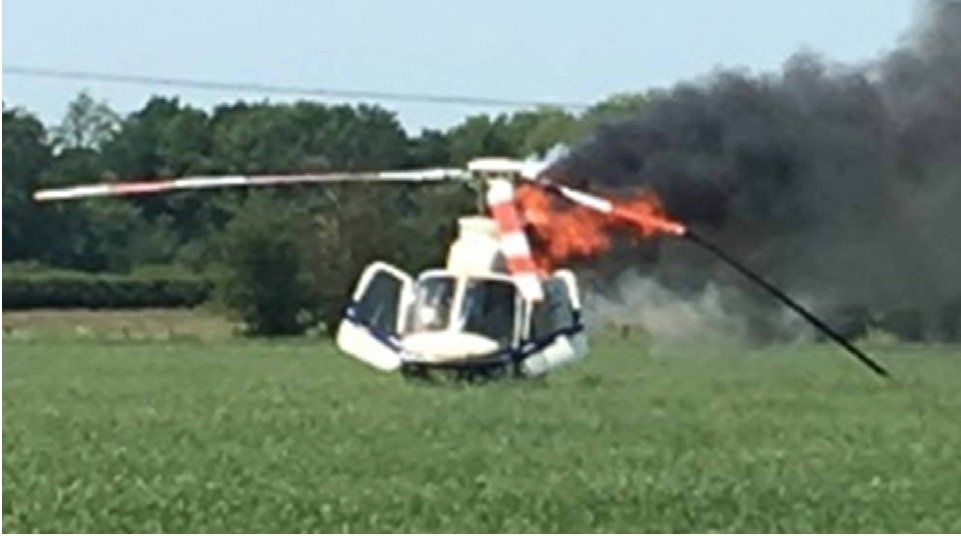
**Figure 6**

N120HH 48 seconds after the image at Figure 5 was taken  
(image used with permission)

The helicopter had not been fitted with the optional fire detection and warning system, so the pilot and passenger were not aware of the fire until after the helicopter had landed. The time from the engine failure to an extensive fire taking hold on the ground (Figure 6) was approximately 2.5 minutes, which is within the 5 minute minimum requirement specified in 14 CFR Part 27. On this occasion the time was sufficient to complete the autorotation and for the pilot and passenger to safely vacate the helicopter.

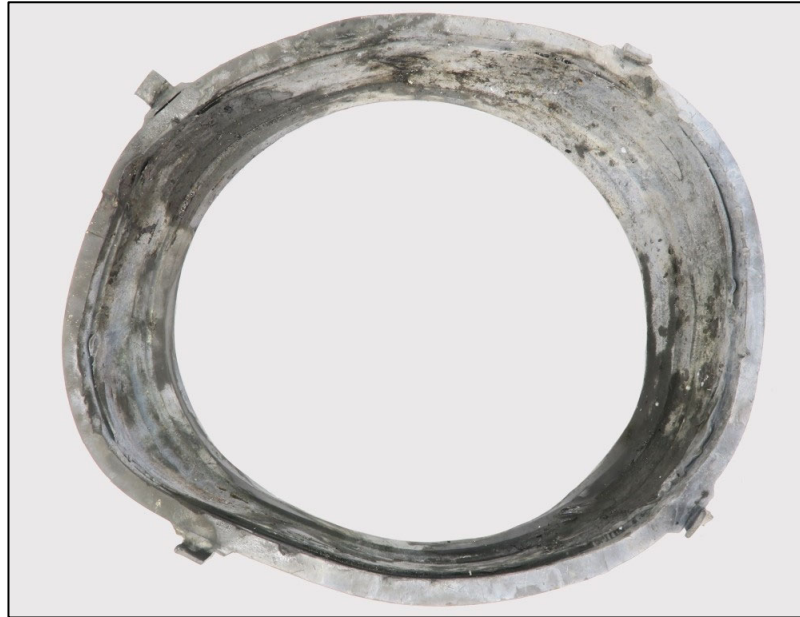
**Figure 23**  
Energy absorbing ring (Front view)  
(Image used with permission of Rolls-Royce PLC)

The energy absorbing ring around the GP1 rotor was significantly deformed (Figure 23). There was no deformation to the casing around the PT turbine.

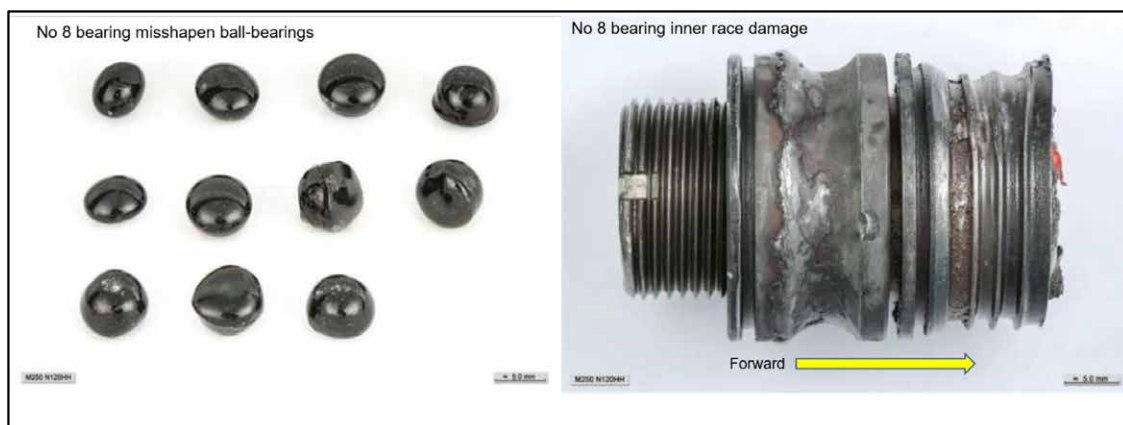
**Figure 27**

The bearing was removed with the remaining GP1 rotor shaft section seized in place. Detailed inspection found the cage had seized onto the outer race due to overheating. This type of damage typically occurs when the cage expands into the race while it is rotating. The designed split in the outer race was noted to gape, and likely to indicate excessive hoop stresses from the thermal expansion of the cage. The assembly was stripped to inspect the ball bearings. All the balls were misshapen with none of the original contact surface remaining. The inner race exhibited smearing on the rear lip indicating the balls were sliding rather than rolling over the circumference (Figure 27). Inspection of the outer race also noted a circumferential burr to the front lip. This would also correlate with the condition of the bearing degrading prior to the disc fragmentation.

No 8 ball bearings and inner race  
(Image used with permission of Rolls-Royce PLC)

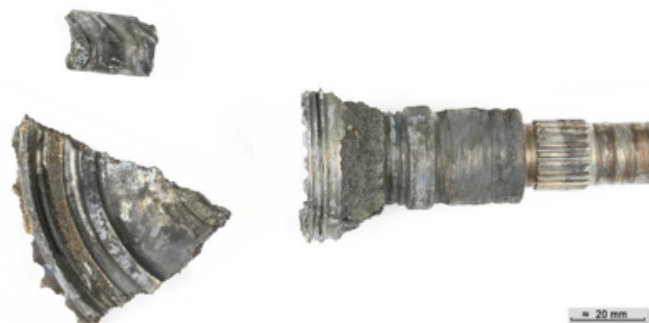
**Figure 32**

Approximately one eighth of the GP2 disc was recovered (Figure 32). The largest fragment of rotor was examined and found to have failed in overload, with multiple radial cracks in the machined face of the rotor rim. The remnants of the turbine blade were found to have experienced similar heating effects to the blades on GP1.

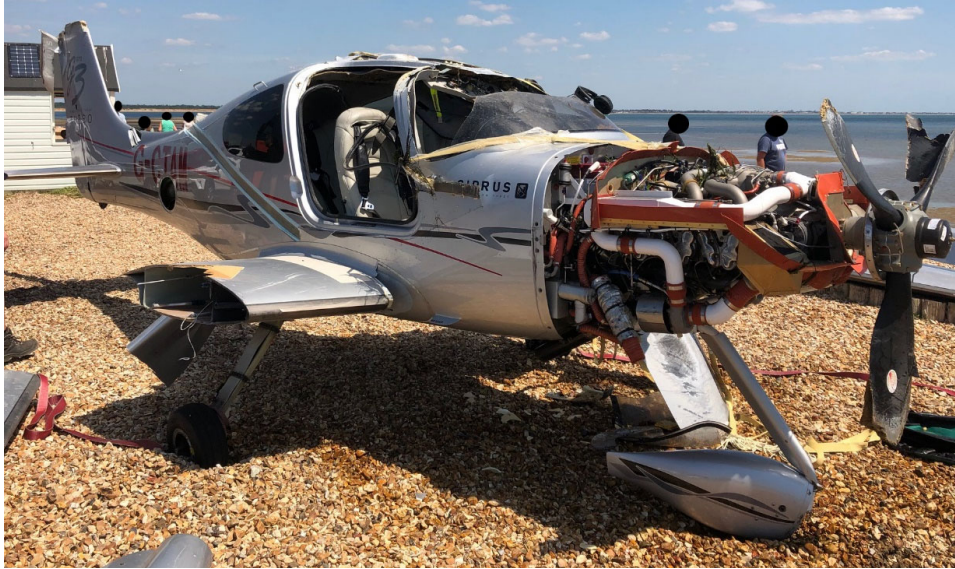
**Figure 2**

The aircraft's wings were cut off and the aircraft was transported to a secure facility. The aircraft had suffered significant damage to its upper fuselage structure and windscreen from being dragged up the beach inverted (Figure 2).

Aircraft after it was righted, the engine cowling removed, and the wings cut off

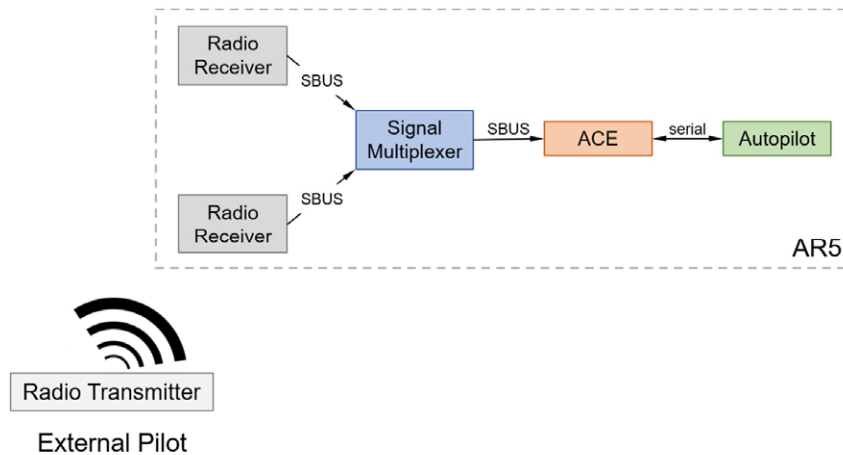
**Figure 4**  
EP control path

In normal flight conditions the aircraft is controlled via the RLOS and BRLOS communication channel from the GCS. However, in an emergency the EP can take direct control of the aircraft via a separate controller with its own radio link. Although there is only one transmitter (used by the EP), at the time of the event the AR5 had a dual receiver system which provided redundancy should one of the receivers fail. The dual receiver system also marginally extended the range at which the EP could control the aircraft. The outputs from the dual receivers were routed through a multiplexer which merged the signals and passed them via the ACE to the Autopilot (Figure 4). When out of range of the EP's controller, receivers are programmed to send a signal down one of the control channels to the autopilot. The autopilot then ignores all the other control channel signals until a receiver detects that the aircraft is back in range.

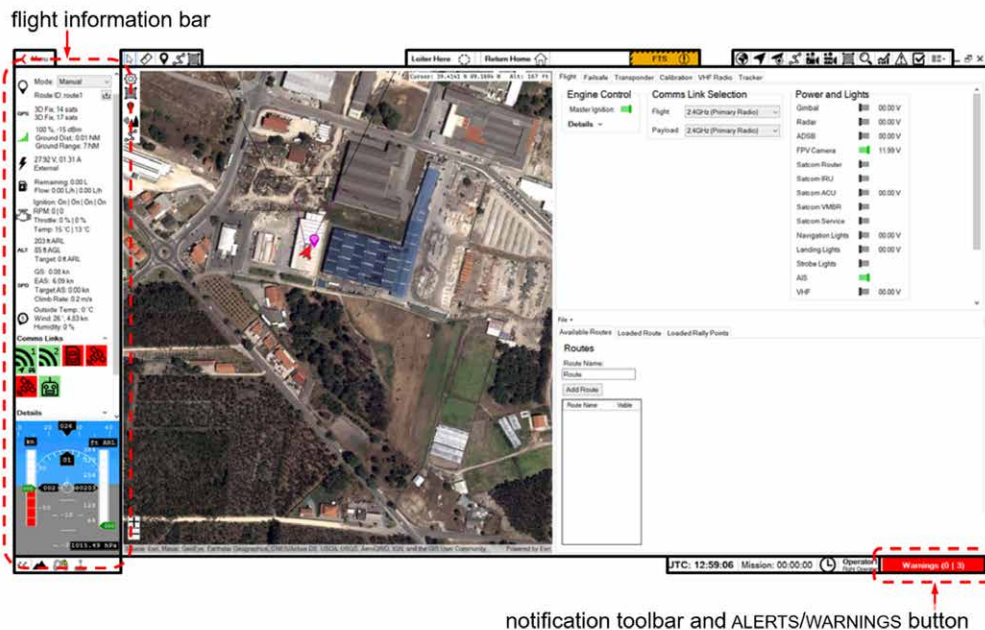
**Figure 5**  
fGCS Primary display – MiSt screen

The fGCS consisted of a dual screen display, of which the primary screen displayed the Mission Station (MiSt) screen (Figure 5). The mGCS consisted of a three-screen display, one of which mirrored the MiSt display.

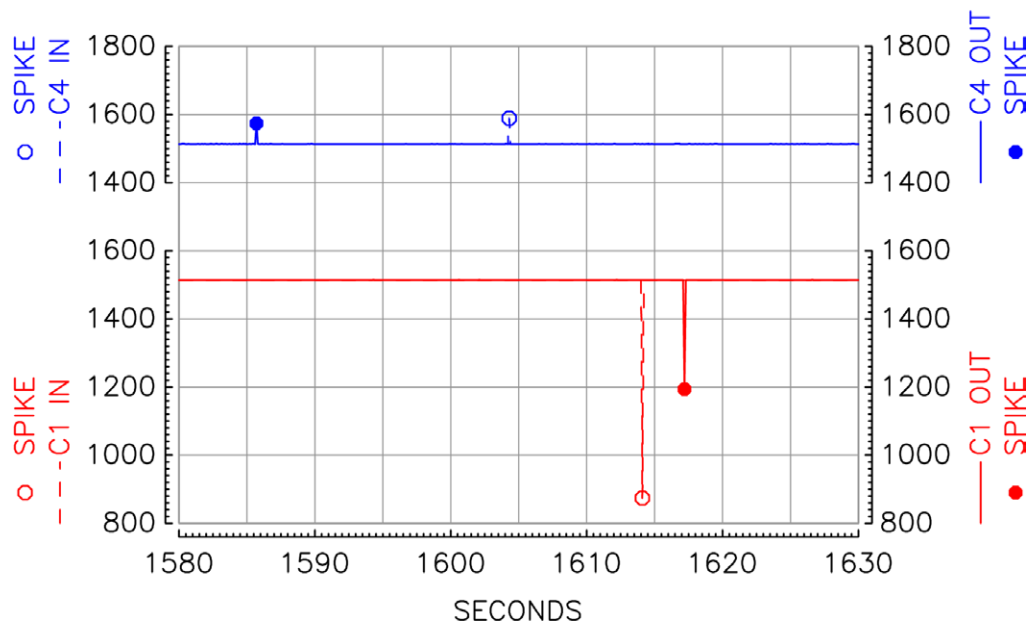
**Figure 7**

After further testing, the operator identified erroneous values, in the form of bit errors, within the data passed from the multiplexer via the ACE to the autopilot (Figure 7) and began an investigation to understand how and where these signal errors were being introduced.

Data from the aircraft log file showing spikes on the control channels in and out of the autopilot for Aileron (C1) and Rudder (C4) for the June 2020 event
