ACCIDENT

Aircraft Type and Registration:	Cirrus SR22, G-CTAM	
No & Type of Engines:	1 Teledyne Continental IO-550-N piston engine	
Year of Manufacture:	2007 (Serial no: 2740)	
Date & Time (UTC):	31 May 2020 at 1345 hrs	
Location:	Calshot Spit, Hampshire	
Type of Flight:	Private	
Persons on Board:	Crew - 1	Passengers - 1
Injuries:	Crew - None	Passengers - None
Nature of Damage:	Damaged beyond economical repair	
Commander's Licence:	Private Pilot's Licence	
Commander's Age:	56 years	
Commander's Flying Experience:	587 hours (of which 89 were on type) Last 90 days - 11 hours Last 28 days - 6 hours	
Information Source:	AAIB Field Investigation

Synopsis

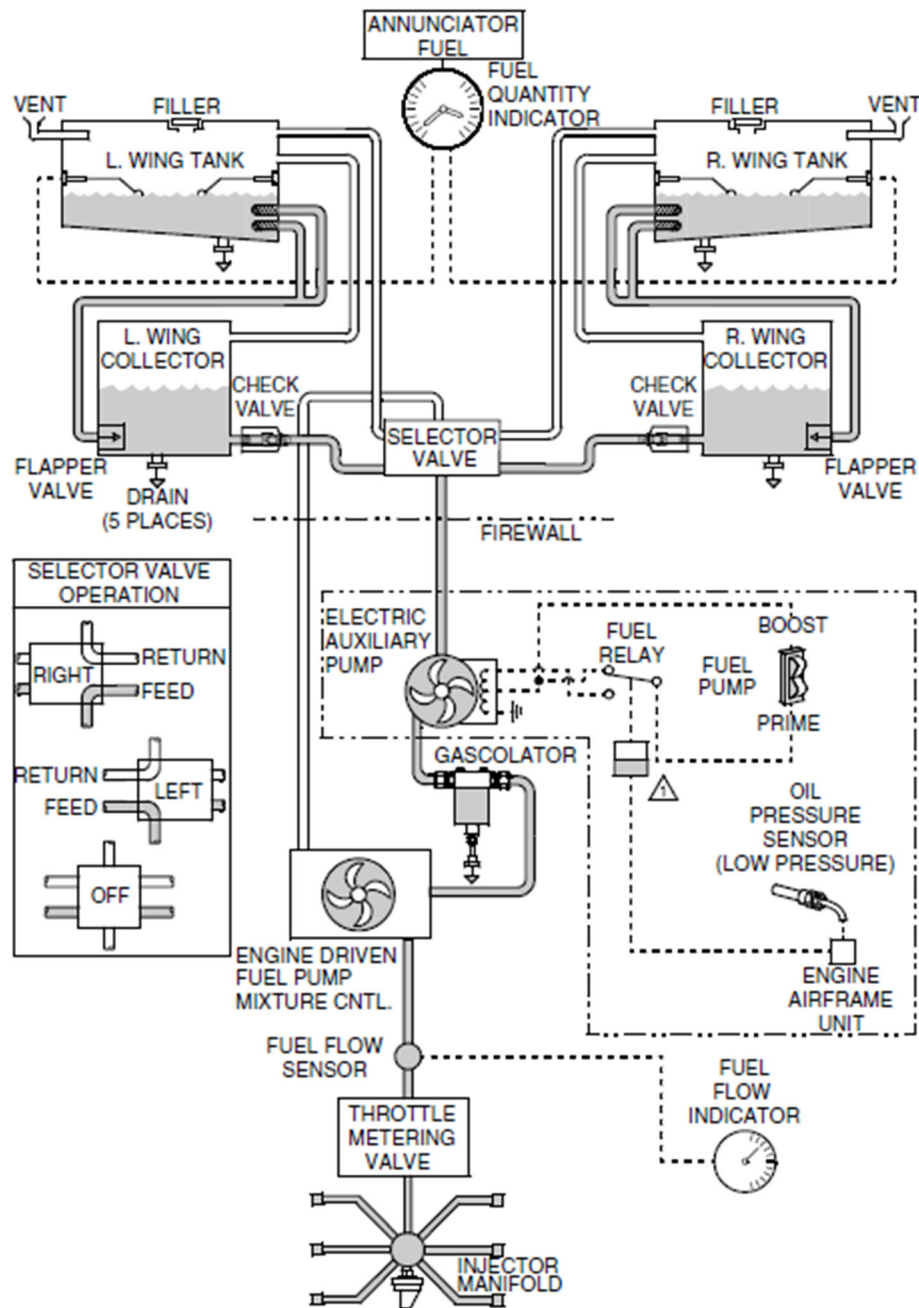
Figure 3

Two main wing tanks and two collector tanks provide for a total capacity of 94.5 USG (358 litres), of which 92.0 USG (348 litres) are usable. When filled to the tabs, below each filler neck, the total usable fuel is 60 USG (227 litres). Fuel is gravity-fed from each tank to the associated 2.8 USG collector tank where the engine-driven fuel pump draws fuel through a filter and selector valve to pressure feed the engine fuel injection system (Figure 3). An electric fuel pump is provided for engine priming when the fuel pump switch is set to PRIME and vapour suppression when set to BOOST. Each wing tank and collector tank has a drain valve to collect water and contaminants. Each wing tank has an air vent at the top of the tank which is connected to an air inlet on each lower outboard wing surface. Each collector tank has a vent line connected to its main tank.

Fuel system diagram for Cirrus SR22 with G3 wing

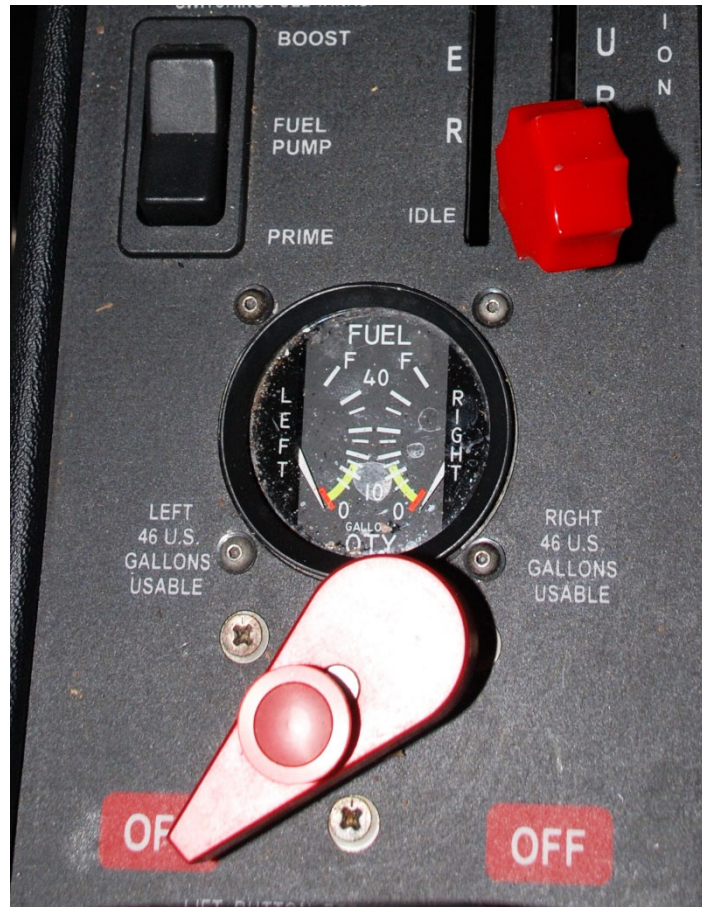
Figure 4

The fuel tank selector valve is mounted in the centre console (Figure 4). It has four positions: LEFT, RIGHT, RIGHT-OFF and LEFT-OFF. To move the selector to one of the OFF positions requires lifting the circular plunger in the centre of the selector; this design is intended to prevent an inadvertent OFF selection. Fuel is balanced throughout the flight by the pilot alternating the selection between left and right tank. The maximum allowable fuel imbalance is 10 USG.

Fuel selector valve, fuel gauge and fuel pump switch

The fuel selector was removed at the AAIB's facility, and although its rotating mechanism had seized due to corrosion as a result of sea water ingress, once the corrosion was removed the fuel selector operated normally and the central knob functioned correctly to reduce the chance of a pilot inadvertently turning it off while changing tanks. A test fluid was passed through the left and right inlets and there was no restriction to flow in either the left or right position.

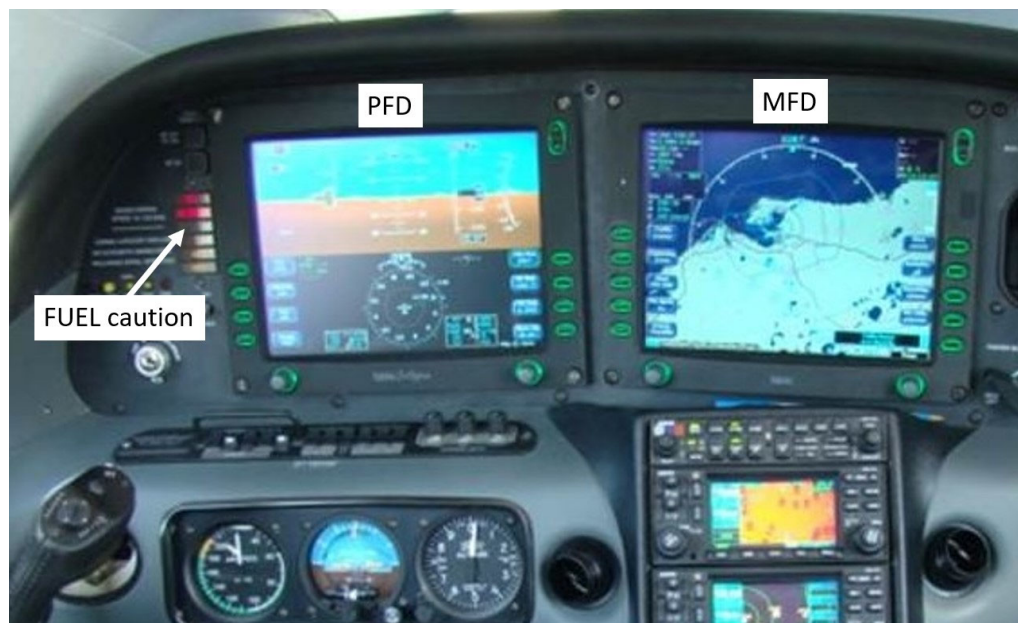
**Figure 5**

Each wing tank contains two analogue float-type sensors, one outboard and one inboard. These sensors provide fuel level information to the analogue fuel quantity indicator mounted forward of the fuel selector. An amber FUEL caution light located to the left of the PFD (Figure 5) comes on to indicate a low fuel condition. It is triggered by switches in the fuel quantity indicator when both tanks are indicating below approximately 14 USG. If both tanks are equally balanced at about 14 USG, then the light will illuminate at an indicated usable fuel quantity of about 28 USG. However, if one tank is run dry when the other tank is above about 14 USG, then the light will illuminate at a usable quantity of about 14 USG.

PFD, MFD and location of FUEL caution light
