ACCIDENT

Aircraft Type and Registration:	Bell 407, N120HH	
No & Type of Engines:	1 Rolls-Royce M250-C47B turboshaft engine	
Year of Manufacture:	2005 (Serial no: 53661)	
Date & Time (UTC):	24 June 2020 at 1219 hrs	
Location:	Long Marston, Stratford-upon-Avon, Warwickshire	
Type of Flight:	Private	
Persons on Board:	Crew - 1	Passengers - 1
Injuries	Crew - None	Passengers - None
Nature of Damage:	Helicopter destroyed by post-impact fire	
Commander's Licence:	Private Pilot's Licence (Helicopter)	
Commander's Age:	45 years	
Commander's Flying Experience:	16,900 hours (of which 475 were on type) Last 90 days - 7 hours Last 28 days - 2 hours	
Information Source:	AAIB Field Investigation

Synopsis

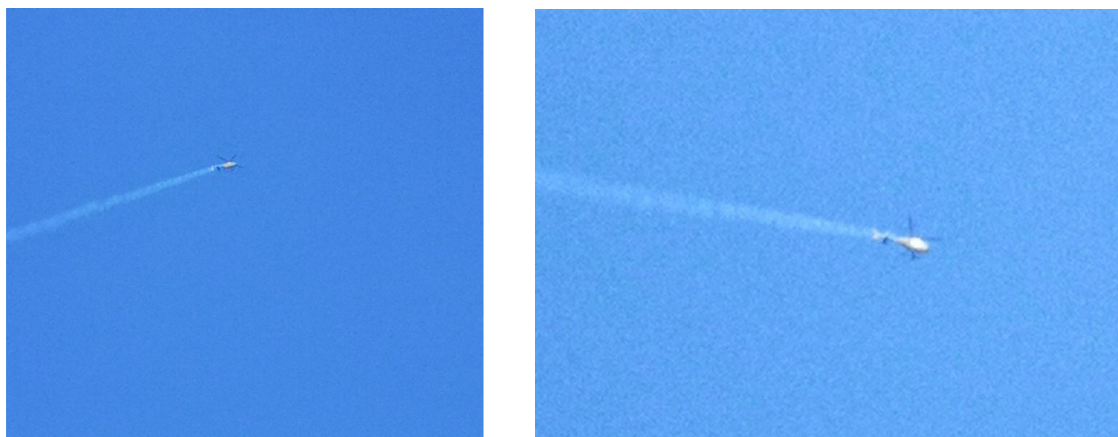
Figure 3

Two witnesses noticed the helicopter as it was flying towards Wellsbourne (Witness 1 and 2). The first witness was just south of Bidford-on-Avon. He saw the helicopter flying towards him from the west and could see the helicopter clearly through his binoculars. He described seeing what looked like a “contrail” coming from above the cabin but below the rotor. He watched the helicopter as it passed overhead and flew to the east; the ‘contrail’ continued throughout this time. In the distance he saw it turn to the south but did not see the accident. The second witness, who was near Dorsington described seeing “white smoke” coming from the helicopter and took a couple of photographs (Figure 3). As it passed him, he heard a “popping noise”, saw the smoke turn grey and saw the helicopter descend to the ground near Long Marston.

Witness photographs of helicopter in flight (images used with permission)

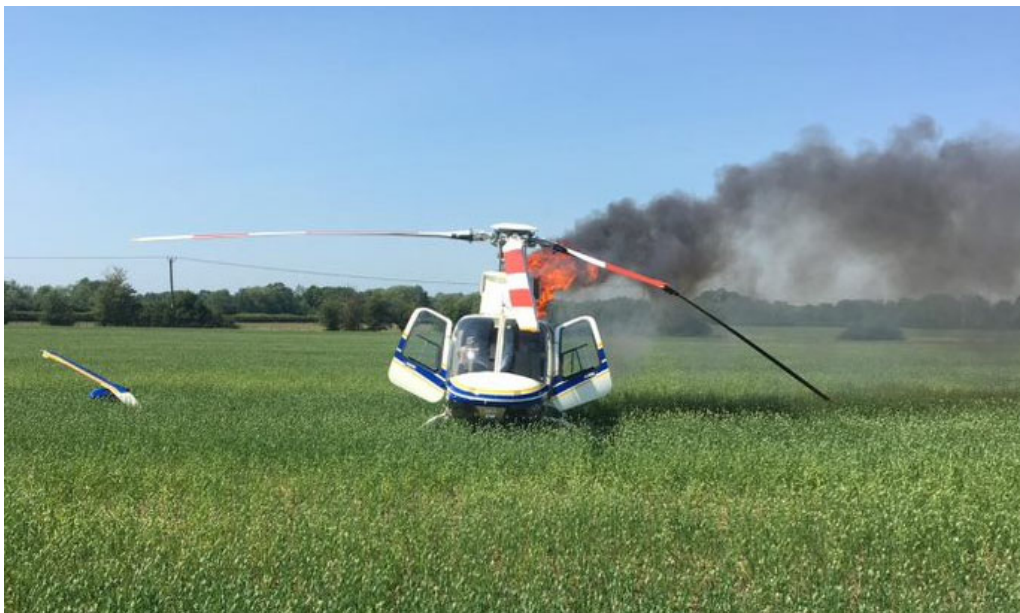
Figure 5

N120HH approximately 30 seconds after the landing (image used with permission)

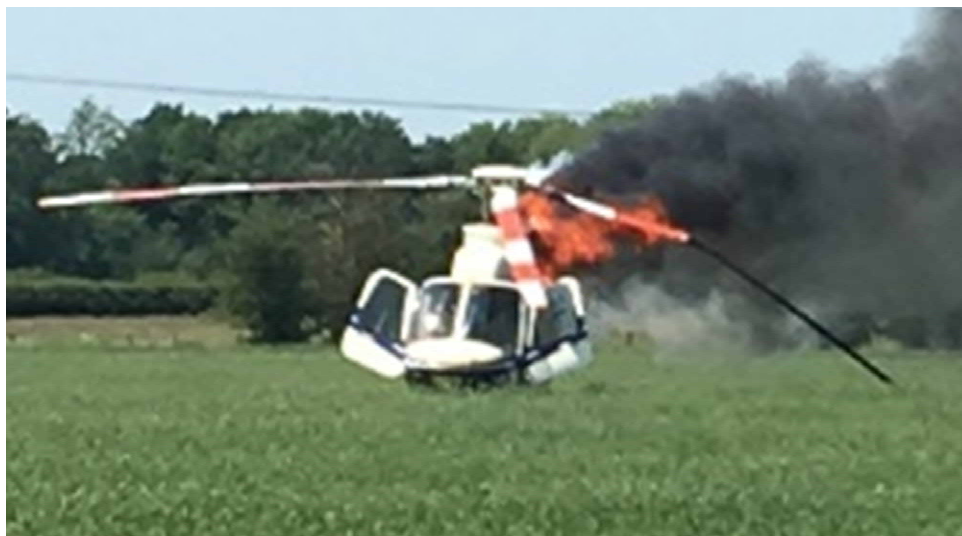
Figure 6

N120HH 48 seconds after the image at Figure 5 was taken
(image used with permission)

The helicopter had not been fitted with the optional fire detection and warning system, so the pilot and passenger were not aware of the fire until after the helicopter had landed. The time from the engine failure to an extensive fire taking hold on the ground (Figure 6) was approximately 2.5 minutes, which is within the 5 minute minimum requirement specified in 14 CFR Part 27. On this occasion the time was sufficient to complete the autorotation and for the pilot and passenger to safely vacate the helicopter.

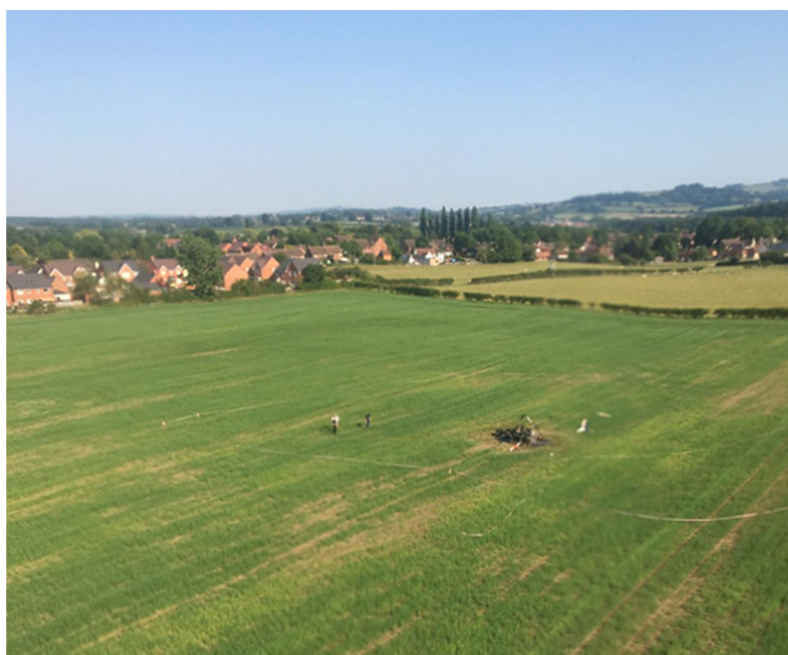
Figure 7

The accident site was contained in a relatively small area within a crop field (Figure 7). There were no indications on the ground that the helicopter had slid or struck the ground prior to its final position. The fire service advised that the wreckage had been covered in a precautionary layer of foam due to the magnesium fire in the gearbox casing.

Accident site (image used with permission)

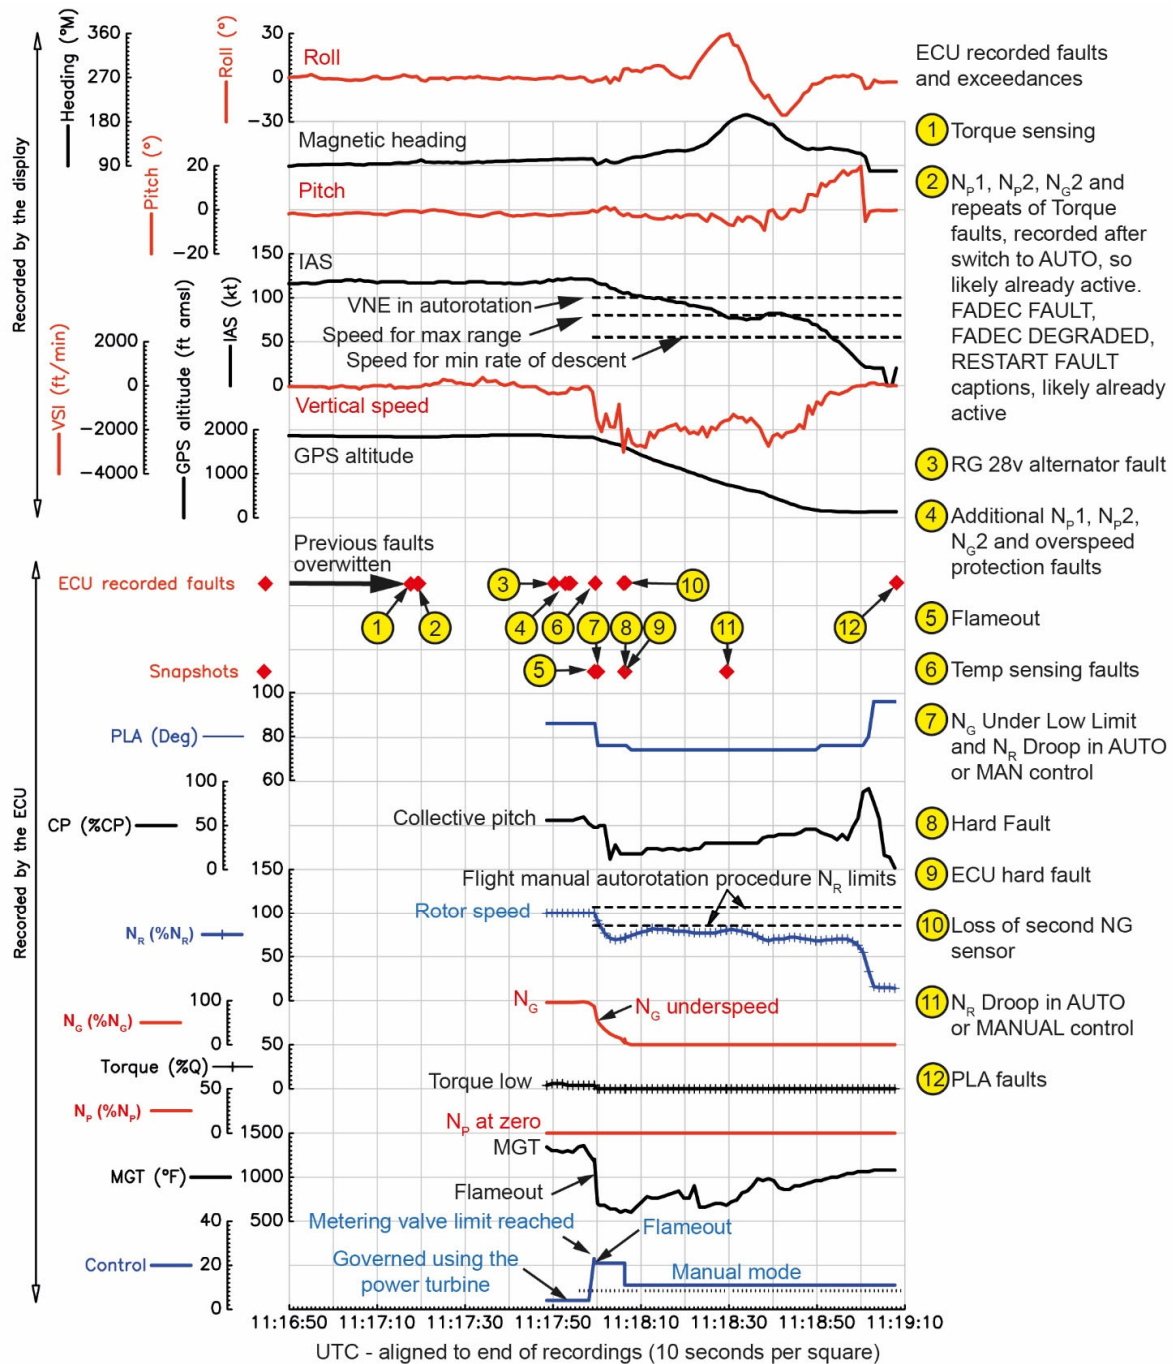
Figure 17 shows data extracted from the PFD and ECU from the later part of the accident flight. The two sources of data were combined by aligning the ends of both recordings.

Extracts from the data recorded by the PFD and ECU

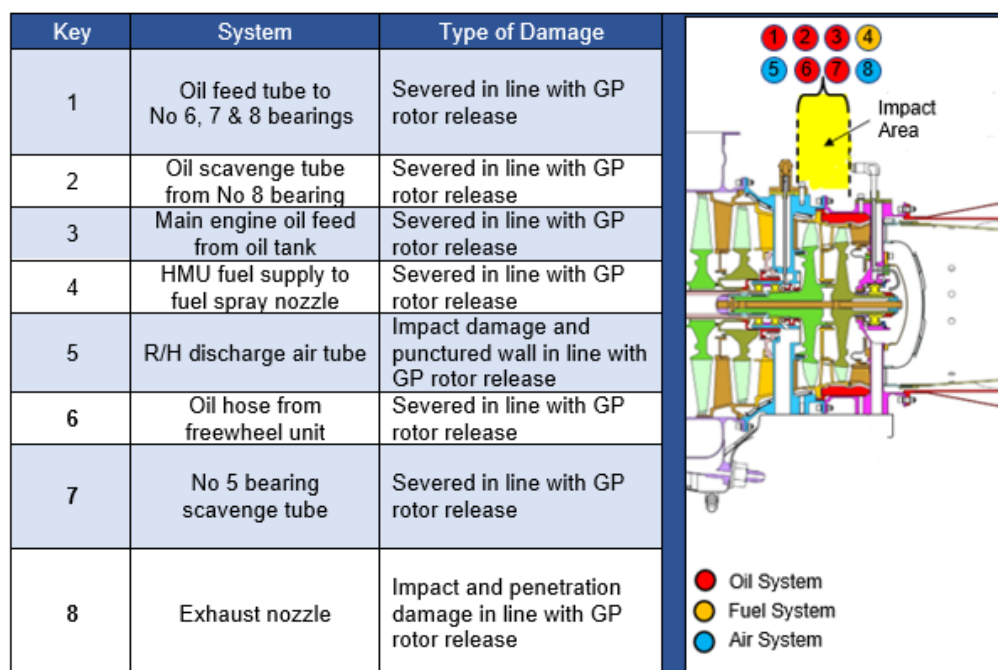
Figure 19

The engine bay was removed from the wreckage and assessed prior to removal of the engine itself. Damage in this area could be attributed to the fire and the release of the turbine rotor discs. There was no evidence that the fire walls had been breached. The main fuel supply line to the HMU was intact. The magnesium gearbox had been partly destroyed although many of the internal components such as gears remained in place. There was evidence that some interconnections had been severed by the released turbine rotor discs. These connections are mapped against the projectile analysis at Figure 19.

Projectile analysis

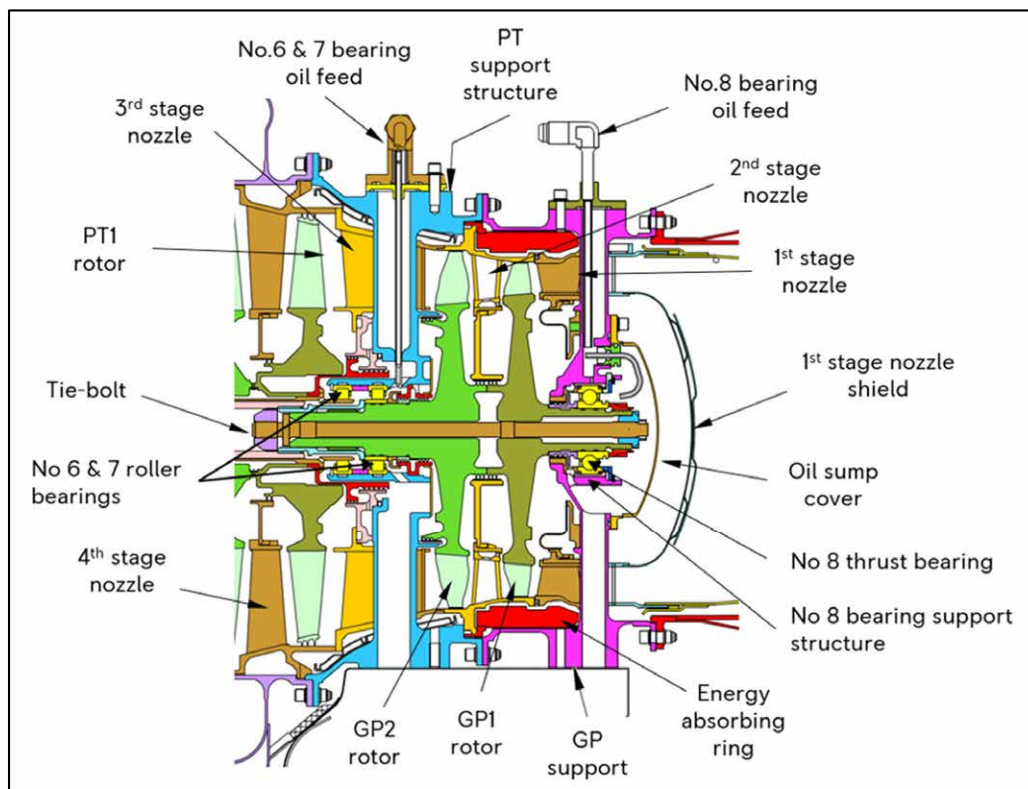
The engine was taken to an engine overhaul organisation, where it was disassembled under the supervision of the AAIB and a representative from the engine manufacturer's sister company in the UK. Figure 22 shows the key components on which observations were made during the disassembly.

The energy absorbing ring around the GP1 rotor was significantly deformed (Figure 23). There was no deformation to the casing around the PT turbine.

The GP1 rotor shaft had fractured and the tie-bolt which locates the GP turbine rotors had sheared (Figure 24) in overload in line with the GP1 disc and shaft, separating the curvic couplings in the process. A small middle section of the tie-bolt was not found.
