Collision between fishing vessel *Achieve* (HL257) and general cargo ship *Talis*, resulting in the sinking of *Achieve* off Tynemouth, England on 8 November 2020

SUMMARY

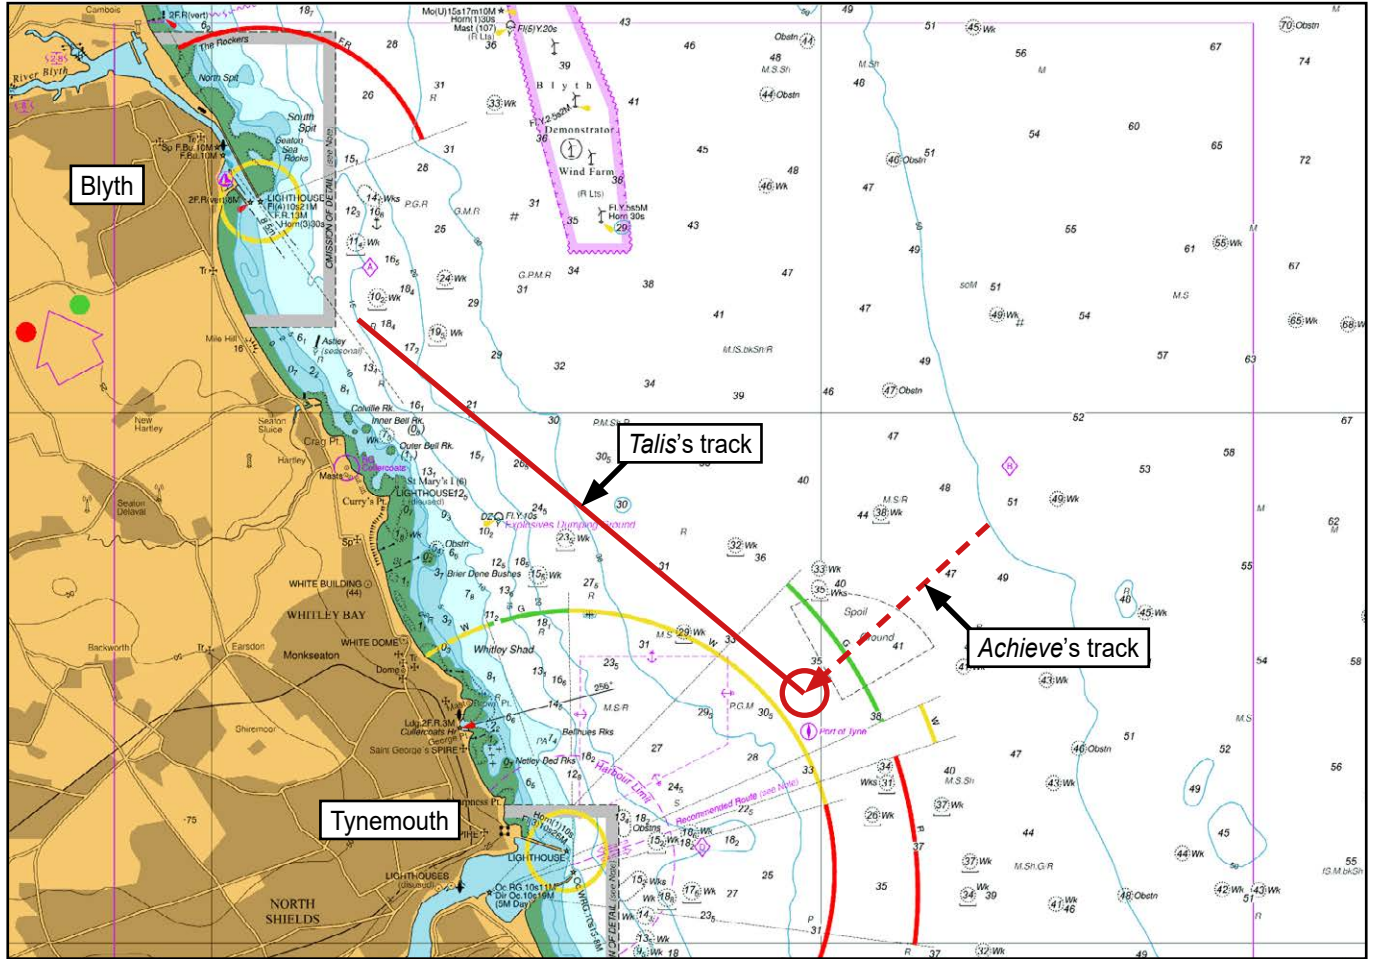
Figure 1: Extract from Admiralty Chart 156, showing tracks of *Talis* and *Achieve*

At about 0530 UTC¹ on 8 November 2020, the UK registered prawn trawler *Achieve* departed North Shields, England, bound for fishing grounds off Tynemouth (**Figure 1**). A skipper and a deckhand crewed the vessel. The skipper planned to fish during the day and return to North Shields in the afternoon. There was a light southerly wind and it was overcast with fog patches.
