ACCIDENT

Aircraft Type and Registration:	Cessna FRA150L, Aerobat, G-CIIR	
No & Type of Engines:	1 Rolls-Royce Continental O-240-A piston engine	
Year of Manufacture:	1973 (Serial no: 187)	
Date & Time (UTC):	11 October 2020 at 1342 hrs	
Location:	Troutbeck Airfield, Cumbria	
Type of Flight:	Private	
Persons on Board:	Crew - 1	Passengers - None
Injuries:	Crew - 1 (Fatal)	Passengers - N/A
Nature of Damage:	Destroyed	
Commander's Licence:	Private Pilot's Licence	
Commander's Age:	44 years	
Commander's Flying Experience:	69 hours (of which 52 were on type) Last 90 days - 3 hours Last 28 days - 2 hours	
Information Source:	Field Investigation

Synopsis

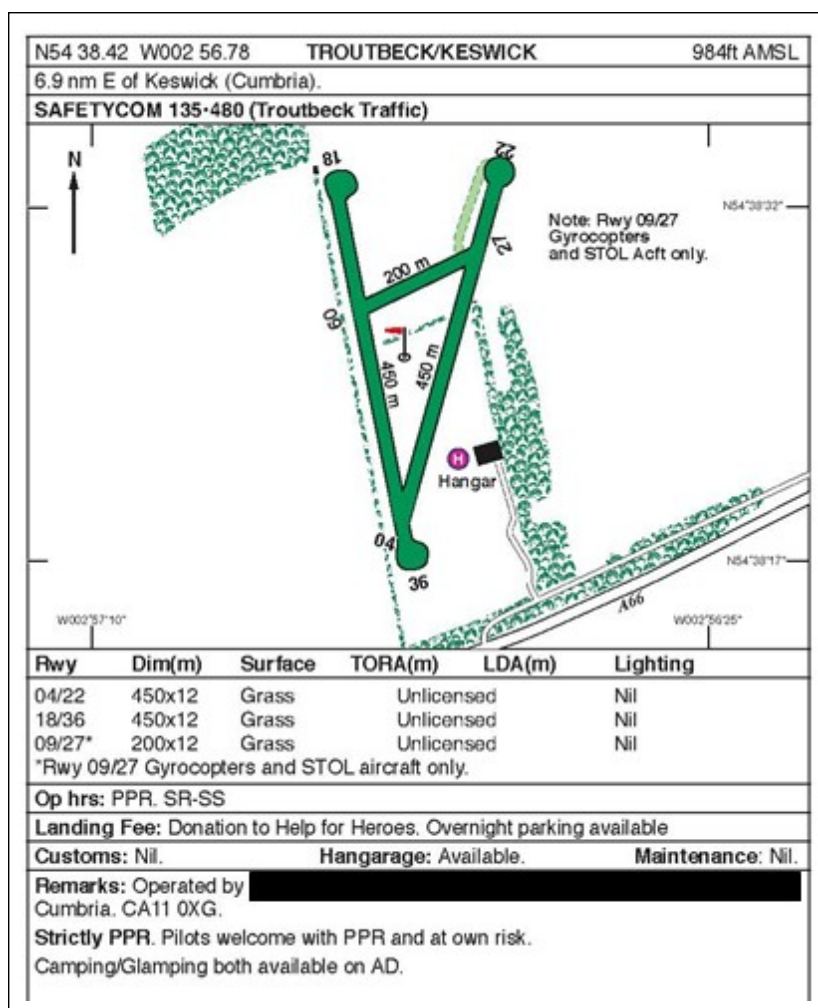
Figure 1

Plate of Troutbeck Airfield - © Pooleys

Troutbeck Airfield has three grass runways oriented 18/36, 04/22 and 09/27 (Figure 1). Runway 36 is a 450 m grass runway. The runway has a positive gradient of about 3.3% from the threshold of Runway 36 to just after the intersection with Runway 04. Thereafter, it has a negative gradient. The elevation is approximately the same at the threshold of Runway 36 and Runway 18. Runway 36 is approximately 320 m long from the intersection of Runway 04.

As stated in Figure 1, Troutbeck airfield is '**Strictly PPR**' and the SafetyCom frequency (134.480 MHz) is to be used for RTF communications.
