AAIB Bulletin

10/2021

Published 14 October 2021

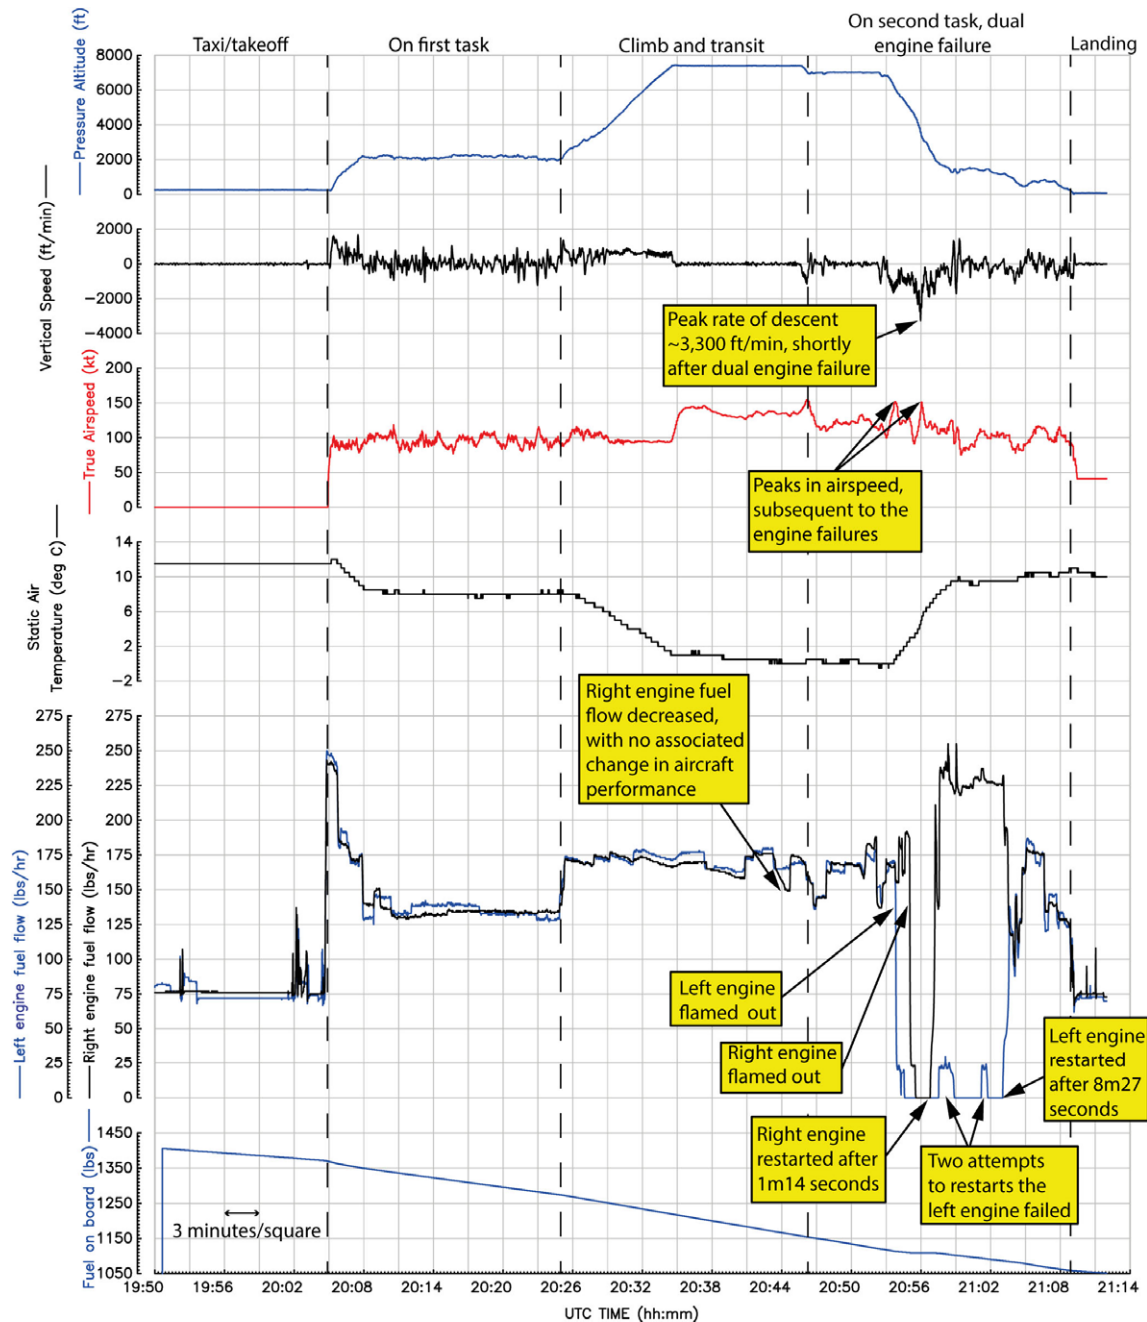
G-CGTC entered a descent, at up to 1,500 ft/min, and its true airspeed increased to 150 kt. A minute later, at 2054 hrs, the right engine's fuel flow reduced to zero as this engine also flamed out. (The data showed that the engines did not fail in the order recalled by the pilot). G-CGTC then entered a steeper descent, during which the true airspeed (which after the first engine flameout had reduced to 120 kt) again reached 150 kt, the SAT rose rapidly and a peak rate of descent of approximately 3,300 ft/min was recorded.

The right engine was successfully restarted 74 seconds after it flamed out and at a pressure altitude of 2,500 ft (2,100 ft amsl), at which point G-CGTC's flight path began to stabilise with a reduction in both the rate of descent and true airspeed recorded. The data then showed two unsuccessful attempts were made to restart the left engine, while the aircraft was in a shallow descent towards Eglinton, before it was successfully restarted at a pressure altitude of 1,200 ft (800 ft amsl) 8 minutes 27 seconds after it had failed. G-CGTC landed at 2109 hrs, with both engines operational, after one circuit flown at approximately 500 ft agl. An annotated copy of this data is shown in Figure 2 below.

FMC data for the incident flight

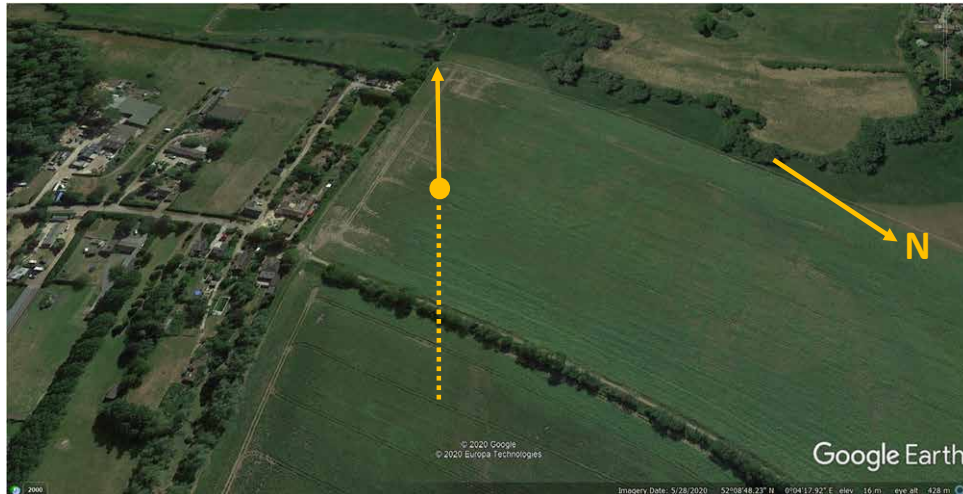
Figure 5
Accident location

The aircraft touched down mid-way across a smooth ploughed field travelling in a south-westerly direction and continued until it reached a dense hedgerow with trees (Figure 5). It did not slow significantly, travelling approximately 160 m, with the landing gear raised, over the dry hard earth. After the initial impact there was a second impact impression and thereafter a debris trail of small metallic items, remains of antennas and part of an engine mount.

The left wingtip struck the hedge first and caused the aircraft to rotate anti-clockwise (as viewed from above) whilst travelling along the hedge line. The aircraft came to rest in three pieces: the engine, the forward fuselage with wings, and the rear fuselage. The engine had detached from its mountings during the ground slide but was still attached to the airframe by several large-diameter electrical cables. The fuselage had broken just aft of the front windscreen, which coincided with the rear of the wing structure.

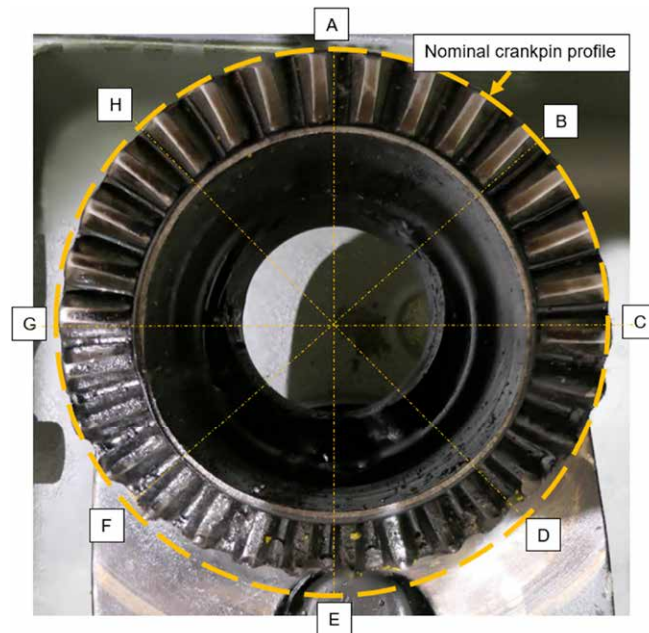
Figure 26
View looking aft on rear crankpin (centre crankshaft removed)

The crankshaft was split into its three sections and the master rod assemblies were removed. Both crankpins were deeply scored and one side of the rear crankpin was heavily worn. The nominal diameter of a crankpin is 89.027 mm (3.505 inches) and Table 1 shows the diameter with reference to Figures 26 and 27 for the rear crankpin. Front crankpin wear

Measurement (mm)	1	2	3	4
A-E	84.328	84.074	84.023	84.455
B-F	86.665	86.360	86.436	87.757
C-G	89.408	88.773	88.265	88.900
D-H	87.173	86.157	85.344	85.852

Table 1
Rear crankpin diameters
