AAIB Bulletin S3/2021

SPECIAL

ACCIDENT

Aircraft Type and Registration:	Escapade, G-CGNV	
No & Type of Engines:	1 Rotax 912-UL piston engine	
Year of Manufacture:	2011 (Serial no: LAA 345-14901)	
Date & Time (UTC):	14 November 2021 at 1204 hrs	
Location:	Brighton Airfield, East Riding of Yorkshire	
Type of Flight:	Private	
Persons on Board:	Crew - 1	Passengers - None
Injuries:	Crew - 1 (Fatal)	Passengers - N/A
Nature of Damage:	Aircraft destroyed	
Commander's Licence:	Private Pilot's Licence (Aeroplanes)	
Commander's Age:	66 years	
Commander's Flying Experience:	945 hours (of which 4 were on type) Last 90 days - 9 hours Last 28 days - 3 hours	
Information Source:	AAIB Field Investigation

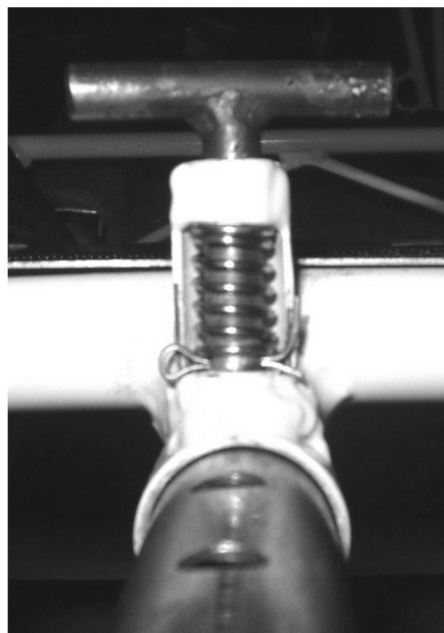
The seat is held in the selected position by a small spring-loaded pin centrally positioned at the front of the seat pan. The pin locates in equally spaced holes in a tube called an '*adjustment rail*' attached to the cockpit floor cross frame. Figure 3 shows the seat adjustment pin.

Image of seat pin from the aircraft assembly manual
(courtesy of the manufacturer)

Post-accident examination of the pilot's seat assembly showed that the seat pin was not correctly located in a hole in the adjustment rail. The damage and distortion to the adjustment rail was consistent with the seat being towards the rearmost extent of its travel when the aircraft struck the ground. Marks on the damaged adjustment rail showed that the seat adjustment pin and holes were slightly misaligned, with their centrelines offset (Figure 6), making it difficult for the pin to locate correctly.

The evidence indicates that the seat adjustment pin was not correctly located in one of the holes in the adjustment rail and therefore the seat was not locked in the fully forward position required by the pilot. Additionally, the seat adjuster backup strap, intended to prevent rearwards seat movement in case of pin failure, appears not to have been tightened.

It is recommended that the Light Aircraft Association remind owners of this aircraft type of the necessity, after every seat position adjustment, to:

It is recommended that the British Microlight Aircraft Association remind owners of this aircraft type of the necessity, after every seat position adjustment, to:
