Rail Accident Investigation Branch

Rail Accident Report

Runaway and derailment of wagons at Toton, Nottinghamshire 17 January 2021

Report 09/2021
December 2021

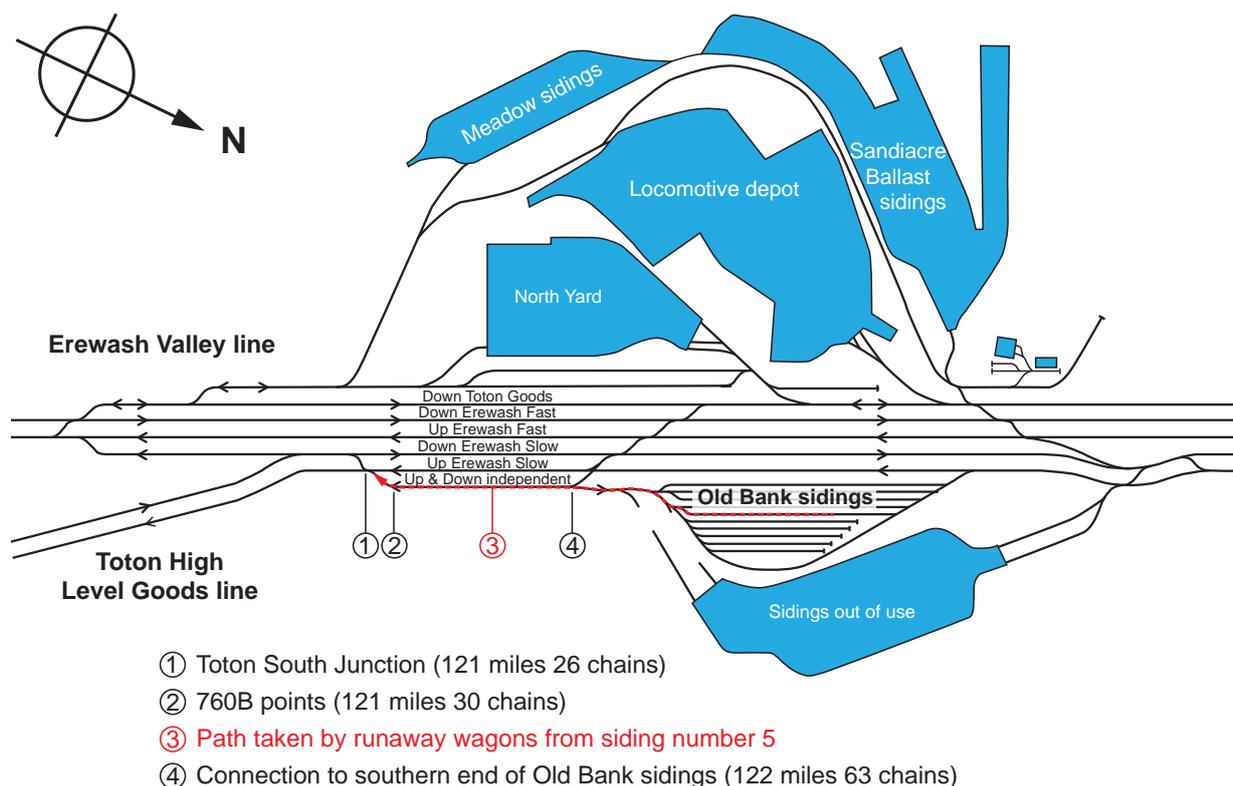
Figure 6: Track layout at Toton

- 8 The southern end of Old Bank sidings joins the up and down independent line at 122 miles 63 chains⁵ (from a zero reference at London St Pancras), at the boundary where ownership of the infrastructure changes from DB Cargo to Network Rail. At 121 miles 30 chains, the up and down independent line joins the up Erewash slow line at Toton South Junction. The trap points that derailed the wagons, reference number 760B, were located here (figure 6).

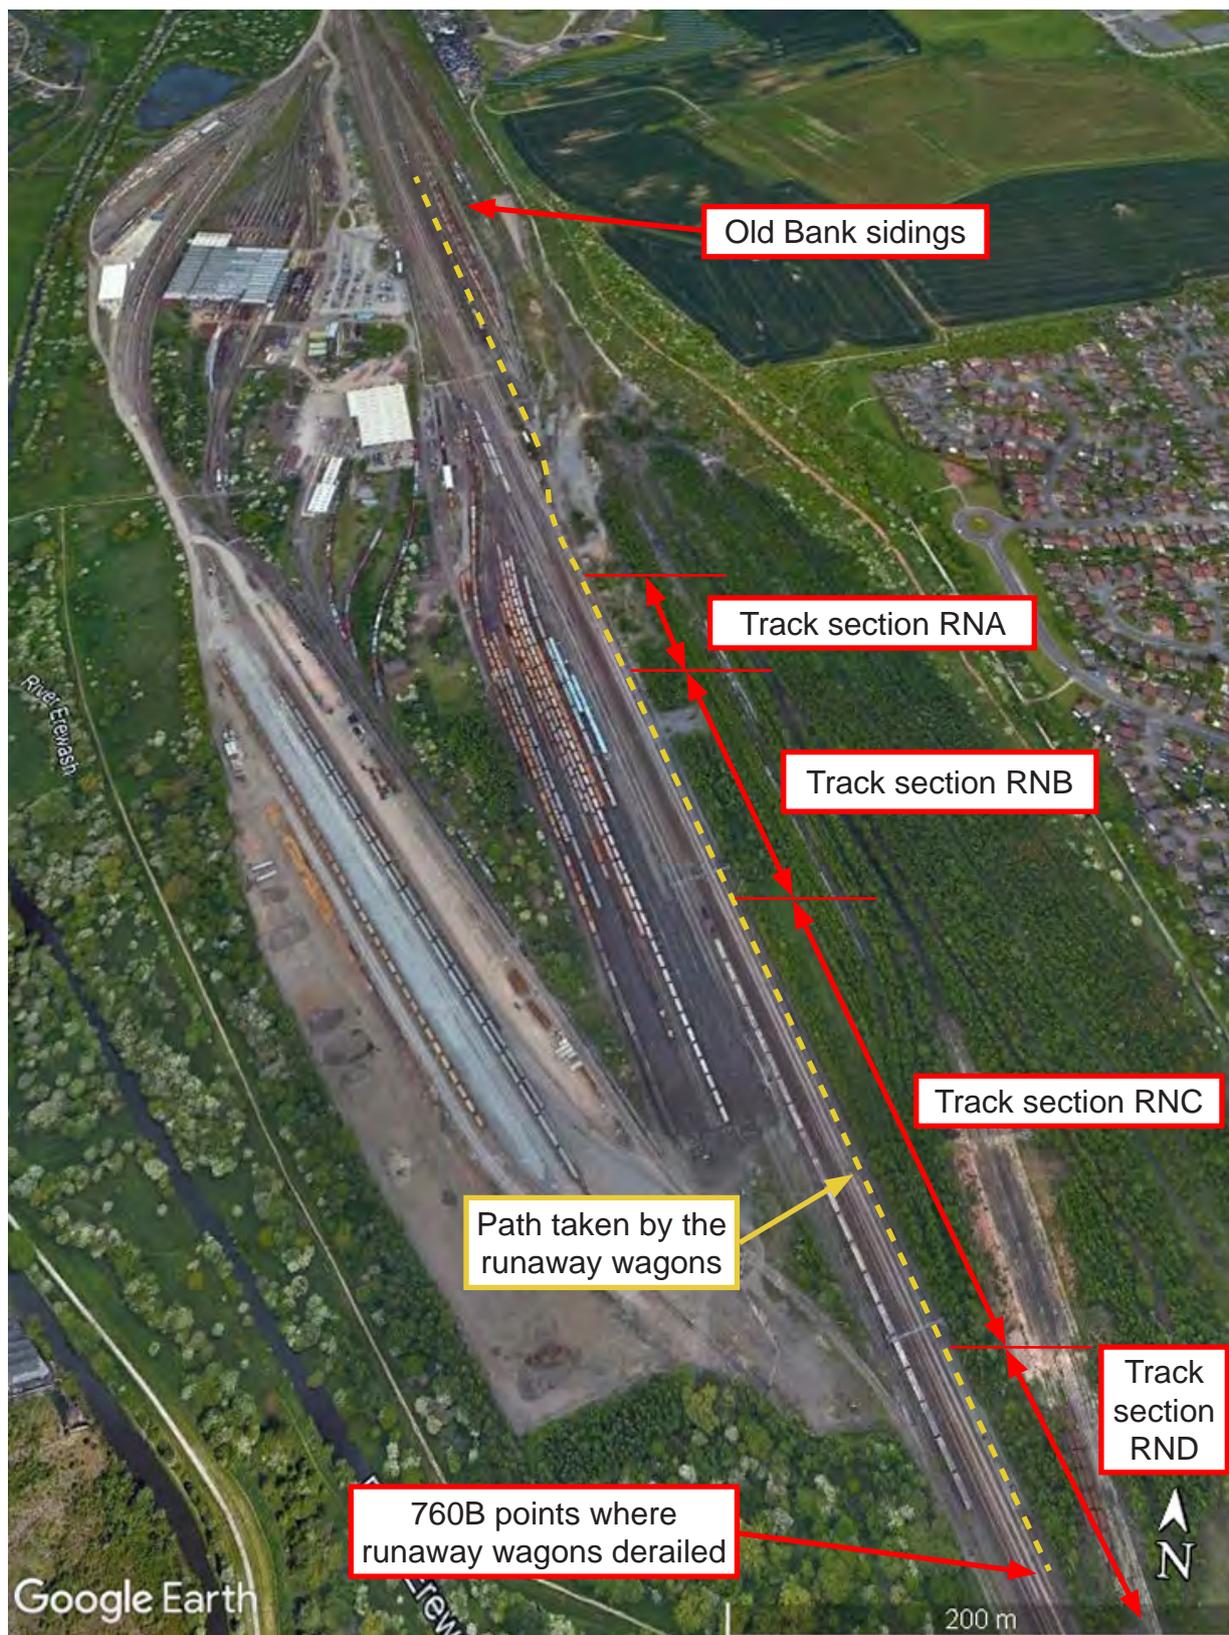
Figure 8: Track sections on the up and down independent line

- 38 The rake then continued for a short distance before it derailed on the run-out rails of 760B trap points. The rake eventually came to a stop with the leading two wagons obstructing the up Erewash slow line at Toton South Junction. Track section PJN on the up Erewash slow line showed as occupied at 04:45:59 hrs, due to the wheels of the derailed wagons damaging axle counter equipment.

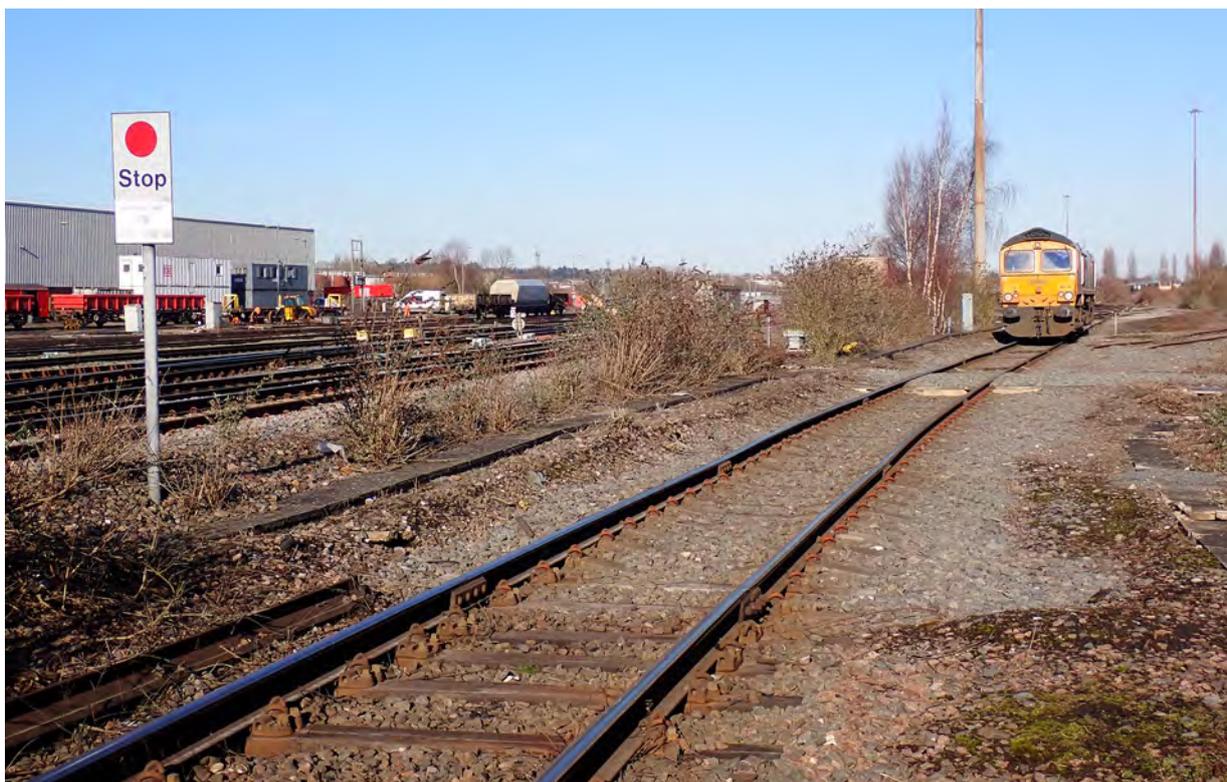
Figure 9: The stop board at the southern entrance to Old Bank sidings

- 49 When a train that was destined for Old Bank sidings was approaching Toton, the signaller at EMCC would call the PIC to obtain permission to route the train up to the stop board at the entrance to the sidings (figure 9).
