**SERIOUS INCIDENT**

<b>Aircraft Type and Registration:</b>	Evolve Dynamics Sky Mantis	
<b>No &amp; Type of Engines:</b>	4 Electric Motor Engines	
<b>Year of Manufacture:</b>	2020 (Serial no: LINC S 2)	
<b>Date &amp; Time (UTC):</b>	1) 14 January 2021 at 1100 hrs 2) 17 February 2021 at 0930 hrs	
<b>Location:</b>	1) Skegness, Lincolnshire 2) Skegness, Lincolnshire	
<b>Type of Flight:</b>	Commercial Operations	
<b>Persons on Board:</b>	Crew - None	Passengers - None
<b>Injuries:</b>	Crew - N/A	Passengers - N/A
<b>Nature of Damage:</b>	1) Moderate damage to landing gear, fuselage and a motor. One blade missing  2) Moderate damage to landing gear and propellers. One blade missing	
<b>Commander's Licence:</b>	1) Other 2) Other	
<b>Commander's Age:</b>	1) 38 years 2) Unknown	
<b>Commander's Flying Experience:</b>	1) 14 hours (of which 2 were on type) Last 90 days - 5 hours Last 28 days - 5 hours  2) 9 hours (of which 2 were on type) Last 90 days - 2 hours Last 28 days - 2 hours

**Synopsis**

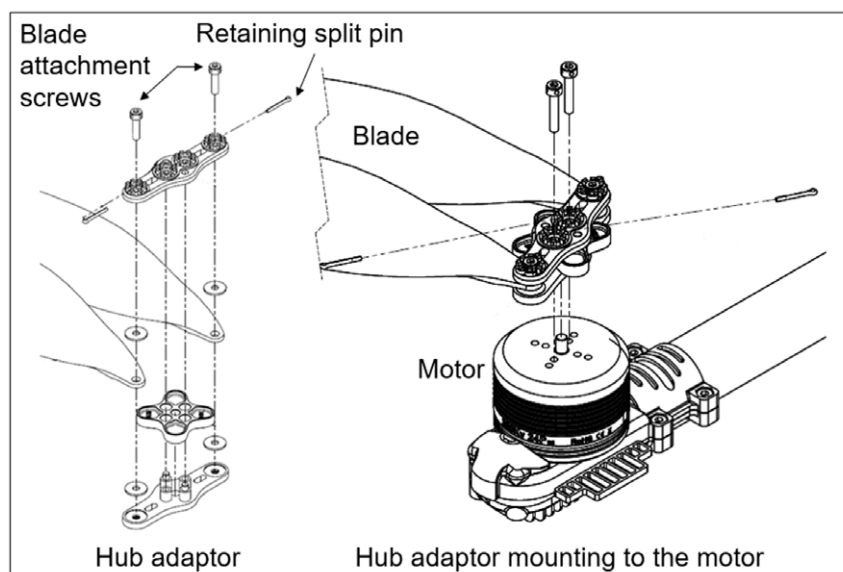
**Figure 2**  
Type 1 Motor hub adaptor

Each propeller blade is attached to the hub adaptor by a single M3, zinc plated, class 12.9 steel, socket head, shouldered cap screw. The 12 mm long screw is fastened into the threaded lower plate and secured with a split pin which engages with the castellations in the upper plate. Two further screws with split pins attach the adaptor to the motor. Washers are used to protect the composite blade (Figure 2).

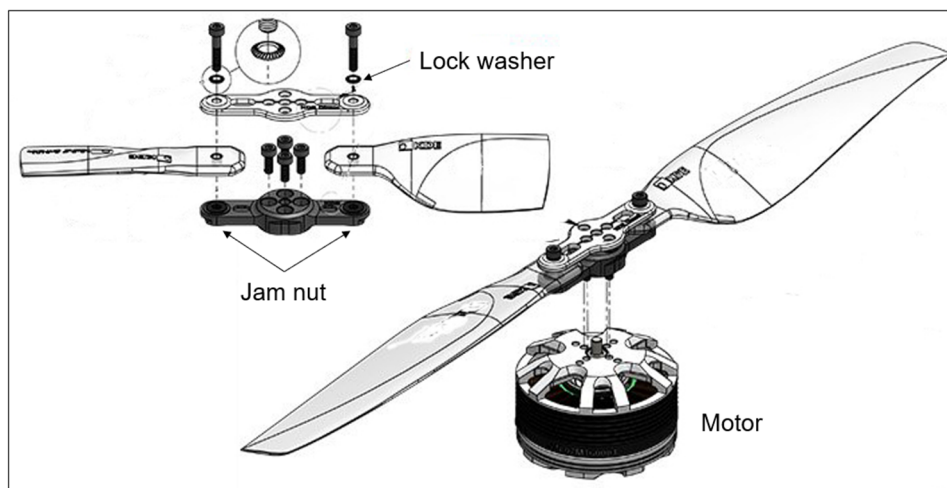
**Figure 3**

The type 2 motor hub adaptor is similar in design except that it uses a jam nut underneath the lower plate, lock washers and thread lock compound to retain the propeller blade screw. The M3 screw is also made from class 12.9 steel however, it has a black oxide finish (Figure 3).
