SERIOUS INCIDENT

Aircraft Type and Registration:	Piper PA-31, G-UKCS
No & Type of Engines:	2 Lycoming TIO-540-A2C piston engines
Year of Manufacture:	1974 (Serial no: 31-7400984)
Date & Time (UTC):	23 July 2021 at 0933 hrs
Location:	Doncaster Sheffield Airport
Type of Flight:	Aerial survey
Persons on Board:	Crew - 1 Passengers - 2
Injuries:	Crew - None Passengers - None
Nature of Damage:	Lower cabin door damaged
Commander's Licence:	Airline Transport Pilot's Licence
Commander's Age:	26 years
Commander's Flying Experience:	1,513 hours (of which 66 were on type) Last 90 days - 37 hours Last 28 days - 15 hours
Information Source:	Aircraft Accident Report Form submitted by the pilot and further enquiries by the AAIB

Synopsis

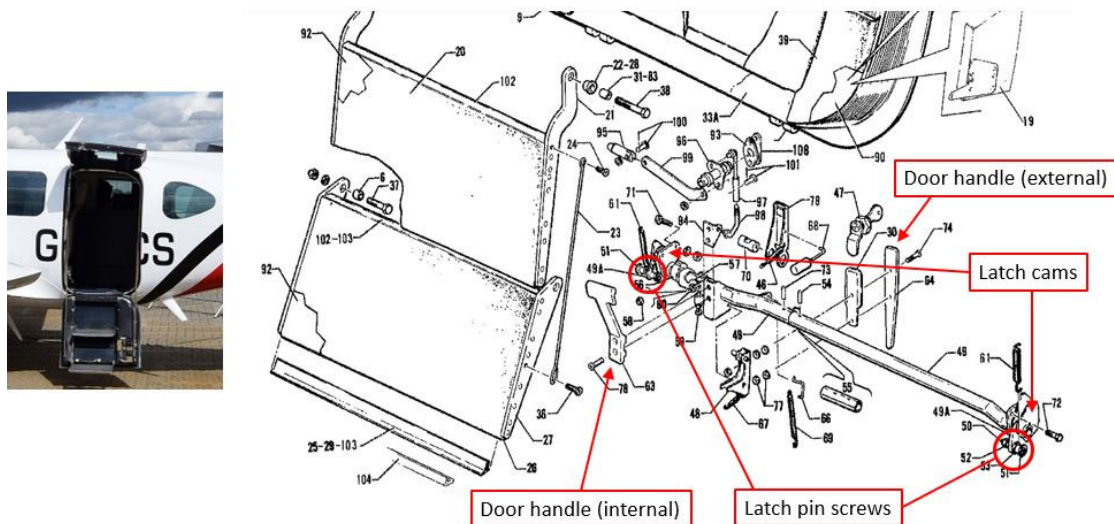
Figure 1

The main cabin door is a clamshell design (Figure 1) with upper and lower outward-opening doors. The lower door is fitted with two folding steps and when open is supported by two cable-stays.

PA-31 cabin door and latching mechanism (illustration courtesy of Piper)

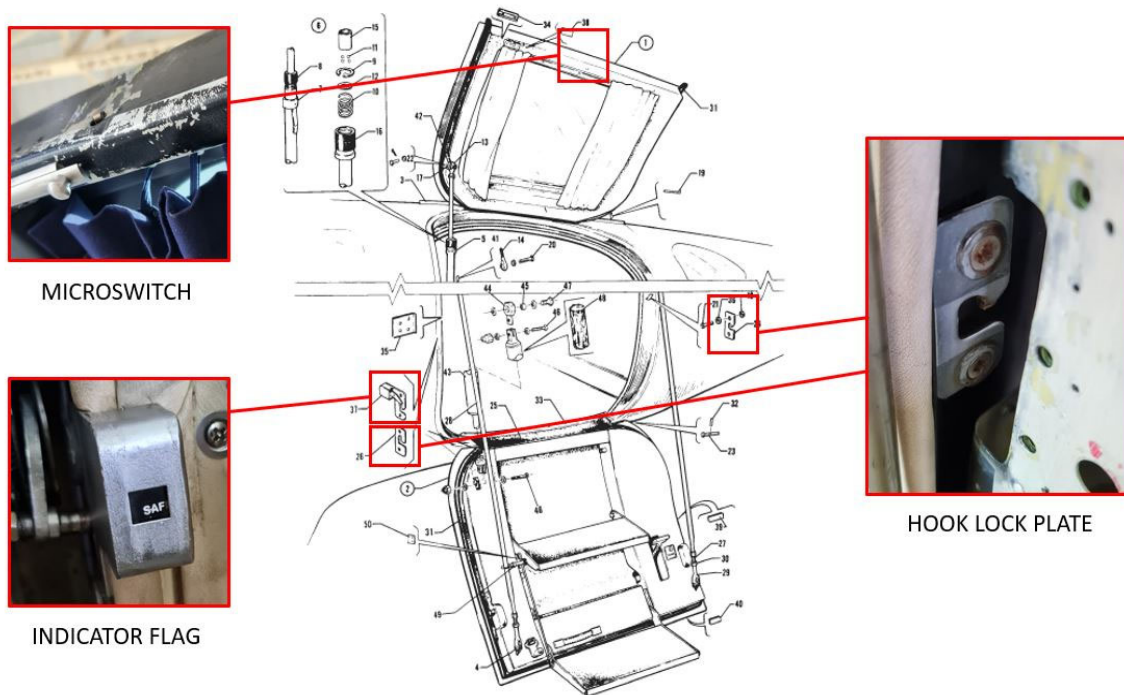
Figure 2

The lower door is locked by means of two cams, mounted at either end of a rotating torque tube that is operated by movement of either the internal or external door handles. Latch pins, composed of a bushing sleeved over a latch screw that rotates with the latch cam, engage in hook lock plates fixed to the cabin door frame when the lower door is locked closed (Figure 2).

PA-31 cabin door components (illustration courtesy of Piper)
