ACCIDENT

Aircraft Type and Registration:	Druine D.31 Turbulent (modified), G-AREZ	
No & Type of Engines:	1 Volkswagen 1834 piston engine	
Year of Manufacture:	1960 (Serial no: PFA 561)	
Date & Time (UTC):	8 July 2021 at 1730 hrs	
Location:	Easterton Airfield, Birnie, Elgin	
Type of Flight:	Private	
Persons on Board:	Crew - 1	Passengers - None
Injuries:	Crew - 1 (Serious)	Passengers - N/A
Nature of Damage:	Engine separated from aircraft and aircraft broken in two. Damaged beyond economic repair	
Commander's Licence:	Private Pilot's Licence	
Commander's Age:	55 years	
Commander's Flying Experience:	1,614 hours (of which 64 were on type) Last 90 days - 45 hours Last 28 days - 19 hours	
Information Source:	Aircraft Accident Report Form submitted by the pilot

Synopsis

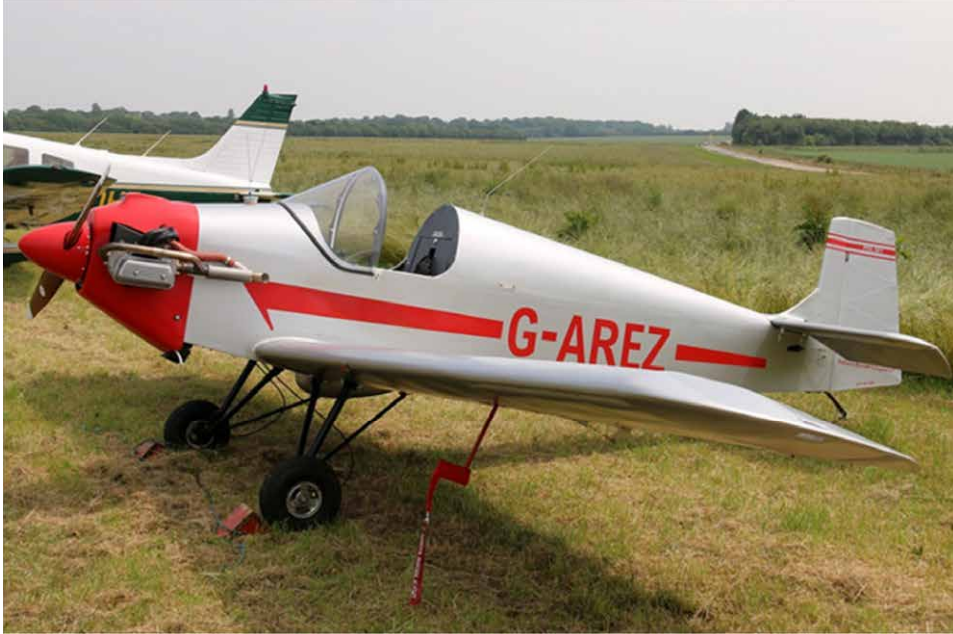
G-AREZ (Figure 1) was originally built by Rollason Aircraft and Engines Ltd in 1960. The aircraft was badly damaged in a heavy landing circa 1980, and after a long period out of service it was repaired, refurbished and returned to flying in August 2018. It was sold to the current operator in November 2019.

Figure 1
G-AREZ
