## ACCIDENT

<b>Aircraft Type and Registration:</b>	Supermarine Aircraft Spitfire Mk 26, G-CIEN	
<b>No &amp; Type of Engines:</b>	1 Isuzu V6 piston engine	
<b>Year of Manufacture:</b>	2014 (Serial no: PFA 324-14492)	
<b>Date &amp; Time (UTC):</b>	12 August 2021 at 2010 hrs	
<b>Location:</b>	Newtownards Airport, County Down	
<b>Type of Flight:</b>	Private	
<b>Persons on Board:</b>	Crew - 1	Passengers - None
<b>Injuries:</b>	Crew - None	Passengers - N/A
<b>Nature of Damage:</b>	Damage to landing gear, left wingtip, propeller, and engine cowlings	
<b>Commander's Licence:</b>	Private Pilot's Licence	
<b>Commander's Age:</b>	47 years	
<b>Commander's Flying Experience:</b>	712 hours (of which 1 was on type) Last 90 days - 42 hours Last 28 days - 8 hours	
<b>Information Source:</b>	Aircraft Accident Report Form submitted by the pilot and further enquiries by the AAIB

## Synopsis

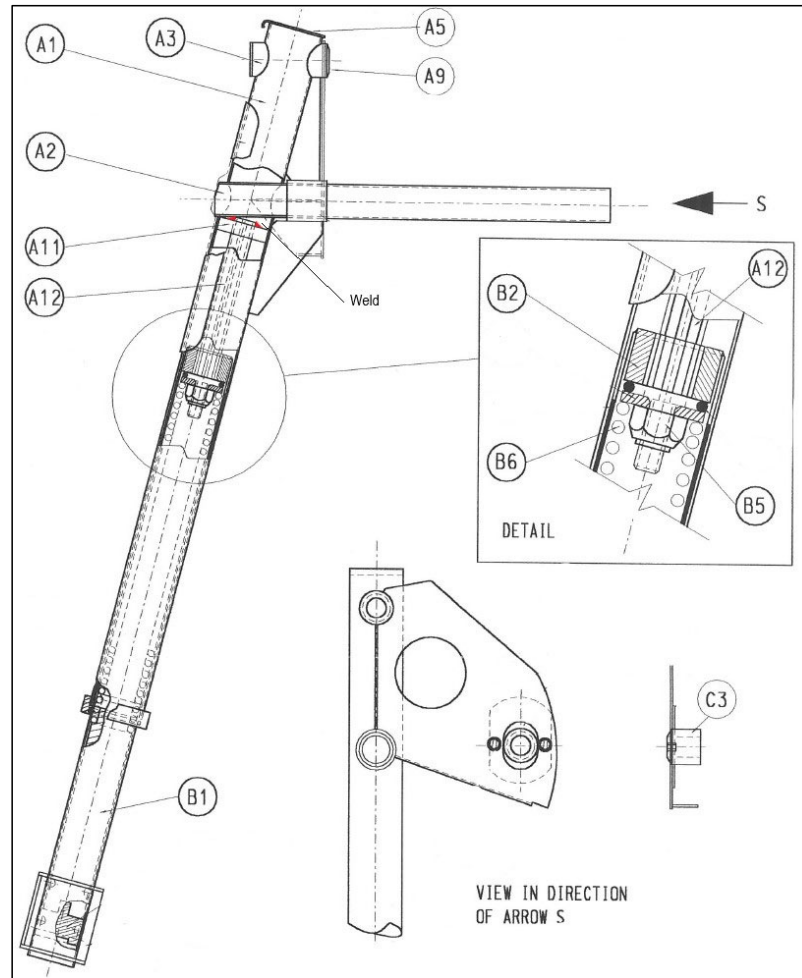
**Figure 2**

Each main gear leg has a large diameter upper steel tube (Figure 2 - A1) fitted with a pintle pin (A2), an attachment for the extension / retraction actuator (C3), and a locator for the locking pin (A3 & A9). Inside the upper tube, underneath the pintle pin, is a thick washer (A11) welded to the tube, and a splined shaft (A12) that is welded (shown) to the top surface of the washer. A thin metal disc (A5) is welded to the top of the upper tube to close it. A smaller diameter steel lower tube (B1) slides inside the upper tube, and a coil spring (B6) supports the weight of the aircraft. Another thick washer (B2), which has an internal spline that matches the splined shaft, is welded to the top of the lower tube. This arrangement allows the lower tube to slide and compress the spring but not rotate relative to the upper tube. A nut (B5) on the end of the splined shaft retains the lower leg. The brake and wheel axle are attached to the bottom of the lower leg.

Section views of undercarriage leg

The left main gear leg was removed from the aircraft, and the upper tube was cut between the pintle pin and the thick washer (Figure 3). This enabled the fillet weld between the splined shaft and the thick washer to be inspected. It was evident that the weld had broken, and the splined shaft had rotated. The fillet weld was measured to be approximately 2 mm (Figure 4) with minimal weld penetration on the splined shaft.

Comparison of the failed weld from G-CIEN and another pair of Mk 26 gear legs revealed poor weld penetration. This may have been the result of manufacturing variability and would have reduced the strength of the welded joint. The heavy landing may have damaged the weld, such that it failed after a further two landings.

The Light Aircraft Association has issued a warning to all UK owners of Spitfire Mk 26 aircraft that there is potential for hidden damage to a weld following a heavy landing.

The Light Aircraft Association is reviewing of the design of the Spitfire Mk 26 undercarriage leg, including the access restriction to inspect the weld that failed.
