# AIRCRAFT ACCIDENT REPORT 1/2020

Report on the accident to  
**Piper PA-46-310P Malibu, N264DB**  
22 nm north-north-west of Guernsey  
on 21 January 2019

**Air Accidents Investigation Branch**

Published 13 March 2020

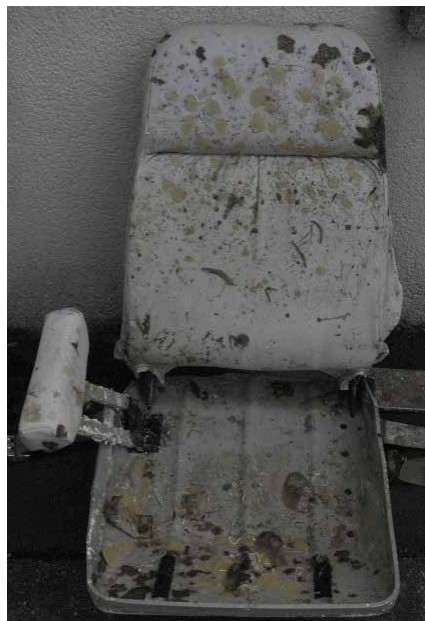
**Figure B-2**

On 26 September 2019, the crew of a trawler informed the French authorities that they had brought up what they believed to be an aircraft seat while conducting a trawl approximately 7 km to the west of the location of the main wreckage site. The seat was assessed by the AAIB as the left middle passenger seat from N264DB (Figure B-2).

Passenger seat from N264DB

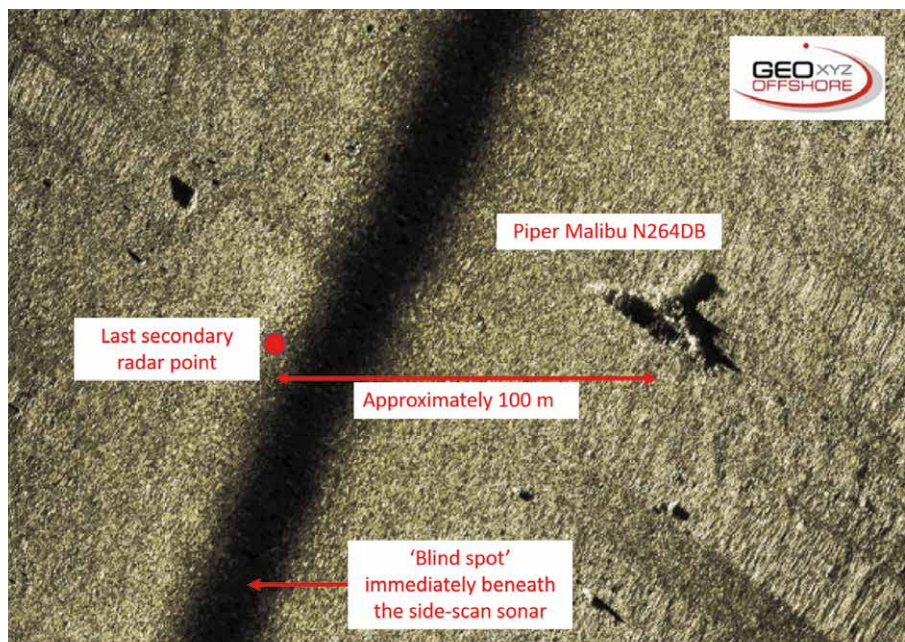
Figure B-5

Both vessels began their side-scan survey of the seabed on the morning of 3 February 2019. Early in the search, the FPV Morven identified an object of interest at a depth of approximately 68 m and cleared the immediate area. The Geo Ocean III subsequently used its own side-scan sonar to observe the object (Figure B-5).

Side-scan sonar image of N264DB

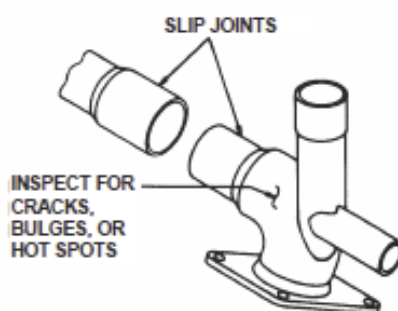
**Figure 6-96. Exhaust Slip joint Inspection****WARNING**

<b>Part</b>	<b>Inspection Action</b>
Stacks Risers Elbows	Check parts for the following: Burned areas Cracks Loose parts/hardware Pay particular attention to welded areas and seams, checking for cracks. Replace parts that are cracked, burned, or worn
Slip joints	Check for bulges, cracks, or hot spots (see Figure 6-96)
Multi-segment V-band clamps	Inspect spot-weld (or rivet) areas for cracks or physical damage. Inspect the corner radii of clamp inner segments for cracks with a flashlight and mirror. Inspect the inner segment spacing. Inspect the clamp outer band for flatness using a straight edge, especially within 2 inches of spot-weld tabs that retain the T-bolt fastener - clearance must be less than 0.062 inches. Verify 100% inner and outer band segment contact. To replace a multi-segment V-band clamp, refer to the primary ICA. Ref: Section 1-1.1
Heater muff	Inspect the heat exchanger seams, joints and transitions with a flashlight and mirror or a flexible borescope for physical damage, cracks, corrosion, and burn-through. Inspect connecting flanges for security and proper mating.

**Exhaust system weld repairs may only be performed by an FAA Part 145 authorized repair station certified to perform the specific repairs.**
