# ***AAIB Bulletin***

***1/2019***

Agusta AW 169	G-VSKP	27-Oct-18	3
---------------	--------	-----------	---

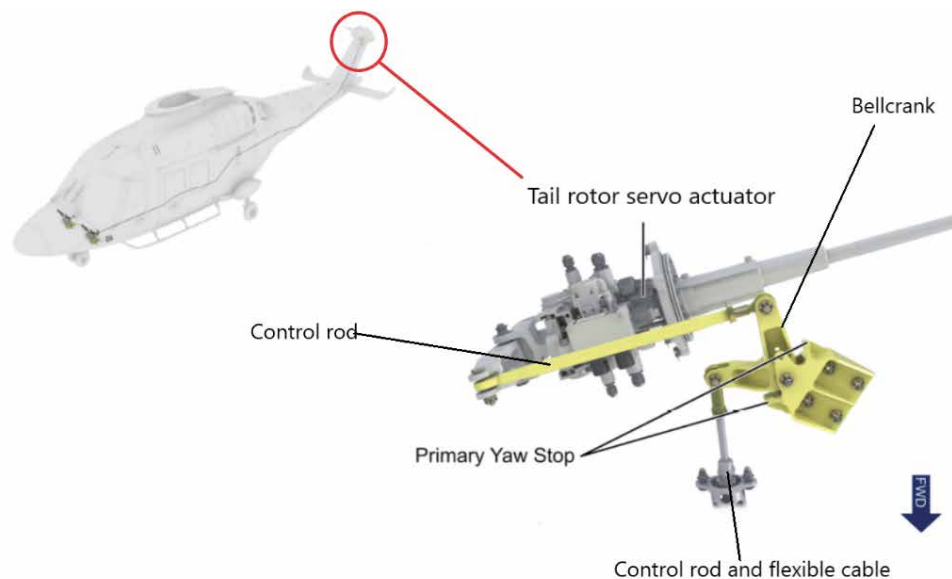
**Figure 1**

Yaw pedals in the cockpit are connected to the tail rotor control system by a flexible cable running on ball bearings within an outer casing. This is connected to one end of a rigid control rod via a bellcrank. The range of movement of the bellcrank is limited in each direction, providing the primary control stops for the yaw system (Figure 1).

AW169 tail rotor control yaw stops

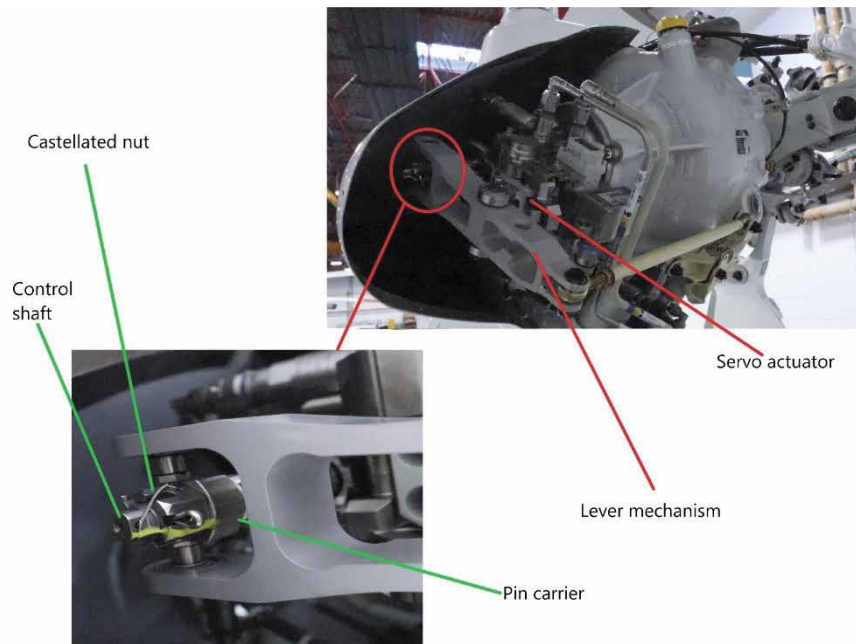
**Figure 2**

The pin carrier is secured to the shaft by a castellated locking nut, which attaches to a threaded section on the end of the shaft. The nut has a torque load applied before a split pin is fitted between the castellations of the nut and through a hole in the shaft. It is also wire locked in place (Figure 2).

Tail rotor actuator control input mechanism

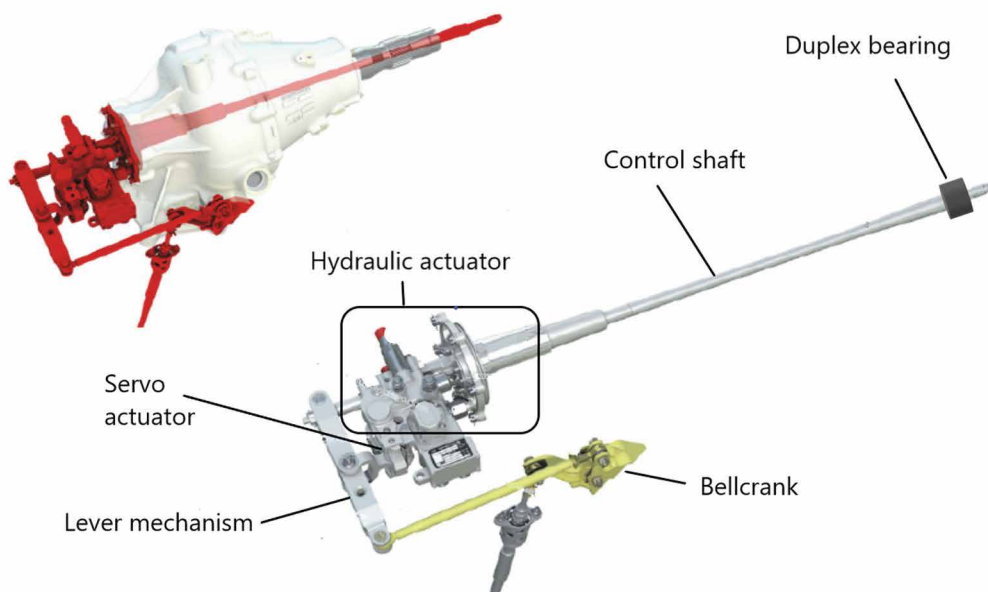
**Figure 3**

The control shaft passes through an outer shaft, which forms part of the tail rotor hydraulic actuator piston, and continues through a tunnel in the gearbox and engages with the inner race of a duplex bearing installed in the tail rotor slider/spider assembly (Figure 3). The control shaft is secured to the inner race of the bearing with a second, larger, castellated nut and split pin.

AW169 tail rotor actuator and duplex bearing

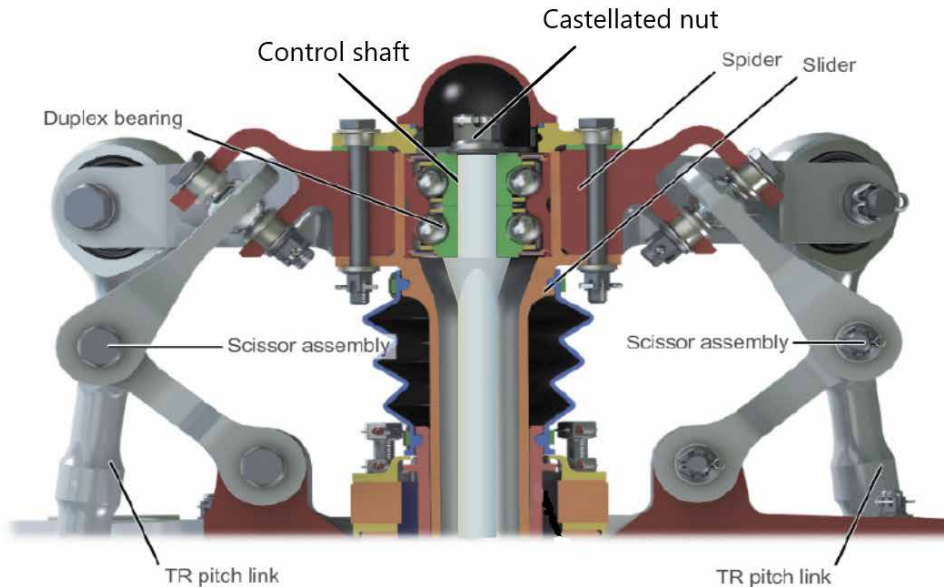
**Figure 4**

Each arm of the spider is connected by a rod to the rear of a tail rotor blade. The spider/slider assembly rotates with the outer race of the duplex bearing, while the control shaft attached to the inner race remains stationary (Figure 4).

Tail rotor spider and pitch link assembly

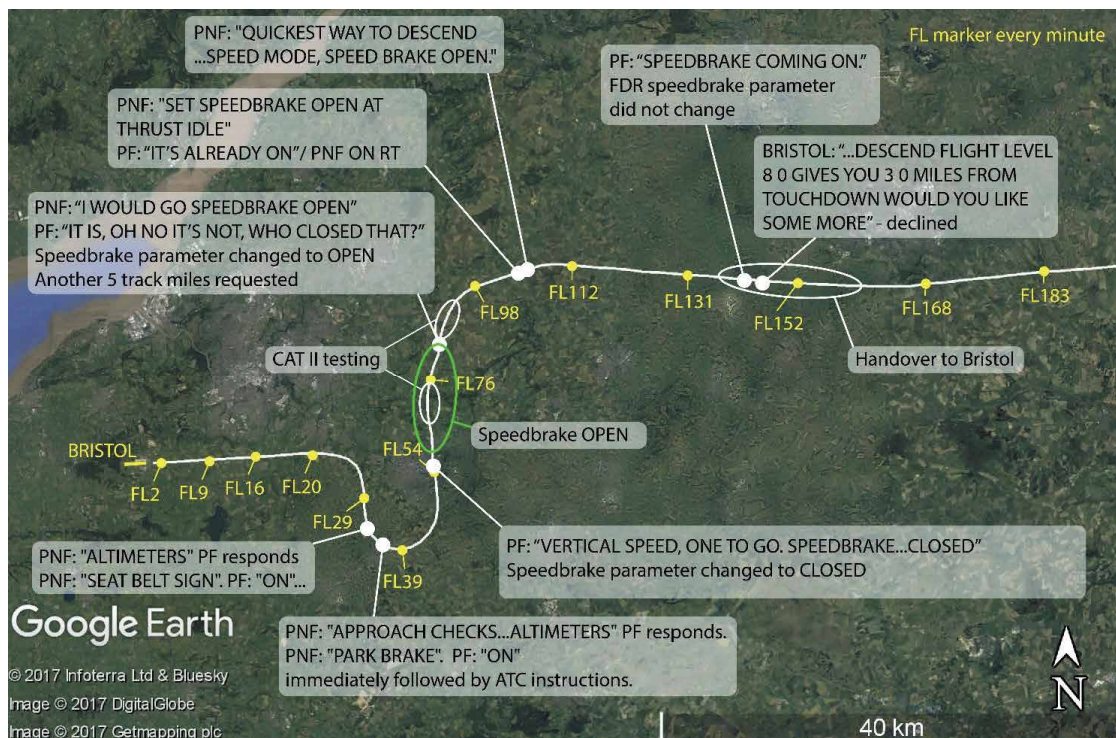
**Figure 2**

Figure 2 shows pertinent extracts from the CVR and FDR overlaid on the radar track of the aircraft. There was significantly more RT than shown due to the weather, and ATC vectoring and management of another aircraft with marginal capability given the runway visibility. There were also significantly more crew communications than shown relating to checklists, minima, alternate airports and other operational issues.

There was no recorded parameter for the parking brake. At the point of ATC handover to Bristol, the PF expressed the intent to set the speed brake but the recorded parameter for the speed brake did not change from closed.

Pertinent extracts from the CVR and FDR overlaid on the aircraft radar track

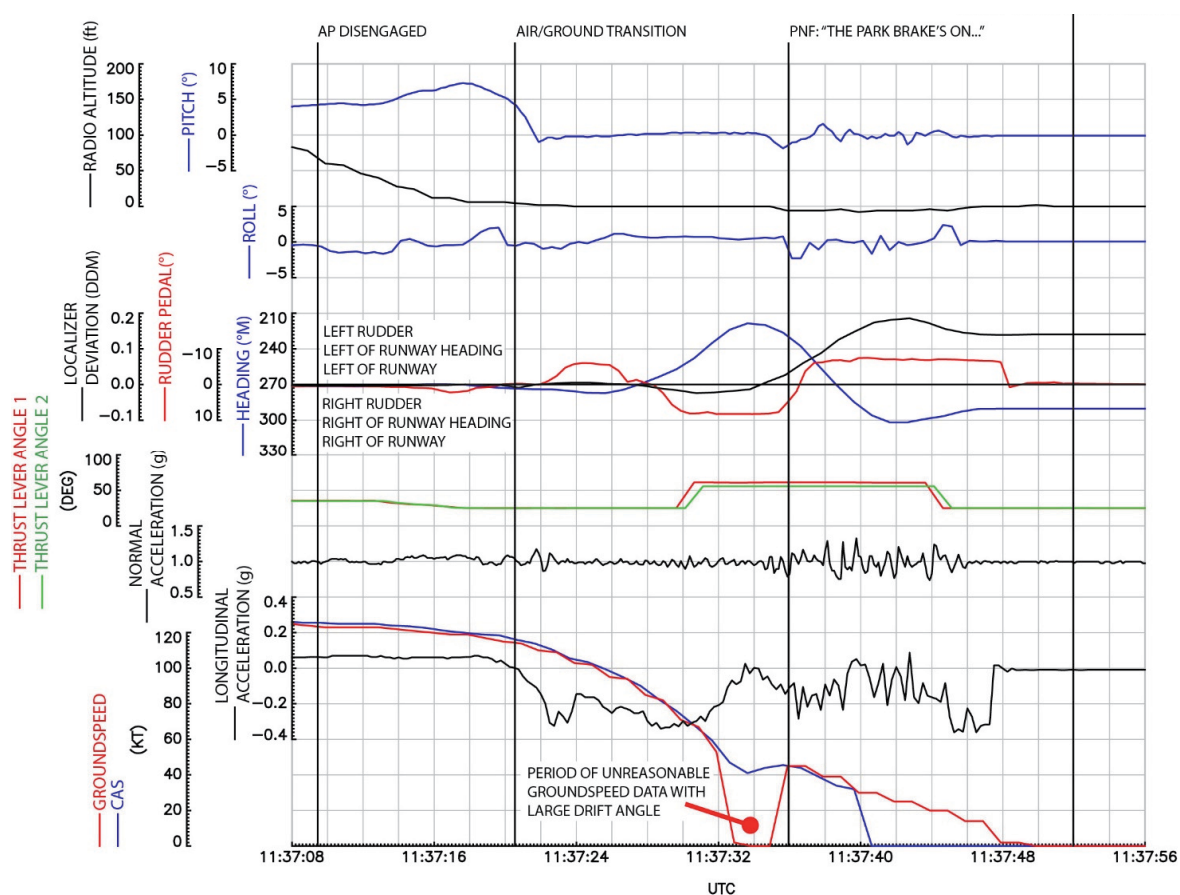
**Figure 3**

Figure 3, shows pertinent extracts from the CVR and FDR during the landing. The autopilot was disengaged at about 80 ft aal and the aircraft touched down on the centreline. The aircraft started tracking right of the runway centreline and opposite rudder was used. The aircraft heading swung to the left of the centreline, skidding approximately along the centreline as indicated by the localizer (the antenna is in the tail). Right rudder was applied but the yawing to the left continued. With a heading of between 15 and 30° to the left of the runway heading the thrust levers were advanced, slightly more left thrust than right. The aircraft carried on yawing to the left and the previous longitudinal deceleration was eroded. The divergence from the runway heading peaked at approximately 50° before starting to reduce, but with thrust applied the aircraft tracked to the left and went off the side of the runway with a groundspeed of approximately 45 kt. The aircraft was decelerating and as the groundspeed reduced to approximately 20 kt the thrust levers were brought back to IDLE. The aircraft came to a stop about three seconds later. The crew identified that the parking brake was applied as the aircraft left the runway.

Pertinent extracts from the CVR and FDR during the landing

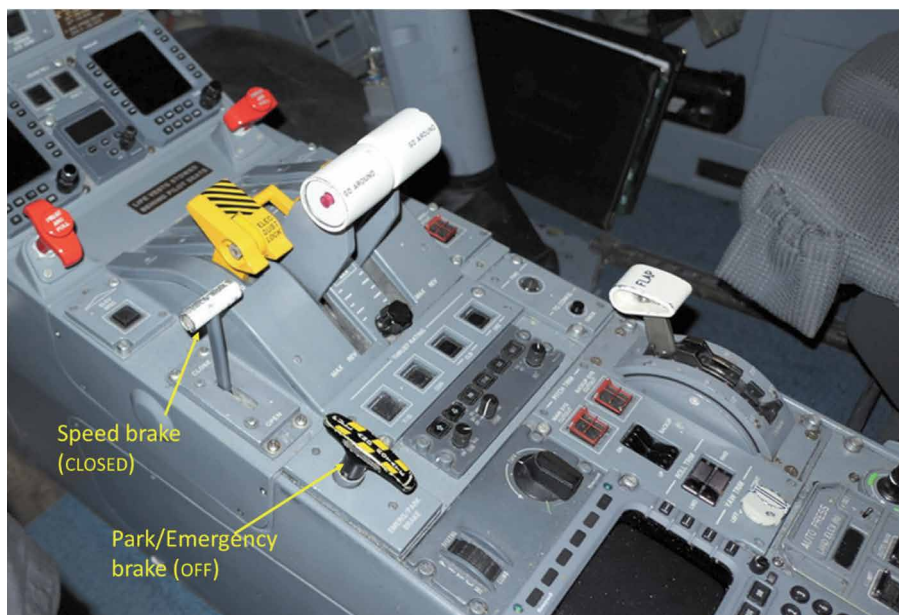
**Figure 9**

The speed brake function is electrically controlled by a small lever next to the power levers on the left side of the centre console (Figure 9). A green 'OPN' caption is displayed on the lower right area of the central Engine Indication and Crew Alerting System<sup>2</sup> (EICAS) screen when any of the surfaces are open.

Location of the controls on the centre console (viewed from the left)

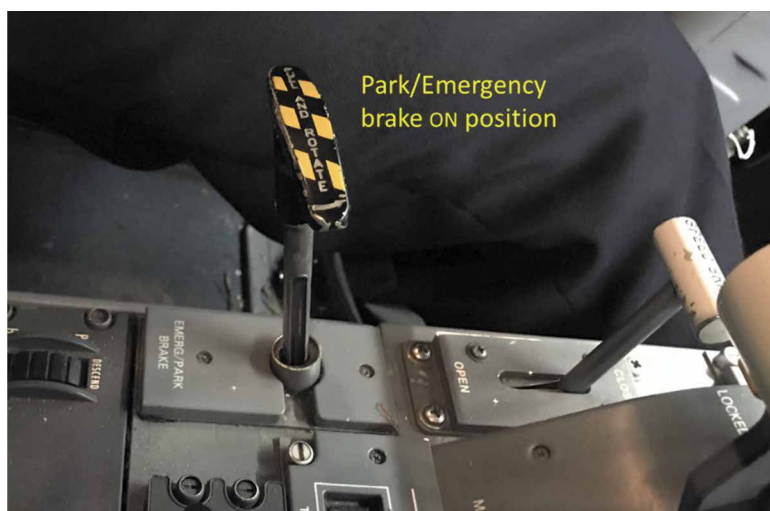
**Figure 10**

Apart from the extended position of the parking brake handle when the parking brake is applied, the only other brake condition indication is on a small illuminated indicator on the instrument panel marked BRAKE ON. Figure 9 shows the location of the controls on the centre console and Figure 10 shows the parking brake in the ON condition.

Figure 10 shows the left seat in its rearwards position. When the seat is towards its fully forward position the parking brake handle is out of the seat occupant's direct line of sight and is likely to be operated by 'feel'. When the aircraft is on the ground with the parking brake set to ON there is a warning feature built into the system which displays an EICAS caution NO TAKEOFF CONFIG if the power levers are advanced to 60%. This system does not apply when the aircraft is airborne.

Parking/Emergency brake ON (viewed from the right, seat in most rearwards position)

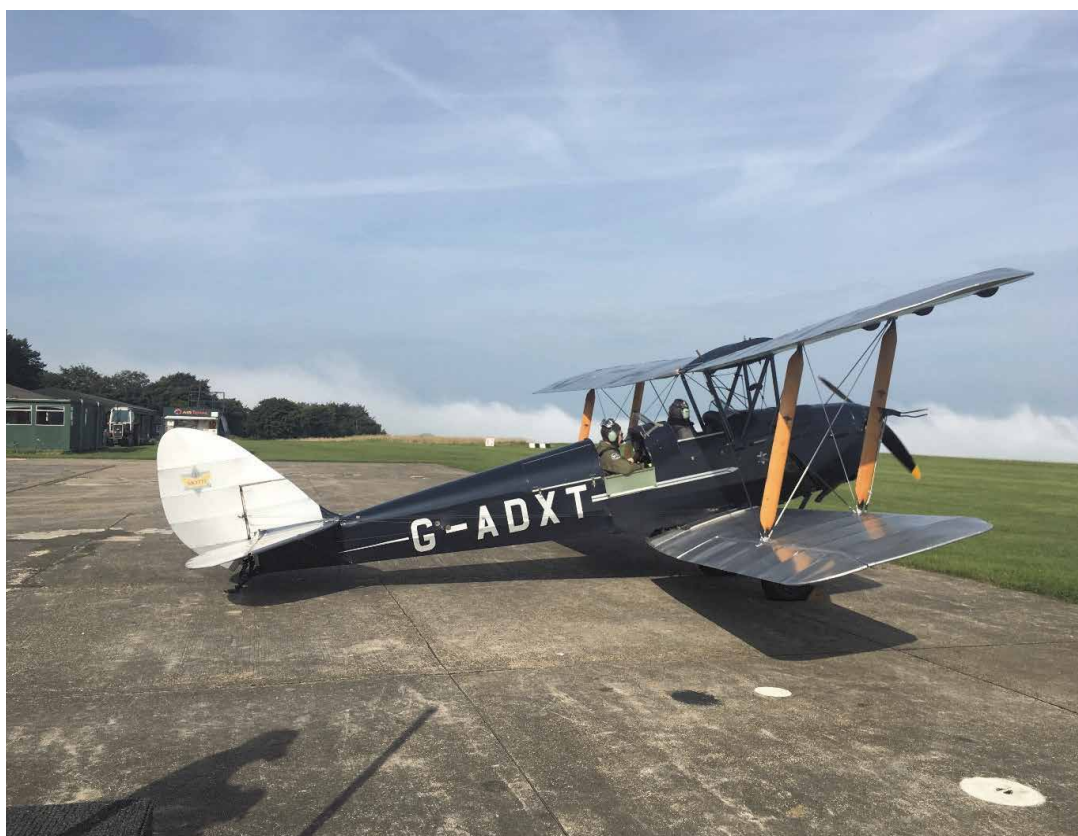
**Figure 1**  
G-ADXT before the accident

Figure 1 below shows the aircraft immediately prior to departure with the weather as described and the fog at the western end of the valley north of the airfield.

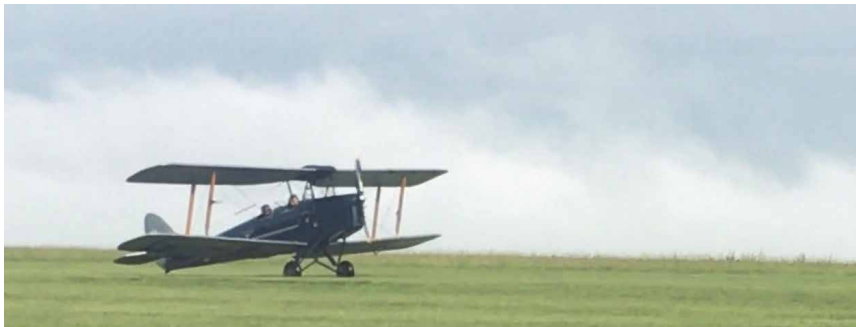
**Figure 3**

At the beginning of the takeoff run showing the tops of cloud or fog in the valley to the west of the airfield

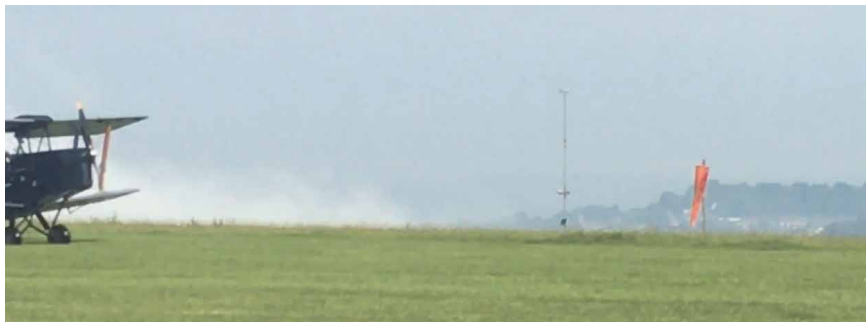
**Figure 4**

The cloud or fog conditions are not the same in the valley to the north of the airfield (separated from the westerly valley by a ridge). The windsock indicates a light crosswind from the north

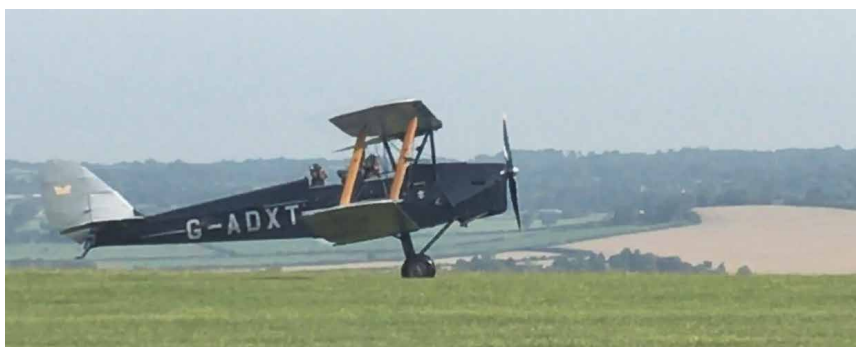
**Figure 5**

Abeam the camera location

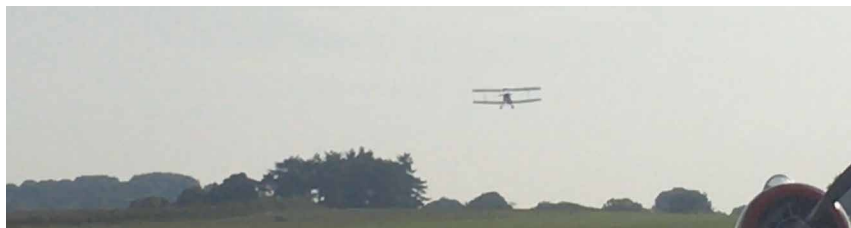
**Figure 8**  
Last video clip, initial climb

The propeller speeds were established from the images in the video clips. The aircraft engine was running at approximately 2,000 rpm when passing the camera location but had reduced to approximately 1,710 rpm by the end of the video clips.

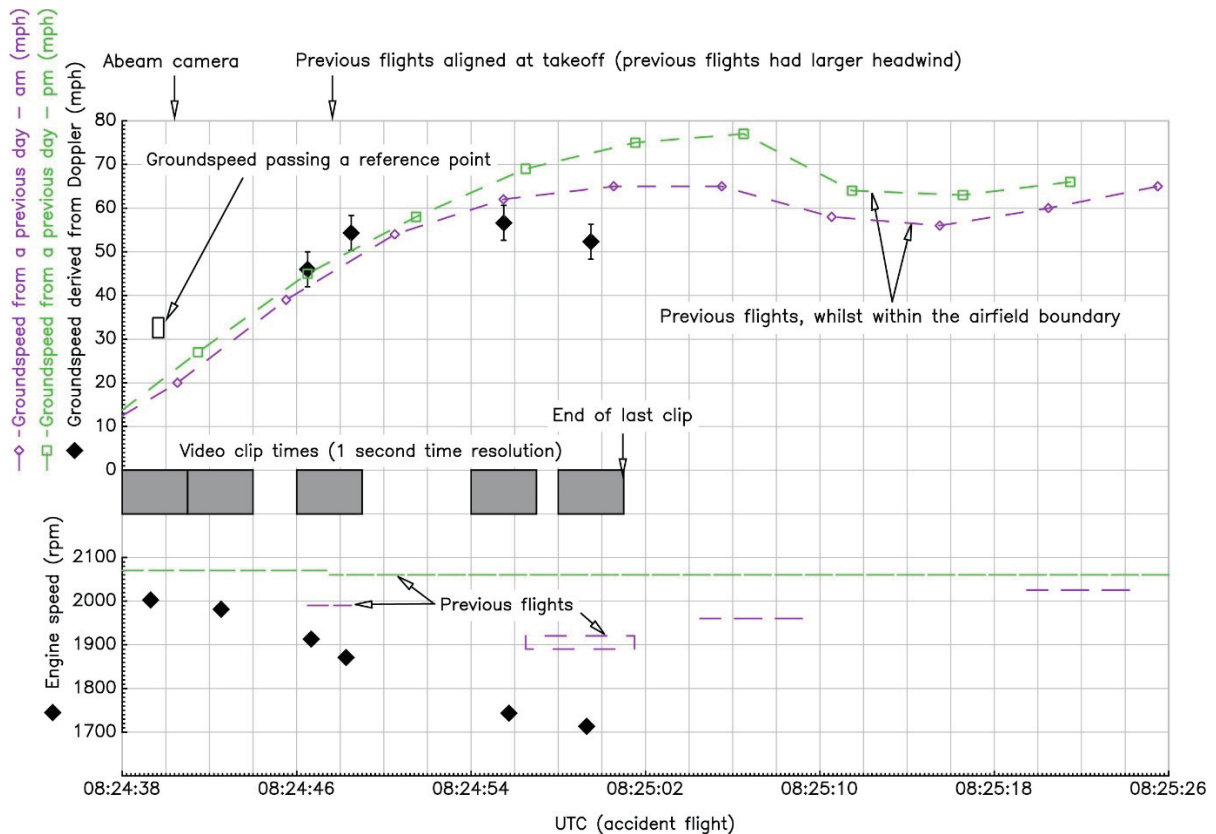
**Figure 9**

Figure 9 shows that during the takeoff of both the previous flights engine speeds were faster than those for the accident flight; there was also a marked difference between the previous two flights. The engine speed for the morning flight showed a reducing trend, which subsequently increased to engine speeds closer to those achieved during the afternoon flight. This was similar in behaviour to the accident flight but with only about half the reduction.

Accident flight parameters compared to previous flights aligned to the point in time of takeoff

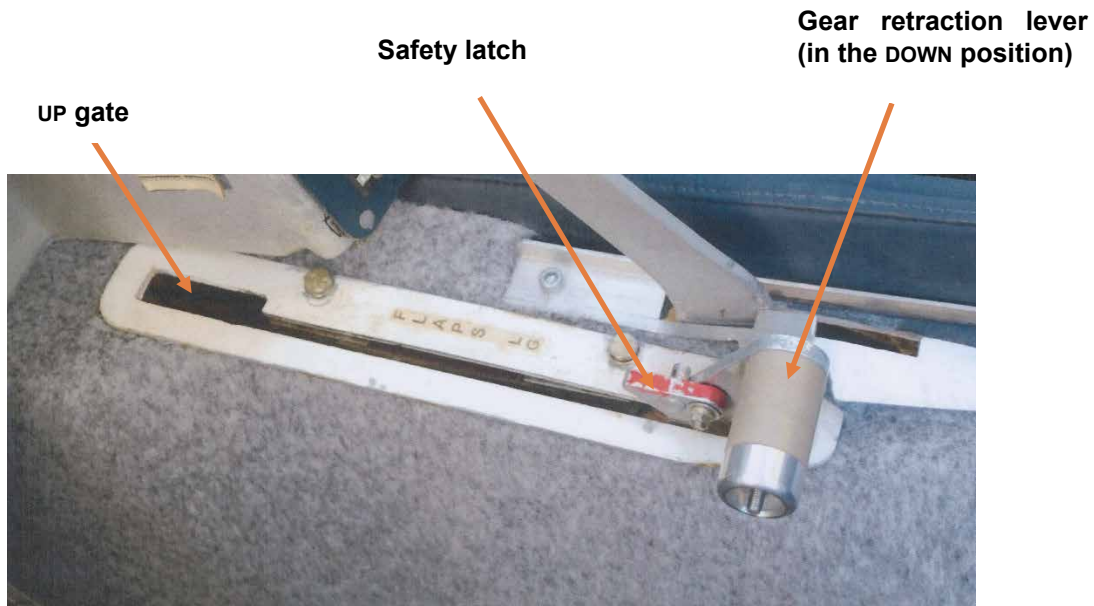
**Figure 1**

The Europa XS has a retractable mainwheel with a fixed tailwheel and retractable outriggers on the wings. The landing gear and flaps are selected by a single lever on the centre console between the seats (Figure 1). The lever has two gates at either end of its travel, coinciding with the UP and DOWN positions; it is biased to the right so that it naturally enters the gates. To avoid inadvertent retraction, a safety latch rotates under its own weight, dropping into the retraction lever slot. Some owners have installed a spring to assist the operation of the safety latch, but this was not the case with G-IMAB.

To retract the landing gear, positive action is required to lift the latch out of the slot before the lever can be moved sideways out of the gate and pushed forwards. By design, if the lever is inadvertently moved out of the DOWN gate, the landing gear over-centre mechanism should stop the lever moving forwards without input.

Landing gear operating lever

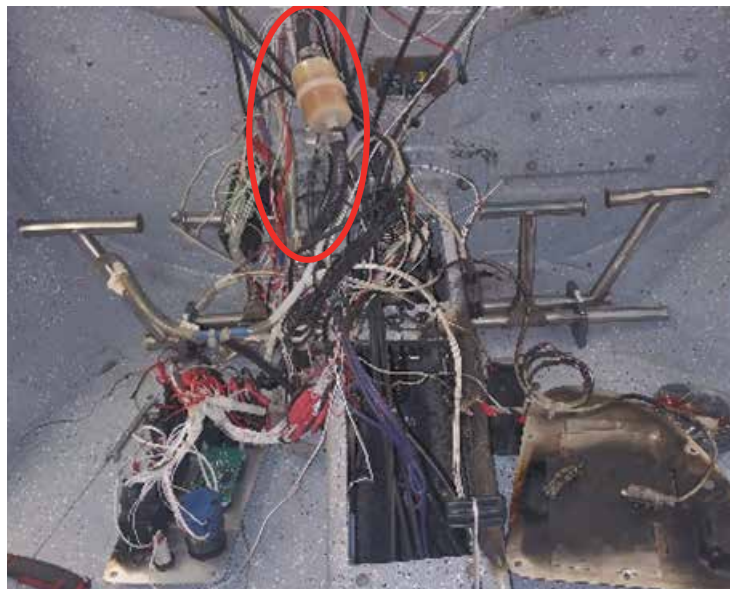
**Figure 3**

Located in the rear of the instrument console (Figure 3) was the engine fuel supply pipe, and the fuel filter, from the wing fuel tanks to the engine.

Fuel supply and filter location (Instrument console removed)
