AAIB Bulletin

3/2022

Published 10 March 2022

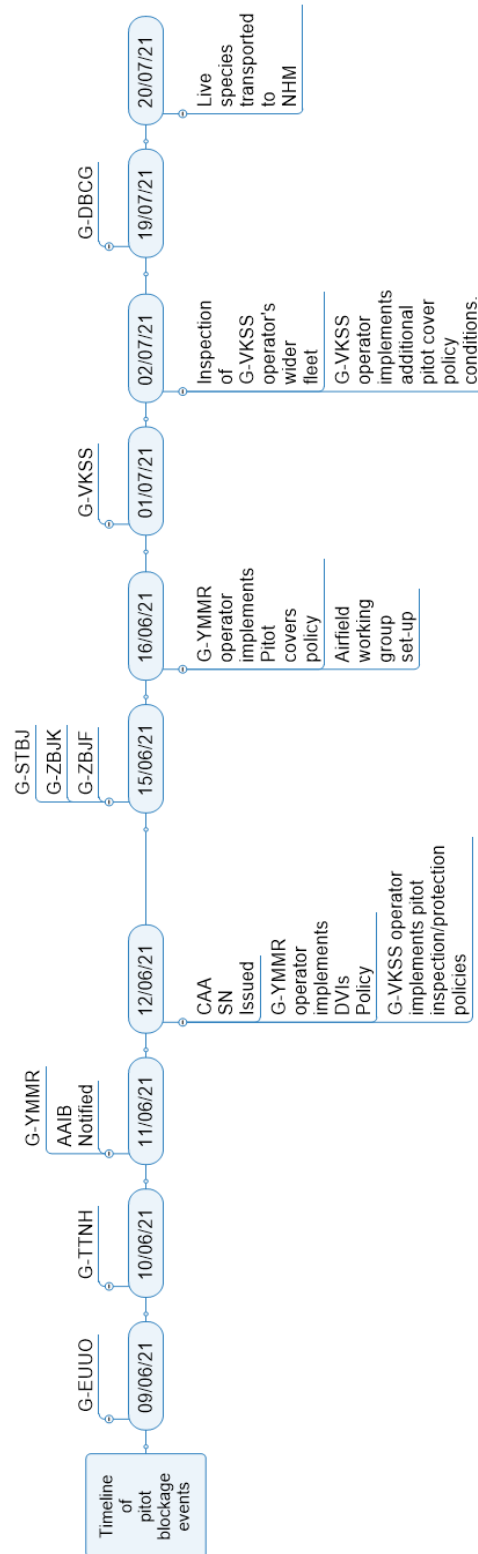
A summary of the occurrences and the various actions is shown in Figure 7.

Figure 7
Timeline of events

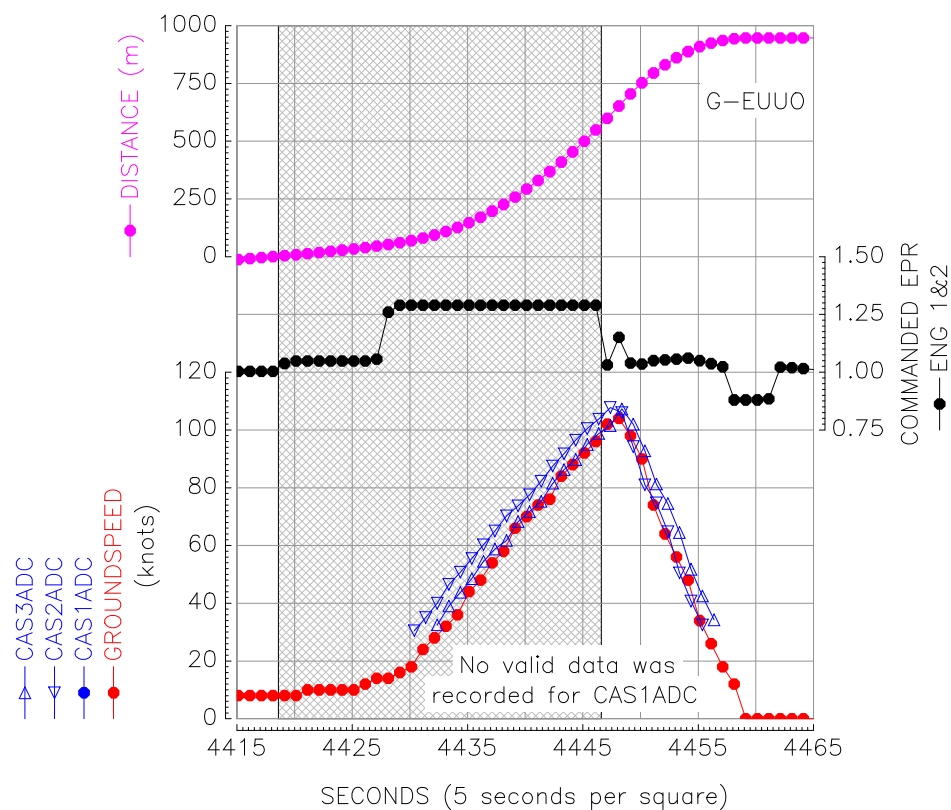
Figure 16

Data from the aircraft's Digital Aircraft Condition Monitoring System (ACMS)¹² Recorder (DAR)¹³ for the rejected takeoff is shown in Figure 16. The data shows the CAS from the aircraft's three pitot probes: CAS1ADC, CAS2ADC and CAS3ADC. CAS1ADC was displayed on the commander's PFD, and CAS2ADC on the co-pilot's PFD. CAS3ADC is dedicated to the standby systems.

During the event, the recorded CAS1ADC airspeed was zero, indicating that the sensed airspeed by the commander's pitot was below 30 kt (the minimum airspeed that is considered valid by the associated ADC). The takeoff was rejected at 104 kt airspeed (a groundspeed of about 96 kt).

G-EUOO DAR data for the rejected takeoff
(shaded area is from start to abort)

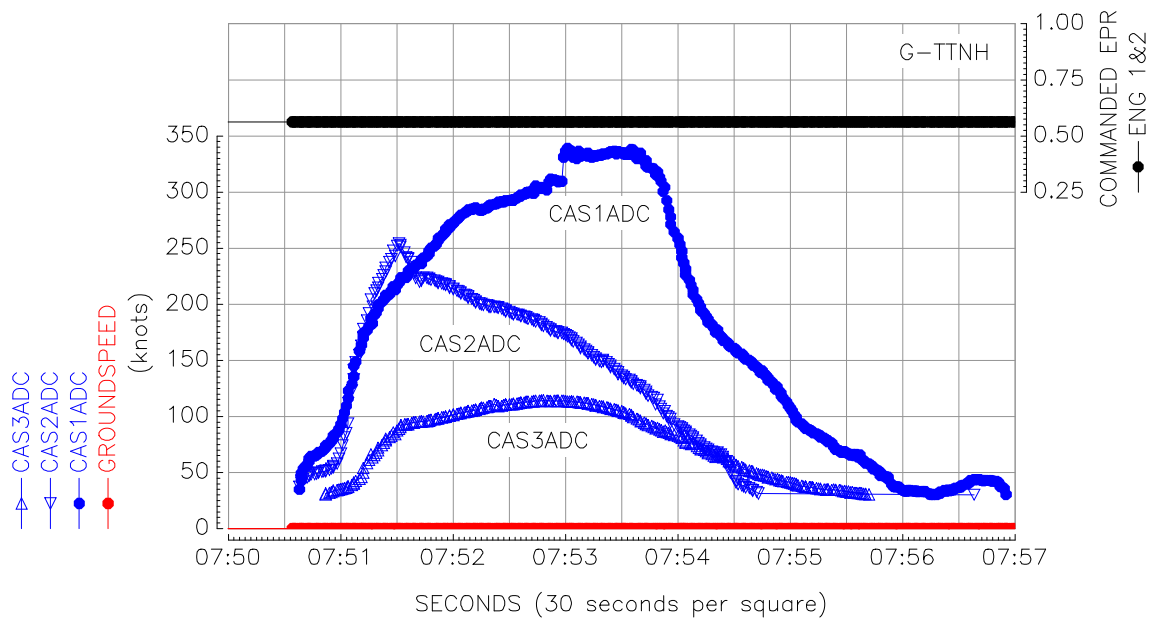
**Figure 17**

Data from the aircraft's DAR after pushback is presented in Figure 17 and shows that all three pitot probes were sensing airspeeds in excess of 100 kt even though the aircraft was not moving.

Between times 0754 hrs and 0757 hrs, whilst the aircraft was stationary, 11 ECAM alerts were generated (detailed in Table 2) that were associated with either a touchdown or landing roll (< 80 kt) phase of flight.

G-TTNH DAR data after pushback whilst aircraft was stationary

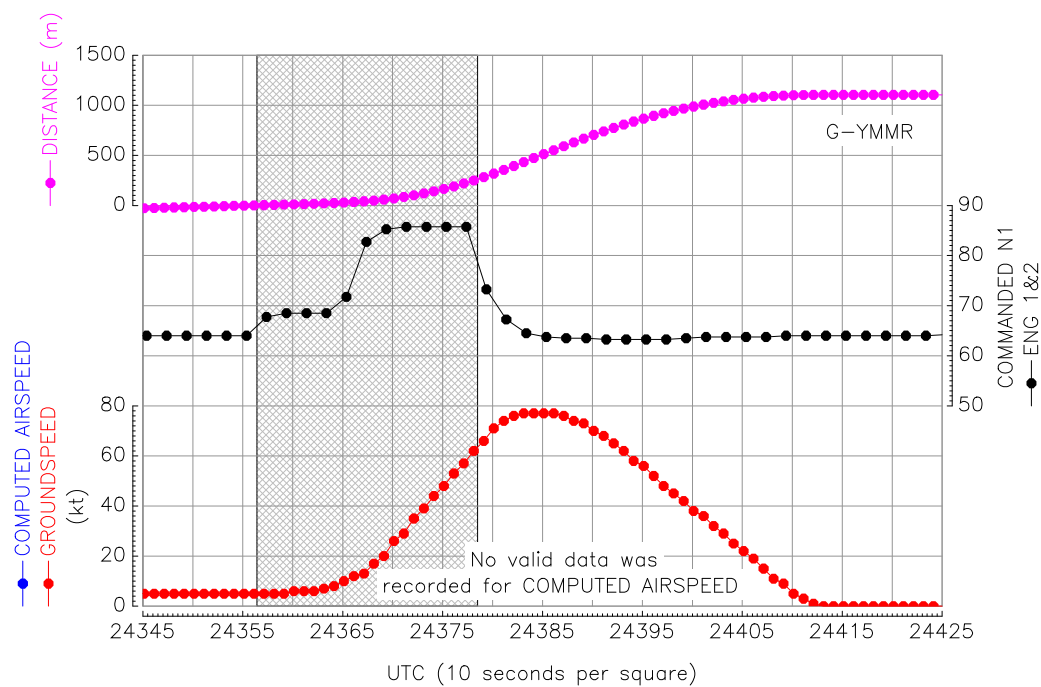
Figure 18

Data from the aircraft's FDR for the rejected takeoff is shown in Figure 18. For this aircraft, the FDR only records the CAS which is displayed on both crew's PFD and the values recorded are only valid if greater than 30 kt. Throughout the rejected takeoff the CAS remained invalid. The takeoff was rejected 275 m into the takeoff ground roll at a groundspeed of about 64 kt.

G-YMMR FDR data for the rejected takeoff
(shaded area is from start to abort)

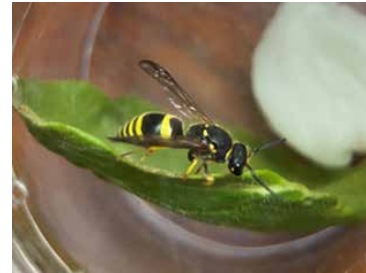
Table 3

The live wasp from G-DBCG was identified as a female *Ancistrocerus parietum* (see Table 3), commonly called the Wall Mason wasp (also known as the Notched Mason wasp). This identification was in keeping with a previous identification by the NHM specialist who, from the photograph of the insect entering G-STBJ's probe shown in Figure 4, tentatively identified the species as being from the subfamily, *Eumeninae* (Potter and Mason wasps). DNA tests on the larvae found in the blocked pitot probe from G-STBJ confirmed that the species was *Ancistrocerus parietum*.

Wall Mason wasp species identified

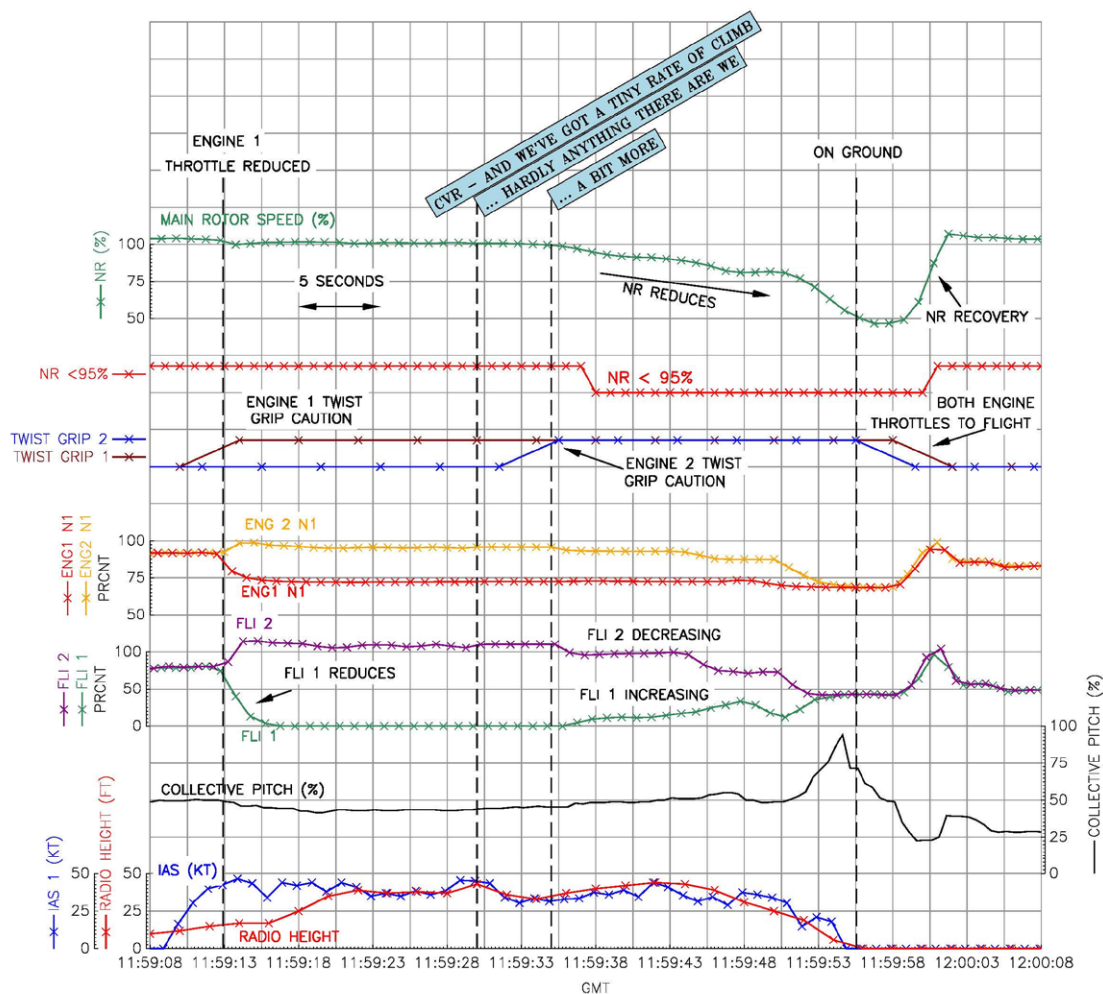
Figure 8

At 1159:13 hrs, while climbing through 16 ft agl at an IAS of 43 kt, Engine No 1 FLI began to reduce, signifying the point at which the Engine No 1 throttle was reduced. This was confirmed by the CAU TWIST GRIP parameter (Figure 8). The position of the Engine No 1 throttle was not recorded but within 3 seconds, Engine No 1 torque had reduced to less than 3%.

G-MPSB FDR parameters
NOTE FLI is recorded as percentage on the FDR
