SERIOUS INCIDENT

Aircraft Types and Registrations: (in date order of occurrence)	Airbus A320-232, G-EUUG Airbus A320-251N, G-TTNH Boeing 777-236, G-YMMR Airbus A330-343, G-VKSS
Other Aircraft Affected:	Boeing 787-9, G-ZBKJ Boeing 777-336ER, G-STBJ Boeing 787-8, G-ZBJF Airbus A319-131, G-DBCG
Date & Time (UTC):	Between 9 June 2021 and 19 July 2021
Location:	London Heathrow Airport, UK
Types of Flight:	Commercial Air Transport (Passenger)
Injuries:	None
Nature of Damage:	Various pitot tubes blocked
Information Source:	AAIB Field Investigation

Synopsis

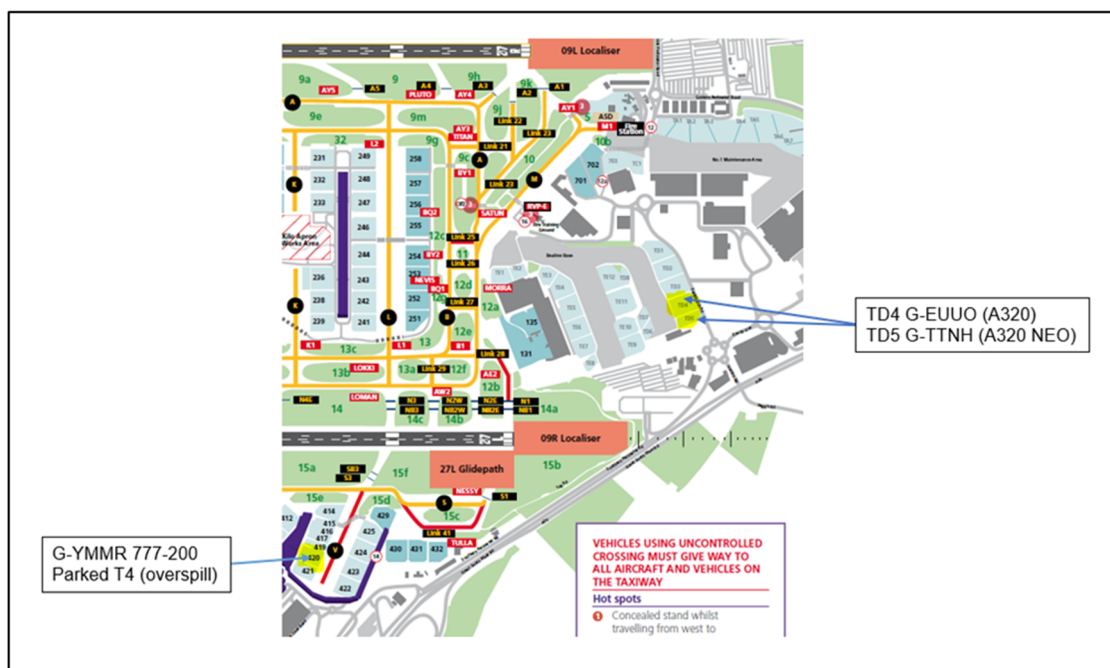
Figure 1

G-EUUG was an Airbus A320 Current Engine Option (CEO) variant that had been parked on maintenance stand TD4 (Figure 1) at Heathrow since 4 June 2021 when it had returned to service after a period of 2 months storage at London Gatwick Airport (Gatwick). Before leaving Gatwick, it underwent a standard return to service works package which included a pitot/static system flush and subsequent leak checks. There were no problems reported during the positioning flight from Gatwick to Heathrow. On arrival at Heathrow the aircraft underwent a maintenance package to prepare it for operations. This included an operational check of the bleed air valves on the engine. There was no further work carried out on the pitot/static system. The aircraft was parked on stand TD4 from 0346 hrs on 8 June 2021 until 0617 hrs on 9 June 2021. In line with regulatory requirements/guidance and the normal company operating procedures at that time, whilst parked at Heathrow the aircraft had not been fitted with pitot/static covers.

Parking locations of aircraft affected
