Rail Accident Investigation Branch

# Rail Accident Report

## **Derailment of a passenger train at Carmont, Aberdeenshire 12 August 2020**

Report 02/2022  
March 2022

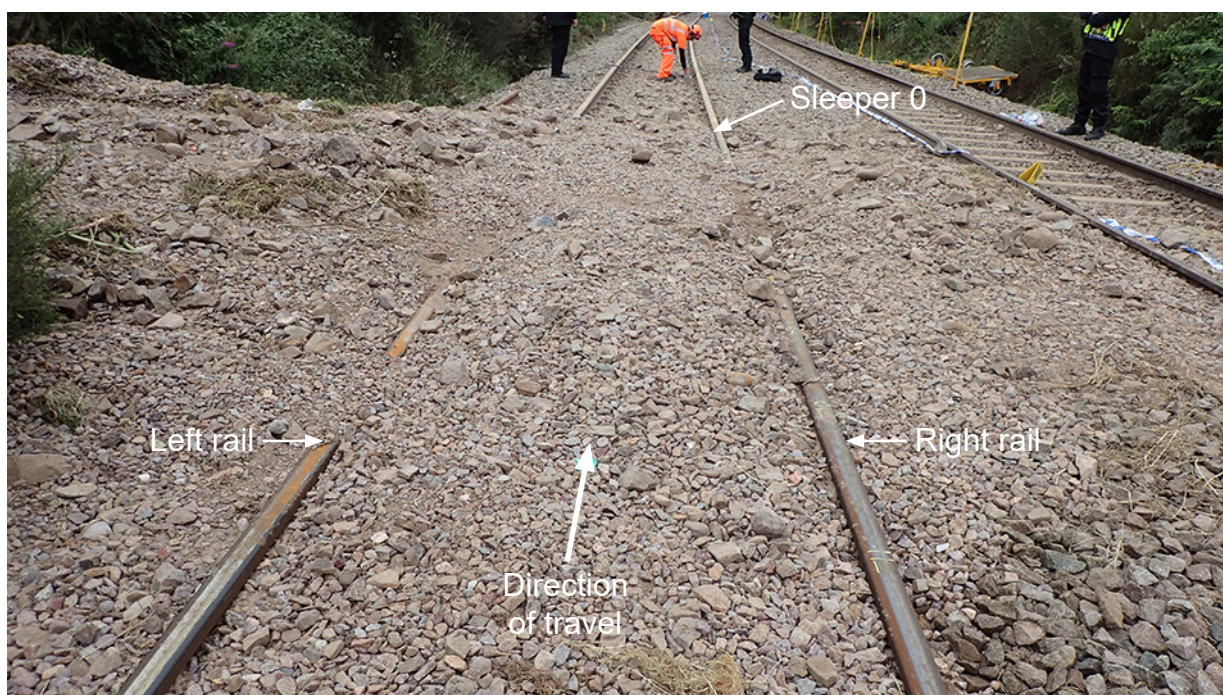
- S4 Train 1T08 derailed because it struck debris washed out from a 15 metre length of steeply sloping drainage trench. This is evidenced by CCTV images from the train, grooves cut through the debris, the absence of derailment marks on the track on the approach to the debris and marks indicating that the leading wheelset had derailed immediately after the debris field.
- S5 The debris mainly comprised gravel with some cobbles and covered the down line for a length of about 10 metres. Estimates made by RAIB after the derailment indicate the maximum depth of debris on the left and right railheads was probably around 170 mm and 135 mm respectively before the train ran through it.

*Washout debris covering the track*

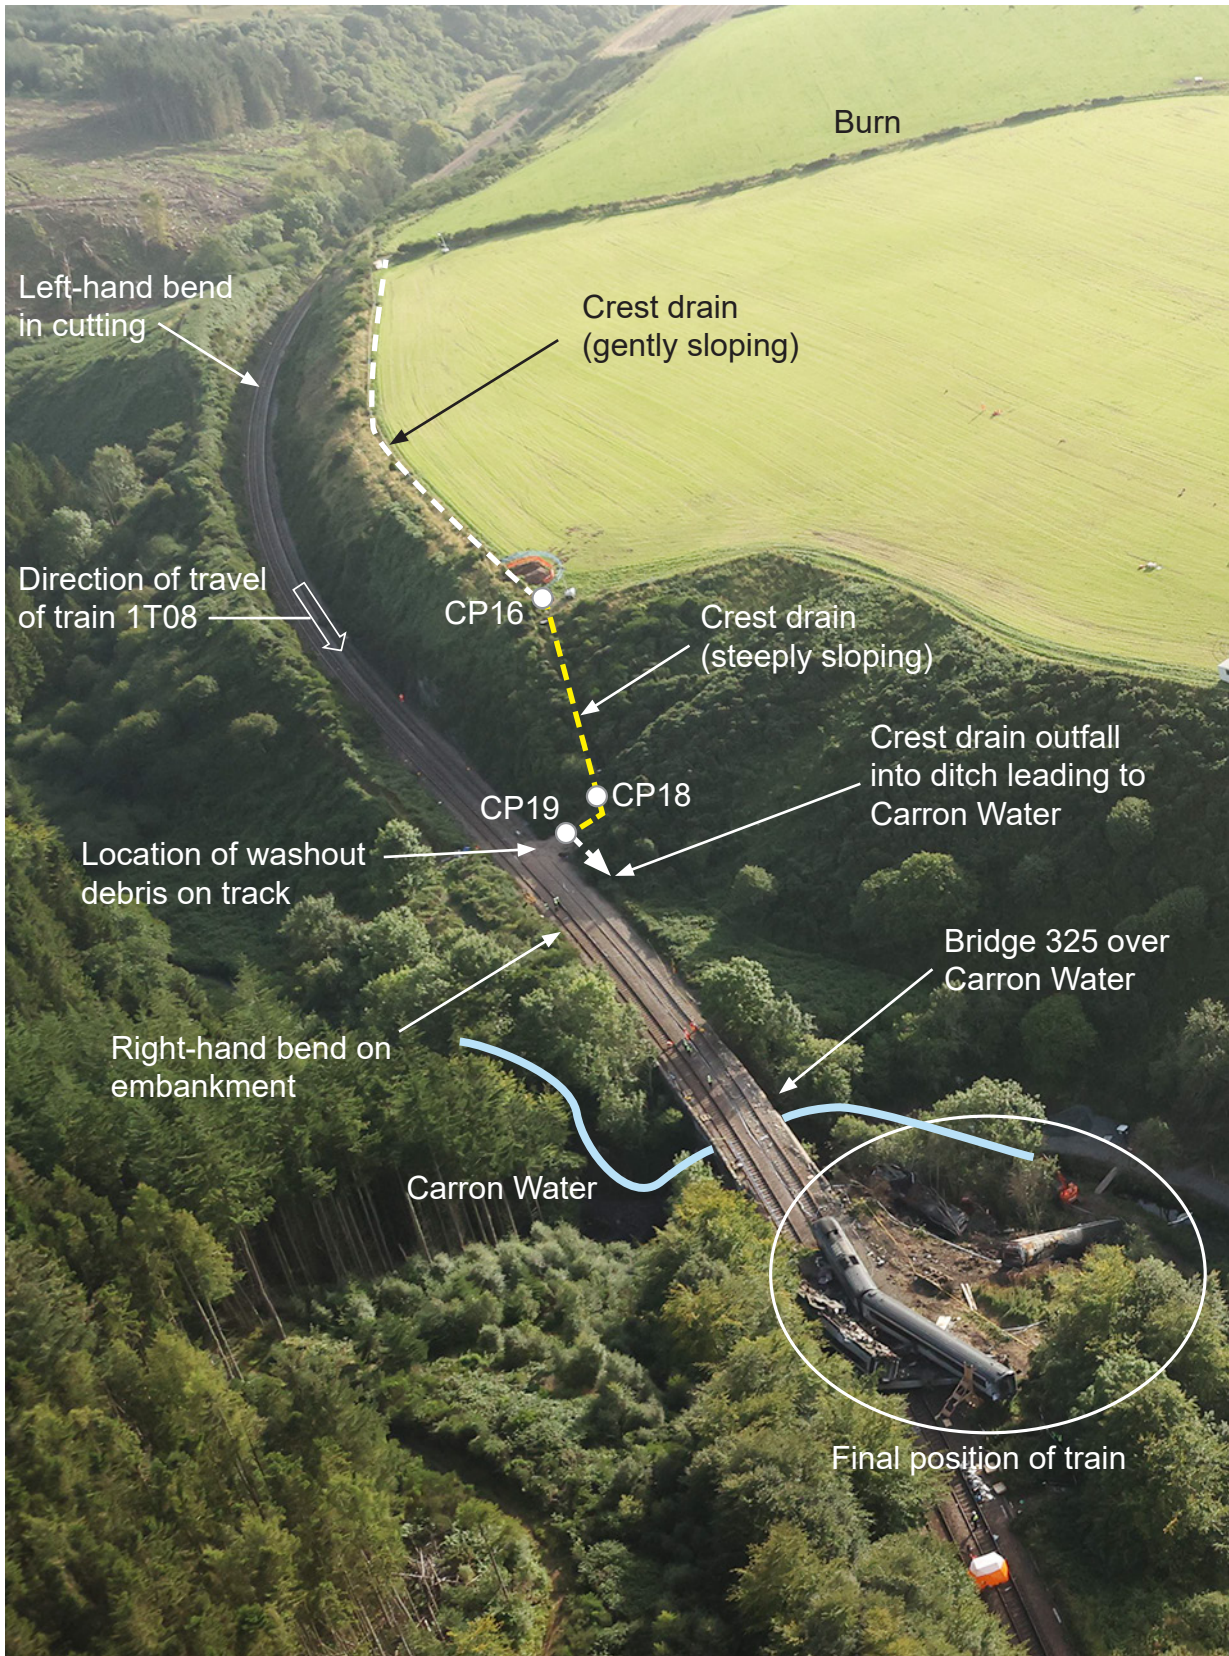
Overview of the drainage system (locations marked 'CP' are catchpits)

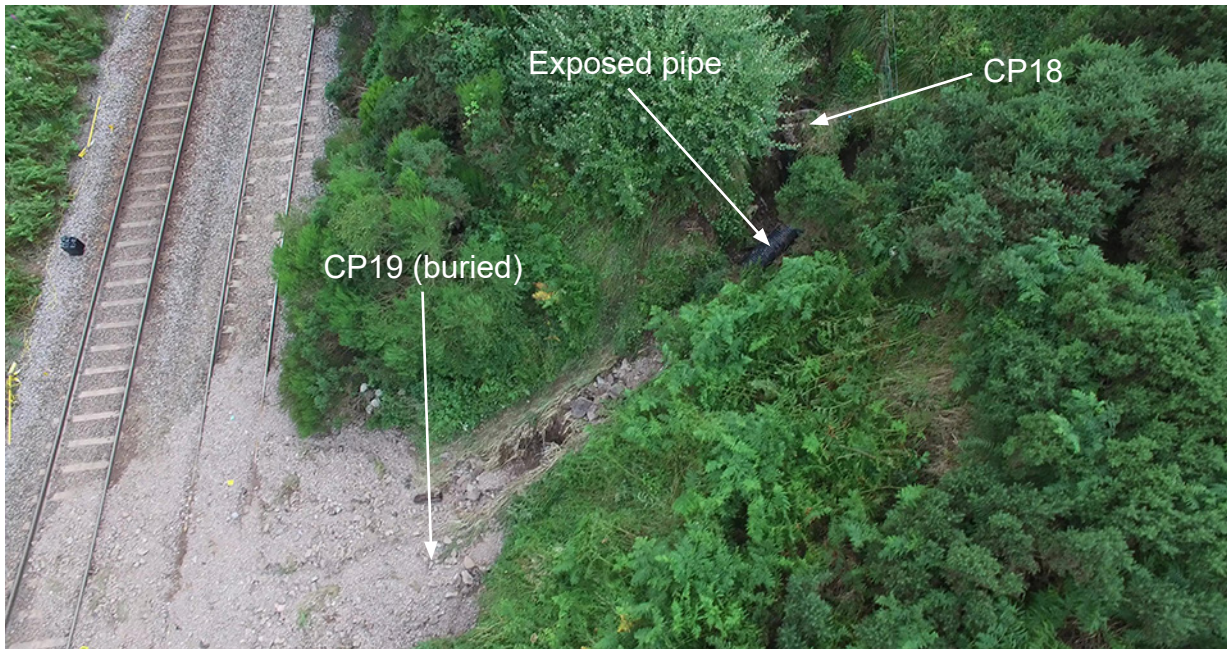
S12 The trench which contained the drainage pipe was filled with gravel (mainly between 20 mm and 40 mm in size) in accordance with normal practice for french drains. However, the use of this gravel in such a steeply sloping trench increased the likelihood of it being washed away should the water reach the drain as a concentrated flow.

*The washout (locations marked 'CP' are catchpits)*

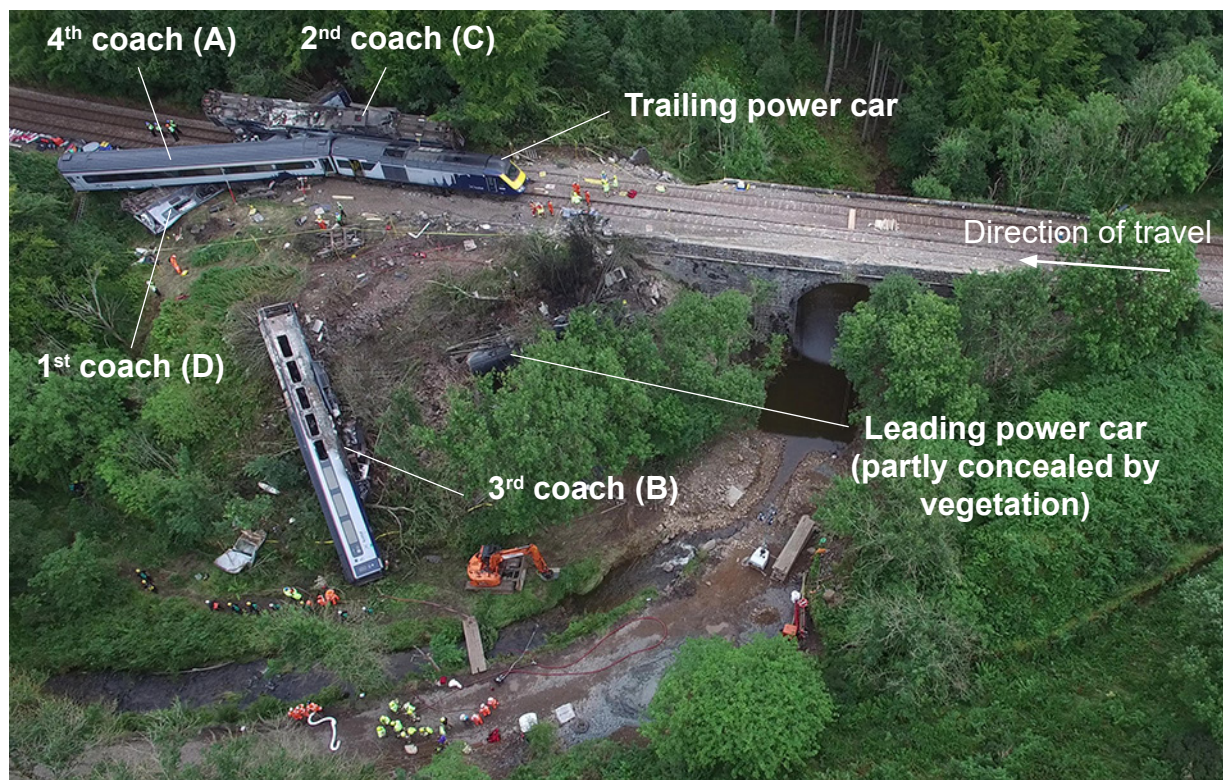
*The derailed train*

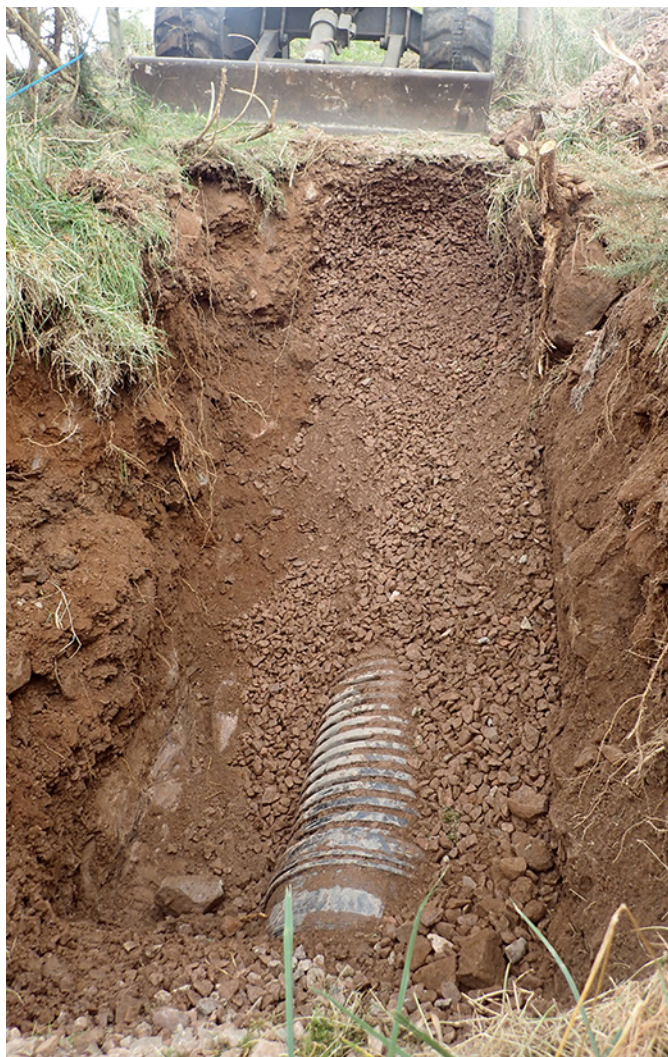
Figure 8: Gravel-filled drain close to washed out areas as exposed during post-accident excavations

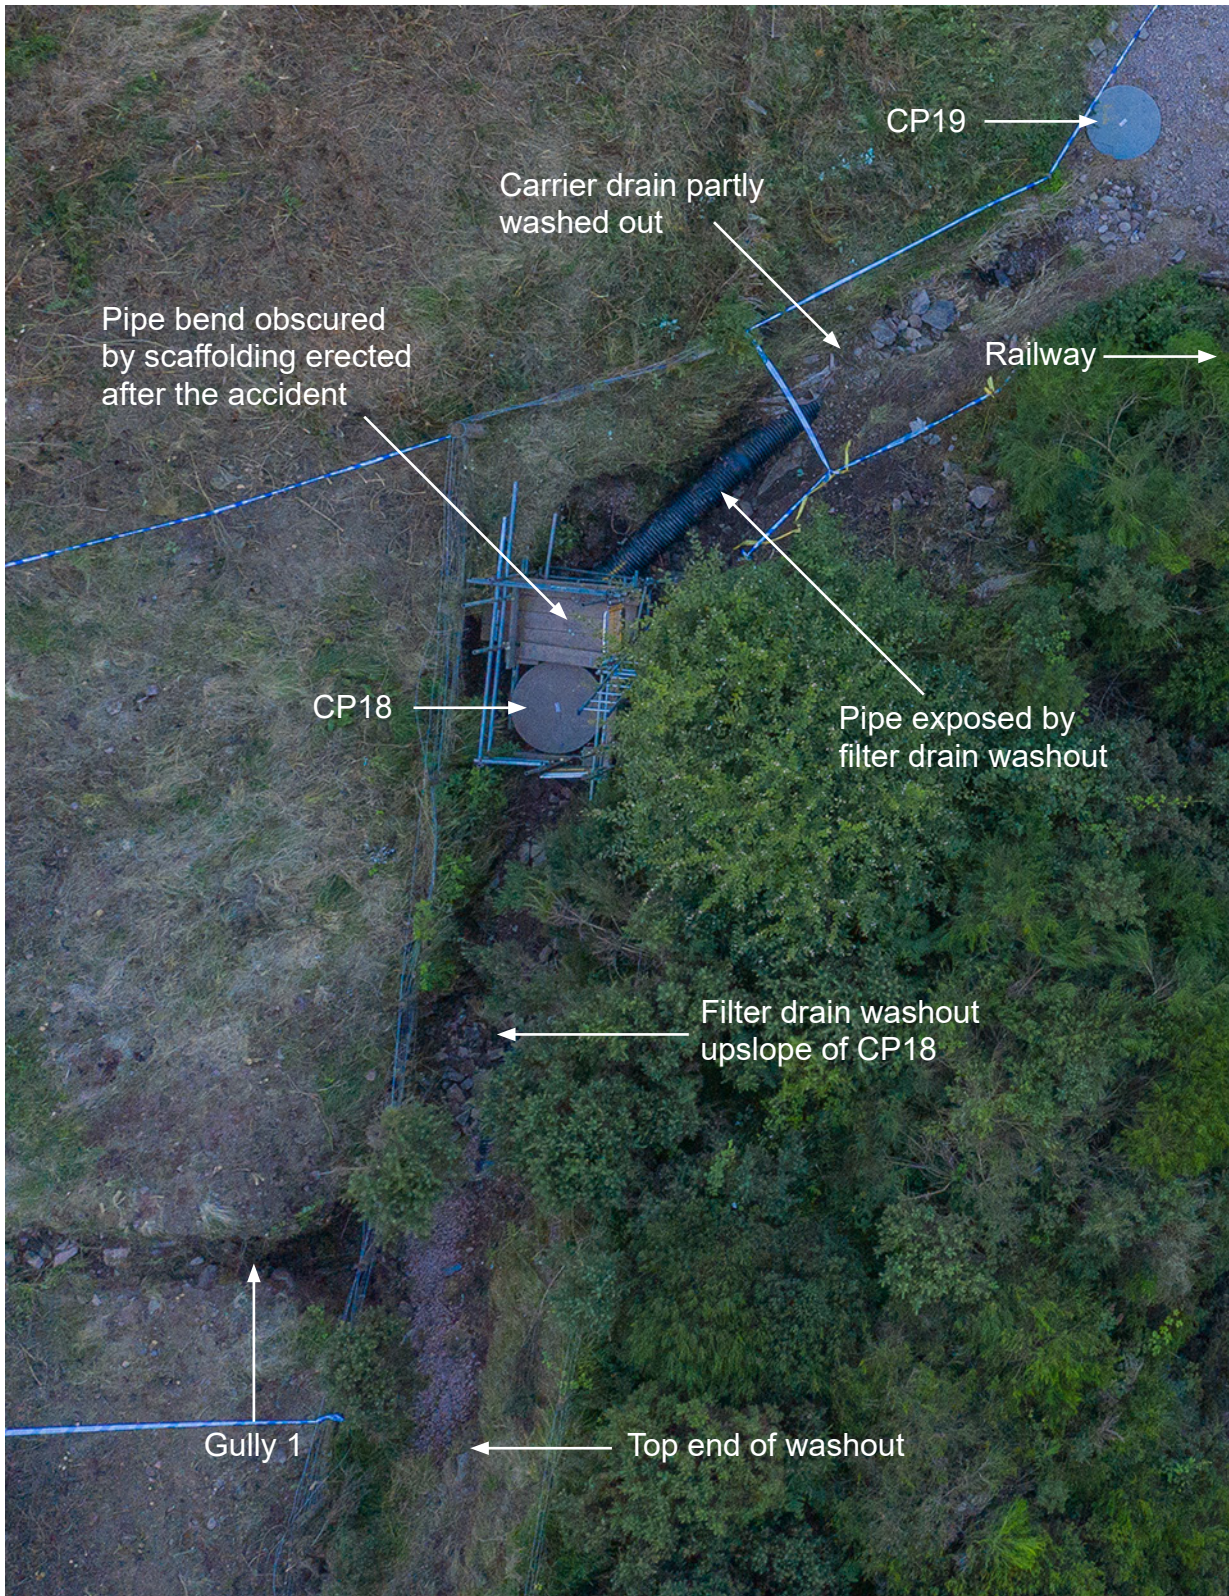
- 59 In the area of bridge 325, north of Carmont signal box, heavy rain between 05:50 hrs and 09:00 hrs on 12 August washed gravel from the 2011/12 drain (paragraph 25), together with stone and soil eroded from the ground on either side of the drain, onto the track. Most of the gravel was washed out from the drain trench for a distance of approximately 9 metres immediately upslope of CP18 and about 6 metres immediately downslope of this catchpit (figure 17 and figure 18). This, and stones from the surrounding ground, covered the down line between 220 miles 1610 yards and 220 miles 1621 yards (figure 19). The precise time at which this occurred is not known, but must have been between 07:07 hrs, when the last train before the accident passed this location (paragraph 50), and the arrival of train 1T08 at 09:37 hrs. Modelling indicates it was probably between 08:15 hrs and 09:00 hrs (appendix H).

Figure 17: Aerial view of CP18 showing extent of washout

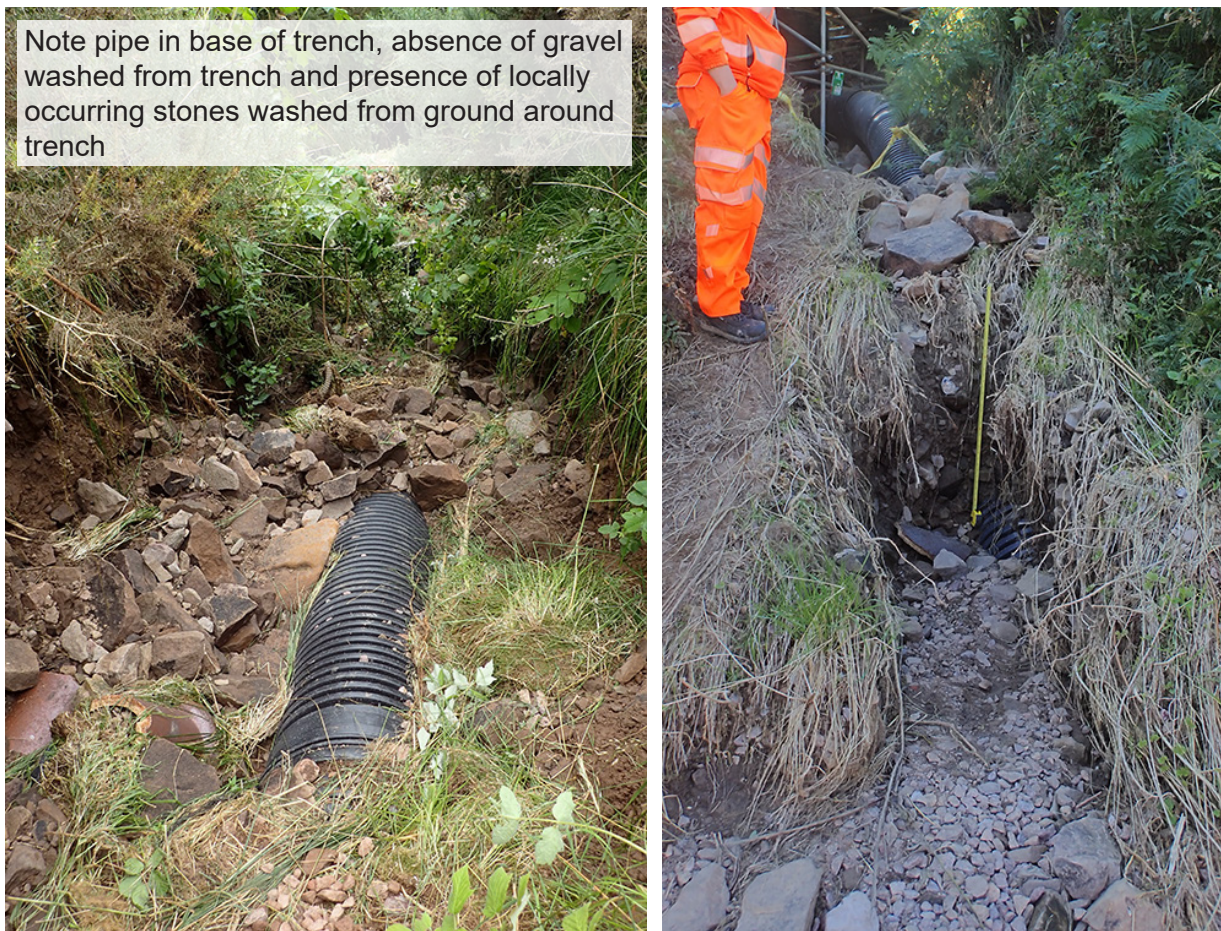
Figure 18: Washout upslope of CP18 (left image) and partial washout downslope of CP18, both images facing towards CP18

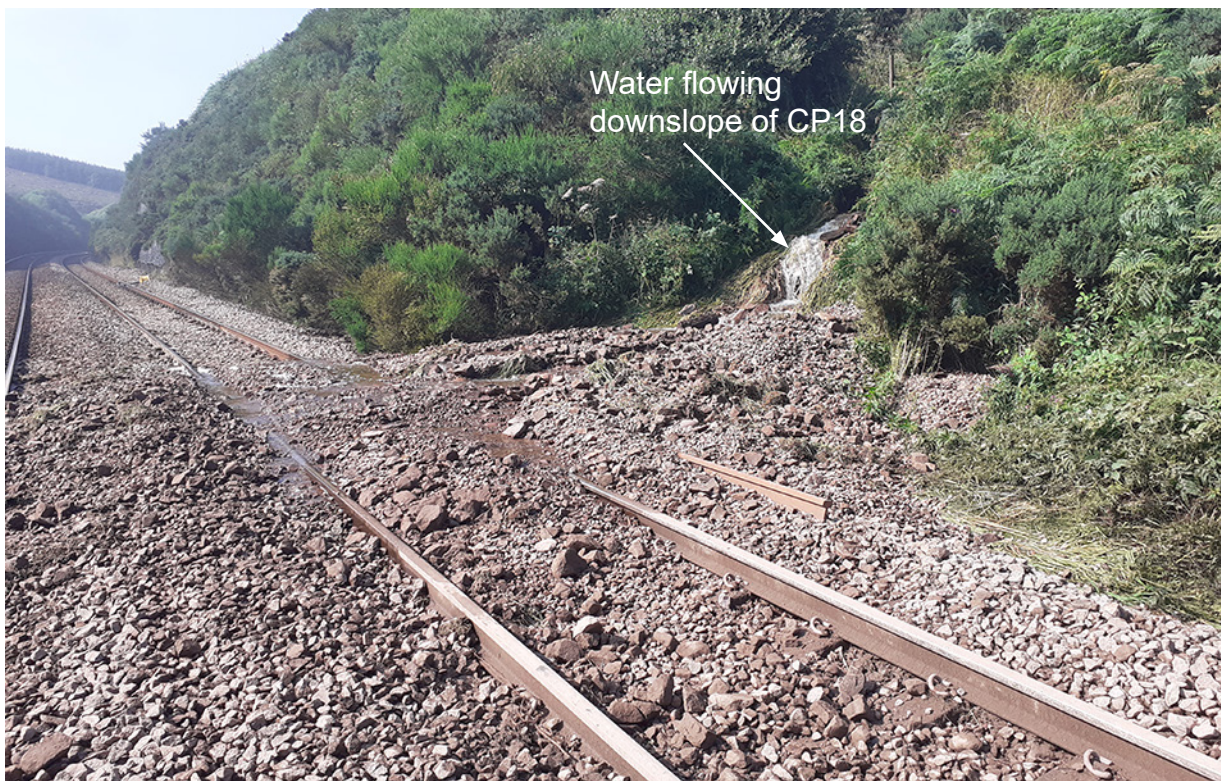
Figure 19: Washout debris on the track approximately 55 minutes after the accident. A short length of scrap rail unrelated to the accident is also visible (Story Contracting)

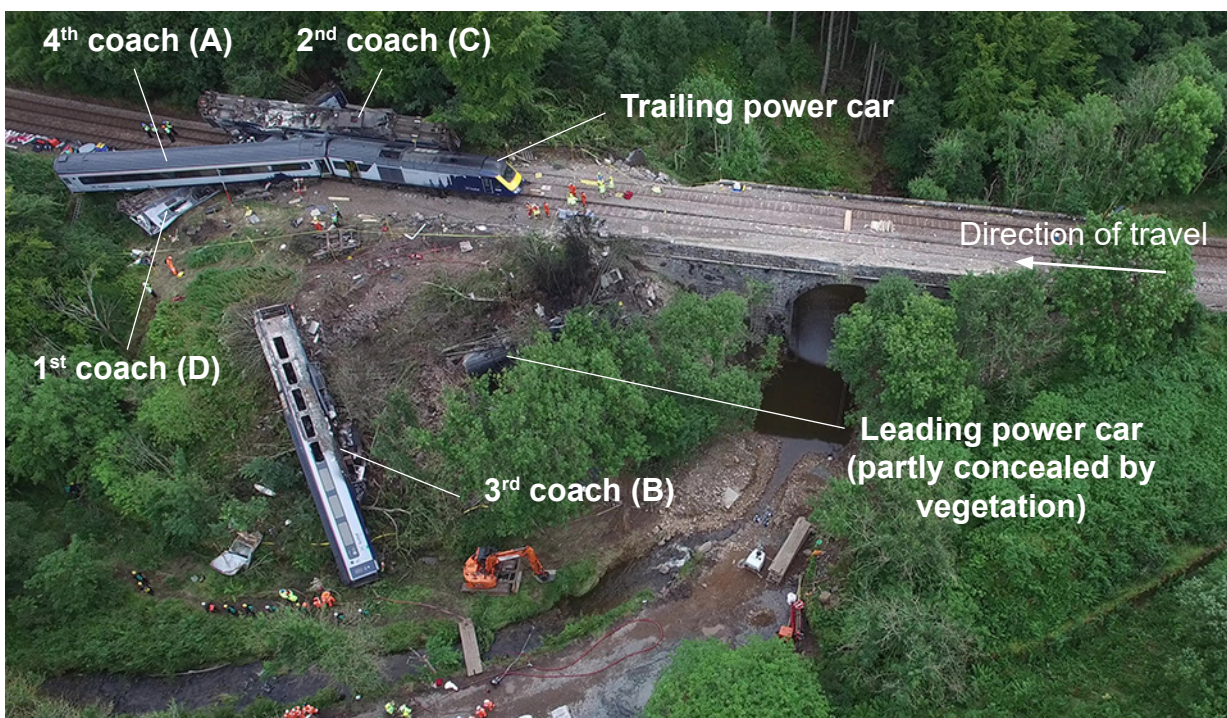
- 61 Three of the following five vehicles travelled in different directions beyond the bridge (figure 20). The first passenger coach (D) came to rest on its roof, almost at right angles to the track. The second passenger coach (C) came to rest overturned onto its roof with its trailing end on top of the first coach and facing the direction of travel. The third passenger coach (B) ran down the steep embankment to the left side of the railway, came to rest on its right-hand side and subsequently caught fire. The fourth passenger coach (A) remained upright and came to rest with its leading end on top of the first coach. The trailing power car remained upright on the down line, still coupled to the rear of the fourth coach. Its left-hand wheels were derailed and its right-hand wheels were resting on the right-hand rail which had rolled over to the right. The behaviour of the train in the derailment and the damage it sustained are described in more detail in paragraphs 453 to 469.

Figure 20: Derailed train

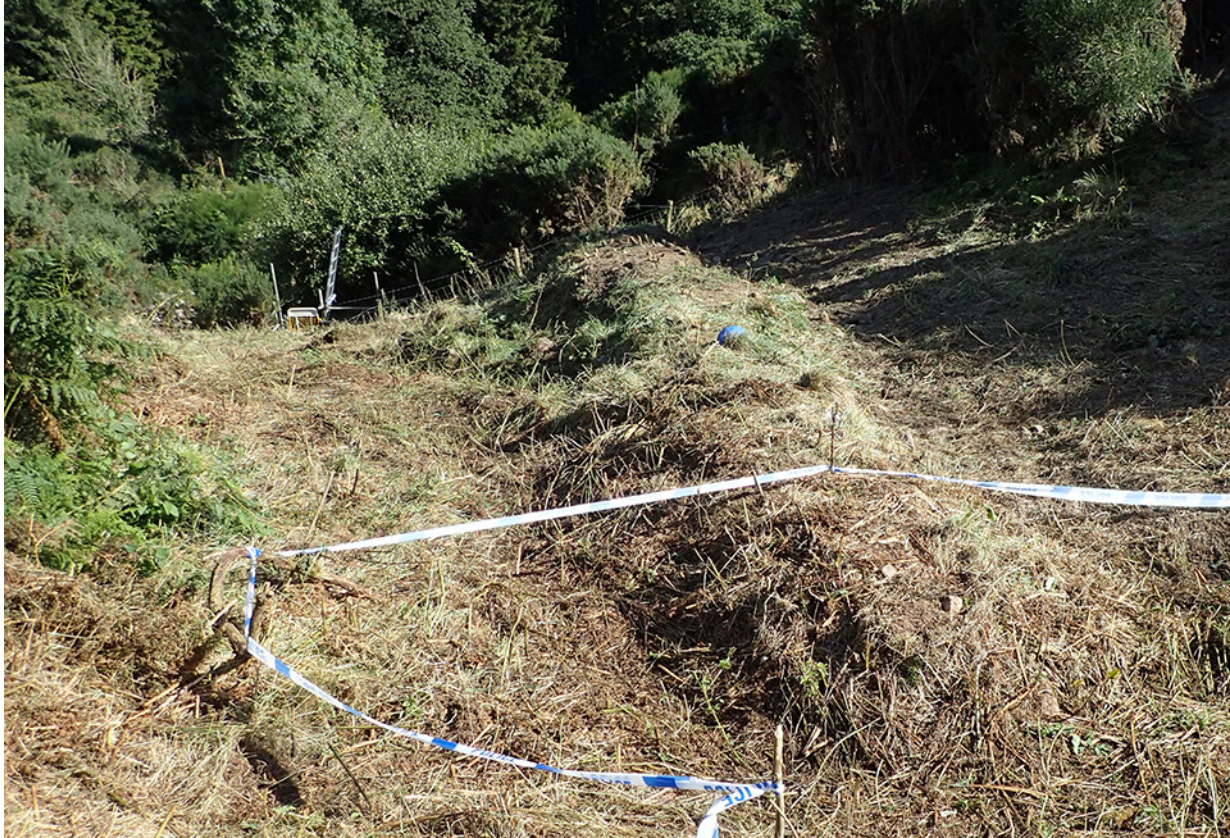
Figure 34: Bund viewed facing towards the 2011/12 drain post-accident after clearance of vegetation

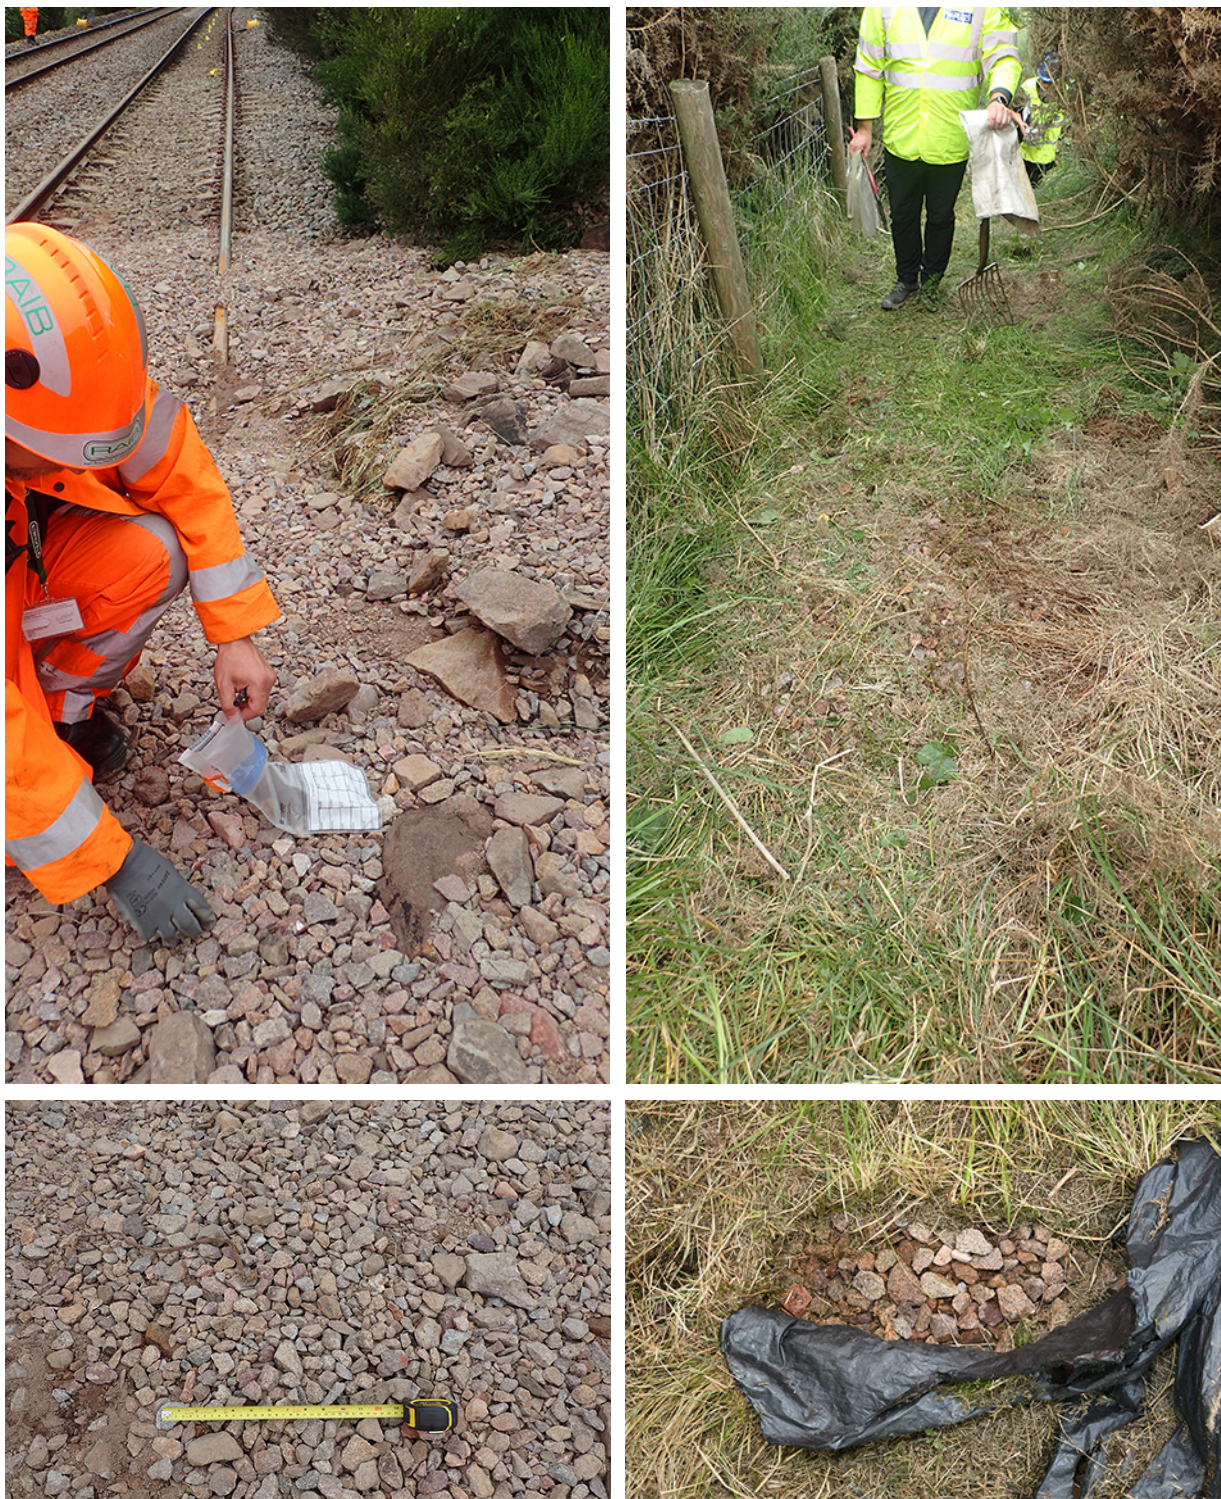
- 99 Site inspection by RAIB in the period immediately after the accident found that:
- The debris on the track comprised a pinkish-grey granite gravel with some gravel and cobbles of grey stone (figures 20 and 37).

Figure 37: Landslip debris (left-hand images) and undamaged area of 2011/12 drain between washout and CP16. Surface of drain, probably protected by discarded plastic sheet since around the time it was constructed, shown in lower right image (Police Scotland)

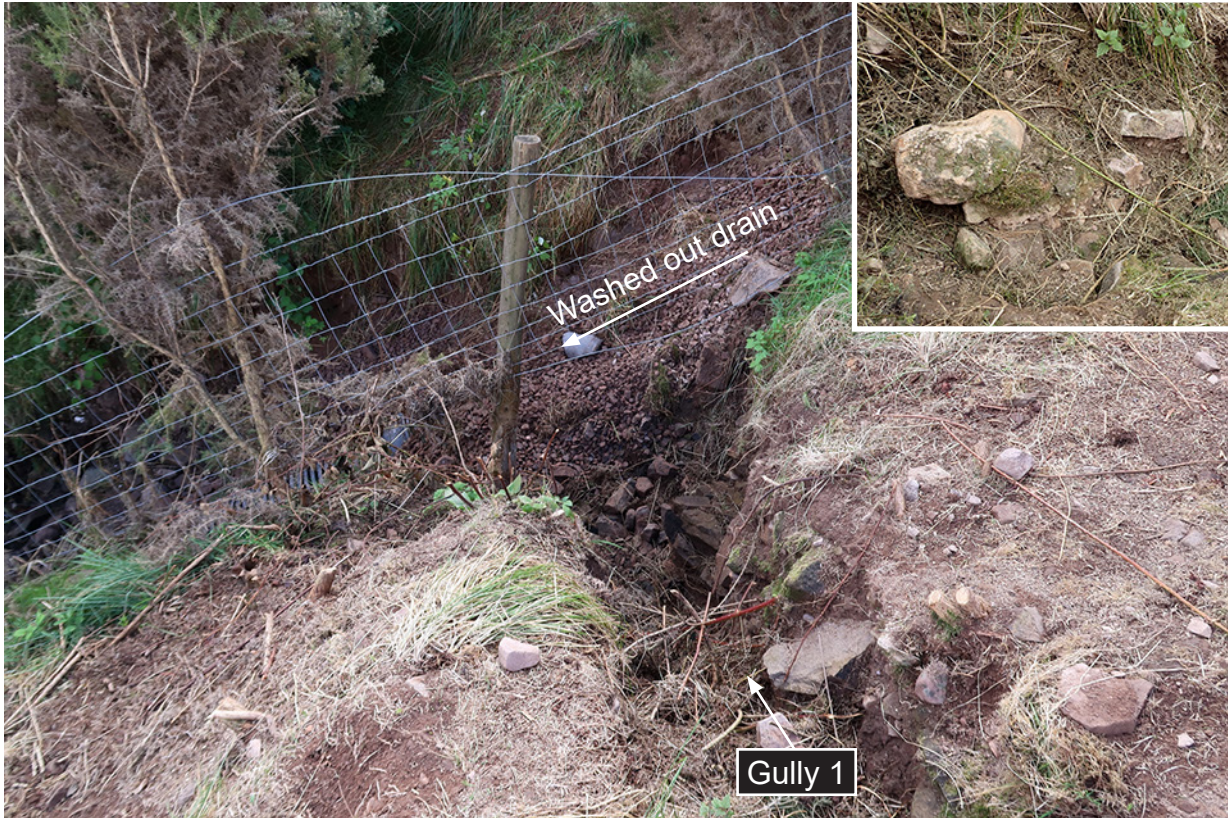
Figure 38: Gully 1 erosion at junction with 2011/12 drain (ORR/Coffey). Inset shows organic growth in base of gully 1 just outside main picture

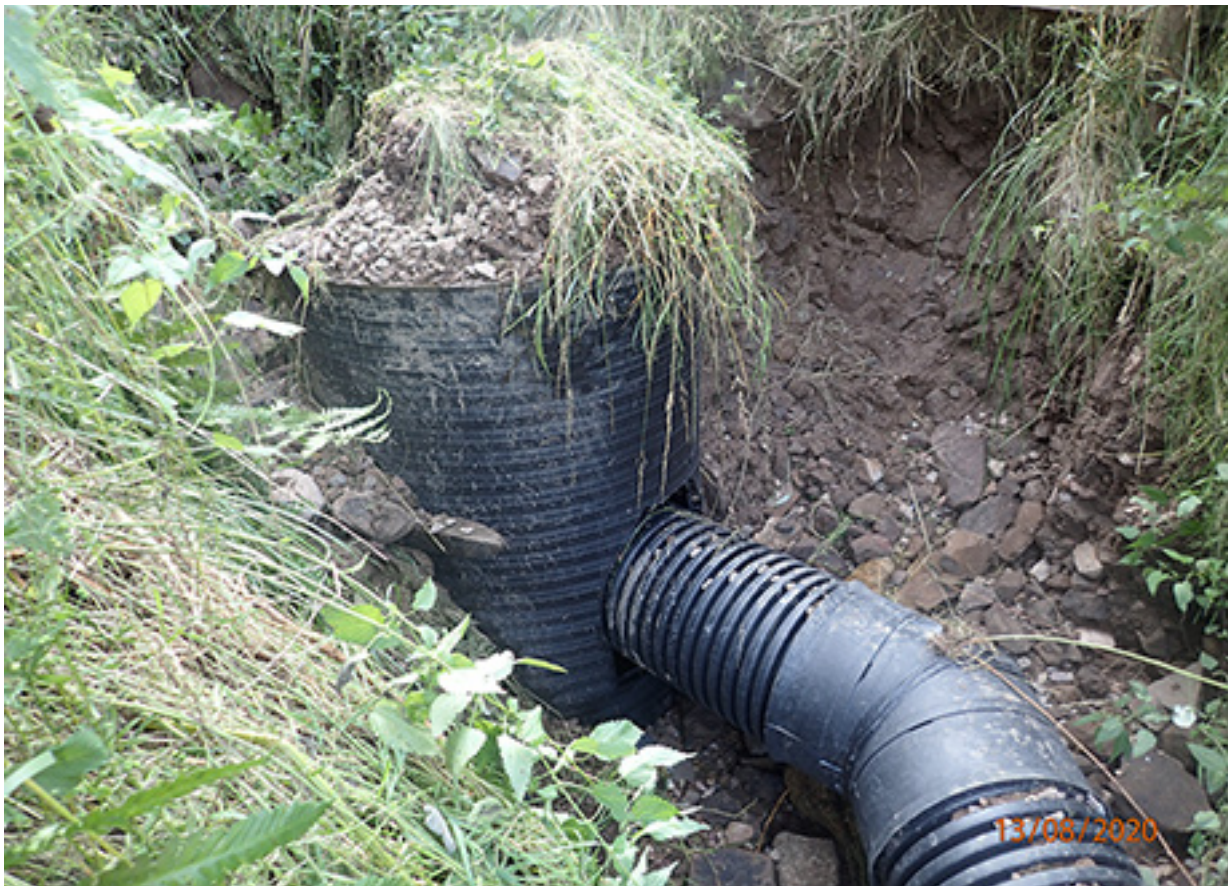
Figure 39: CP18 viewed from downslope on 13 August 2020 with the end of gully 2 visible at the upper right of the image

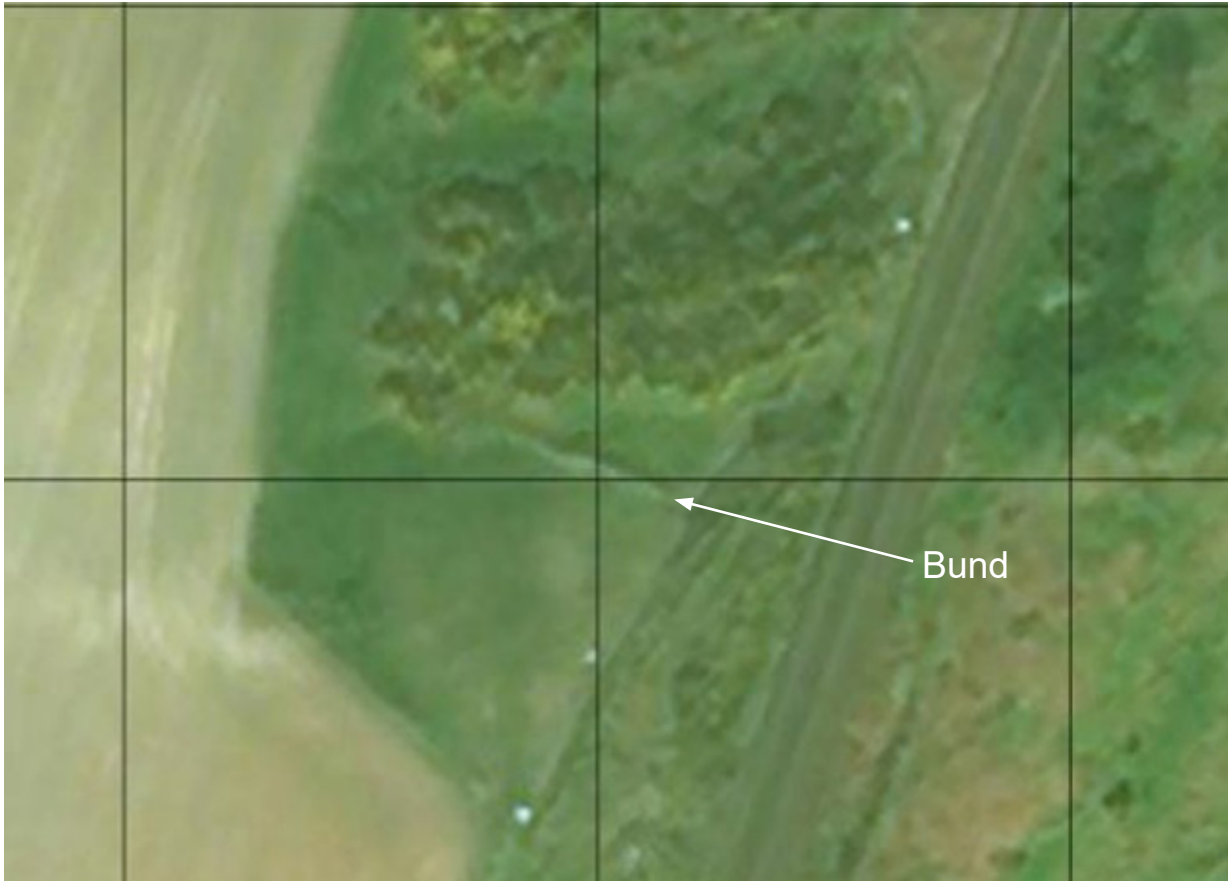
Figure 47: Satellite image April 2014 (Network Rail/ESRI Wayback imagery)

- 132 The bund is visible in a satellite photograph of the same area in April 2014 (figure 47). The larger, thus likely to be the older, gorse growing from the bund was found to contain 'tree' rings indicating approximately seven years' growth (that is, growing since around 2013). There is no evidence of any construction work in the area of the bund after completion of Carillion's drainage work.

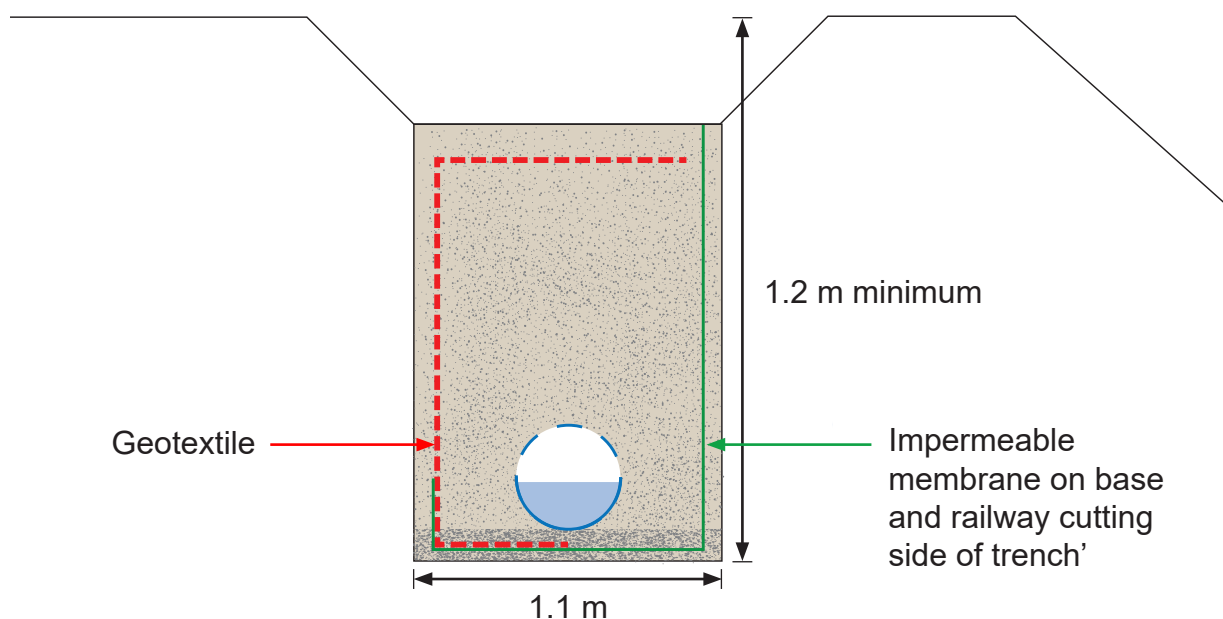
Figure 49: Drain as shown on Arup drawings (simplified from Arup drawing 002/002)

- 145 Arup's design for the 2011/12 drain required a geotextile to be placed on the upslope (field) side and near the top of the gravel. This is a sheet with very small holes which allows water, but not fine soil particles, to pass through it. This was intended to prevent fine particles in surface runoff water from being washed into the spaces between the gravel where they would impede water flow to the pipe. An impermeable membrane was specified on the downslope (railway) side and lower part of the trench, to prevent water seeping out of the drain and into the adjacent cutting slope where it could cause instability. The geotextile and the impermeable membrane are shown on Arup drawing 002/002 issue 04 'Drains and Pits' and in a photograph taken during construction at a location between the south end of the 2011/12 drain and CP16 (figures 49 and 50).

- 146 The geotextile was omitted in the area of the washout, as shown by post-accident excavation of the drain immediately upslope of the washout (figure 8), and by the absence of any geotextile within the erosion scar upslope of CP18 (although not a factor in the accident, the impermeable membrane was also omitted). These areas of drain were constructed in October or November 2012. Geotextile was visible in part of the length between CP18 (as-built) and CP19, in and near the section constructed in May 2011.

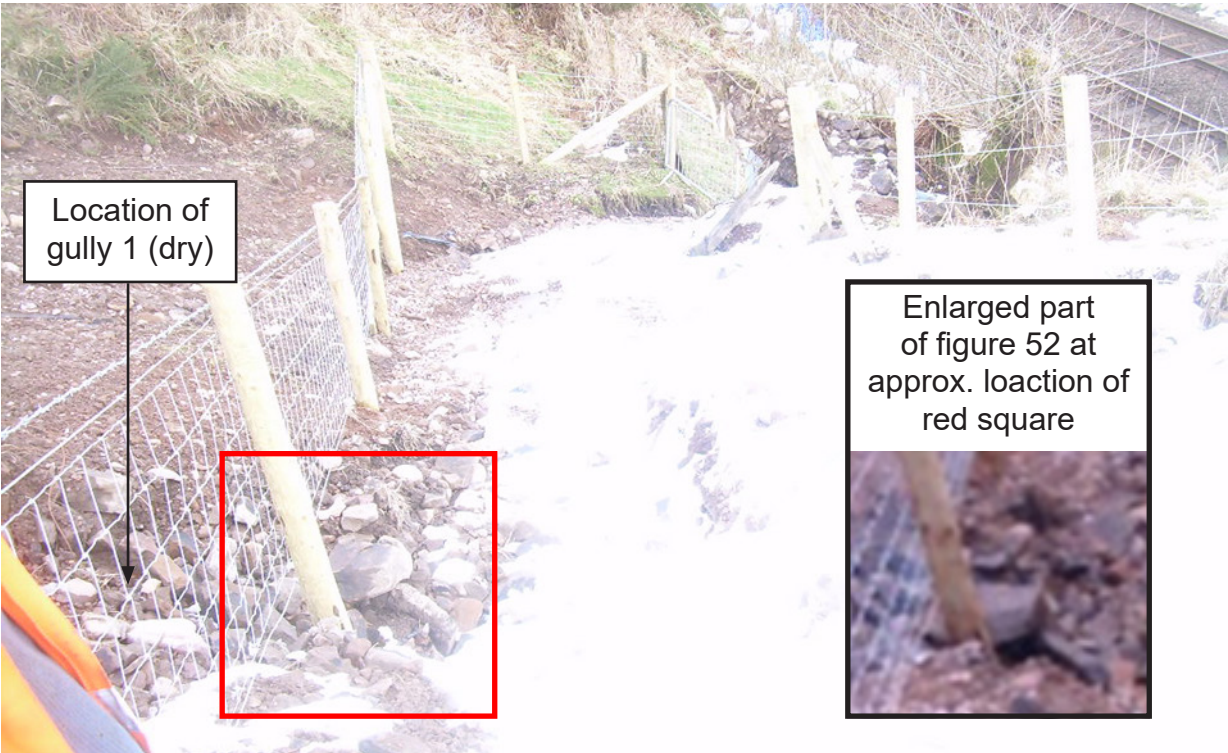
Figure 53: Surface of drain in light snow looking towards CP18 and railway in March 2013 during an inspection of the completed works (Network Rail). The original image is over-exposed

- 187 A photograph of this area was taken during an inspection of the completed works by Carillion and Network Rail in March 2013. Although the photograph is of poor quality, it indicates that the flow of surface water into the drain was established by the time of this visit (figure 53). Snow cover means the photograph cannot be used to definitively determine whether erosion on the surface of the 2011/12 drain was also still present. However, the limited areas visible on this photograph suggest remedial work had not taken place; there is no evidence of the ground surface disturbance likely to have accompanied any remedial work undertaken in response to the December 2012 photograph.

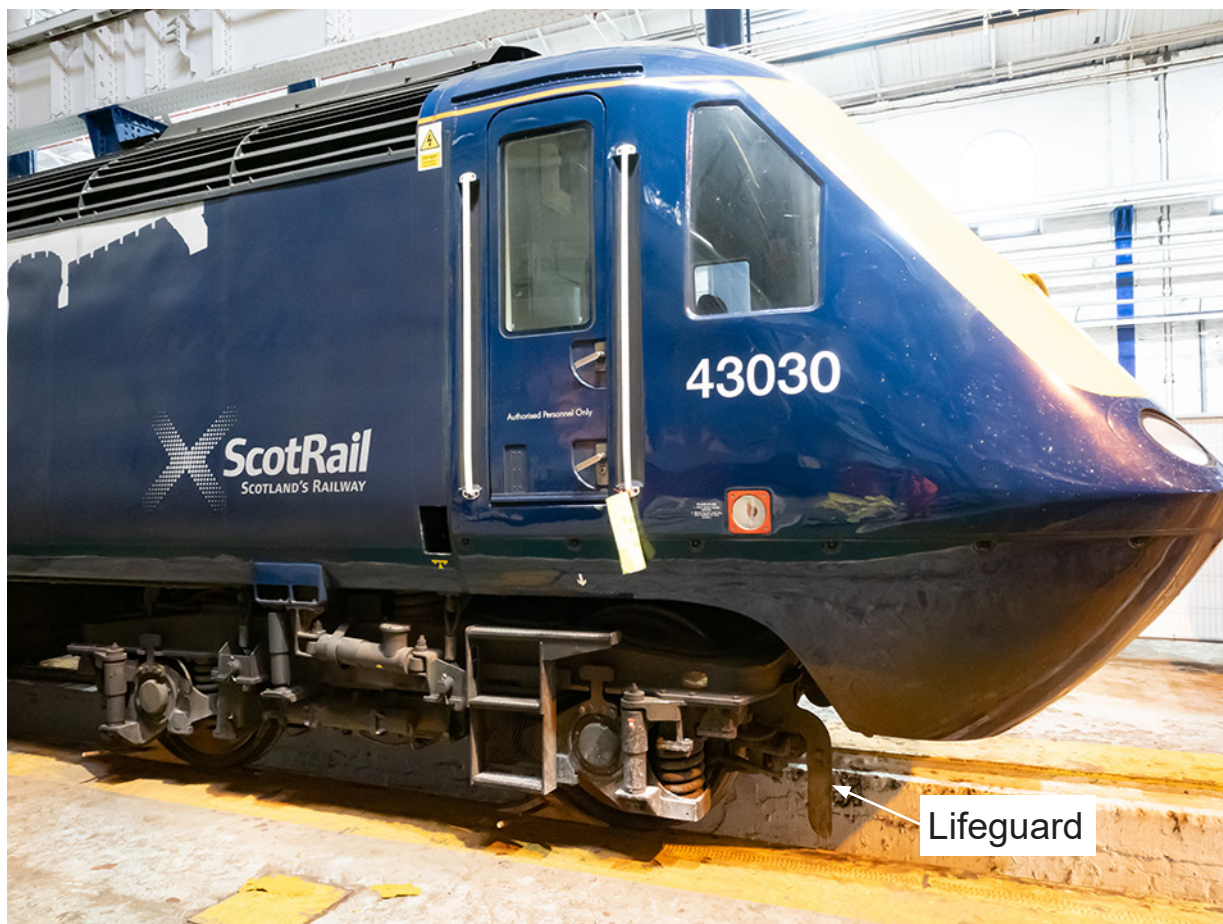
Figure 58: HST lifeguard (trailing power car)

268 Lifeguards on rail vehicles are heavy metal brackets fitted immediately in front of the leading wheels of a train. Their purpose is to prevent small<sup>30</sup> obstacles getting under the leading wheels and causing derailment. Figure 58 shows one of the lifeguards fitted to the trailing power car.

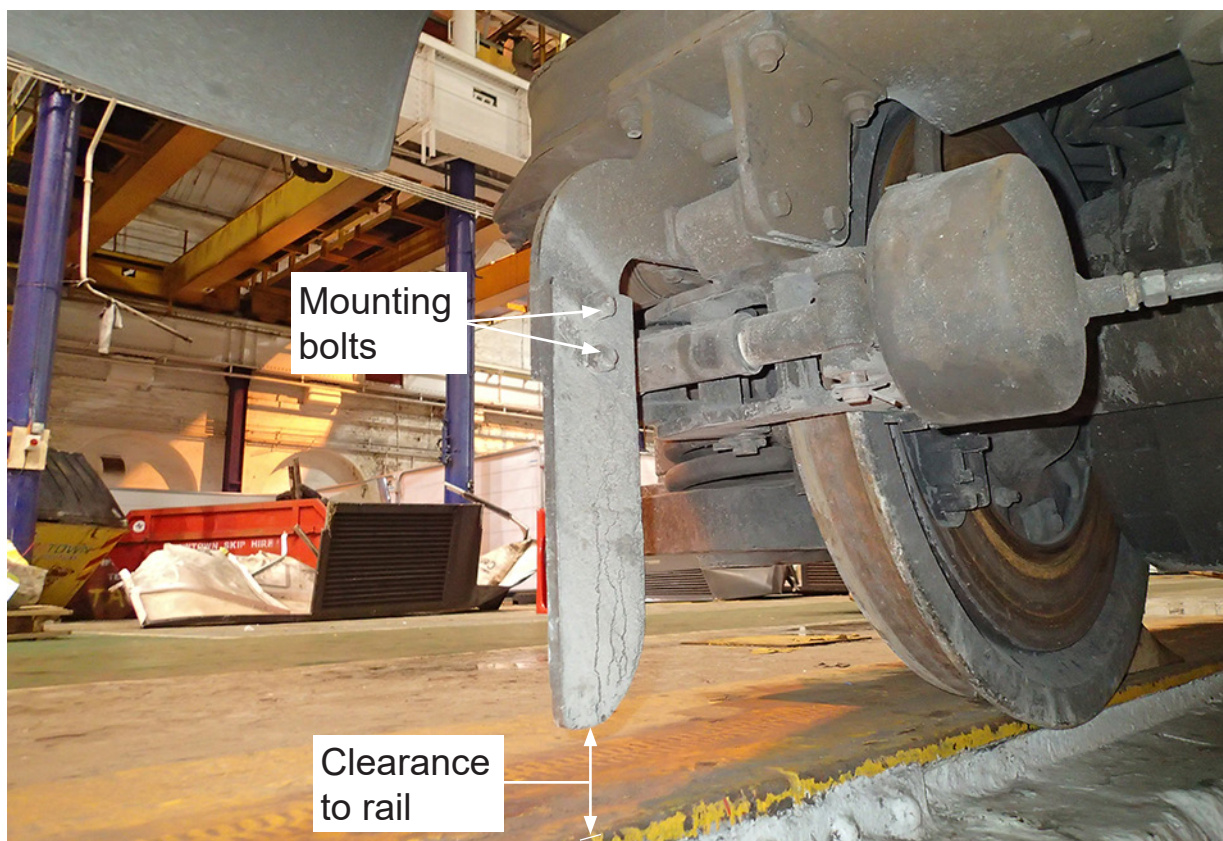
269 To allow for suspension movements and wheel wear, lifeguards are mounted with a clearance between the bottom of the lifeguard and railhead (figure 59) to ensure the lifeguard never contacts the railhead during normal operations. The amount of clearance varies between train types and until 2011 there was no specified value in British railway standards. From 2011 the LOC&PAS TSI<sup>31</sup> (now superseded by the LOC&PAS NTSN<sup>32</sup> which imposes the same requirement) applied to new rolling stock and introduced a height range above the railhead of between 30 mm and 130 mm in all conditions. There is a parallel requirement in British domestic standards, introduced from 2011, for a lifeguard to be positioned as close as reasonably practicable to the railhead taking into account wheel wear, suspension movements, suspension wear and assembly tolerances. The clearance of the lifeguards above rail level on the leading power car could not be measured due to the damage they sustained in the accident. The clearance on the trailing power car was measured by RAIB as 58 mm for both lifeguards. The normal operational range for HST power cars is 48 to 85 mm.

Figure 59: Lifeguard mounting bolts and clearance between bottom of lifeguard and railhead

- 271 The HST lifeguard was designed before the introduction of GM/RT2100. The lifeguard comprises a vertical blade made from mild steel which is bolted to a bogie-frame mounted bracket by means of two bolts (figure 59). Using design drawings, RAIB has calculated that the ultimate strength of the HST lifeguard is around 15 kN. This is less than half the minimum ultimate strength of lifeguards compliant with current standards. The weakest point of the HST lifeguard is the lower of the two attachment bolts, which shears when the lifeguard is overloaded, allowing the lifeguard to rotate backwards, so preventing it from carrying any significant load and performing a clearing function. At Carmont both lifeguards failed at the bolted joint and rotated backwards. This mode of failure is similar to that seen in a previous accident, but in that case the train struck heavy debris from a fallen bridge parapet, which would have been likely to have damaged a modern lifeguard.<sup>34</sup>
