Rail Accident Investigation Branch

# Rail Accident Report

## **Derailment of a passenger train at Carmont, Aberdeenshire 12 August 2020**

Report 02/2022  
March 2022

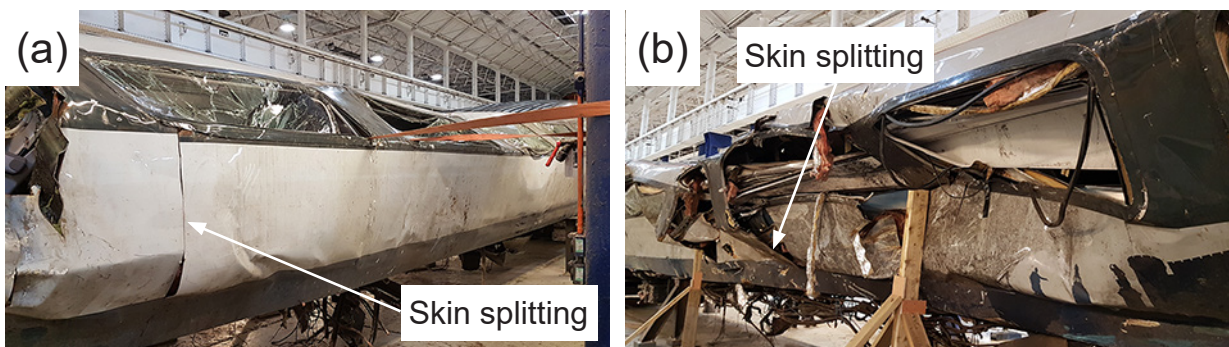
- 501 Vertical splitting of the bodyside skin panels was observed on all the coaches but particularly on coaches C and D. Examples of the bodyside splits on the left and right-hand sides of coach D are shown in figure 82. On examination, these were found to be due to failure of the welds that were laid to join the panels together during the original build, caused by inadequate depth of weld fusion. Because the mark 3 coach is designed as a monocoque structure the observed splitting of the skin panels is also likely to have aggravated the deformation of coach D.

Figure 82: Bodyside skin splitting on coach D, left side (a) and right side (b)

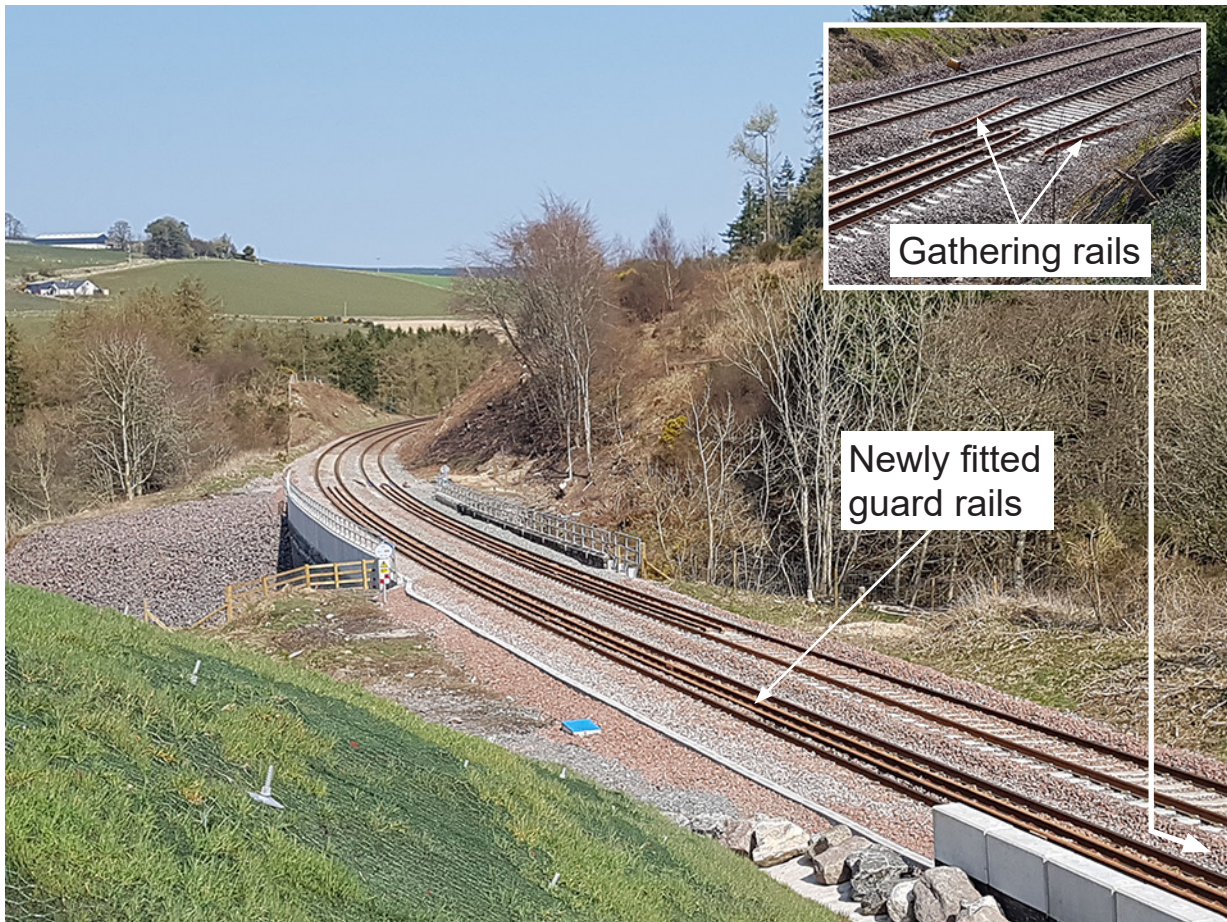
537 At the time of the derailment, no guard rails were installed on the approach to and over the bridge at Carmont. The purpose of guard rails is to contain any derailed wheels so that they remain close to the track and do not allow the train to deviate into collision with the infrastructure (for example, tunnel portals, bridge parapets) or trains on adjacent lines. Guard rails usually comprise a pair of parallel steel rails fitted to the sleepers in the four-foot. The ends of the rails are usually tapered so that they converge to a point at the centre of the track and are able to gather any derailed wheels. Gathering rails can also be fitted outside the running rails. To be effective in guiding a derailed train approaching a high-risk area, guard rails need to extend for a sufficient distance on the approach to the tunnel, bridge or other feature that poses the potential risk to the derailed train. Guard rails have since been installed at the Carmont accident site as part of the track reinstatement works (figure 86).

Figure 86: Guard rails fitted post-accident at bridge 325. The gathering rails are positioned at the start of the guard rails to the right of the main picture

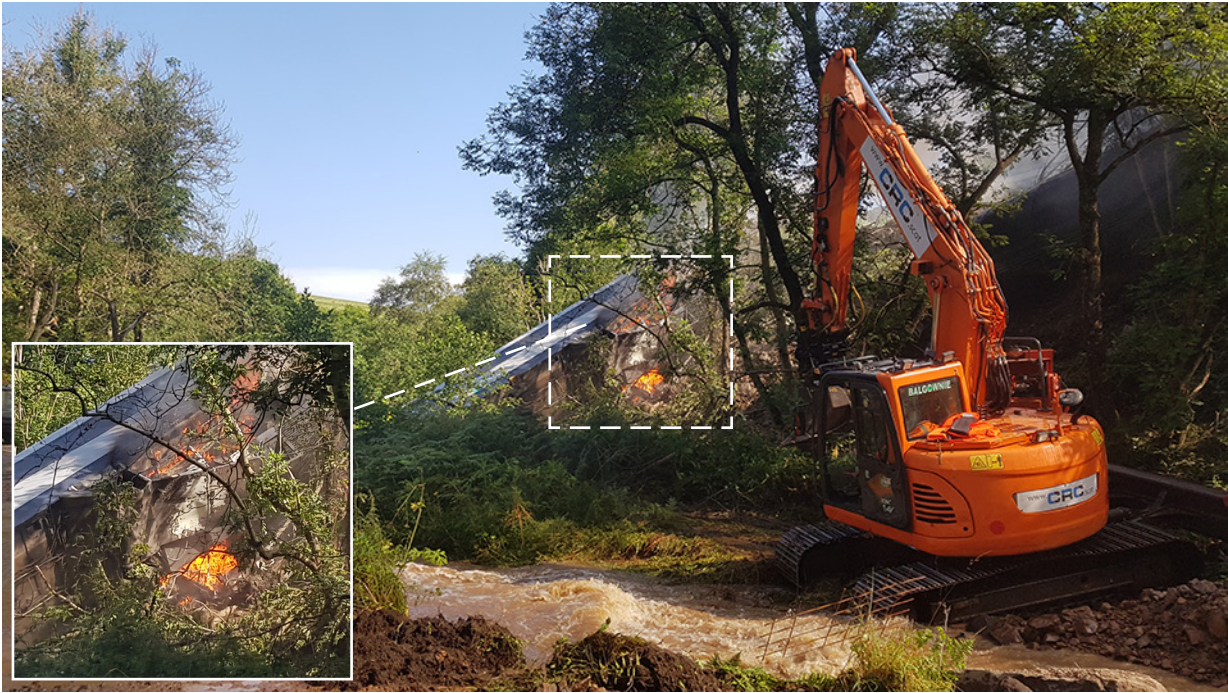
549 Coach B caught fire after coming to rest on the embankment flank with its right-hand side on the ground and sloping so its leading end was lower than its trailing end. The fire was not apparent to witnesses until around 11:00 hrs (approximately 90 minutes after the accident). Photographs indicate that no fire was apparent before 10:22 hrs, but by 11:09 hrs a significant fire had developed around the battery box (figure 88). The following paragraphs describe the evidence showing that this was the source of the fire which then entered the coach through a floor opening, required for the ventilation system, before spreading up towards the rear of the coach.

Figure 88: Coach B on fire at 11:09 hrs (Mark Davidson)

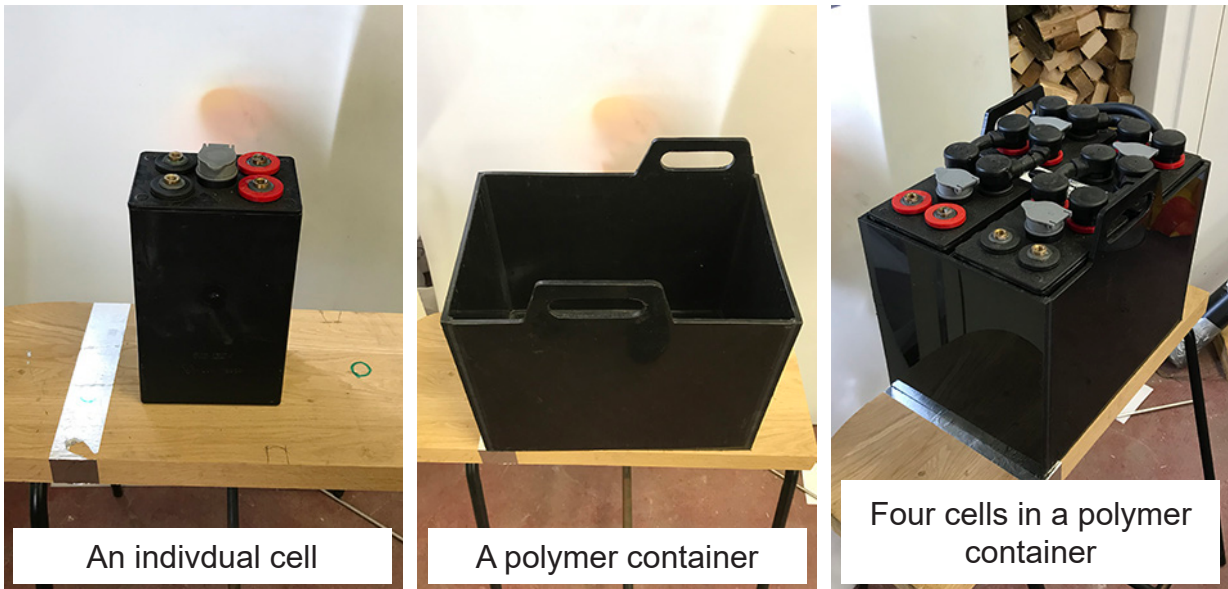
Figure 89: Coach B auxiliary battery arrangement

550 Coach B equipment included auxiliary batteries located in a battery compartment on the right-hand side of the underframe, between one-third and halfway along the coach from the front. The battery compartment contained 48 individual lead-acid cells, each of which contains 2 kg of a polymer material. These individual cells are packaged in groups of four, each group contained within a polymer box containing sheets of polymer honeycomb (figure 89).

- 552 The tests showed that the polymer battery boxes and cell casing materials are easily ignited, sustain burning at ambient temperature, generally burn until little of the material remains, and burn with a comparatively high heat release rate.

- 554 The means by which the cells, both those detached from and those remaining within, the battery box, were ignited has not been established. The destruction caused by the fire made this impractical. However, the Fire Research Centre reported that it seems probable that the underframe of coach B sustained mechanical damage as the coach was derailing. Such contact would have damaged cells, and electrical wiring, probably shedding battery acid and possibly resulting in friction heating as the underframe was dragged along the rails.

- 555 Electrical heating and/or sparking due to damage caused to electrical circuits are likely to explain the ignition of the battery materials. The large thermal mass (the ability to absorb and store energy) of the lead plates within the cells is considered likely to be the main factor that delayed the growth of the fire, and therefore resulted in the significant time period before combustion was observed on site.

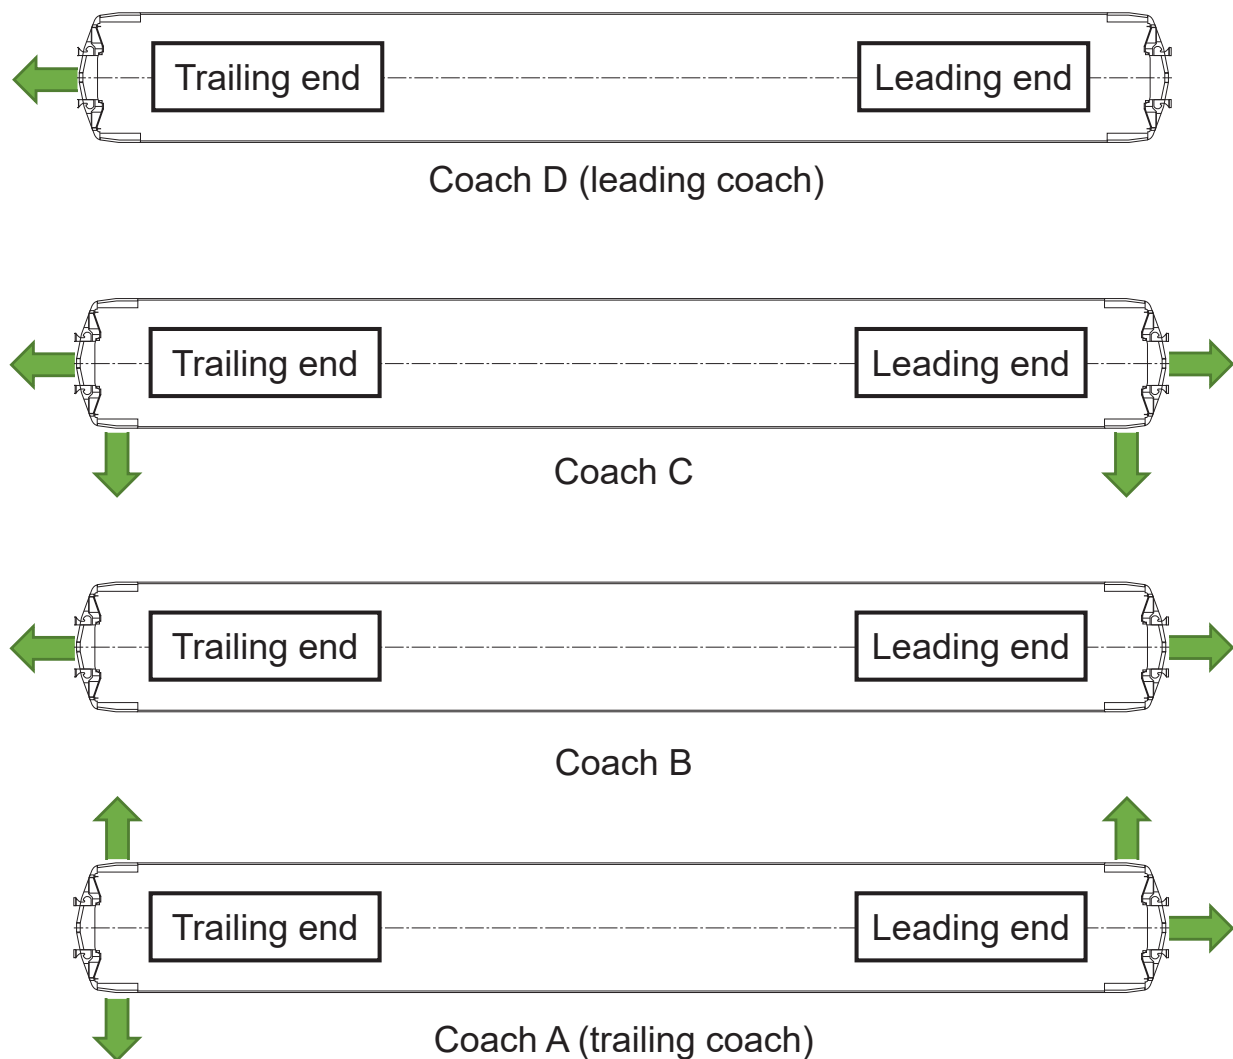
Figure 93: Egress routes available to survivors from each vehicle

564 Post-accident inspections of the train after it was removed from the accident site were undertaken to determine the status of the egress routes, taking into account the disposition of the vehicles on site. The forces required to manually open the doors after activating the emergency door release (where possible) were also measured. Those which required a greater force than 250 Newtons (25 kg force) were considered too difficult to open and considered unavailable. Figure 93 shows the available egress routes.

565 Coach D only had only one egress route available (discounting broken windows). All the other coaches had a minimum of two routes available. Coach B, which had rolled onto its side, only had two routes because the doors on the low side were blocked and those on the high side would have been difficult to open due to their position above anyone in the coach. There were no egress issues resulting from the power door modifications to the mark 3 coaches.

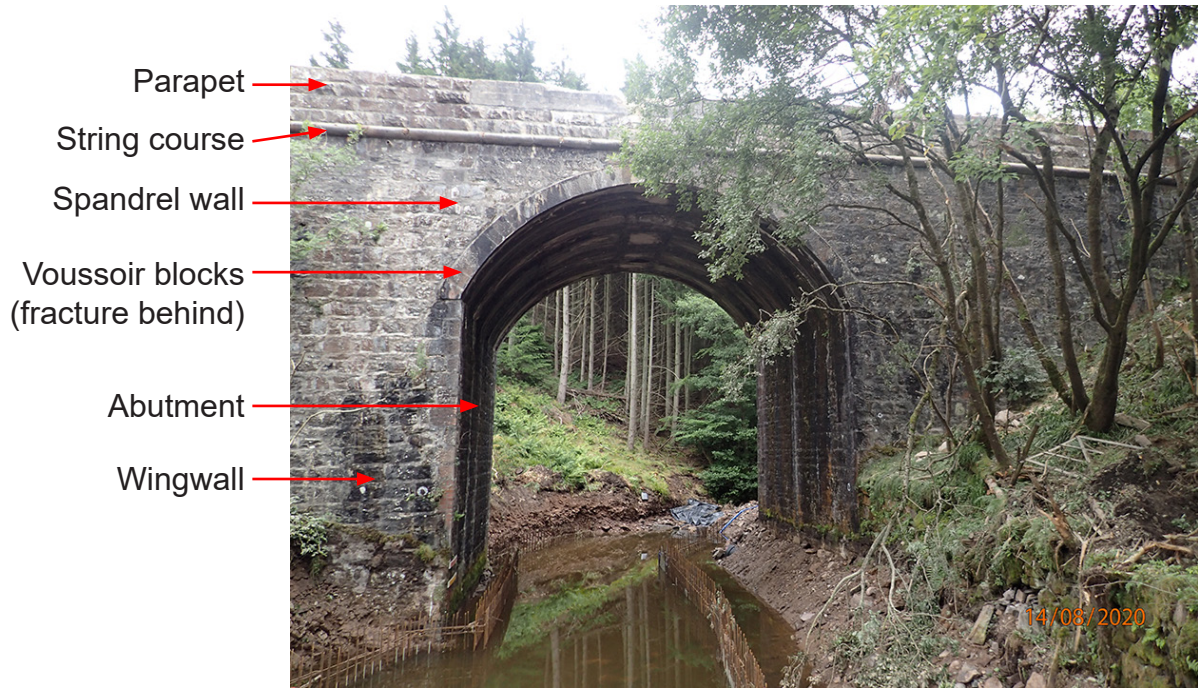
Figure F.7: Down-side elevation of bridge 325 on 14 August 2020

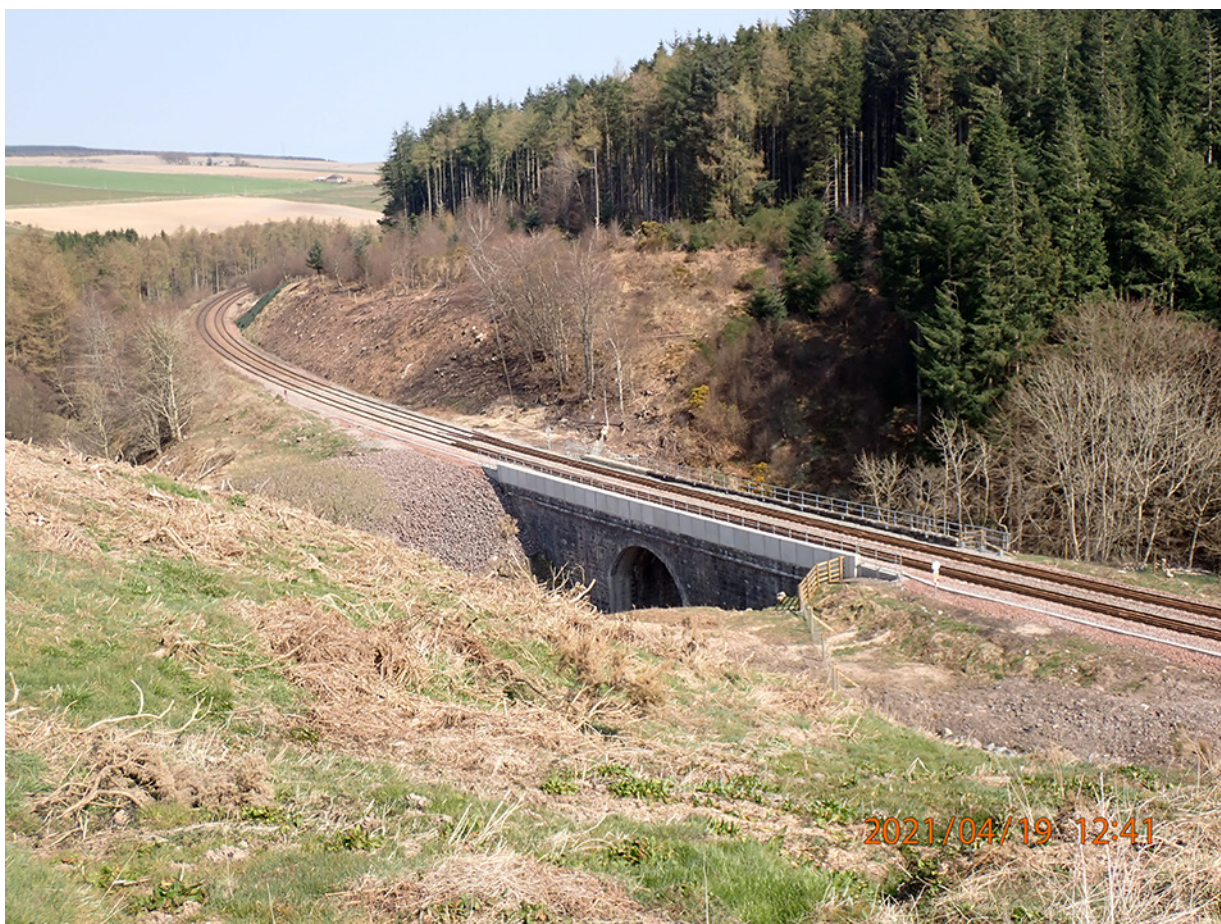
Figure F.9: Bridge 325 in April 2021 following the replacement of the down-side parapet and track

- Grouted stitching bars were installed to each stone (voussoir) in the arch ring embedded 2 metres into the arch barrel on both the up-side and down-side. Network Rail has confirmed that these works addressed existing defects within the structure (longitudinal separation fracture between spandrel (voussoir) and barrel), and were considered integral to reinstating the full integrity of the structure due to the potential impact damage suffered during the accident.

- Grouting of a vertical hairline fracture to the high mileage (north) abutment.

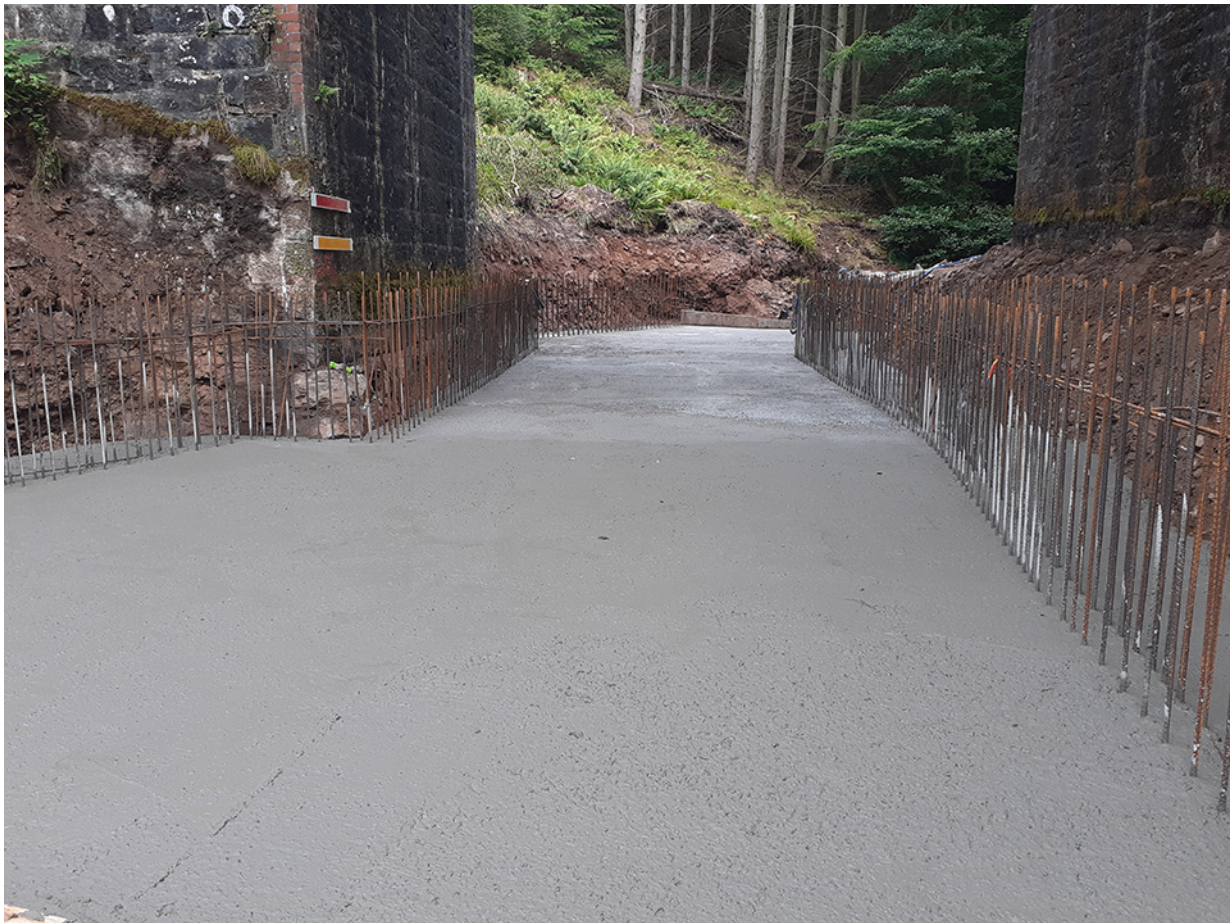
F29 At the base of bridge 325, scour protection works were in progress at the time of the accident to prevent the river eroding away the bridge foundations. The northern abutment had been identified as vulnerable during a scour assessment undertaken on behalf of Network Rail in September 2016. Scour risk meant that the structure was monitored when river levels were high, but this was not the situation on the morning of 12 August 2020.

- F30 In its planning application to Aberdeenshire Council submitted in June 2019, Network Rail described the works as ‘to construct a reinforced concrete invert within the channel near the bridge to provide a high level of scour protection with minimal excavation, mitigating the risk of undermining the bridge’s shallow abutment.’ Story Contracting was awarded the contract to install scour protection to both bridge 325 and bridge 328 located approximately 1.8 km (1.1 miles) further north.
- F31 Work at bridge 325 commenced on 20 July 2020, and the concrete forming the main base slab across the river bed was poured on 11 August 2020 (figure F.10). During these works, the river flow was controlled by a temporary dam and diverted through a pipe. There is no evidence suggesting that scour or the works being undertaken to address scour risk were factors in the accident.

*Figure F.10: Scour protection works at bridge 325 on 11 August 2020 (Story Contracting)*

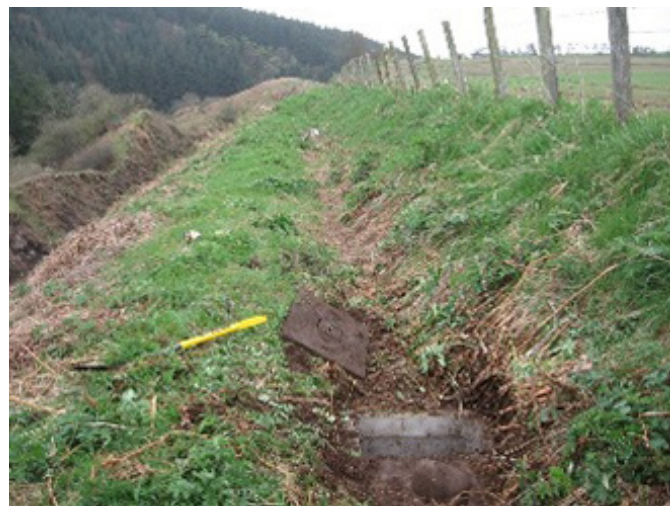
*Figure G.1: Pre-2010 crest drain catchpit between CP10 and CP16 showing drain close to the cutting crest in 2010 (Carillion)*

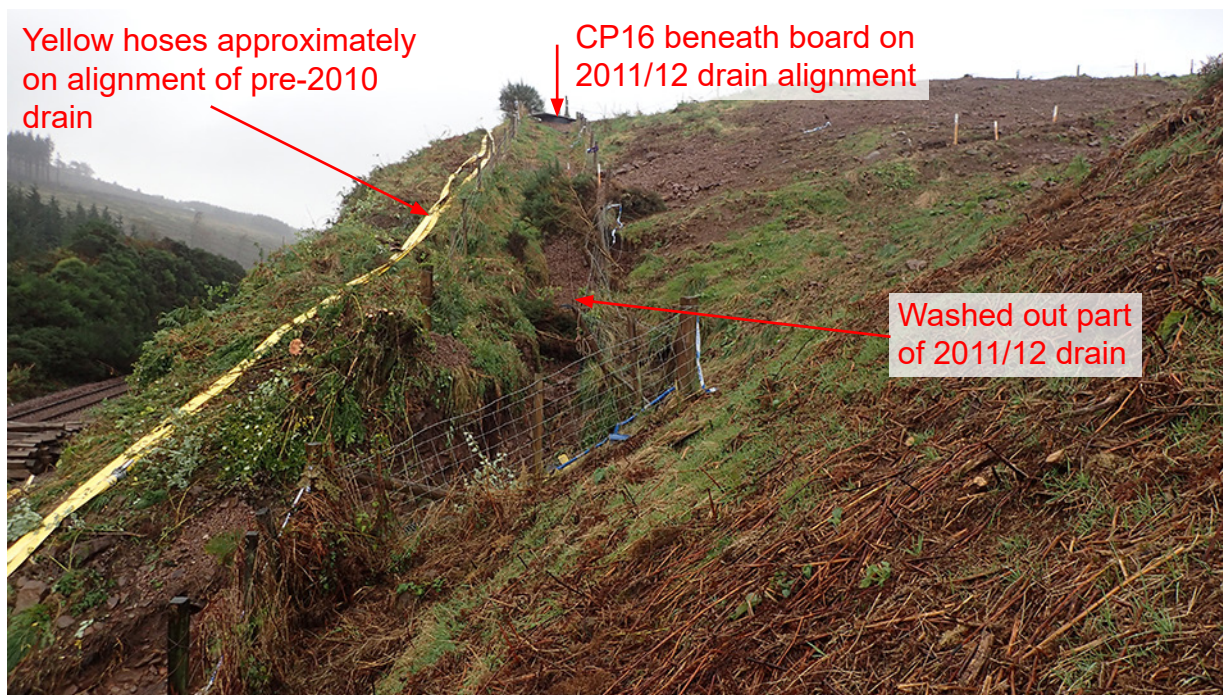
Figure G.2: View from near CP18 towards CP16 showing alignment of the pre-2010 crest drain and the 2011/12 drain after post-accident vegetation clearance

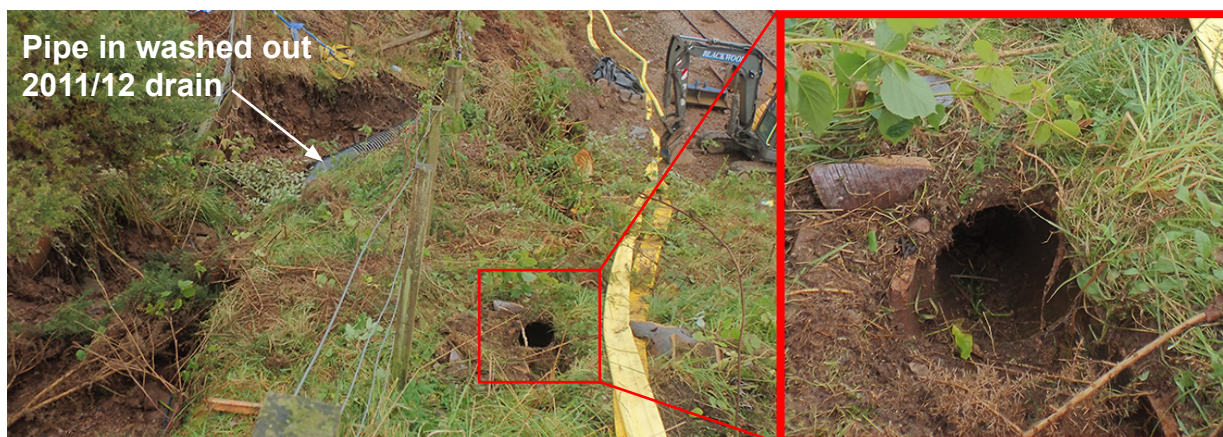
Figure G.3: Break in pre-2010 crest drain near top of washed out section of 2011/12 drain looking downslope with railway visible in top right-hand corner of image

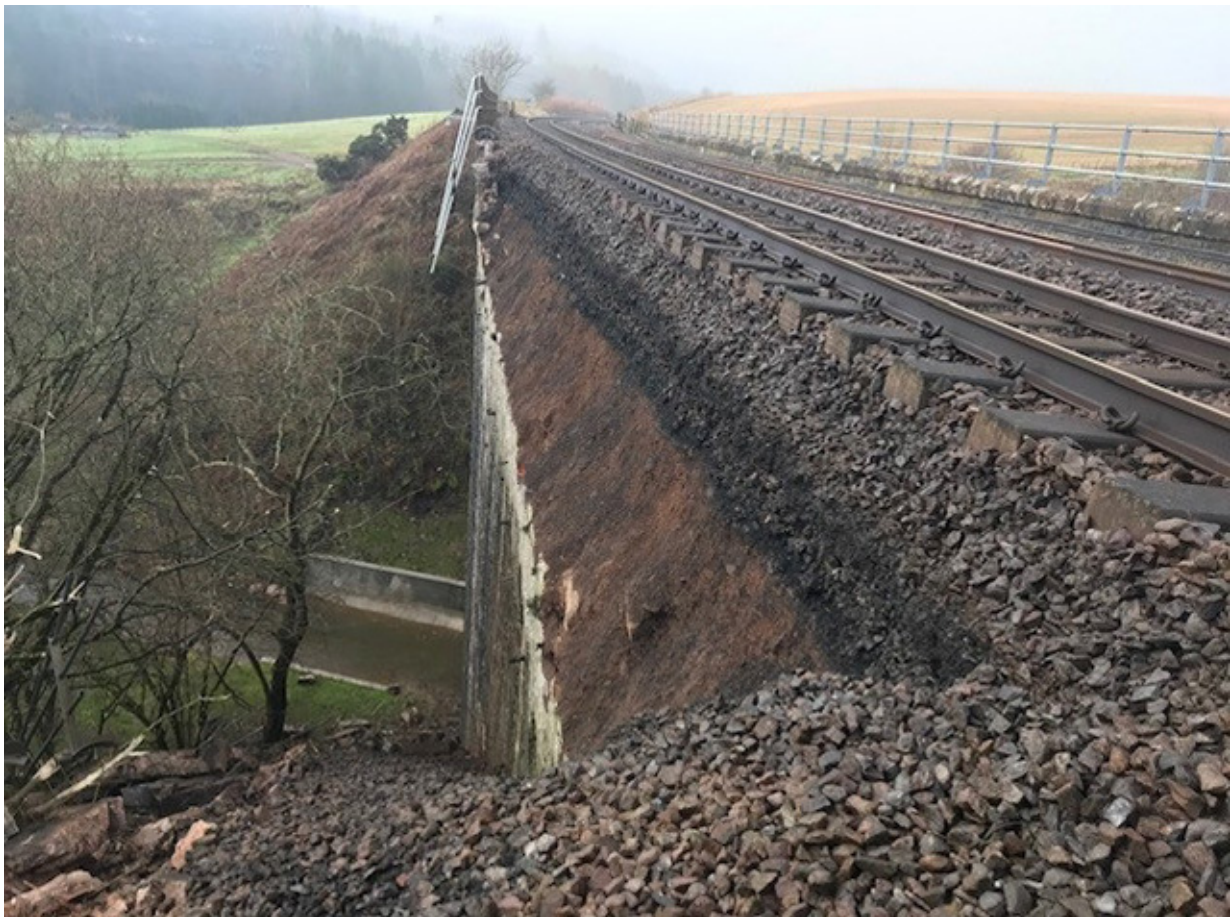
Figure M.2: Up line on bridge 328 looking south on 15 January 2021 (Network Rail)

- M5 An investigation undertaken by Network Rail found that the parapet had become pushed outwards by deep ballast on the bridge. Additional ballast had been placed as part of a track upgrade undertaken between 1980 and 1993. During this project, jointed rail was changed to continuous welded rail. The depth of the ballast was increased to support the stresses and forces generated by the rail being welded together and stressed and to allow train speeds to be increased. There was no evidence that the parapet wall had been designed to carry forces from the ballast and its failure was exacerbated by the presence of existing defects in the parapet and wingwall.

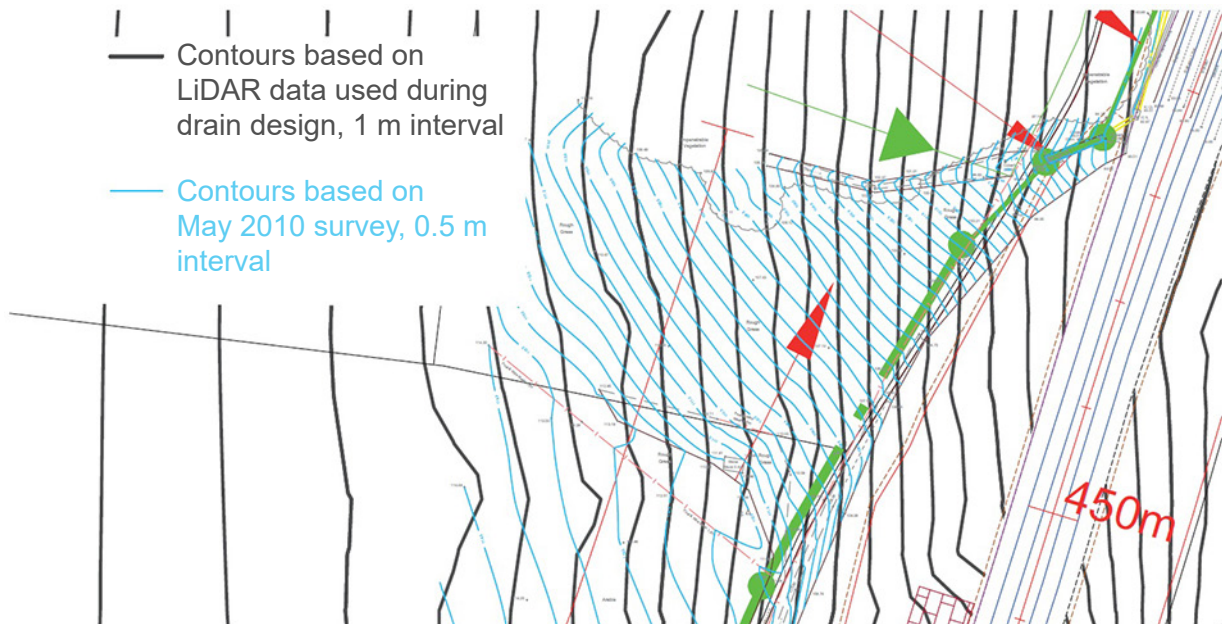
Figure N.1: Funnel area contours compared

- N3 The LiDAR data used by Arup lacked the accuracy needed to show the funnel feature, but this was shown on additional survey data which was provided to Arup in May 2010 (paragraph 95 and figure 33). The two sets of data are compared on figure N.1.

- N4 Some unwanted material excavated during construction of the 2011/12 drain was placed on the southern face of the funnel feature, so it is shown on the post-accident LiDAR survey, but not on the May 2010 survey. There is no evidence suggesting that the placement of this material affected the accident.
- N5 Network Rail standards applicable in 2010 did not specify the method to be used to calculate the amount of water reaching each part of the 2011/12 drain. Arup used the Institute of Hydrology Report 124 (IH124) method. AECOM confirmed that the Arup calculations were in accordance with this.
